## OLD SYDENHAM HERITAGE AREA HERITAGE CONSERVATION DISTRICT STUDY

Cultural Heritage Resource Inventory and Evaluation Report: April, 2009

## PART 1 CULTURAL HERITAGE RESOURCE INVENTORY AND EVALUATION

# PART 1A BUILT HERITAGE RESOURCE INVENTORY AND EVALUATION

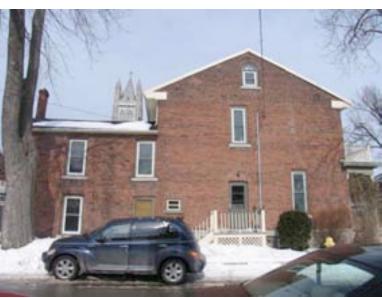
44 Clergy Street

William Street elevation including 'tail'

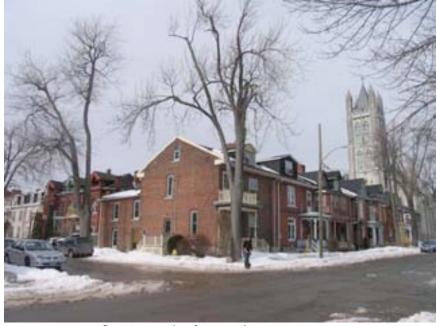
Streetscape view form southeast

Building appears to be generally sound but some decay at front porch and settlement of porch deck. Tie rods noted through gable.

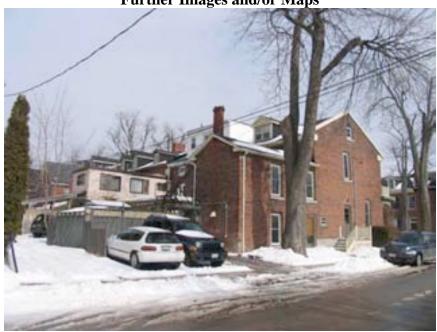
View from northwest showing relationship with 'cross' lane

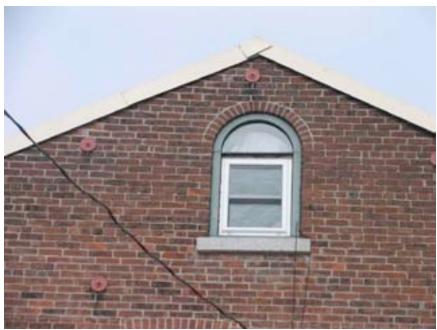
Arched window with rowlock voussoirs. Note wall ties and common bond brickwork

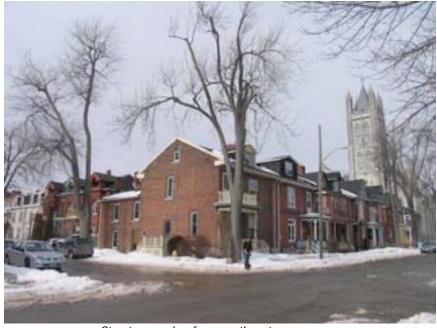
Streetscape view form southeast

Building appears to be generally sound but decay at front porch and at dormer sill.

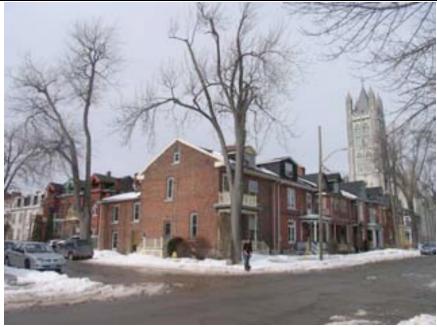
Streetscape view form southeast

Building appears to be generally sound but some sagging of the balcony and damage at the eaves where abutting the eaves of 50 Clergy.

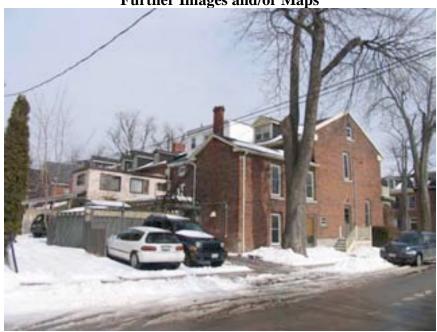
View from northwest showing relationship with 'cross' lane

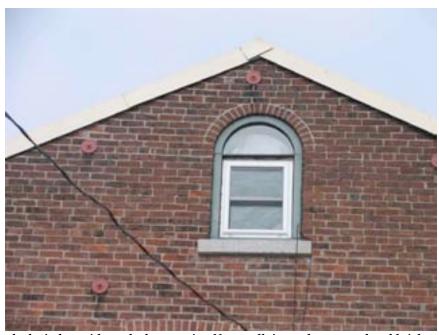
Arched window with rowlock voussoirs. Note wall ties and common bond brickwork

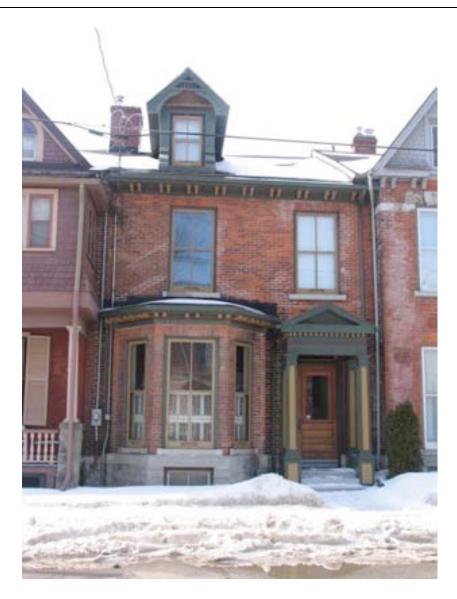
50 Clergy Street

Briefly describe the general condition of the property and highlight any areas of concern.

Property appears to be in generally good condition. However evidence of relatively recent repointing of past cracks and at these locations the joint is thicker and more variable than the original. Also some evidence of effluoresence (could also be mortar staining which had not been fully cleaned off.)

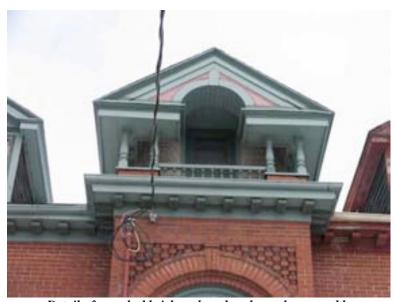
Detail of spandrel brickwork and umbraged cross gable

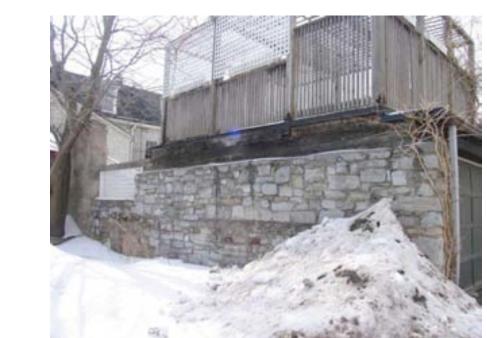
Section of original garden/boundary wall

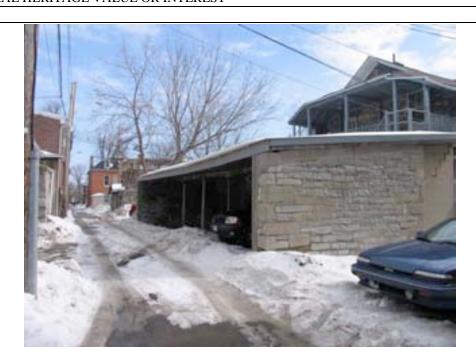
Stone 'tail' and surviving stone side wall of carriage house from lane

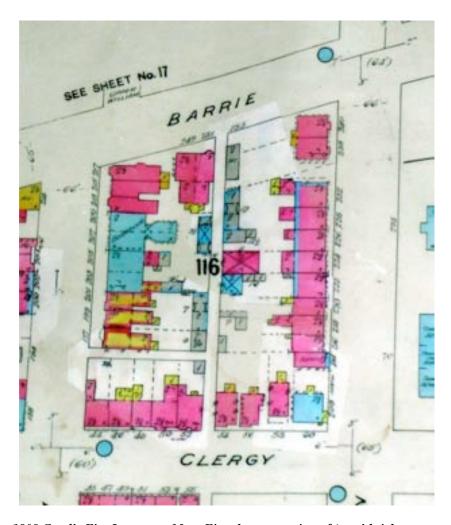
1908 Goad's Fire Insurance Map: First documentation of 'new' brick terrace.

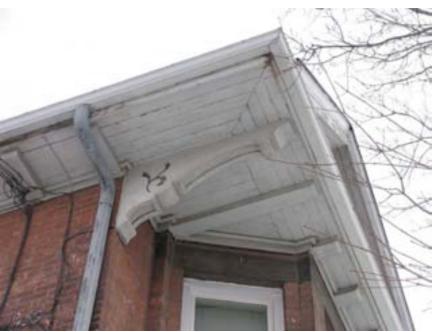
Detail of soffit at base of cross-gables Detail at projecting bay of 215 William. Note the right angled return at each section.

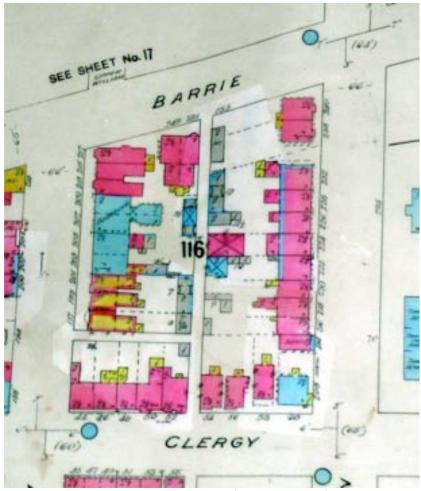
1908 Goad's Fire Insurance Map: First documentation of 249-251 Barrie.

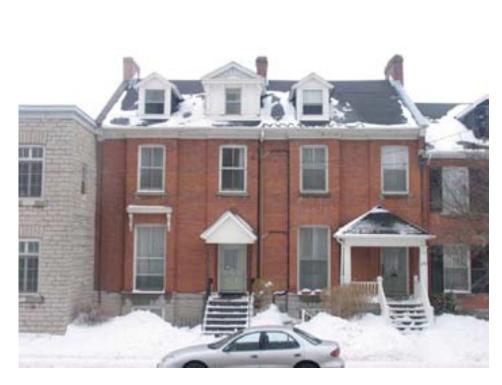
Front elevation

Generally sound but areas of open and/or deteriorated mortar joints at brickwork and flaking paint at cornice.

The limestone foundation is laid up in coursed ashlar, scrabble finished, with a beveled water table below the stretcher bond brickwork walling. Both units retain their original doors which feature two projecting prismatic panels with heavy panel moulds and a single glazed section above, also with highly articulated margins.

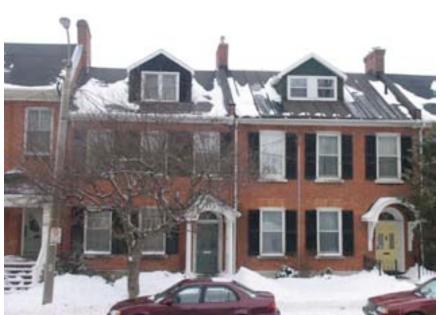
272-274 Johnson Street

The terrace is built on a coursed ashlar limestone foundation with scrabbled finish and beveled water table. The walls above are laid in stretcher bond brick with composite voussoired 'flat' (actually slightly segmental) arches at the first storey and simple voussoirs above (except for 282 which has a composite arch at the upper storey as well). Except for 272 Johnson the rear and west walls of the terrace are of roughly coursed 'rubble' limestone. At 272 the rear wall is constructed in common bond brickwork, suggesting it was built at a different time (probably slightly later) than the others. Actually while the buildings certainly were all built within a relatively short time frame, a close examination of construction and architectural detailing reveals that they were probably completed in four separate phases. 272 and 274 are each separate entities while 276-280 and 282-286 are each true double-houses. In each case the brick coursing does not extend through and there are variations in the finish and size of the foundation stonework between these sections.

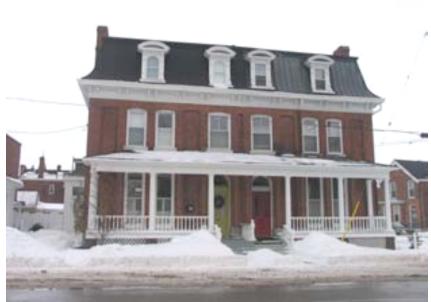
Front elevation

Generally sound but some areas of missing and/or deteriorated mortar, particular/y at west chimneys & upper wall.

Some spalled brick in that area. Flaking paint at cornice. Unfortunately roofing is nearing end of service life.

The two chimney stacks at each side elevation are the key features of those elevations, 'standing proud' with the arched niches above the roof line as noted above. The foundation is of coursed ashlar limestone with a beveled cut stone water table, a feature of the side elevations but not visible, due to the verandah, at the façade.

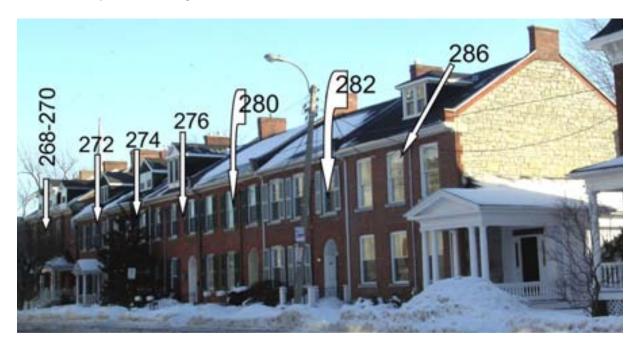
• **272-286 Johnson**, Wesley Terrace, row of 6 two-storey brick houses, built by 1860 for William Anglin (Walling map); 272 may have been built at a different time (note joint line in brick and

change in foundation stonework and that the rear walls of 274-286 are stone unlike the brick rear wall of 272) and attached on the east to 2 brick houses (268-270); although published as being by architect William Coverdale, the entry in his account book (E32, priv. coll.) is "15 Sept. 1858 plans for a cottage for William Anglin, paid \$30" and, consequently, 274-286 Johnson can not be attributed to him on that basis; the building date of 1856 is somewhat tenuously based on William Anglin living on Johnson Street near Barrie in the Canada directory for 1857-8; not on the 1850 map but on the Walling wall map of 1860 with the name W. Anglin and positioned opposite the Bishop's Palace; in the 1865 directory, Richard Tossell, builder, home 1 Wesley Terrace, Johnson, year r. of house and Henry Cunningham, J.P. (Chown & Cunningham), home Wesley Terrace, Johnson, opposite St Mary's Church; Cunningham is added in a different hand than the map-maker's to a plan of Block W watermarked 1850 on lots B and b while R. Tossell (?) is on lot 18 and J. Power on part of 17 with G. Baker on the remaining part ("Plan of the Block of Land as laid out into Lots, bounded by Barrie, Johnson, Clergy & William Streets, Kingston", watermarked 1850, filed with the 1892 fire insurance plan in Special Collections, Queen's University, no buildings are shown on the plan); in 1889-90 Mrs Richard Tossell is living in 220 Johnson, which today is renumbered 272 Johnson. Questions:

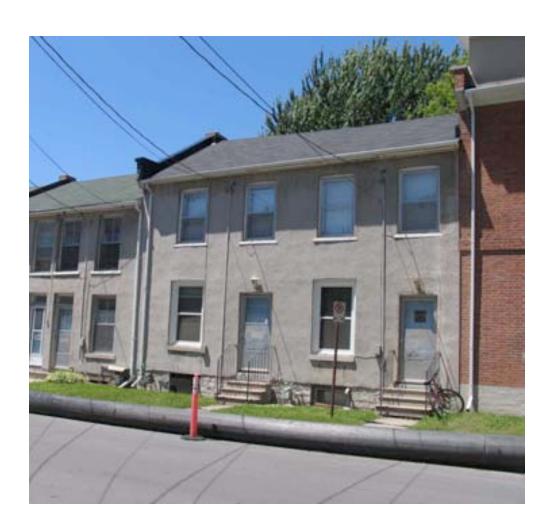
Front elevation

Generally sound but some cracks in stucco particularly in area of southeast door.

The appearance of the façade of this originally solid brick double house has changed a great deal due to the application of stucco in the later 20<sup>th</sup> century. However in scale, rhythm of openings, nature of roofline and remnant detailing it still manifests the essential character of the streetscape. The window and door openings have flat arches which, no doubt, are voussoired but it appears that the rectangular transoms at the doors have been infilled. The limestone foundation is exposed above grade and appears to be coursed, roughly squared rubble with a scrabbled finish. Its brick roof parapet at 172 is supported by a cut stone corbel and has a chimney (stack now lowered) at the peak.

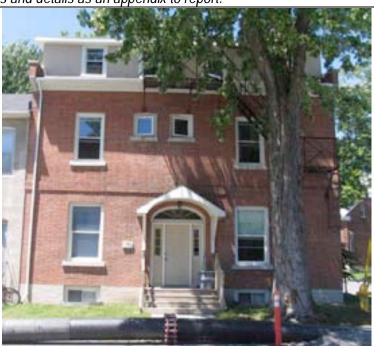
Bagot Street elevation

Generally sound but sandblasting has made the brick vulnerable to moisture penetration.

While the brick walls have been sandblasted and many of the windows and the main door and much of its surround replaced, this remains a mid-19<sup>th</sup> century brick structure of note. The first storey is constructed in true Flemish bond, relatively rare and typically associated with fine early brick construction while the 2<sup>nd</sup> storey and gables are done in a freer version with bond bricks more widely spaced but at both levels the corners are finished with Queen's closers. The brick walling rests on a stone foundation of regularly coursed hammer dressed limestone.

Despite the replacement of most of the main entrance treatment in modern materials what appears to be the original elliptical fanlight still remains. Opening placement at the Bagot Street façade is asymmetrical although this seems to reflect changes over time. Several openings have been closed in and, what appear to be, bathroom windows inserted. The Brosius 1875 'Bird's Eye 'View' shows symmetrical three bays on Bagot St. but no door. This is of interest as there is a bricked in door opening at the middle of the three symmetrical bays on William Street which now appears as a niche. It is possible that the building had two entrances, or perhaps the entrance was moved at different periods in the building's history. Certainly the brickwork of the arch above the fanlight at the existing location has been completed in the traditional manner and does not readily betray a Colonial Revival renovation.

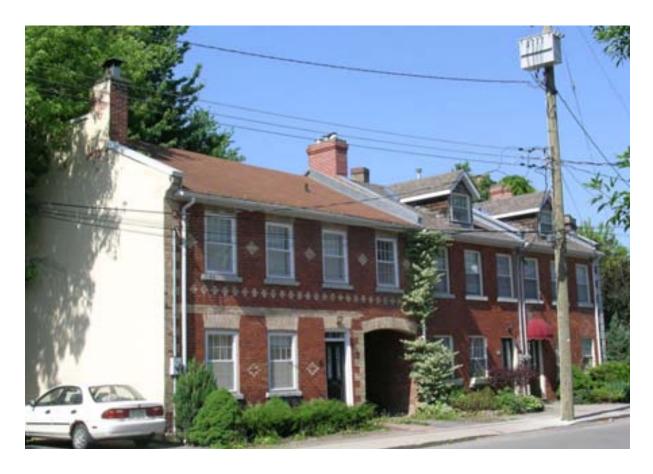
#### 112-114-116 William Street

- Lot 5, part of Park Lot 2
- Three units of red brick two-storey, attached houses with a common gable roof divided by parapets: 112 William is four bays long including a carriage-way next to 114 William; 114 William and 116 William are each three-bays with 116 terminating in a corner marked by stone quoining; 112 William is differentiated by an unusual pattern of yellow bricks forming decorations and quoins; the appearance suggests different building dates but the documentation is difficult to interpret in this regard

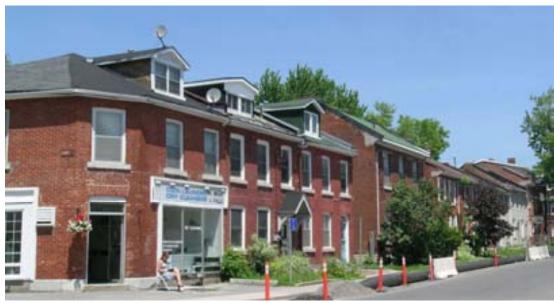
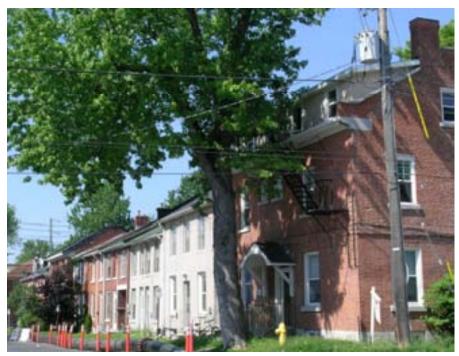
#### **Bagot Street between Earl and William:**

• There are buildings in situ by Gibbs' city map of 1850 on lots 5 (at William), 6, 7 and 8 (at Earl); while this more or less corresponds to the footprints of the buildings now on Bagot, it does not confirm whether any are replacements; however, all share similar aspects: red brick, two-storeys, gable roofs, corbels on the parapet end walls but with variations in height, suggesting different owners and times being built; today, only 160 Bagot is a free-standing structure; in comparing the Gibbs map of 1850 with the one by Innes in 1865, there is a possibility of earlier buildings giving way to later ones, for

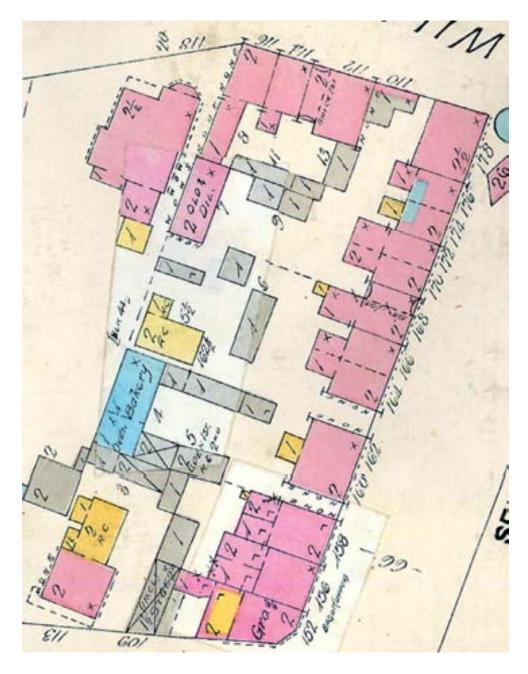
1908 fire insurance plan showing the numerous buildings (including a stone bakery) in the back yards of the buildings fronting Bagot (running diagonally on the right), William (at the top) and Earl (at the bottom) Streets

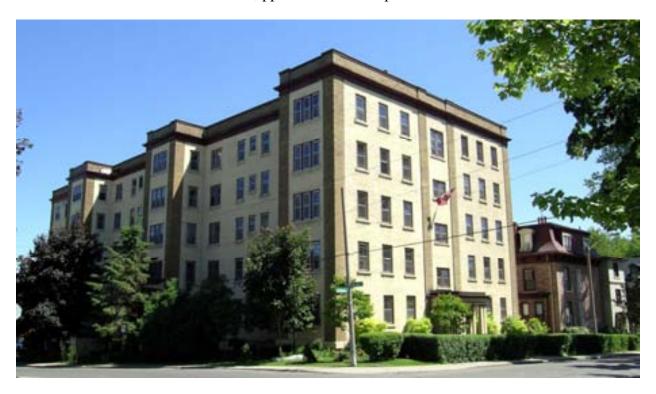
Fig. 1: Photographed from William and Sydenham Streets in 2004, photo by J. McKendry

The ads included ones sponsored by Clugston brothers, contractors, who did the mason and stucco work. The painting was by William Vince, the plumbing by N.S. Davie, and the Allan Lumber Company supplied the doors and lumber. Drawings by Kingston architect Colin Drever are in the Library & Archives of Canada (Power Collection F182 & F111). The structural system is revealed on the 1947 fire insurance plan as steel with reinforced concrete (Fig. 2). The present appearance of five storeys seems original (Fig. 1).

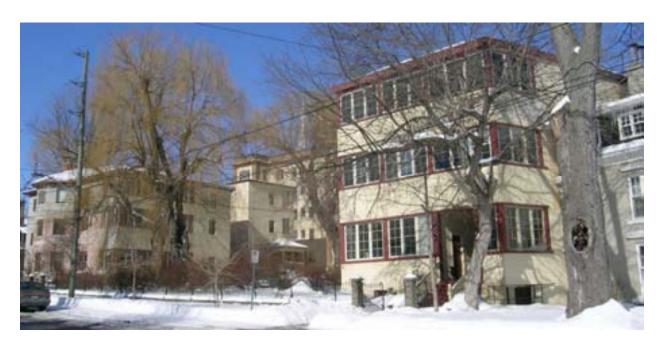
Fig. 3: Annandale Annex of 1928-29 on Earl Street in 2008 (with Carruthers Villa on the left), photo by J. McKendry

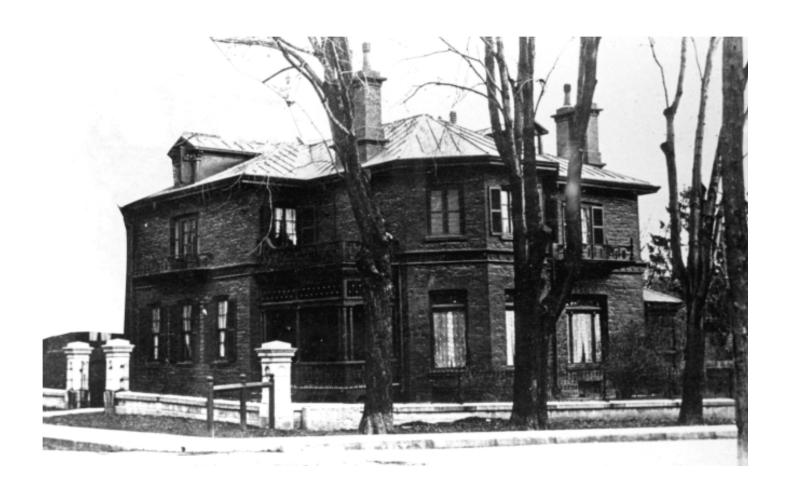
The site was that of the **Carruthers Villa**, built in 1849 for John Carruthers (1815-89), a wholesale grocer, to the designs of William Coverdale (Fig. 5)<sup>3</sup>. The two-storey stone house faced Earl Street with its grounds extending along Sydenham Street to Earl. Its stone carriage-house faced William Street but was demolished for the Annandale high-rise in 1927<sup>4</sup>. In 1873, a large two-storey wing with a mansard roof was added to the villa's rear along Sydenham Street by architect Robert gage (Fig. 4).<sup>5</sup> There are no significant differences to the site on the 1892 and 1924 fire insurance plans but, on the 1947 plan, the original part of villa has been raised a storey and additions made to two corners; it is labelled Annandale Court Apartments. Between 1849

Fig. 5: Carruthers Villa before conversion to the Annandale Court Apartments; the original verandahs have been altered, Queen's University Archives

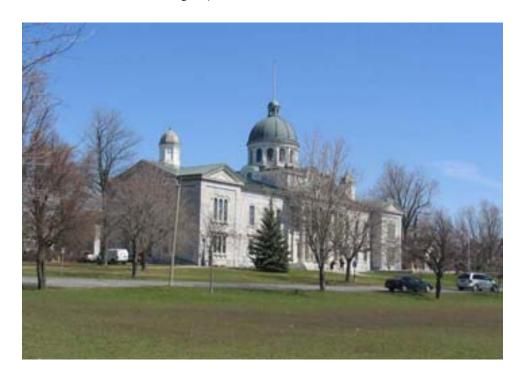
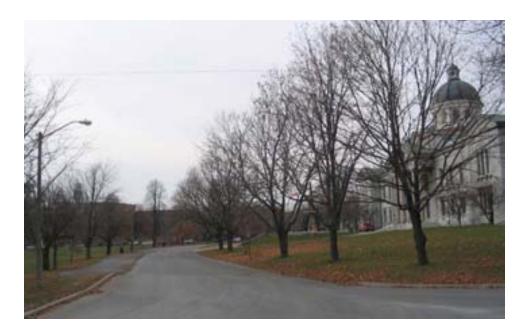
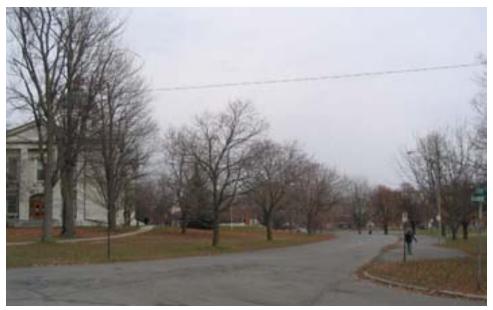
The Courthouse and Registry Office dominate the street. The ornamental

fountain, multi-columned portico and large cupola are the principal visual elements in this large façade: the more modest stonework on the Registry office complements the grand scale and detailing of the Courthouse.

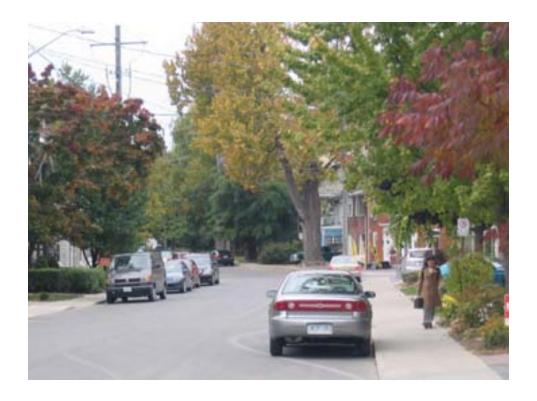
Although a surface parking lot now marks the eastern corner, the rest of lower Earl Street is an intact residential streetscape of varied character. Along the east side above the parking lot is a grade change along the top of which runs a laneway giving access to rear yard parking. Stone gateposts mark the lane entrance. Next to the lane is a 2-storey stone duplex and a 1-storey frame wing of a large house at the King Street corner. On the west side, a 3-storey brick gable-roofed late-20th-century row of townhouses begins the street, next to which is a 2-storey brick terrace that ends in a stone dwelling flanked by a high stone wall along its north side. A large surface parking lot is behind a

large brick house on the King Street corner that has a large side yard on Earl. The brick terrace is a landmark on this part of the street.

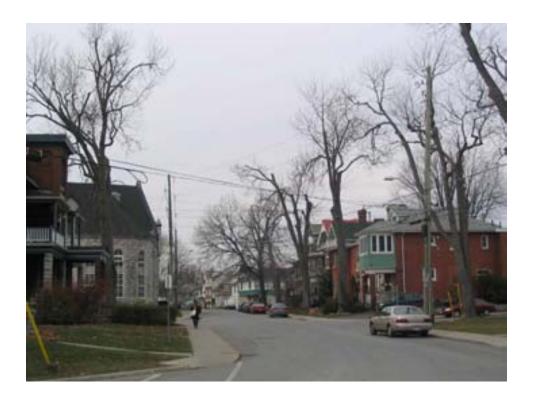
This block contains some of the finest stone dwellings on this street. At the

corner on the north side, set back behind a cast iron and stone fence, is a 3-storey gable-roofed stone Tuscan villa with an engaged corner tower. Next to it is a 3-storey mansard-roofed stone terrace, beyond which are three large stone detached houses with front porches (the last one with a full wrap around verandah). At the Clergy Street corner, set back from the street line, is a detached brick house with a small porch.

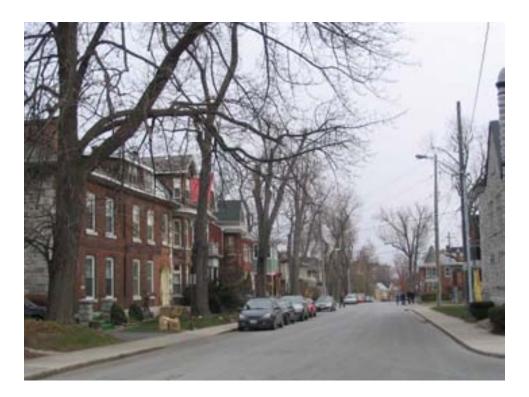
On the north side of this short block is a brick corner house with a double height porch, next to which is a pair of bay fronted brick houses, one with a

porch. Next to these is a brick-faced stone duplex, with inset doorways. At the Barrie Street corner is a 2-storey brick detached dwelling set back behind a wooden fence. Across the street, a large house converted and expanded into apartments wraps around the West Street corner and abuts the school on the Barrie Street side. Chalmers United Church completes the south side of Earl Street between Clergy and Barrie.
