**City of Kingston
Report to Heritage Kingston
Report Number HK-16-044**

To: Chair & Members of Heritage Kingston
From: Lanie Hurdle, Commissioner, Community Services
Resource Staff: Paige Agnew, Director, Planning, Building & Licensing Services
Date of Meeting: November 2, 2016
Subject: Application for Heritage Permit under the *Ontario Heritage Act*
Address: 197 William Street (P18-1227)
File Number: P18-073-2016

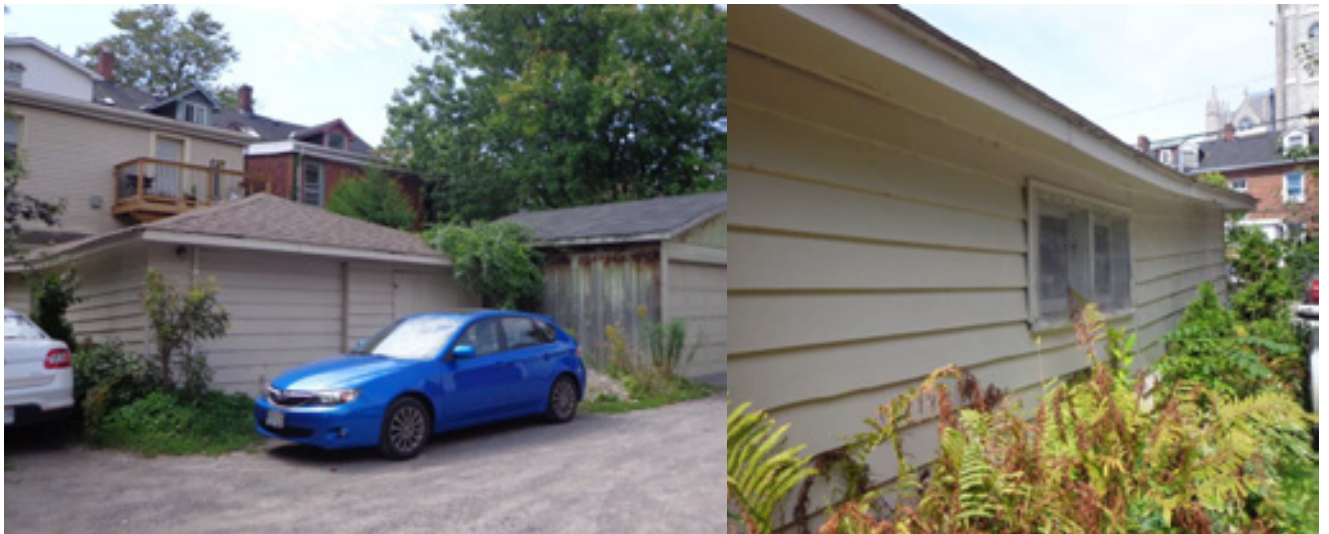
Figures 1 and 2: (Left) Rear garage proposed for demolition. (Right) East façade, next to right of way.

That it be recommended to Council that the demolition of the rear garage/shed at 197 William Street, be approved in accordance with details described in application number P18-073-2016, which was deemed complete on September 29, 2016; and

- a) All required demolition permits be obtained;
- b) All Public Health approvals be obtained;
- c) All grading and drainage shall not adversely affect neighbouring properties;
- d) A City of Kingston Heritage Planner shall be present on the day of demolition to document the structure; and
- e) Demolition shall not interfere with the Utilities Kingston watermain replacement work within the lane behind the subject property.

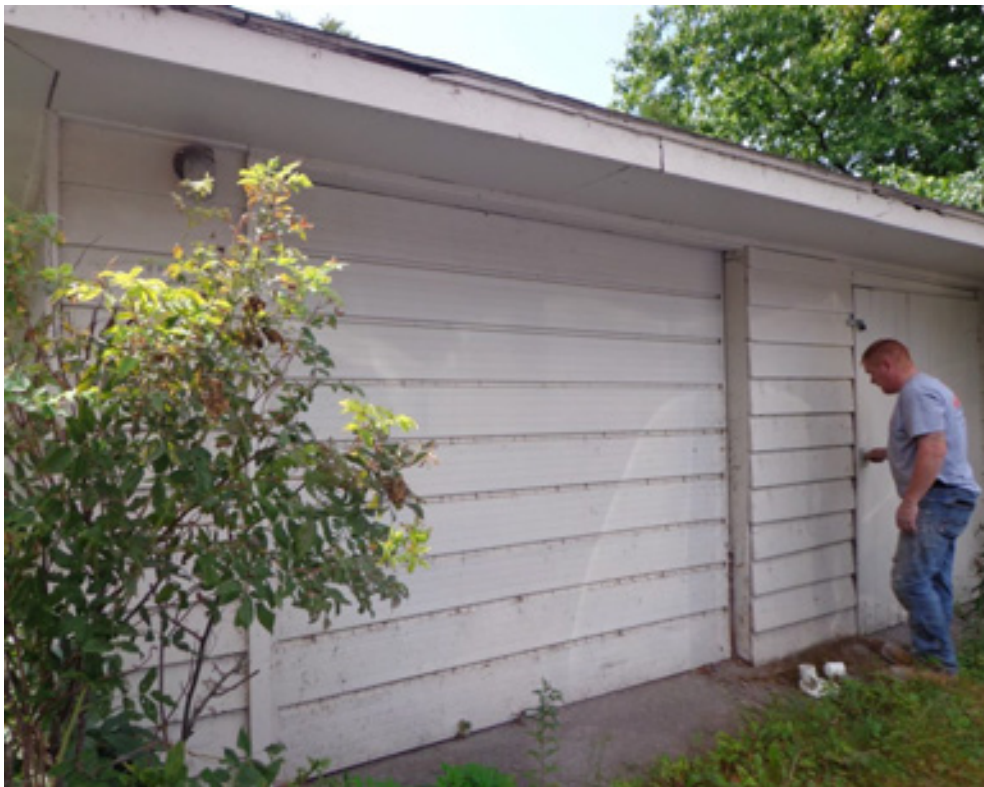
Figure 3: North façade, facing laneway.

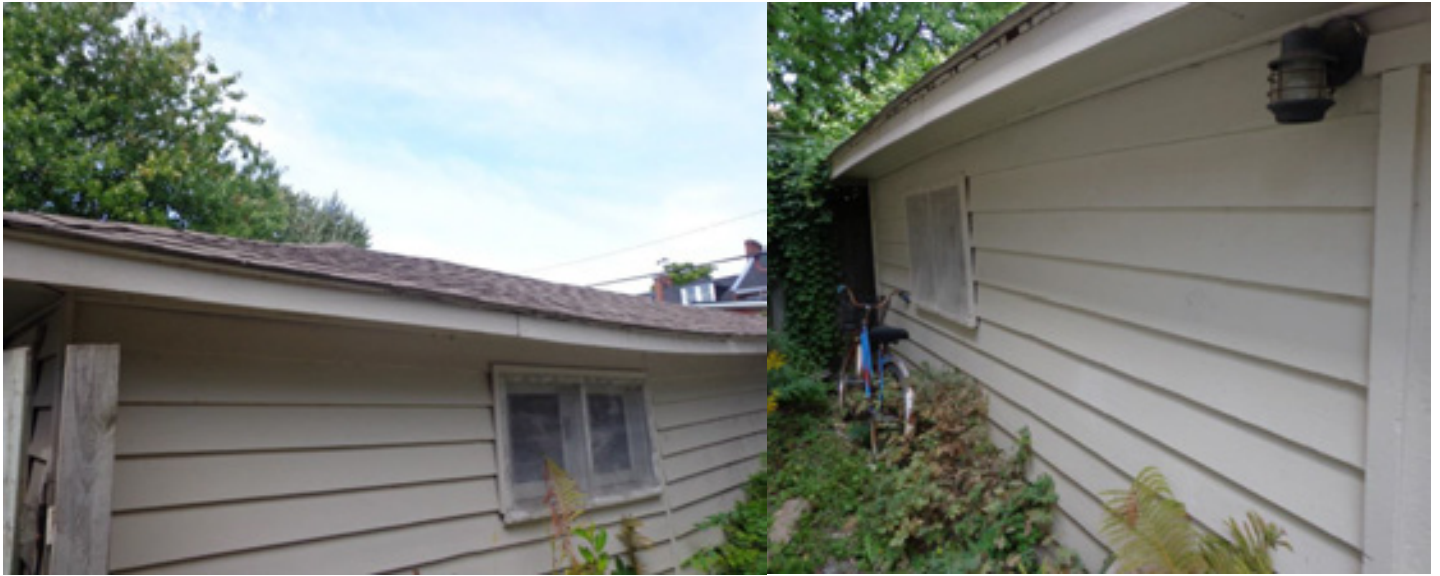
An application for alteration under Section 42 of the *Ontario Heritage Act* (File Number P18-073-2016) has been submitted to request approval to demolish the existing detached garage structure. The applicant has noted that the garage is not in good condition and has no plans to construct anything in its place. The garage is being removed to provide parking for the principal dwelling.

Figure 4 and 5: (Left) Roof of garage, appears structurally unsound. (Right) South façade facing rear of house.

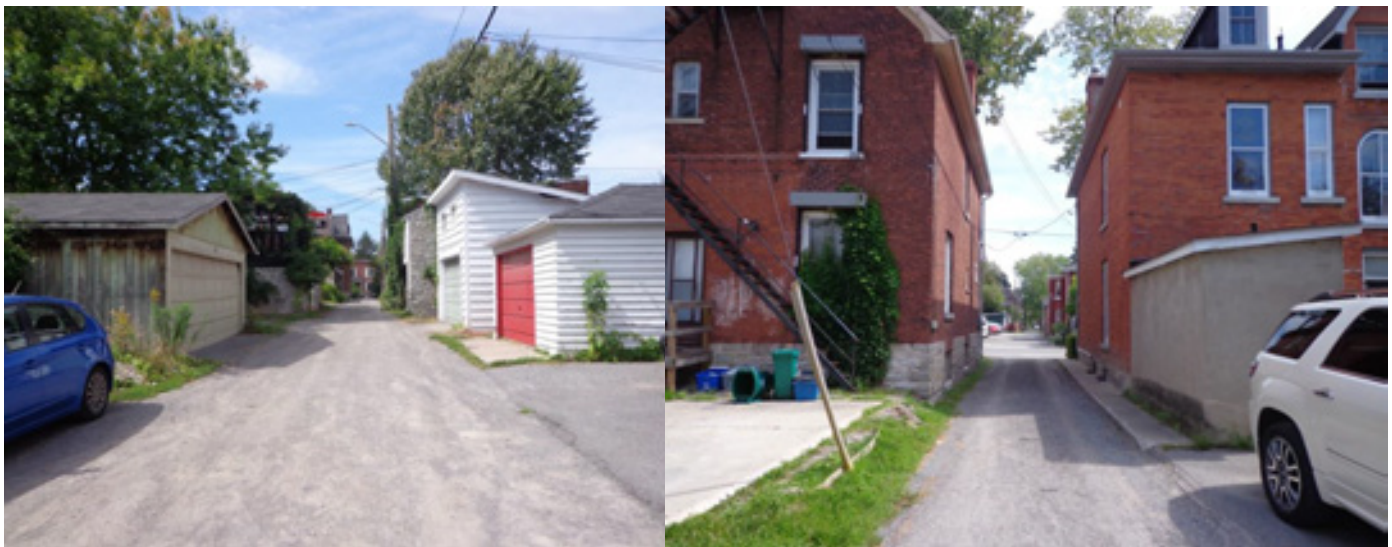
Figures 6 and 7: Rear lane way behind 197 William Street.

Utilities Kingston: Utilities Kingston has no concerns with the demolition of the garage. The applicant should be aware that the sanitary sewer running along the alley way at the back of the property is being replaced in the near future. Care and control of the construction zone will lie in the hands of the contractor, as per Ministry of Labour Guidelines. The applicant will not be able to work in the area at the same time as the reconstruction of the sewer is taking place.

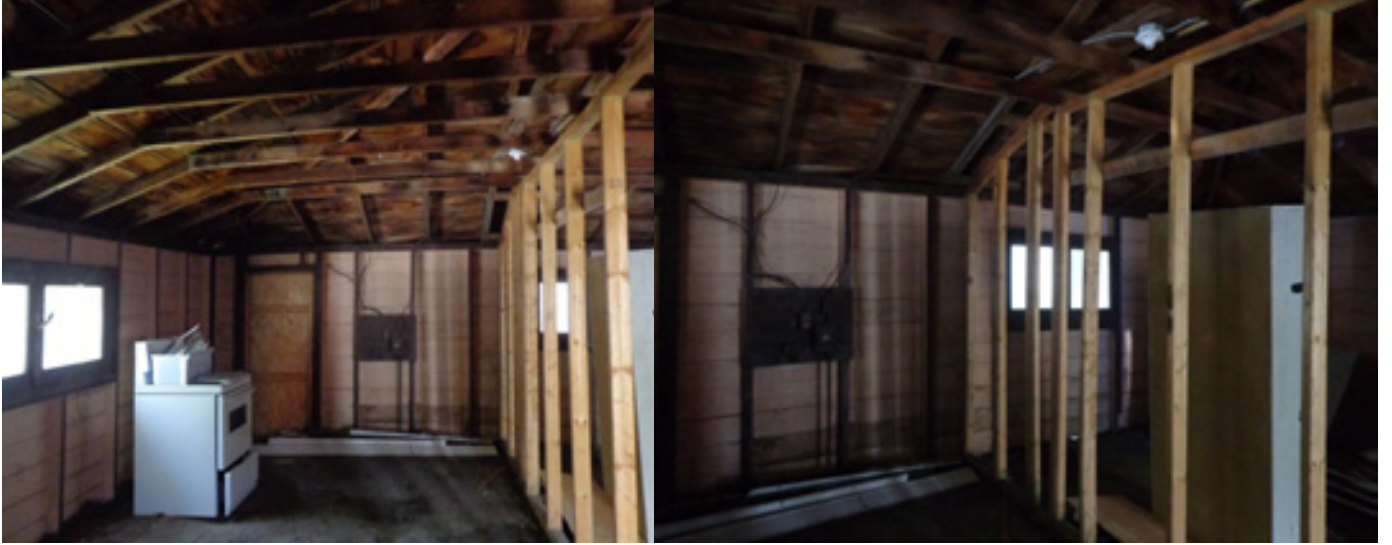
Figures 8 and 9: Interior of garage.

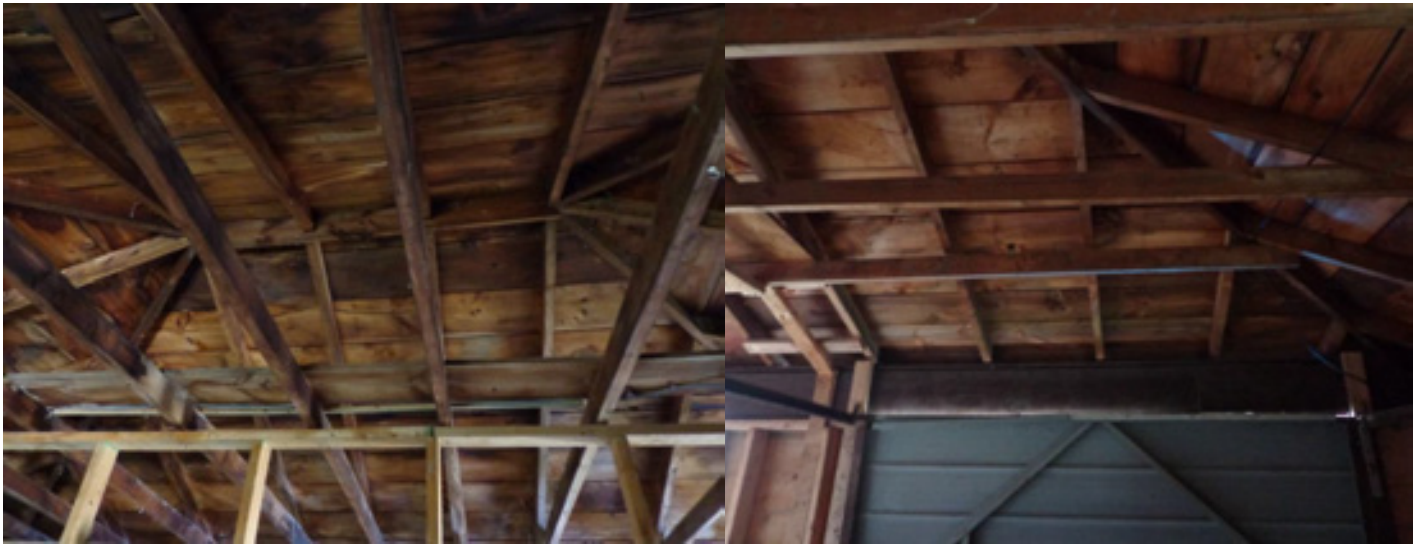
Following a site visit, it was found that this structure currently has electricity and a modern garage door. Given the modern amenities and that the current structure is set nearer to the main dwelling than the lane; staff are of the opinion that the subject structure is a later addition on the property. Historically, most garages that would have been built during the period when automobiles became increasingly affordable, were much smaller than this structure, which suggests that this is a modern construction.

Figure 10: Interior roof with modern garage door.

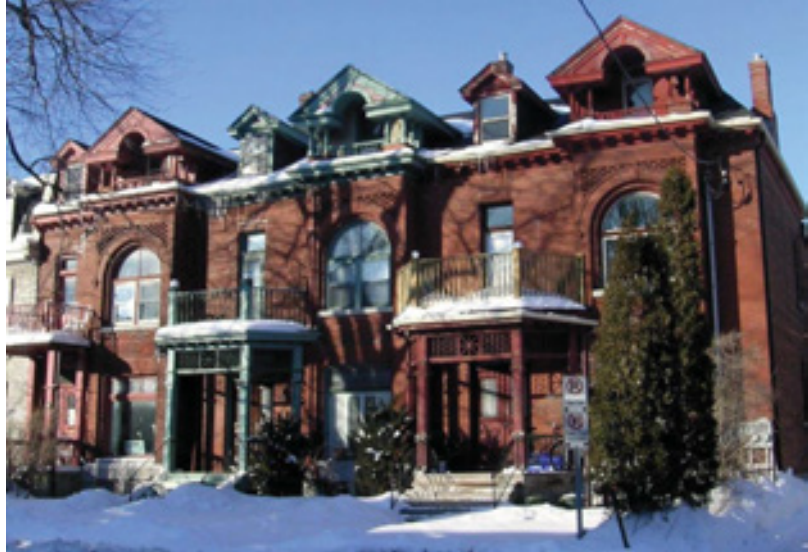
197-199-201 WILLIAM ST.**Built: by 1897****Rating: S**

While the architect still remains unknown 197-201 William Street brings together a number of late 19th century architectural styles in a satisfying composition based on the rhythm of the three 'stepped forward' full height bays and the stature provided by the umbraged gables with balconettes which surmount them. Stylistically, the Queen Ann form and roof line has been combined with a broad Richardsonian Romanesque window arch as the dominant element, and juxtaposed with the fine Eastlake detailing of the verandah frieze. An excellent balance has been struck between robust and attenuated features.

The coursed ashlar limestone foundation rises to a water table course which is integrated with the lintels of the basement windows. The brickwork has been well executed with the main windows set within a two storey arched niche. A panel has been created above the large picture window and the brick corbelled up to the limestone sill of the window above. The main articulation occurs in the forming of the 2nd storey window arch and the treatment of the arch spandrels. The arch has a margin in relief which extends from the projecting 'keystone' (also formed of brick) to brick corbels at the 'spring' points. The spandrel panels above the arch shoulders are formed of alternating 'dogtooth' and block units further accenting the arch. This detail is found at John Power's 1890 Pump House (within a circular panel).

The arch motif is extended as the broken pediment of the 3rd storey cross gables as well as serving to provide space for the window/door opening on to the balconette. The moulded eaves of the cross gables are deep and return at the front to the arched opening. They are 'supported' on paired turned columns themselves set on brick piers with a railing of heavy turned balusters between. The face of the gables are clad in fish scale shaped wood shingles. The main soffit is deep and the frieze features 'mutules' and a large wood roll at the wall junction (a combination found on many Kingston buildings of this period). The transom of the picture window has stained glass (now missing at 197.)

The porch and balcony balustrade is the key feature of the inset bay with its Eastlake spindlework frieze, turned balustrade and chamfered posts. This successful design was used again at 233 Johnson Street.

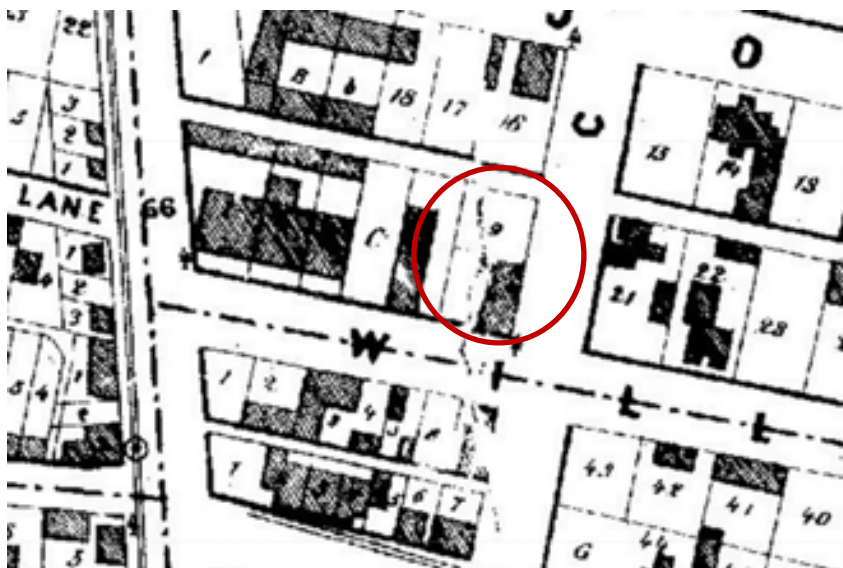
No building is shown on the subject lot until the 1865 Innes Map where a long narrow building is depicted which was likely William Irving Sr.'s shop for planing and making window sash. The existing fine brick range is not definitively documented until 1897 when it is referred to in the Directory as the residences respectively of: (197) Delos Grimshaw who deals in grain at 117 Brock; (199) John C. Metcalfe, a butcher at 62 Brock and (201) James Craig, owner of a Grocery and Crockery Store at 79 Brock. Thus the link between the row and the merchants of Brock Street is well established.

Figure 1: John C Innes Map, 1865

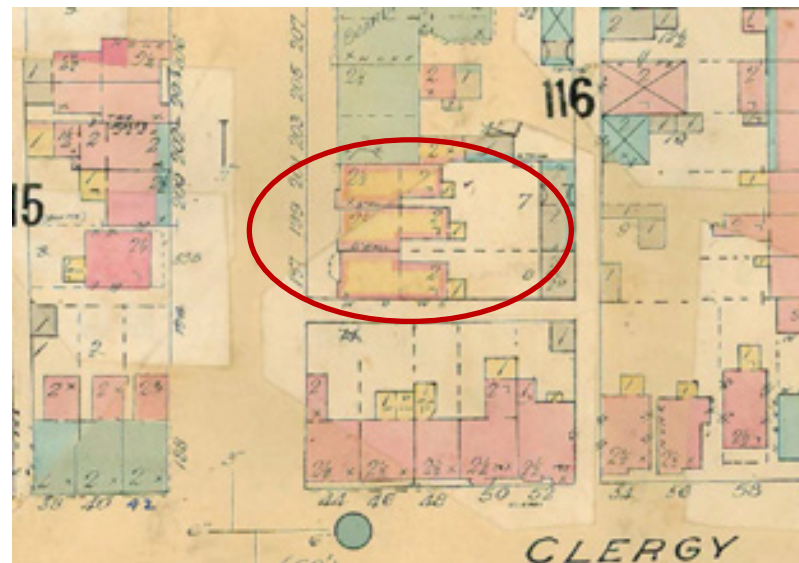
The Old Sydenham District Plan notes in Section 2.3.3 that the Heritage Attributes within the ‘Beyond Bagot Sub-Area’ include “rear lanes on some blocks with outbuildings”. In order to determine the significance of this garage structure, staff undertook a review of several historic maps to establish whether the structure was original to the property. As described in the Property Evaluation, the main dwelling first appears on the 1865 John Innes map, but does not include any outbuildings (Exhibit C – Historic Maps). The 1908 and 1924 Fire Insurance maps do show the brick clad terrace building with a small, one storey wood addition and a wood

structure set at the edge of the lane way. The location of the current structure is located near the main dwelling, but set back from the lane way.

Figure 2: Goad's Fire Insurance Map, 1908
