Appendix A Inventory of properties within the Barriefield Heritage Conservation District

Introduction to the Inventory

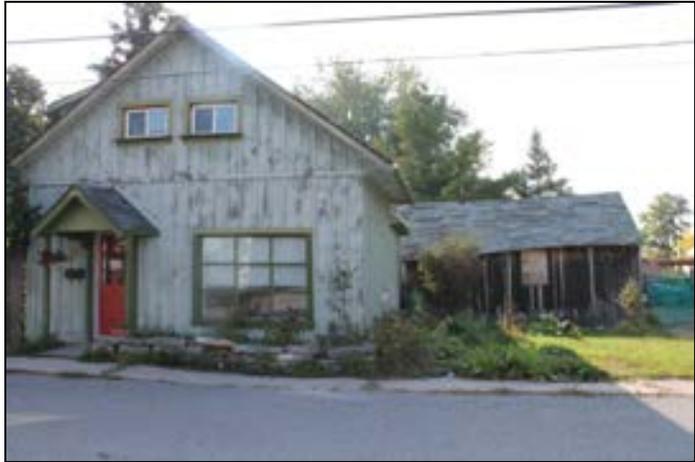
Address: 3 Drummond Street

Property Type:	Residential
Era/Date of Construction:	1927
Architect/Builder:	Not known
Building style/Influence:	Vernacular
Materials:	Frame
Number of Bays:	Two
Roof Type:	Front gable
Building Height:	One and one half storey
Alterations:	Window trim, board and batten siding, frieze board under roof added (2000).
Landscape/setting:	Close setback to street, side yard with lawn and mixed vegetation, wooden shed in rear yard.
Heritage value:	Non-heritage (little known heritage fabric of dwelling remains)

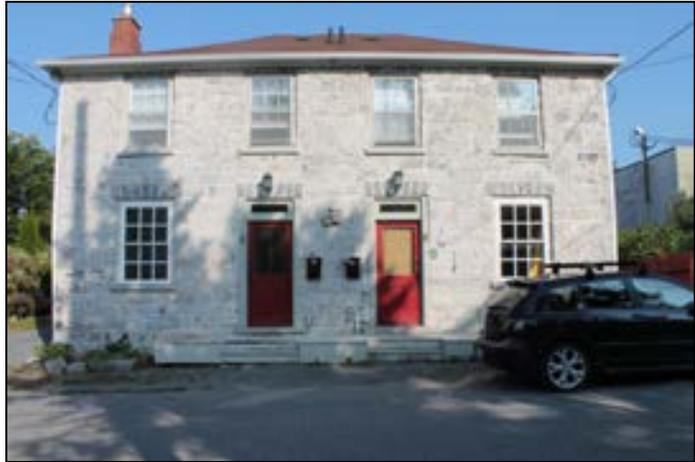
Property Type:	Residential
Era/Date of Construction:	c. 1814 to 1819
Architect/Builder:	Not known
Building style/Influence:	Vernacular
Materials:	Limestone
Number of Bays:	Four
Roof Type:	Hip
Building Height:	Two storey
Alterations:	Rear addition. Transom light, door and steps replaced (2006).
Landscape/setting:	Very close to street, Minimal landscaping, Gravel drive.
Heritage value:	Heritage

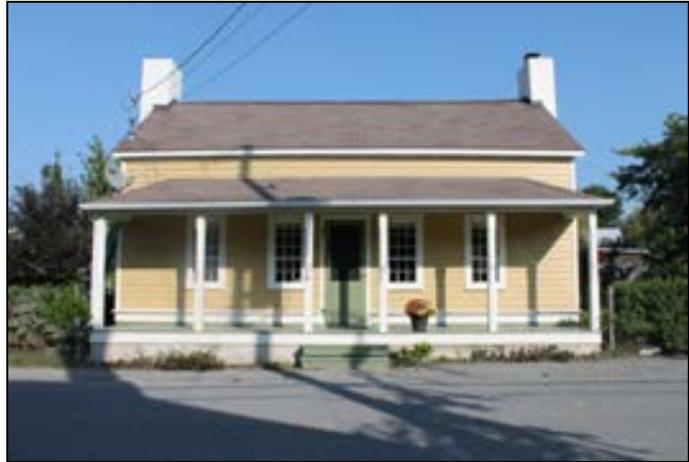
Property Type:	Residential
Era/Date of Construction:	c.1824-1831
Architect/Builder:	Not known
Building style/Influence:	Vernacular
Materials:	Frame
Number of Bays:	Five
Roof Type:	Medium side pitched side gable
Building Height:	One and one half storey
Alterations:	Two additions (including garage) added to rear of building (1994/1995), Original wooden siding covered by synthetic siding but restored (1994), Facade altered with the removal of the window to the immediate south of the main door but restored, One storey verandah once enclosed by screens but restored. Chimneys rebuilt (1992).
Landscape/setting:	Close setback to street, fenced/hedged side yard
Heritage value:	Heritage

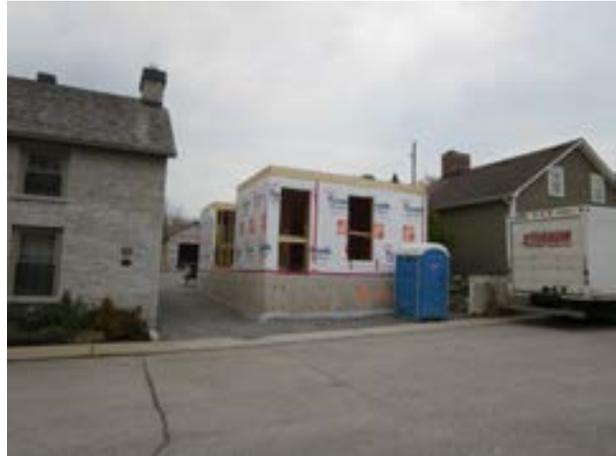
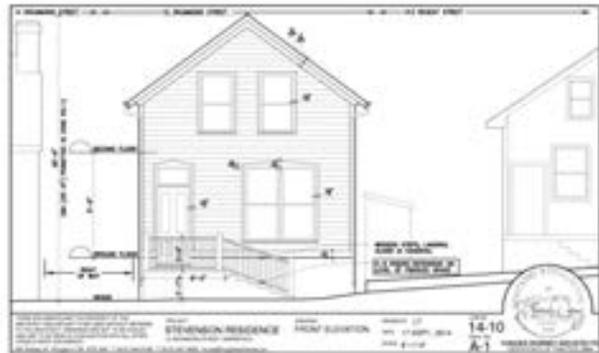
Property Type:	Residential
Era/Date of Construction:	Under construction 2014/2015
Architect/Builder:	Builder Stephenson
Building style/Influence:	Contemporary
Materials:	Frame
Number of Bays:	Two
Roof Type	Front gable
Building Height:	One and one half storey
Alterations:	New building – N/A
Landscape/setting:	Close setback to street
Heritage value:	Non-heritage

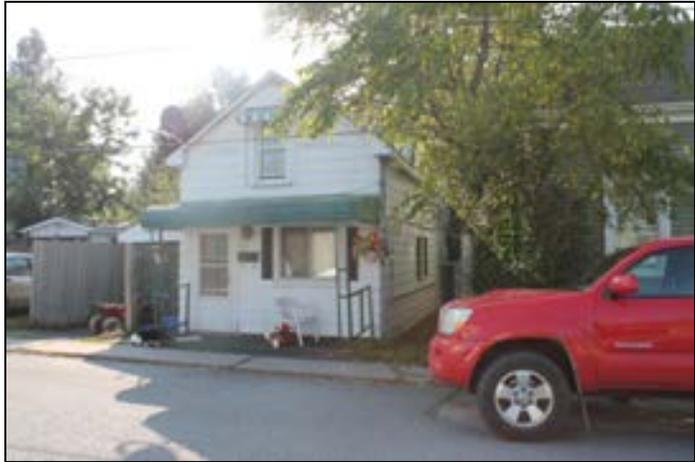
Property Type:	Residential
Era/Date of Construction:	c.1900
Architect/Builder:	Jack Esford
Building style/Influence:	Vernacular
Materials:	Frame, synthetic cladding
Number of Bays:	Two
Roof Type:	Front gable
Building Height:	One and one half storey
Alterations:	Side porch addition, Window and door replacements, Synthetic cladding, Rear second storey addition (1999)
Landscape/setting:	Close setback to street, fenced yard, minimal landscaping
Heritage value:	Heritage

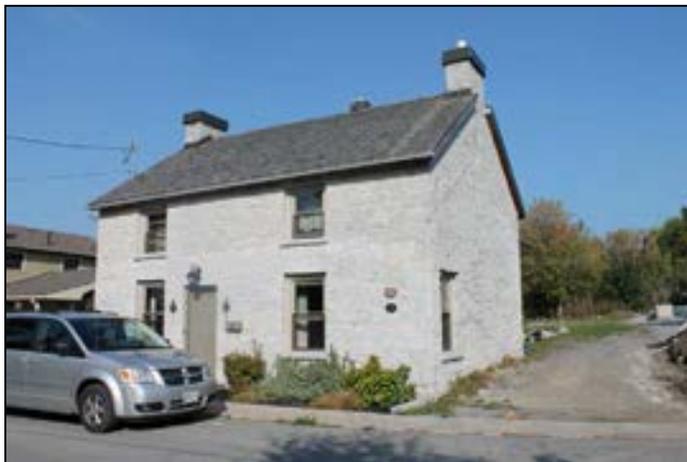
Property Type:	Residential
Era/Date of Construction:	1830-1837
Architect/Builder:	James Pentland
Building style/Influence:	Vernacular
Materials:	Stone
Number of Bays:	Three
Roof Type:	Side gable
Building Height:	Two storey
Alterations:	One storey side addition removed from south elevation, Roof resingled (1993). Two storey addition added to rear (2002). Paint removed from brick surface (1993). Remove porch (2005)
Landscape/setting:	Close setback to street, mixed shrubs, gravel drive
Heritage value:	Heritage

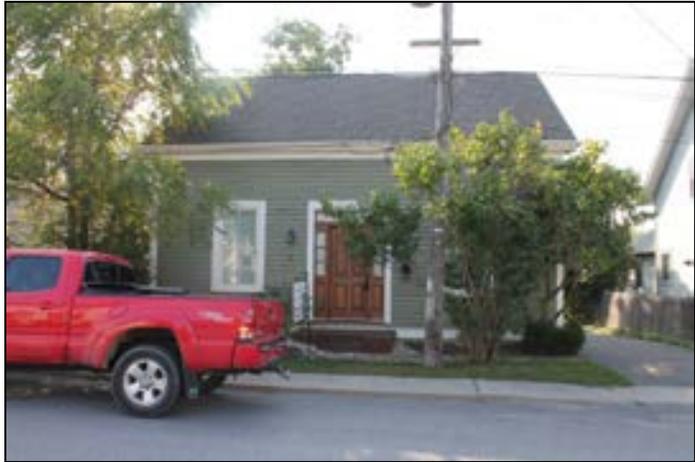
Property Type:	Residential
Era/Date of Construction:	2004
Architect/Builder:	Builder Ian Moffat – Truehaven Design Builders
Building style/Influence:	Contemporary
Materials:	Frame
Number of Bays:	Three
Roof Type	Side gable
Building Height:	One and one half storey
Alterations:	Not known
Landscape/setting:	Close setback to street, lawn, flagstone path, lilac, asphalt drive
Heritage value:	Non-heritage

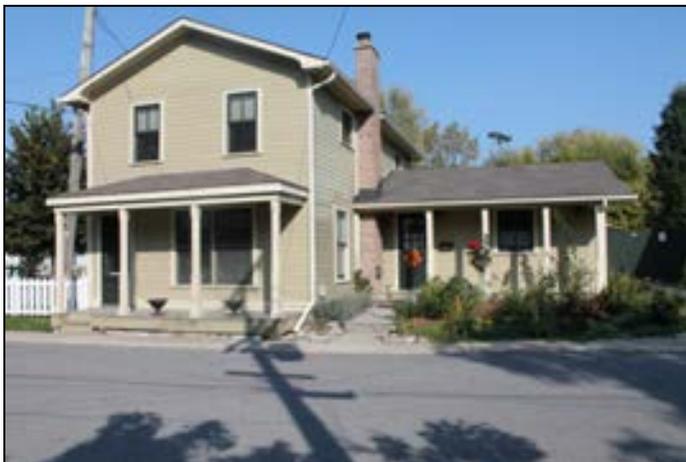
Property Type:	Residential
Era/Date of Construction:	Reportedly constructed 1903, altered in 1990s and 2013
Architect/Builder:	Not known
Building style/Influence:	Vernacular
Materials:	Frame
Number of Bays:	Two bays per wing
Roof Type:	Front and side gable
Building Height:	One and two storeys
Alterations:	Alterations in 1990s – expand rear addition and add new addition, addition to workshop, roof replacement, restore building facade, new windows. Porch and window improvements, (2005/2006). Verandah added to west elevation of one storey addition (2013).
Landscape/setting:	Close setback to street, mixed shrubs, flowers and groundcover, asphalt drive
Heritage value:	Heritage

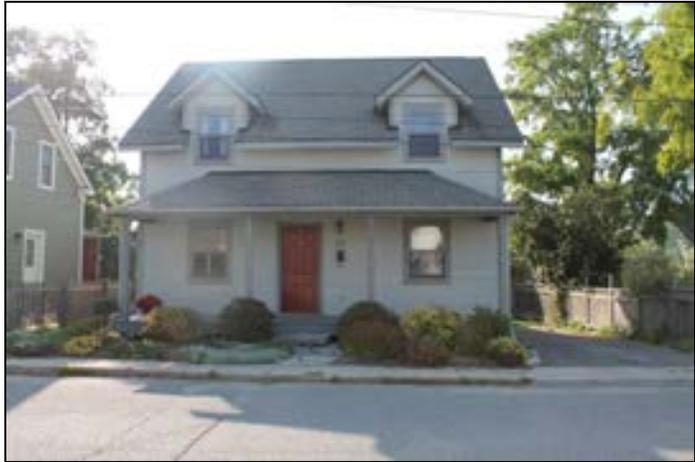
Property Type:	Residential
Era/Date of Construction:	2002
Architect/Builder:	Designed by Sherman A. Hill /Built by Patrick Powers Construction
Building style/Influence:	Contemporary
Materials:	Frame
Number of Bays:	Three
Roof Type	Side gable with gable dormers
Building Height:	One and one half storey
Alterations:	Rear porch added 2002
Landscape/setting:	Close setback to street, mixed shrubs, flowers and groundcover, flagstone walk, asphalt drive
Heritage value:	Non-heritage

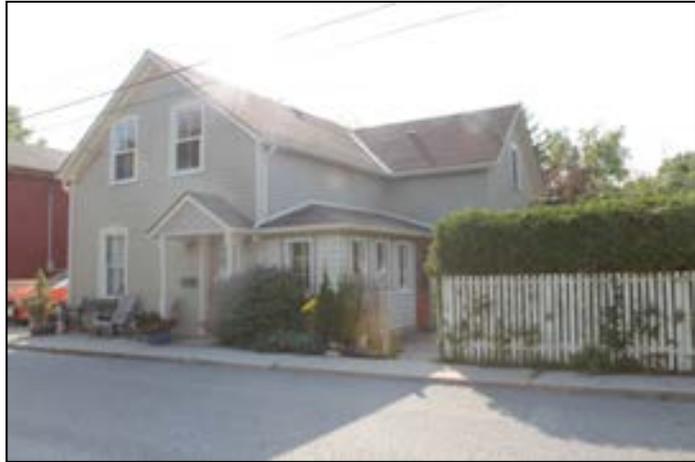
Property Type:	Residential
Era/Date of Construction:	Late 19 th Century
Architect/Builder:	William and Frederick Allen
Building style/Influence:	Vernacular
Materials:	Frame
Number of Bays:	Two
Roof Type:	Front gable
Building Height:	One and one half storey
Alterations:	Small one storey and larger one and one half storey addition to north elevation (2007). Windows replaced (2005). Gable portico added to front entrance after 1992. Fencing added (1993).
Landscape/setting:	Close setback to street, concrete walk, fenced yard, mixed shrubs
Heritage value:	Heritage

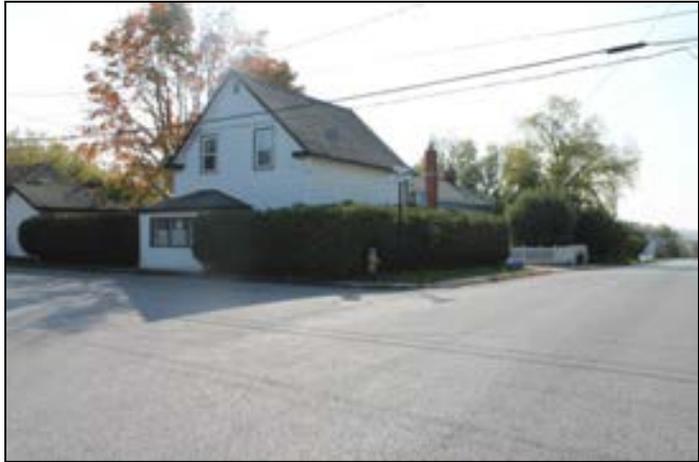
Property Type:	Residential
Era/Date of Construction:	Late 19 th Century
Architect/Builder:	William and Fredrick Allen
Building style/Influence:	Vernacular
Materials:	Frame
Number of Bays:	Two
Roof Type	Front gable
Building Height:	One and one half storey
Alterations:	Original wooden cladding replaced with aluminum siding. Windows repaired (2012).
Landscape/setting:	Hedged yard, close setback to street, corner lot
Heritage value:	Heritage

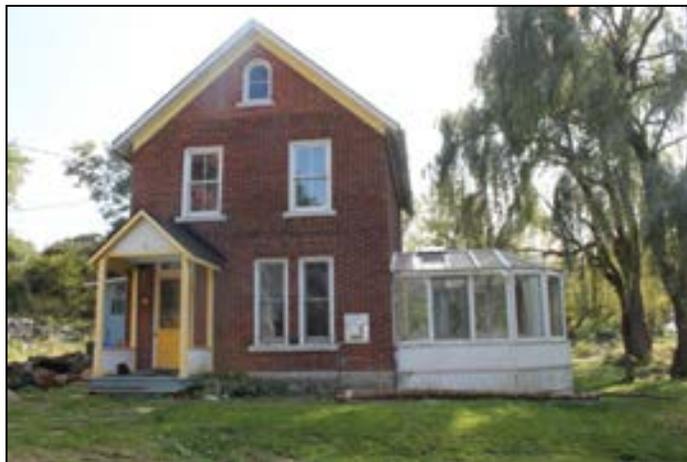
Property Type:	Residential
Era/Date of Construction:	Late 1880s
Architect/Builder:	Not known
Building style/Influence:	Vernacular
Materials:	Brick
Number of Bays:	Two
Roof Type	Front gable
Building Height:	Two and one half storey
Alterations:	Repair second storey windows (2012), repair and repoint damaged bricks (2009), enclose rear west porch (1995), enclose porch (1995), replace windows with wood windows (1992), add solarium (1990). Approval granted to remove south porch, east one storey addition, gazebo addition, north porch, and detached storage building and construct a one and one half storey addition to rear and new detached garage in rear yard (2014).
Landscape/setting:	Open lawn, gravel drive, willow trees and mixed vegetation
Heritage Value:	Heritage

- Two and one half storey massing
- Front gable side hall plan
- Two bay facade (pair of narrow windows on first storey, single windows on second storey)
- Rectangular window and single door opening
- Round arched window in gable
- Brick construction in stretcher bond pattern on the front wall and common bond pattern on the side walls
- Stone foundation

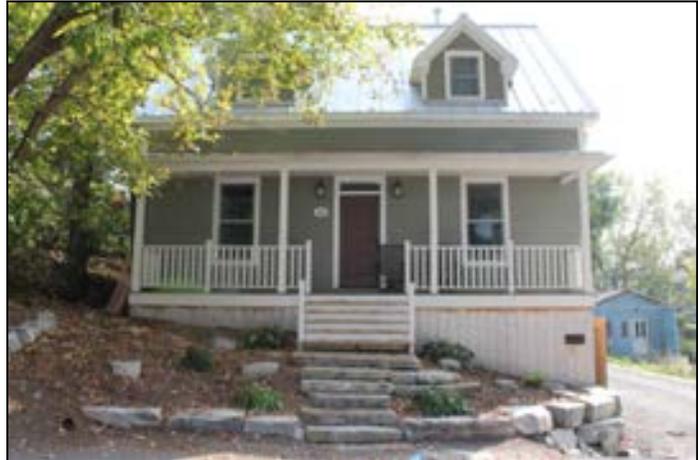
Property Type:	Residential
Era/Date of Construction:	2009
Architect/Builder:	Designed and built by Ian Moffat, Truehaven Designs
Building style/Influence:	Contemporary
Materials:	Frame
Number of Bays:	Three
Roof Type	Side gable with gable dormers
Building Height:	One and one half storey with raised basement
Alterations:	Solar panels installed (2010), granted approval for detached garage (2013)
Landscape/setting:	Stone retaining wall, mixed annuals, mixed vegetation, gravel drive
Heritage Value:	Non-heritage

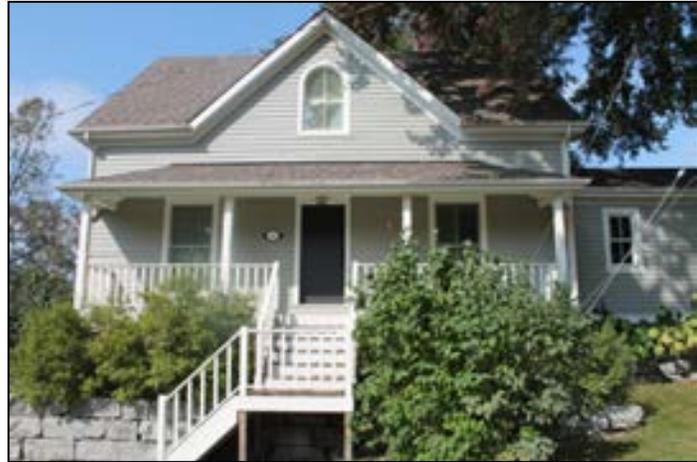
Property Type:	Residential
Era/Date of Construction:	2003
Architect/Builder:	Designed and built by Ian Moffat, Truehaven Designs
Building style/Influence:	Contemporary
Materials:	Frame
Number of Bays:	Three, with two bays on one storey east house extension
Roof Type	Cross gable
Building Height:	One and one half storey with raised basement
Alterations:	Retaining wall constructed (2003).
Landscape/setting:	Open lawn, mixed shrubs and specimen trees
Heritage Value:	Non-heritage

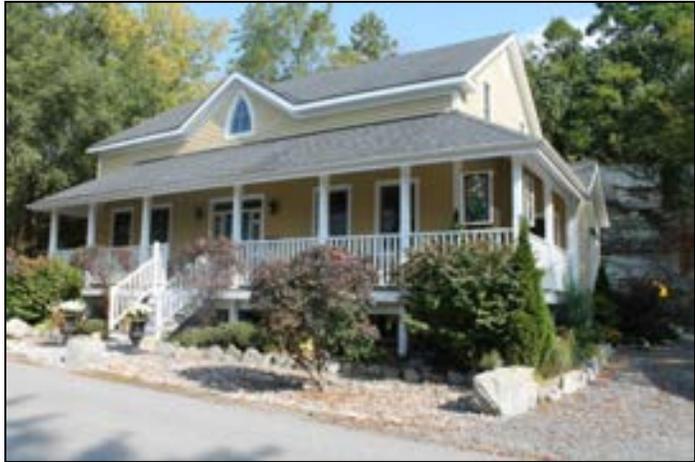
Property Type:	Residential
Era/Date of Construction:	2003
Architect/Builder:	Designed and built by Ian Moffat, Truehaven Designs
Building style/Influence:	Contemporary
Materials:	Frame
Number of Bays:	Six
Roof Type	Cross gable
Building Height:	One and one half storey
Alterations:	None recorded
Landscape/setting:	Stone and mixed shrub garden, gravel drive
Heritage Value:	Non-heritage

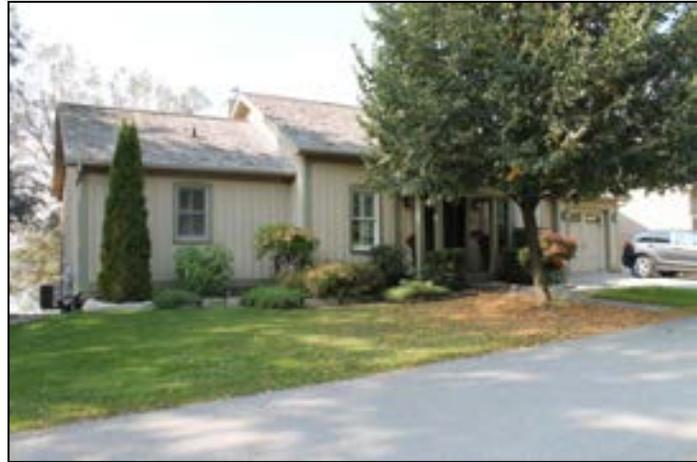
Property Type:	Residential
Era/Date of Construction:	2005
Architect/Builder:	Designed and built by Ian Moffat, Truehaven Designs
Building style/Influence:	Contemporary
Materials:	Frame
Number of Bays:	Five
Roof Type	Side gable
Building Height:	One storey
Alterations:	Stone cladding changed to board and batten (2005)
Landscape/setting:	Open lawn, mixed shrubs and trees, gravel drive
Heritage Value:	Non-heritage

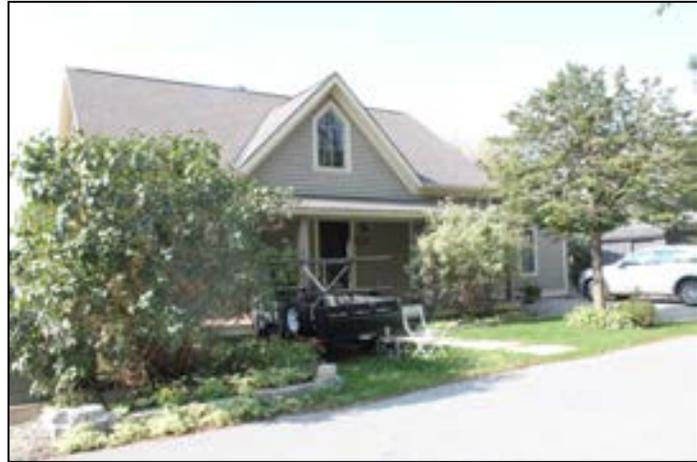
Property Type:	Residential
Era/Date of Construction:	2002
Architect/Builder:	Designed and built by Ian Moffat, Truehaven Designs
Building style/Influence:	Contemporary
Materials:	Frame
Number of Bays:	Three, with one bay on one storey north house extension
Roof Type	Cross gable
Building Height:	One and one half storey
Alterations:	Pool added to rear yard (2004), roof pitch altered at rear (2006).
Landscape/setting:	Open lawn, mixed trees and shrubs, gravel drive
Heritage Value:	Non-heritage

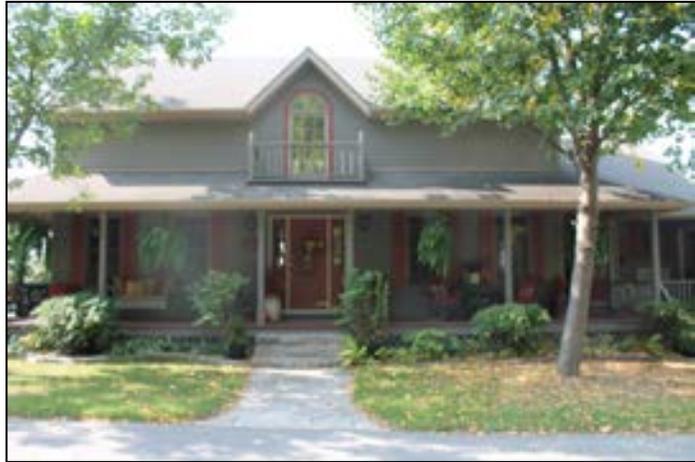
Property Type:	Residential
Era/Date of Construction:	1996
Architect/Builder:	Architect Robert Carothers, builder Garofalo Bros.
Building style/Influence:	Contemporary
Materials:	Frame
Number of Bays:	Seven
Roof Type	Cross gable
Building Height:	One and one half storey
Alterations:	None recorded
Landscape/setting:	Open lawn, mixed shrubs/trees, gravel drive
Heritage Value:	Non-heritage

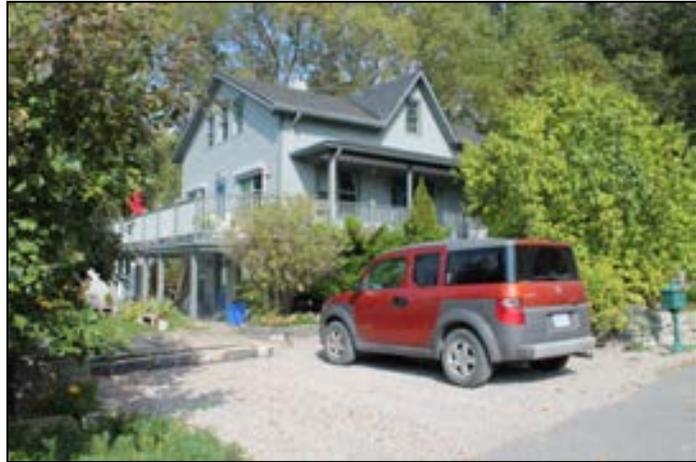
Property Type:	Residential
Era/Date of Construction:	1995
Architect/Builder:	Built by Mac Gervan/SUN builders
Building style/Influence:	Contemporary
Materials:	Frame
Number of Bays:	Three
Roof Type	Cross gable
Building Height:	One and one half storey
Alterations:	Detached building constructed (2008)
Landscape/setting:	Mixed shrubs and trees, stone garden wall, gravel drive
Heritage Value:	Non-heritage

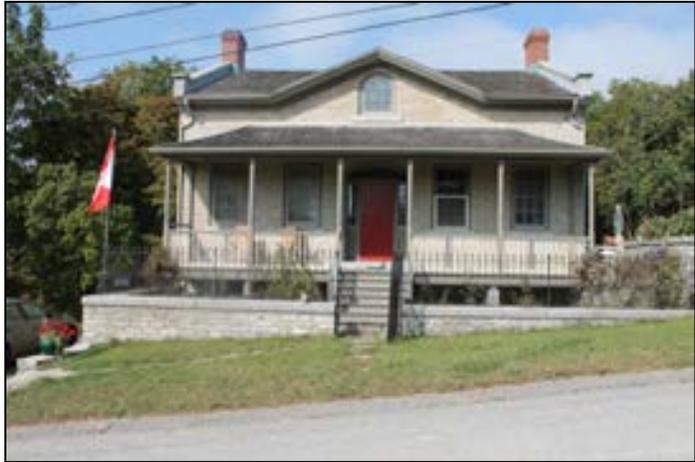
Property Type:	Residential
Era/Date of Construction:	1856-1857
Architect/Builder:	James Medley Jr.
Building style/Influence:	Vernacular
Materials:	Limestone
Number of Bays:	Five
Roof Type	Cross gable
Building Height:	One and one half storey
Alterations:	Main entrance reconstructed, solarium added (1993). Masonry work repaired and repointed, garden shed constructed (1994), roof re-shingled, windows repaired (2006 & 2008), wooden trim repaired and repainted, downspouts replaced (2010), replace porch (2011), repairs to soffit, windows, door; add porch rail and stairs (2012).
Landscape/setting:	Fenced garden, open front lawn to street.
Heritage Value:	Heritage

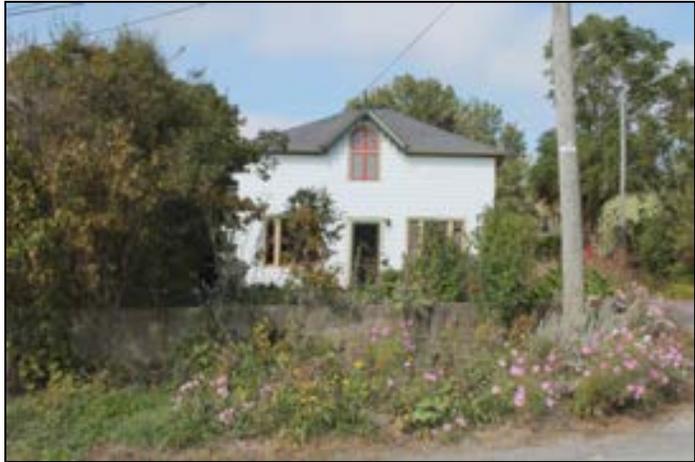
Property Type:	Residential
Era/Date of Construction:	1860s
Architect/Builder:	Jacob Sharman
Building style/Influence:	Vernacular
Materials:	Frame
Number of Bays:	Three
Roof Type	Hip with central front gable
Building Height:	Two storey
Alterations:	Window and door replacements. Porch removal (pre-1992). Removed chimney (2002), replaced concrete with pavers in front yard (2008).
Landscape/setting:	Concrete wall, deeper setback to street, mixed vegetation, asphalt drive
Heritage value:	Heritage

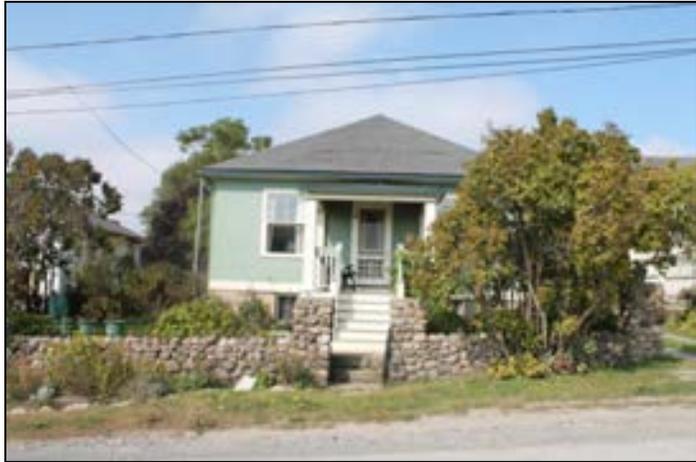
Property Type:	Residential
Era/Date of Construction:	C. 1945
Architect/Builder:	Not known
Building style/Influence:	Post-war vernacular
Materials:	Frame
Number of Bays:	Three
Roof Type	Hip
Building Height:	One storey
Alterations:	Repainted with railings added to front steps (1992). lean-to addition on north side, replaced roof and windows (2011)
Landscape/setting:	Stone wall, open lawn, mixed trees and shrubs
Heritage value:	Heritage

This vernacular frame building is typical of the many post World War II houses constructed during the 1940s and early 1950s. It is one story in height set on a high concrete foundation and has a hip roof. A small open entrance porch with squared column is located at the front facade. The main elevation is divided into three bays with a central doorway and one window on each side. The plan is rectangular with the short side facing the street.

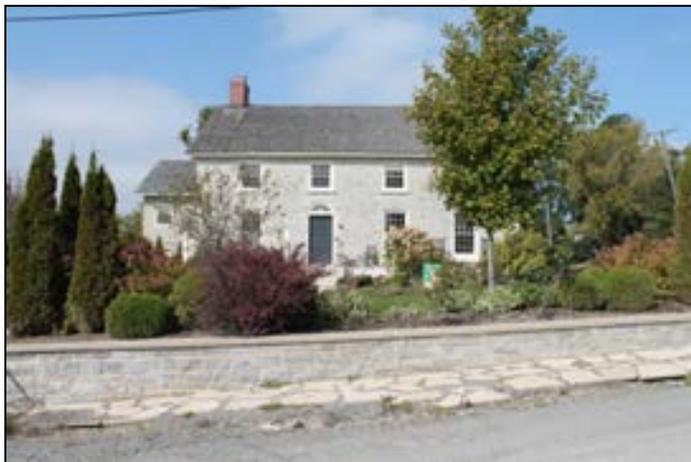
Property Type:	Residential (former Inn)
Era/Date of Construction:	c.1838
Architect/Builder:	William Walker
Building style/Influence:	Vernacular
Materials:	Limestone
Number of Bays:	Four
Roof Type	Side gable
Building Height:	Two storey
Alterations:	Restoration of round arched fanlight above door; Restoration of first storey window voussoir to west of main door; Two storey addition added to west elevation (2007); Large picture window added to east elevation of main structure but removed (2006); Veranda extended to the entire length of south facade (2007); Concrete retaining wall surrounding south end of property replaced with stone wall; Original wooden shingles replaced but later restored; Extensive additions to north elevation added before 1908 but removed prior to 1992.
Landscape/setting:	Stone wall, mixed shrubs and trees, deeper setback from street
Heritage value:	Heritage

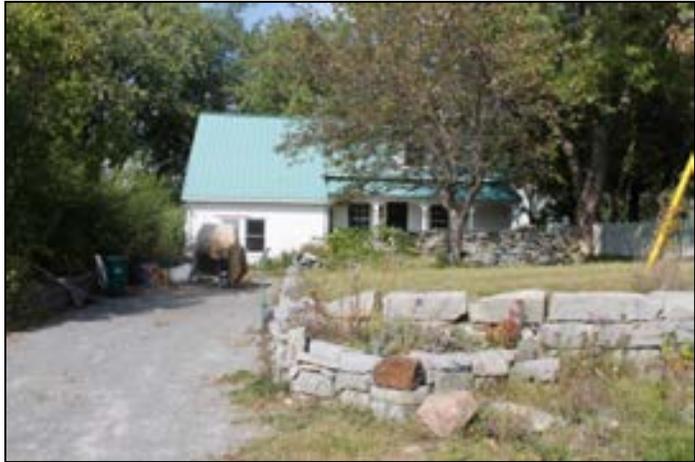
Property Type:	Residential
Era/Date of Construction:	C. 1814
Architect/Builder:	William Baker
Building style/Influence:	Vernacular
Materials:	Frame
Number of Bays:	Three
Roof Type	Side gable
Building Height:	One and one half storey
Alterations:	One storey addition added to west end of main structure and later replaced with garage prior to 1992; Gable dormer altered, windows replaced and metal roof added (1995).
Landscape/setting:	Dry stone wall, open lawn, specimen trees, gravel drive
Heritage value:	Heritage

The original frame section of the house is one and one half storeys in height and is set on a stone foundation. It has an original rectangular plan but additions have been added over the years including a front facing garage on the west end of the building,

which projects forward from the original house. The garage appears to have replaced a one storey frame addition shown on the 1908 Goad's Fire Insurance Plan. A front verandah runs the width of the main facade of the original building.

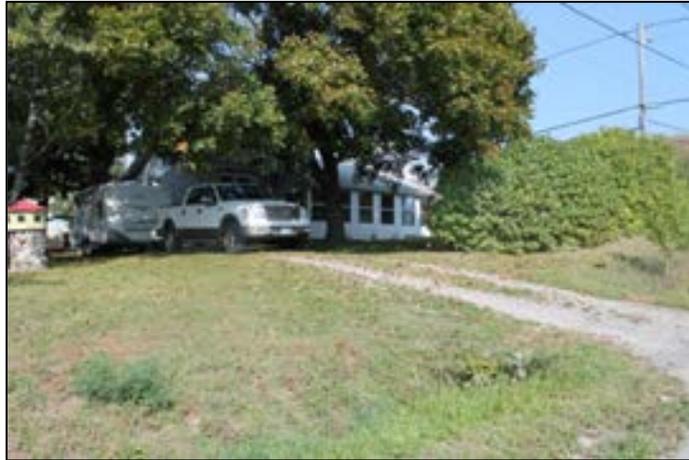
Property Type:	Residential
Era/Date of Construction:	1955 (replaced earlier building destroyed by fire)
Architect/Builder:	Not known
Building style/Influence:	Contemporary
Materials:	Frame
Number of Bays:	Multiple bay
Roof Type	Side gable
Building Height:	One storey
Alterations:	None recorded
Landscape/setting:	Open lawn, hedge row along front
Heritage value:	Non-heritage

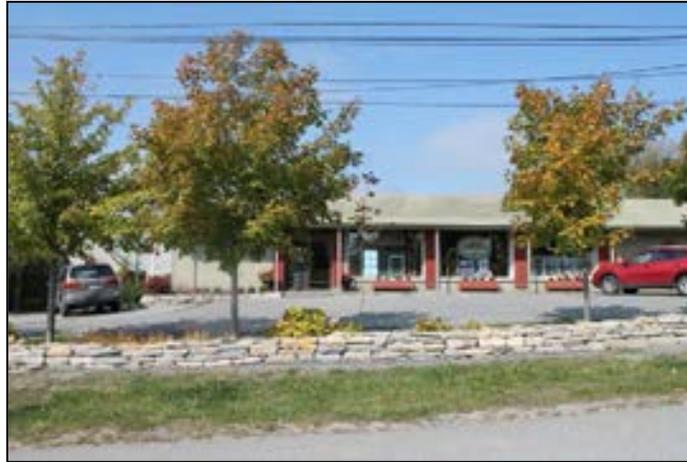
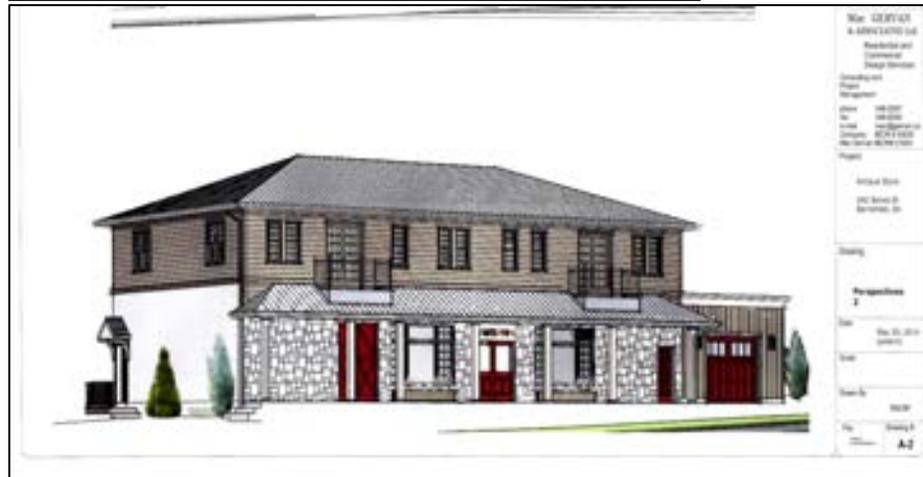
Property Type: Commercial. Antique store since 1990s, previously “Brownie’s” grocery store

Era/Date of Construction: Mid-20th century

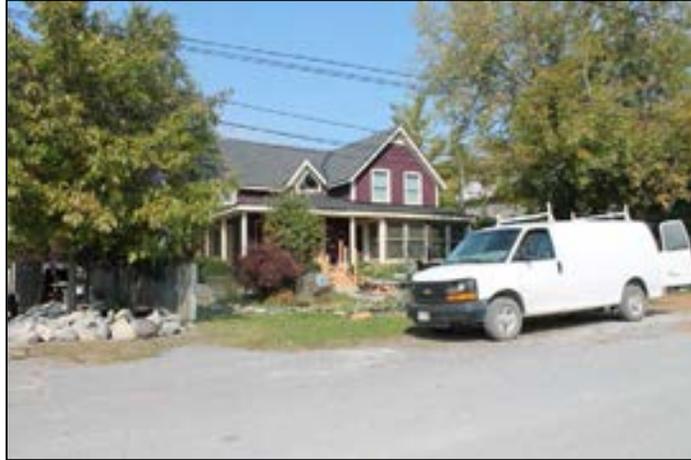
Property Type:	Residential
Era/Date of Construction:	2001-2002
Architect/Builder:	Architect Bruce Downey
Building style/Influence:	Contemporary
Materials:	Frame
Number of Bays:	Multi bay
Roof Type	Cross gable
Building Height:	One and one half storey
Alterations:	Structure repainted sometime between 2012 and 2014, Railings added to front porch steps (2014)
Landscape/setting:	Open lawn, mixed shrubs and trees
Heritage value:	Non-heritage

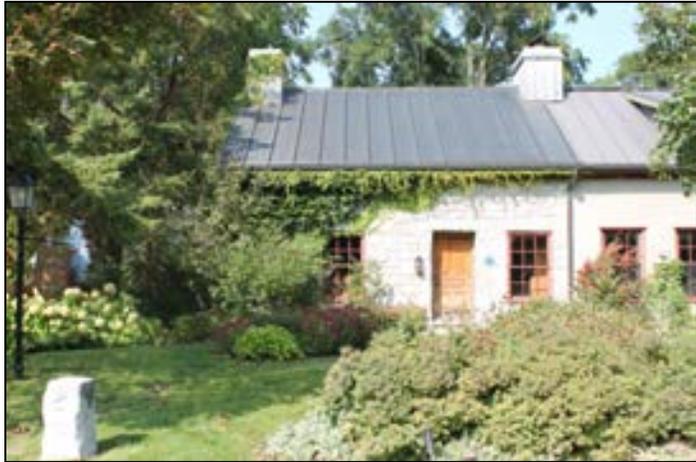
Property Type:	Residential (former Inn)
Era/Date of Construction:	1830-1840
Architect/Builder:	Not known
Building style/Influence:	Vernacular
Materials:	Limestone Rubble
Number of Bays:	Three
Roof Type	Side gable
Building Height:	One and one half storey
Alterations:	Original wooden shingles replaced with metal roofing. Addition and garage constructed (2003).
Landscape/setting:	Open lawn, mixed shrubs and trees,
Heritage value:	Heritage

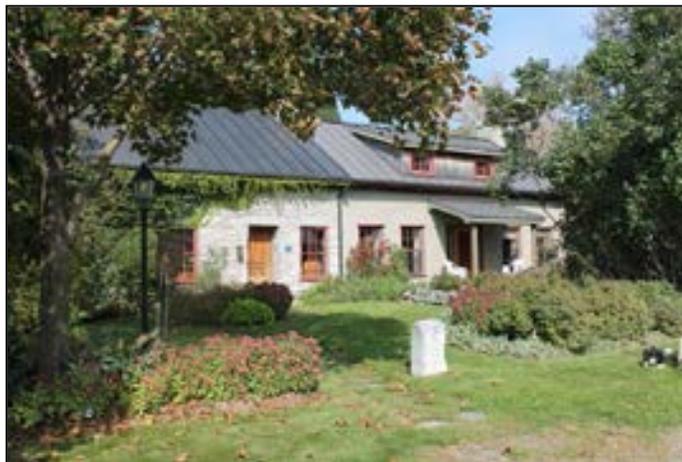
Property Type:	Residential
Era/Date of Construction:	C. 1830
Architect/Builder:	Not known
Building style/Influence:	Vernacular
Materials:	Stone Covered in Stucco
Number of Bays:	Five
Roof Type	Side gable
Building Height:	One and one half storey
Alterations:	Stucco-type cladding, 246 James Street added to eastern elevation as separate residence between 1830 and 1840, Shed dormer added to main elevation, One storey addition added to rear of 248 prior to 1908, One storey verandah across entire length of 248 facade replaced with shed roof portico over main entrance. Board and batten added to dormer, porch supports replaced, windows restored and new roof, stucco repaired (2004).
Landscape/setting:	Open lawn, mixed shrubs and trees
Heritage value:	Heritage

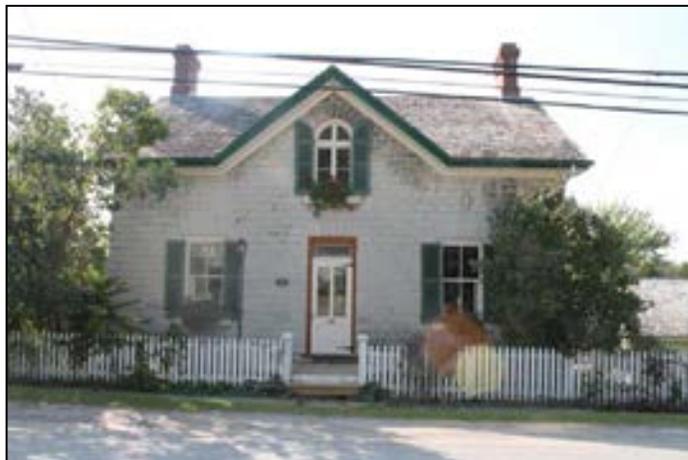
Lot: PLAN 51 PT LOT 3 RP 13R2800;PART
1

Property Type:	Residential
Era/Date of Construction:	C. 1874
Architect/Builder:	William Hutton
Building style/Influence:	Vernacular
Materials:	Limestone
Number of Bays:	Three
Roof Type	Medium pitched cross gable
Building Height:	One and one half storey
Alterations:	Fence replaced according to historic photos (1992), detached garage constructed (2005), rear addition replacing glass enclosure (2005)
Landscape/setting:	Strip of lawn along front
Heritage value:	Heritage

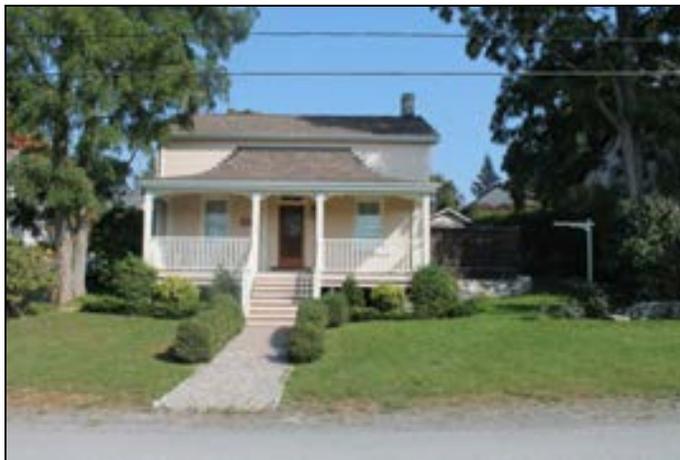
Lot: PLAN 51 PT LOT 4 RP
13R13670;PART 1

Property Type:	Residential
Era/Date of Construction:	1867
Architect/Builder:	John Mitchell
Building style/Influence:	Vernacular
Materials:	Brick
Number of Bays:	Three
Roof Type	Side gable
Building Height:	One and one half storey
Alterations:	Constructed addition and garage, reconstructed front porch, canopy and slab (2003), stove pipe installed (2006), utility garden shed with north side roof extension constructed (2011)
Landscape/setting:	Raise open lawn; Accent shrub plantings, Framed by mature deciduous trees
Heritage value:	Heritage

This house was built on a fieldstone foundation has a medium pitched side gable roof. The projecting boxed eaves are returned on the side elevations. The front elevation is arranged in a typical three bay fashion with a central door and side windows. The window sills are limestone. At one time all windows had operable exterior wooden louvered shutters. The present enclosed porch is a more modern addition replacing an earlier structure which ran the entire width of the facade. The main entrance door has a two light transom.

- One and one half storey massing
- Side gable rectangular plan
- Return eaves on side gables
- Brick construction
- Stone foundation
- Symmetrical three bay facade
- Regularly spaced rectangular window and door openings
- Open porch

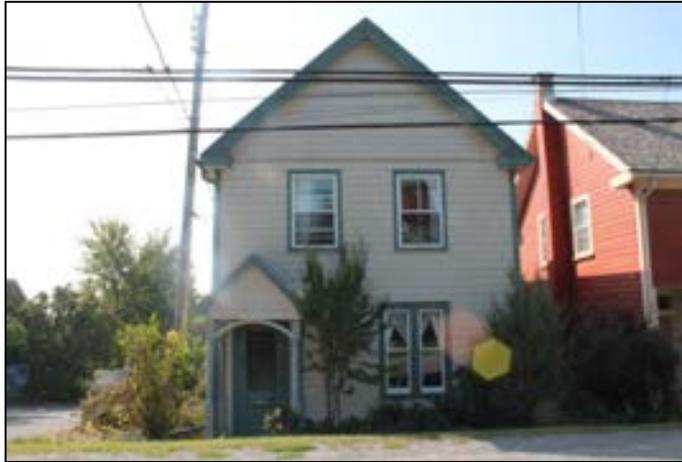
Lot: PLAN 51 PT LOT B RP
13R5604;PART 1

Property Type:	Residential
Era/Date of Construction:	Late 19 th Century
Architect/Builder:	William and Frederick Allen
Building style/Influence:	Vernacular
Materials:	Frame
Number of Bays:	Two
Roof Type:	Front gable
Building Height:	Two storey
Alterations:	Rear wing addition (pre-1992), one storey shed roof addition constructed behind two storey rear wing (pre-1992), house and trim repainted (1992), five sash windows, fascia and eaves troughs restored, repaired and replaced (2010-2011)
Landscape/setting:	Corner lot, lawn, mixed shrubs
Heritage value:	Heritage

The main section sits on a coursed rough-faced limestone foundation and is clad in shiplap siding with accenting cornerboards. The side front entrance has a small gable portico which consists of turned supporting posts and separate semi-circular arches fixed between each post as a decorative element. The window sash consist of typical late 19th century 2/2 lights. An early historical photograph shows that a number of windows had exterior louvred shutters on the main block.

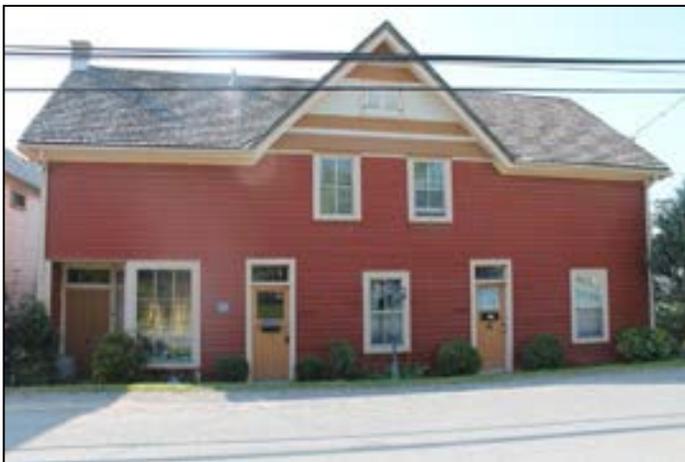
Lot: PLAN 51 PT BLK B

Property Type:	Residential (former commercial)
Era/Date of Construction:	1874
Architect/Builder:	William and Frederick Allen
Building style/Influence:	Vernacular
Materials:	Frame
Number of Bays:	Five
Roof Type	Cross gable
Building Height:	Two storey
Alterations:	Decorative fascia ornamentation on front gable replaced (pre-1992), exterior cladding replaced (pre-1992), restoration (1993), steel roofing, terrace doors with sidelights applied to rear addition (1998), asphalt shingles replaced with cedar (1998), new addition constructed (1998), windows on north and south facades replaced (2004)
Landscape/setting:	Front garden with assortment of shrubs
Heritage value:	Heritage

Rectangular in plan, the principal axis of this structure runs parallel to Main Street. It has a high pitched gable roof with a large central gable on the front elevation. The original eaves were returned on the side gables. At one time the gable was ornamented with a decorative fascia which has been replaced. The decorative wooden shingle work is still extant. The two original brick chimneys located on the end gables have been demolished.

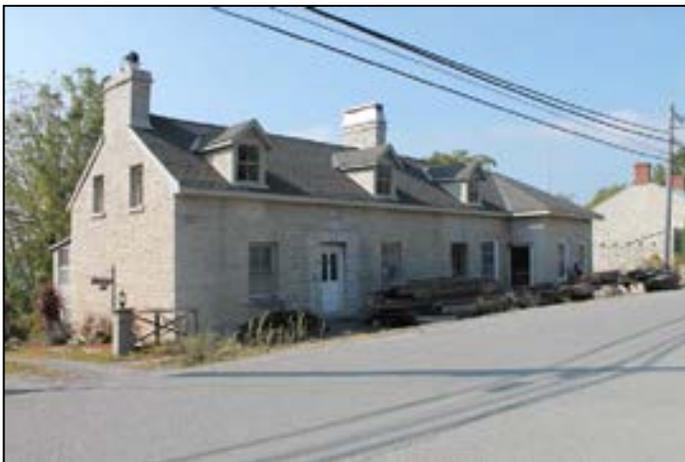
Lot: PLAN 51 PT BLK B RP
13R7631;PART 1

Property Type:	Residential
Era/Date of Construction:	C. 1834
Architect/Builder:	Alexander Mayberry
Building style/Influence:	Vernacular
Materials:	Limestone
Number of Bays:	Multiple
Roof Type	Side gable
Building Height:	One and one half storey
Alterations:	New roofing installed, dormers reconstructed/reconfigured (2011), chimneys repointed (2011), eave and soffit details changed (2012), south gable windows restored (2012), front vestibule demolished (2012),garage to be reconstructed with rear shed dormer
Landscape/setting:	Close setback to street
Heritage value:	Heritage

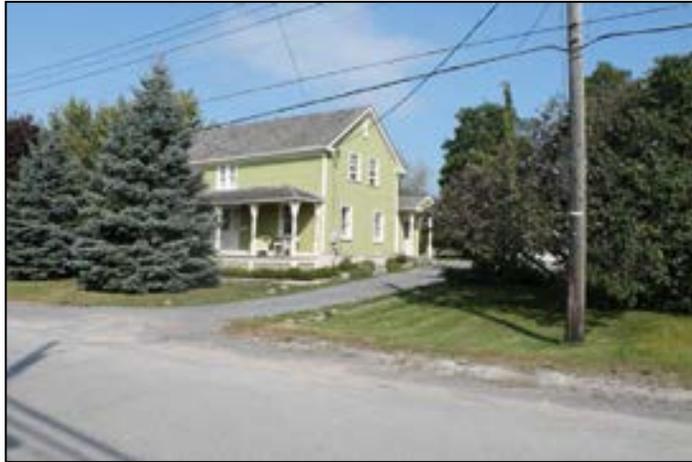
Lot: PLAN 51 PT LOT 4 RP
13R10677;PART 1

Property Type:	Residential
Era/Date of Construction:	Late 19 th Century
Architect/Builder:	Not Known
Building style/Influence:	Vernacular
Materials:	Wood Frame
Number of Bays:	Three
Roof Type:	Side gable
Building Height:	Two storey
Alterations:	Exterior siding repainted (1991), brick chimney removed (pre-1992), wooden shingles restored (pre-1992), two-storey addition with porch and double-car garage constructed (1997), siding replaced with wood cladding (2005), exterior wood repaired, replaced and painted (2011)
Landscape/setting:	Open lawn, mature spruce
Heritage value:	Heritage

Relocated to its present position in the late 19th century, this frame house was apparently placed on the foundations of an earlier 1816 structure which had been destroyed by fire. Its rectangular plan is placed with the long axis oriented to the street. Two storeys high, it has a medium pitched side gable roof with a boxed returned eave on each side wall. A plain frieze board is located below.

- Two storey massing
- Rectangular side-gable plan
- Return eaves on side gable
- Stone foundation
- Frame construction
- Symmetrical three bay first storey facade and central paired window in second storey
- Rectangular regularly spaced window and door openings
- Full width open porch with turned posts and brackets

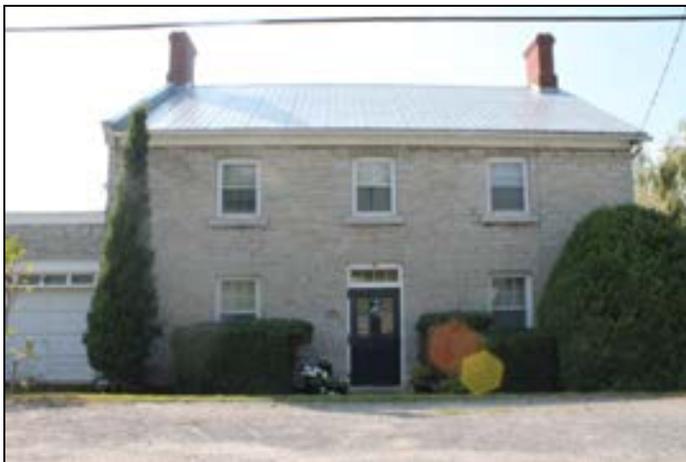
Lot: PLAN 51 PT BLK B RP
13R3500;PART 1

Property Type:	Residential
Era/Date of Construction:	C. 1821
Architect/Builder:	John Mason
Building style/Influence:	Vernacular
Materials:	Limestone
Number of Bays:	Three
Roof Type	Side gable
Building Height:	Two storey
Alterations:	Single storey section converted to garage (pre-1992), replacement of original wooden shingles with metal roof (pre-1992)
Landscape/setting:	Slopes down towards water, Manicured coniferous shrubs frame the front facade.
Heritage value:	Heritage

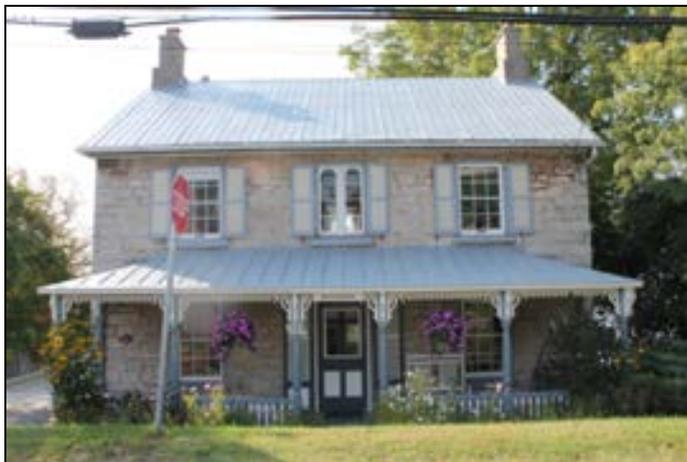
Lot: CON EGCR PT LOT 20
RP;13R12645 PART 2

Property Type:	Residential
Era/Date of Construction:	1818-1819
Architect/Builder:	John Hendry
Building style/Influence:	Vernacular
Materials:	Limestone
Number of Bays:	Three
Roof Type	Side gable
Building Height:	Two storey
Alterations:	Raised roof, wooden shingles replaced with metal batten roof (pre-1992), 1.5-storey shed removed for driveway (pre-1992), two second floor north windows replaced (2010)
Landscape/setting:	Sloping lawn, shrubs and trees
Heritage value:	Heritage

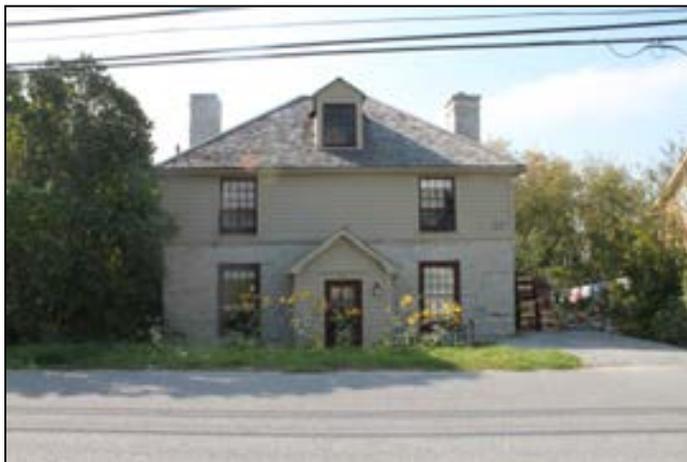
Lot: CON EGCR PT LOT 20
RP;13R2218 PART 1 RIDEAU CANAL

Property Type:	Residential
Era/Date of Construction:	c.1838
Architect/Builder:	Ann and Oliver Boiselle
Building style/Influence:	Vernacular
Materials:	Limestone
Number of Bays:	Three
Roof Type	Truncated hip
Building Height:	Two and one half storey
Alterations:	One storey addition constructed (1928), stone addition extending from rear constructed (pre-1992), upper ¼ of stone chimneys repointed (1994), roof replaced, chimney removed (2000), siding repaired and repainted (various years), window relocated and reinstalled (2000), gutters, downspouts, awning applied to house (2001), chimney repaired (2005), chimney repointed and woodwork painted (2006), storm windows replaced (2008), roofing replaced and two sills and primary windows repaired (2009), iron handrail installed for stone stairs (2010), two sections of cedar roof replaced (2010), vents installed (2011)
Landscape/setting:	Built into slope of the land, open lawn, trees in side yard, gravel drive

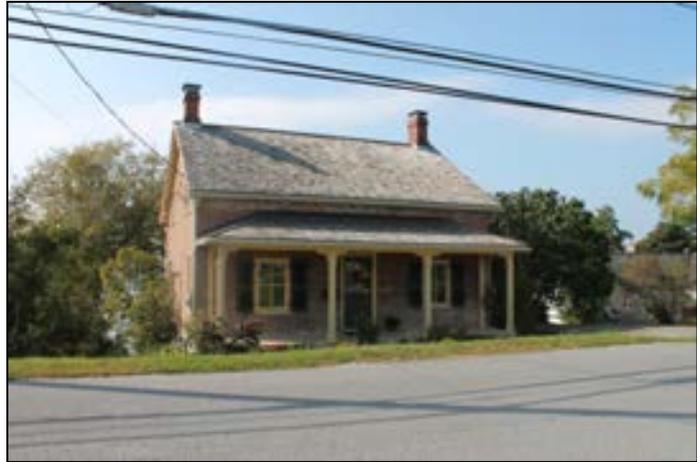
Lot: CON EGCR PT LOT 20
RP13R2012;PART 1 RIDEAU CANAL

Property Type:	Residential
Era/Date of Construction:	C. 1819
Architect/Builder:	Ann and William Michael
Building style/Influence:	Vernacular
Materials:	Brick
Number of Bays:	Three
Roof Type:	Side gable
Building Height:	One and one half storey
Alterations:	Cedar roof replaced (2005), chimneys restored/repointed, chimney caps added (2009-2011), front and back porches repaired and replaced (2011)
Landscape/setting:	Built into a steep embankment,
Heritage value:	Heritage

This one and one half storey brick house is built into the steep embankment overlooking the Cataraqui River. It has a Flemish bond brick pattern and a full fieldstone foundation/basement to the rear facing the slope of the incline. This building is known to have been erected by Ann and William Michael, a master armourer, probably in the 1819.

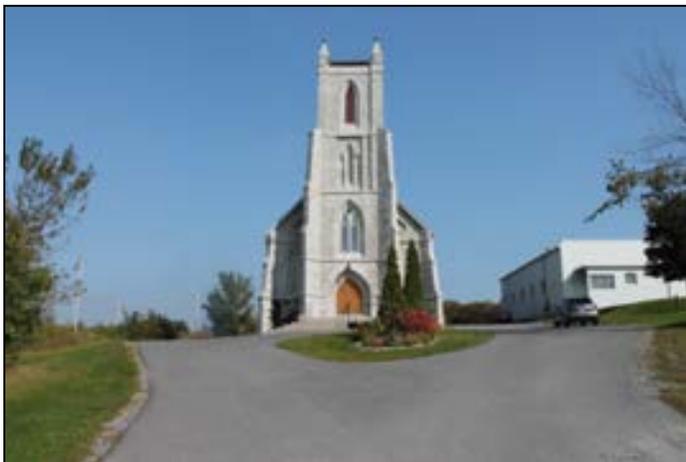
Property Type:	Church
Era/Date of Construction:	1843-1844
Architect/Builder:	Richard Jones
Building style/Influence:	Gothic Revival
Materials:	Stone
Number of Bays:	Three
Roof Type	Front gable with tower
Building Height:	Two storey plus tower
Alterations:	Addition of chancel and sanctuary (1897), balcony and choir loft moved to front of church (1897), church hall constructed next to church (1961), bell tower restored (1993), steel cladding installed (1998), bell tower masonry restored (2006), roof soffit, fascia, eaves, troughs and downspout repaired and restored (2007), chimney repaired (2007), section of bell tower repointed (2010-2012)
Landscape/setting:	Large lot, open lawn, shrubs and specimen plantings, long driveway, constructed on rise of land
Heritage Value:	Heritage

St Mark's Church is a two storey structure with central front tower constructed in the Gothic Revival Style. The church is constructed of stone and features a front gable roof. The Church features many of the hallmarks of the Gothic Revival style, including lancet (pointed arch) window and door openings, buttresses and tower. The church also features recessed quatrefoil details on the front, and stained glass windows. A stone fence with tall pillars and a pointed, gothic motif cap are located at the entrance to the church.

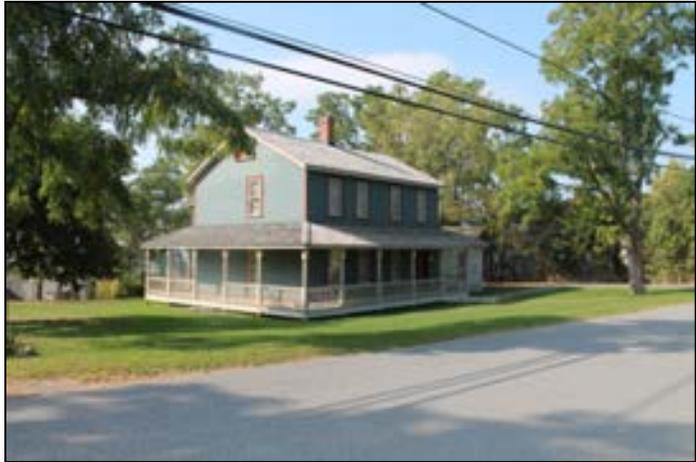
Lot: PLAN 464 PT LOT 3
RP;13R18166 PART 5

Property Type:	Residential
Era/Date of Construction:	1824-1828
Architect/Builder:	Stone structure by John Grant, Main house by John Marks
Building style/Influence:	Vernacular
Materials:	Log and Frame
Number of Bays:	Four
Roof Type	Side gable
Building Height:	Two storey
Alterations:	Restoration (2005), windows restored (2006)
Landscape/setting:	Open lawn, specimen trees, gravel drive
Heritage value:	Heritage

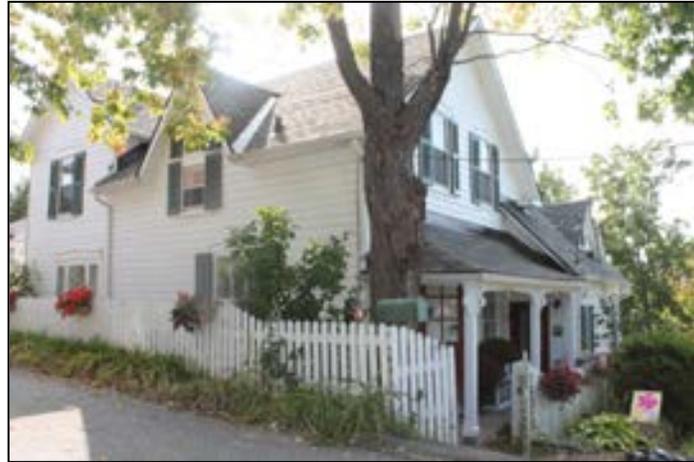
Lot: PLAN 51 PT LOT 2

Property Type:	Residential
Era/Date of Construction:	c. 1895
Architect/Builder:	Alexander Rickey
Building style/Influence:	Vernacular
Materials:	Frame
Number of Bays:	Multi bay
Roof Type	Multi gable
Building Height:	One and one half storey
Alterations:	Barn demolished (pre-1992), wooden shingles replaced (pre-1992), house foundation repaired (1994), verandah posts, gingerbread detailing and original front window restored (2009), windows replaced (2009), repair and paint siding on addition (2011), bay window replaced two original double hung windows on the west elevation (2011)
Landscape/setting:	Assortment of shrubs and specimen trees, picket fence
Heritage value:	Heritage

Built by Alexander Rickey, a local wagon maker and blacksmith, following a devastating fire in 1895, this one and one half to two storey frame dwelling has an irregular plan and a multi gable roof. The main section faces onto Regent Street with a side cross gable running west down the slope towards the river. The rear extension has a raised fieldstone foundation/basement with an entry door from the ground level. Numerous changes have occurred to the exterior of the

An extra window has been added to the east elevation facing Sharman's Lane immediately below an original small gable window. The newer lower window opening creates an unusual feature. A modern picture window has also been added on the first floor. A one storey bay window replaced two original double hung windows on the west elevation c. mid-20th century.
