Appendix A Inventory of properties within the Barriefield Heritage Conservation District

Introduction to the Inventory

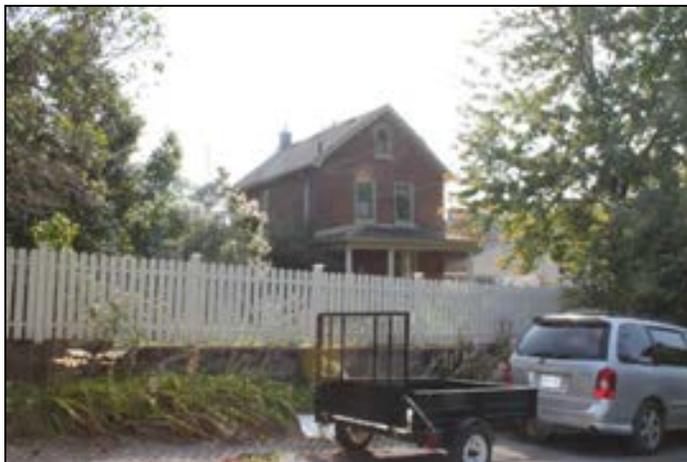
Property Type:	Residential
Era/Date of Construction:	1880s
Architect/Builder:	Mr. Godwin
Building style/Influence:	Vernacular
Materials:	Brick
Number of Bays:	Two
Roof Type	Front gable
Building Height:	Two and one half storey
Alterations:	Front porch added (post-1908), outbuildings removed (post-1908), two dormer windows installed (1994), new window under front gable installed (1994), two storey addition constructed at rear (1994), new mudroom, deck and single storey addition constructed (1996), skylights installed on south facing roof slope of rear addition (1997), asphalt shingles replaced (2010)
Landscape/setting:	Screened enclosure, wall climbing shrubs, specimen trees
Heritage Value:	Heritage

The overall design and plan of the house is reminiscent of the house at 218 Green Bay Road, which was built around the same time. It is a narrow two storey brick structure with a front gable orientation and a side hall entrance plan. The brick is laid on a limestone foundation in a stretcher bond while the one storey brick addition is laid in a common bond. The first floor of the main facade which faces Regent Street has a single side entrance and a double window similar to 218 Green Bay Road. The second floor has two single, closely placed window openings in the centre of the facade. The steeply pitched gable roof was originally covered with wooden shingles. The boxed eave has a slight curve at the bottom end on both the front and rear gables creating the ornamental effect of an arch.

- Two and one half storey massing
- Front gable plan
- Brick construction: with two bond patterns (stretcher and common bond)
- Two bay facade
- Rectangular window and door openings, including double window on first storey
- Round arched gable window
- Stone foundation

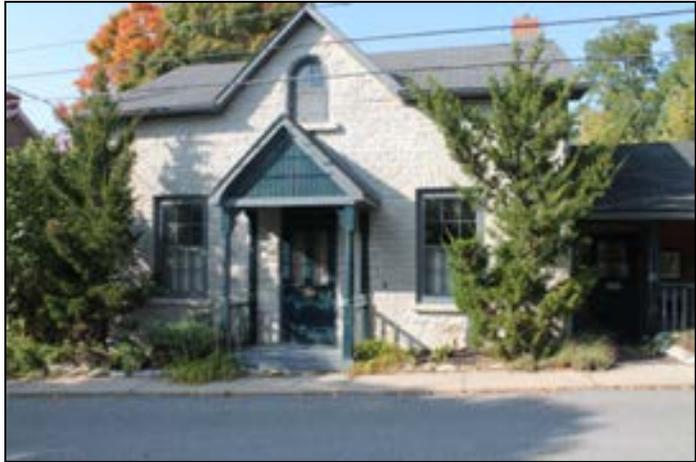
Lot: PLAN 51 PT LOT 4 PT LOT 5

Property Type:	Residential
Era/Date of Construction:	1853-1854
Architect/Builder:	Robert Forbes
Building style/Influence:	Vernacular
Materials:	Limestone
Number of Bays:	Three
Roof Type:	Cross gable
Building Height:	One and one half storey
Alterations:	One storey brick addition added to east elevation (late 1800s), exterior shutters removed (pre-1992), wooden shingles replaced (pre-1992), one storey building added at rear (2008), new garage door installed (2012)
Landscape/setting:	Thin strip of front lawn, made up with coniferous trees which frame the dwelling.
Heritage value:	Heritage

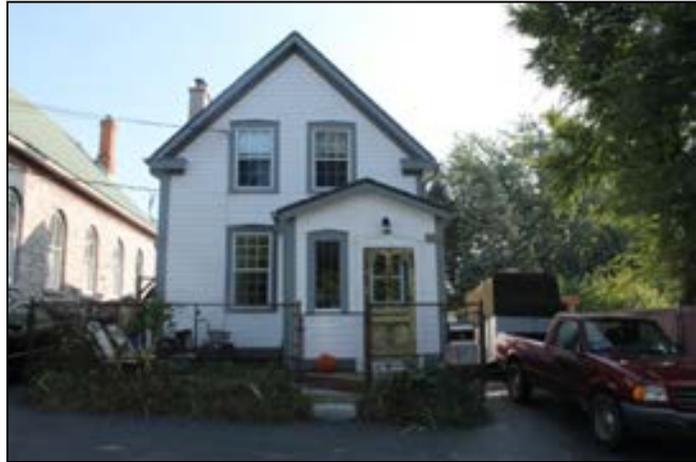
Lot: PLAN 51 PT LOT 5

Property Type:	Residential
Era/Date of Construction:	C. 1890
Architect/Builder:	William and Frederick Allen
Building style/Influence:	Vernacular
Materials:	Frame
Number of Bays:	Two
Roof Type	Front gable
Building Height:	One and one half storey
Alterations:	Insulbrick removed and exterior painted (1994), soffits and eaves troughs replaced (1994)
Landscape/setting:	Asphalt drive, chain link fenced yard, minimal vegetation
Heritage value:	Heritage

One of several structures built in Barriefield by the Allen Brothers, the building's front gable roof and two bay main facade with a side hall entrance is typical of the late 19th century vernacular domestic architecture. It is set on a limestone foundation. The steeply pitched roof has a returned eave detail on the front elevation. The window trim is

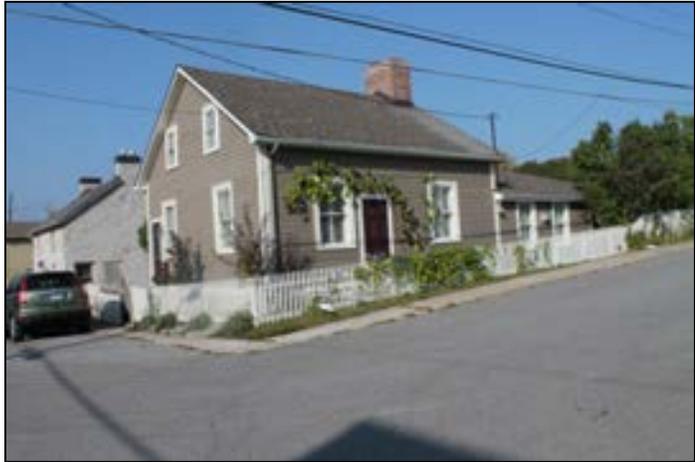
Lot: PLAN 51 PT LOT 6

Property Type:	Residential
Era/Date of Construction:	C. 1830
Architect/Builder:	Stephen Yarwood
Building style/Influence:	Vernacular
Materials:	Frame
Number of Bays:	Three
Roof Type:	Side gable
Building Height:	One and one half storey
Alterations:	One storey addition extending from east elevation constructed (pre-1992), original wooden shingles replaced with metal roof (pre-1992), chimney repaired (1990), metal roof replaced with shingles (1990), vinyl siding installed (2001), sunroom constructed (2007)
Landscape/setting:	Close setback to street, picket fence
Heritage value:	Heritage

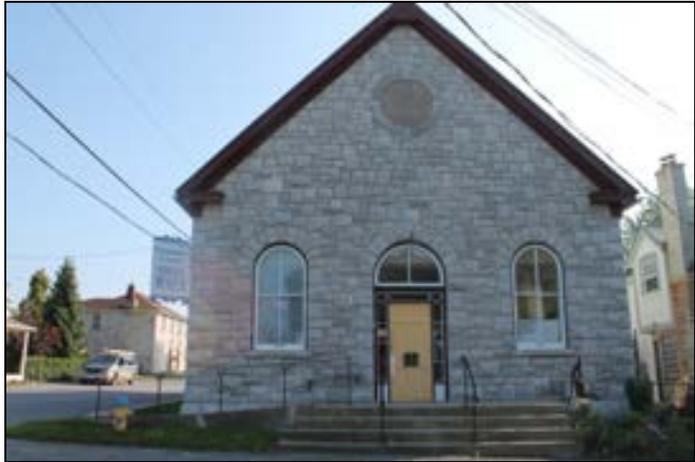
Property Type:	Institutional / Museum
Era/Date of Construction:	1886
Architect/Builder:	Designed by William Newlands, built by Robert Free
Building style/Influence:	Vernacular
Materials:	Limestone
Number of Bays:	Three
Roof Type:	Front gable
Building Height:	One storey
Alterations:	One storey frame addition added to rear of building (pre-1992), wooden shingles removed and replaced with metal roof (1993), ramped access and handrails added to front entrance (1995), new door and concrete pad installed at rear entrance (1995)
Landscape/setting:	None, Narrow strips of grass, Close to sidewalk
Heritage value:	Heritage

The limestone is squared and dressed and laid in a broken course. The corners are emphasized by quoins as are the window and door openings. It has a rectangular plan with the short end towards Regent Street. The side elevations are divided into five bays with semi-circular window openings. The main facade has a central entranceway with sidelights and a semi-circular double transom with flanking semi-circular windows, one on each side. A datestone and inscription stating "Township Hall 1886" is located in the gable peak over the main entrance. Each gable end has returned eaves. Two tall brick chimneys are located on either side of the gable ridge to the rear of the building. According to the 1908 Goad's Fire Insurance Plan the roof was once covered with wooden shingles. It presently has a metal roof. A large one storey frame addition with a shed roof extends from the back of the building.

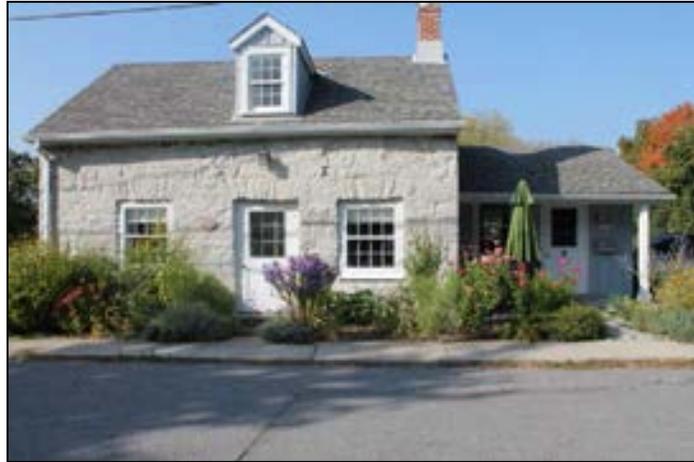
Lot: PLAN 51 PT LOT 6 & 7
RP;13R8111 PART 1 RP
13R13152;PART 1

Property Type:	Residential
Era/Date of Construction:	1830s
Architect/Builder:	George Hyland
Building style/Influence:	Vernacular
Materials:	Stone
Number of Bays:	Three
Roof Type:	Side gable with later front gable dormer
Building Height:	One and one half storey
Alterations:	Gable dormer on front elevation added (pre-1992), one and one half storey addition at east side of structure replaced with one storey addition (late 1900s), one storey frame addition extending from rear of structure replaced with one and one half storey addition (late 1900s), one storey garage on the structure's west side demolished (post-1992), front dormer downsized (post-1992) white cedar shingles replaced with fibreglass asphalt shingles (2004), front door replaced (2008), porch replaced with limestone patio (2010)
Landscape/setting:	Close setback to street, mixed vegetation
Heritage value:	Heritage

The building has a rectangular plan with a typical three bay front elevation consisting of a central doorway and two flanking windows, one on each side. The medium pitched side gable roof slightly projects at the eaves and has a single brick chimney inset on the east gable end. A gable dormer was added to the main elevation at a later date. The large blocks of roughly squared limestone are laid in a broken course with oversized quoins on the corners and around the window openings. According to the 1908 Fire Insurance Plan, a one and one half storey building was once attached at the east side of the structure and a one storey frame addition extended to the rear.

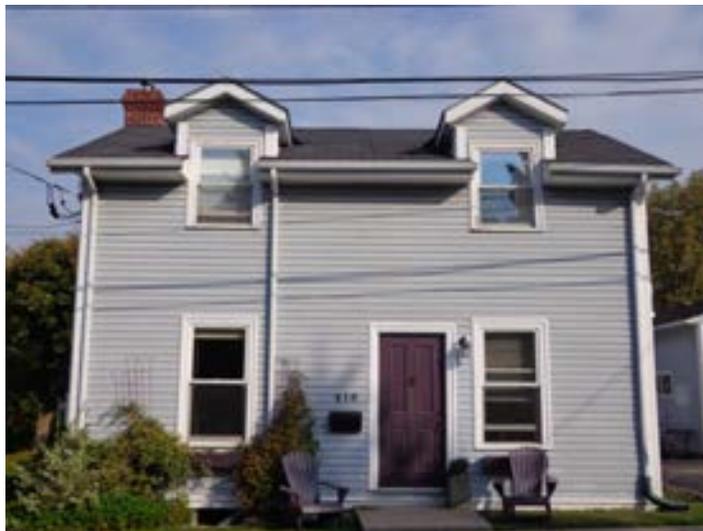
Lot: PLAN 51 PT LOT 7 RP
13R13152;PART 2

Property Type:	Residential
Era/Date of Construction:	1850
Architect/Builder:	Not known
Building style/Influence:	Vernacular
Materials:	Frame with Limestone Foundation
Number of Bays:	Three
Roof Type:	Side gable
Building Height:	One and one half storey
Alterations:	Garage added to property (pre-1992), central brick chimney removed and new chimney added on west elevation (pre-1992), original wooden siding covered by modern aluminum siding (pre-1992), wall dormer added and height increased (post-1992), single window in eastern gable replaced with two separate windows (post-1992), first storey window added on eastern elevation of main structure (post-1992), saltbox rearward addition replaced with one and one half storey structure (post-1992),
Landscape/setting:	Close setback to street, lawn, small shrubs
Heritage value:	Heritage

This small one and one half storey vernacular frame dwelling was constructed on a limestone foundation with a rectangular plan and a low pitched side gable roof. The main facade is divided into three bays with an off-centre entranceway. A central brick chimney has been removed and a brick chimney on the west side has been added. The original wooden siding is now covered with modern aluminium siding which obscures any original detailing. Since the 1992 inventory, two wall dormers have been added to increase space in the upper storey and the saltbox addition out the rear has been replaced with a one and one half storey structure and an east facing vestibule.

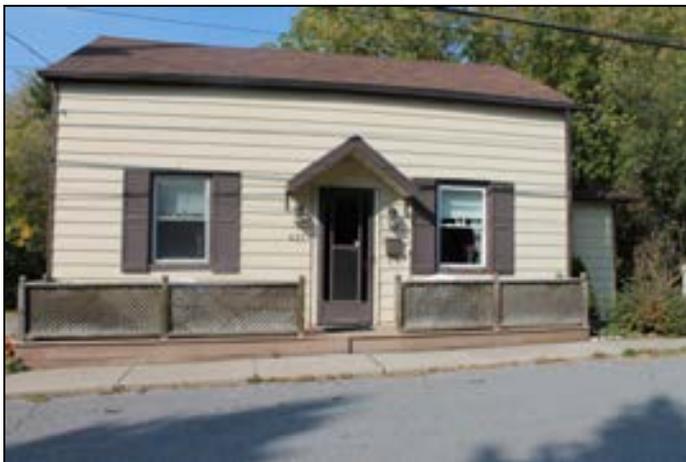
Lot: PLAN 51 W 1/2 LOT 8

Property Type:	Residential
Era/Date of Construction:	Late 19 th Century (after 1874)
Architect/Builder:	George Batten
Building style/Influence:	Vernacular
Materials:	Frame
Number of Bays:	Three
Roof Type:	Side gable
Building Height:	One and one half storey
Alterations:	Small one storey addition added to rear of structure (pre-1992), original windows and doors replaced (pre-1992), original wooden siding replaced with aluminum siding (pre-1992)
Landscape/setting:	Close setback to street, no soft landscaping
Heritage value:	Heritage

Believed to have been constructed by local labourer George Batten after 1874. this small one and one half storey frame vernacular cottage is rectangular in shape and has a low pitched side gable roof. The main facade is divided into three bays with an off-centre main entrance door. A small one storey addition extends from the rear giving the structure an "L" shaped plan. Originally clad in wooden siding the structure now has aluminium siding. The original window and doors have been replaced.

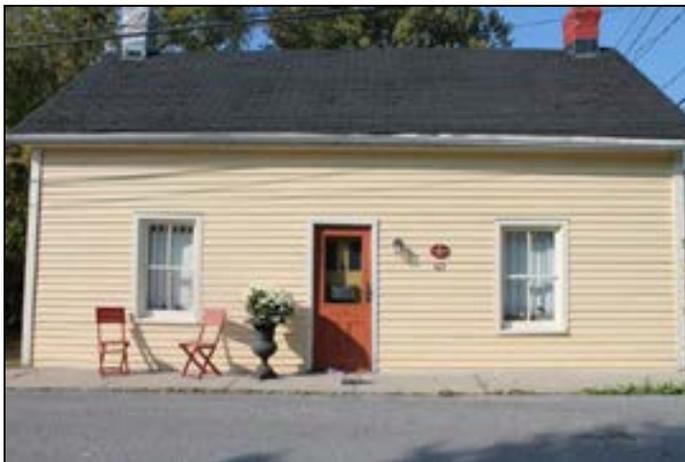
PLAN 51 PT LOT 8

Property Type:	Residential
Era/Date of Construction:	C. 1880
Architect/Builder:	George McAllister
Building style/Influence:	Vernacular
Materials:	Frame
Number of Bays:	Three
Roof Type	Side gable
Building Height:	One and one half storey
Alterations:	One storey shed roof addition added to rear of dwelling (between 1880s and 1908), black asphalt shingle roof replaced (1992), windows and rear door repaired and replaced (2006), siding on west elevation removed (2006), building envelope and fence restored (2006-2010)
Landscape/setting:	None, structure fronts directly onto sidewalk
Heritage value:	Heritage

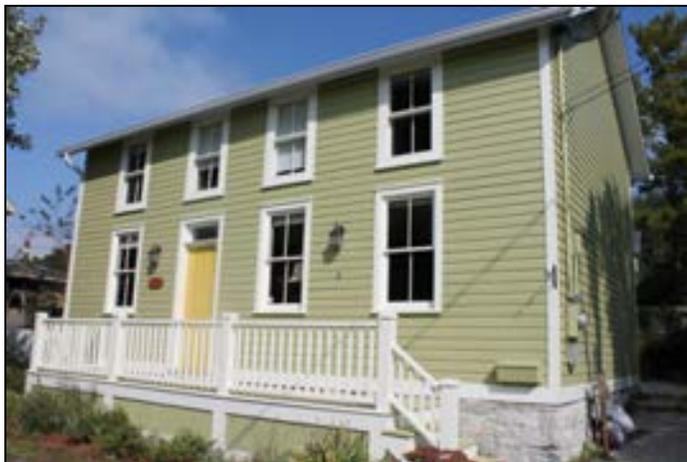
Lot: PLAN 51 PT LOT 3 RP
13R2800;PART 2

Property Type:	Residential
Era/Date of Construction:	Late 19 th Century
Architect/Builder:	Not known
Building style/Influence:	Vernacular
Materials:	Frame
Number of Bays:	Four
Roof Type	Side gable
Building Height:	Two storey
Alterations:	Conversion from double to single unit house, front deck. Interlock pavers added to driveway (2010), exterior repairs (2007), roof replacement (2002).
Landscape/setting:	Close setback to street, shrubs
Heritage Value:	Heritage

- Two storey massing
- Side gable rectangular plan
- Frame construction
- Stone foundation
- Four bay facade
- Rectangular window and door openings
- Narrow horizontal cladding

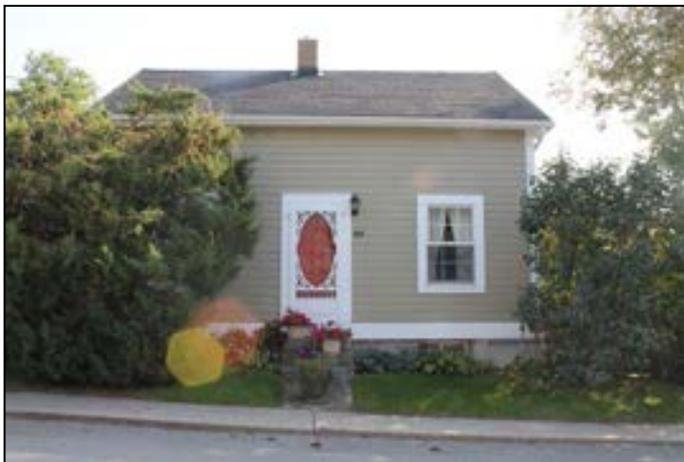
Lot: PLAN 51 PT LOT 5

Property Type:	Residential
Era/Date of Construction:	C. 1840
Architect/Builder:	Not known
Building style/Influence:	Vernacular
Materials:	Frame
Number of Bays:	Three
Roof Type	Side gable
Building Height:	One and one half storey
Alterations:	Window and door replacements, cladding replacement (2003). Several additions have been built onto the main house
Landscape/setting:	Large shrubs, open lawn
Heritage Value:	Heritage

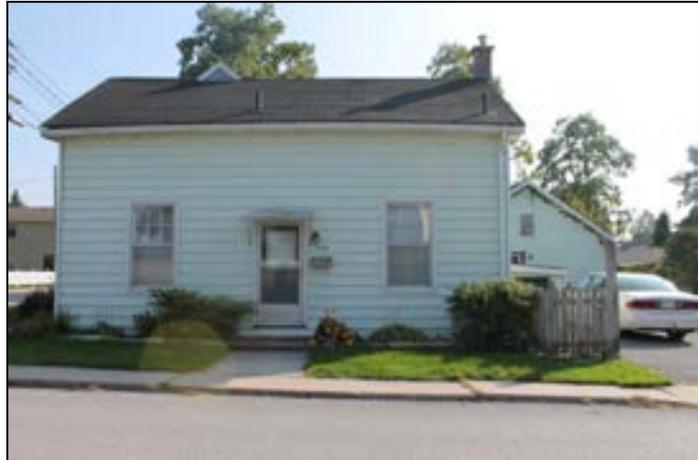
Lot: PLAN 51 PT LOT 5

Property Type:	Residential
Era/Date of Construction:	Late 19 th Century
Architect/Builder:	John Tisdell
Building style/Influence:	Vernacular
Materials:	Frame
Number of Bays:	Three
Roof Type:	Side gable
Building Height:	One and one half storey
Alterations:	Rear one and one half storey addition with a one storey side porch
Landscape/setting:	Small open lawn, assortment of shrubs
Heritage Value:	Heritage

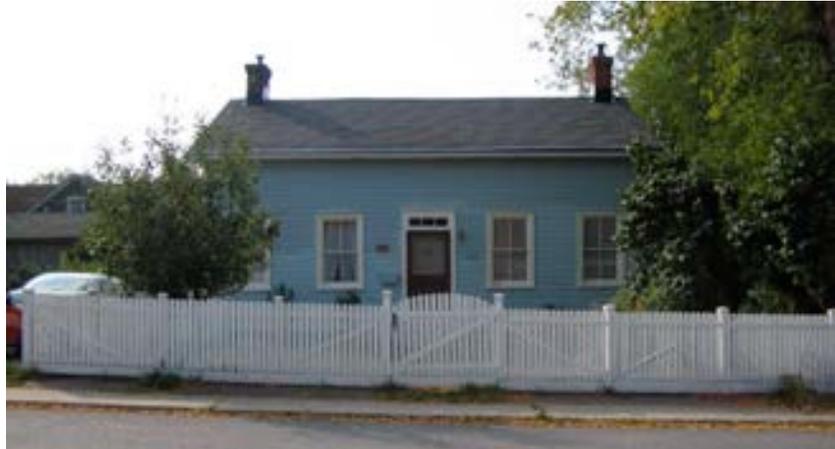
Lot: PLAN 51 PT LOT 7 & 8

Property Type:	Residential
Era/Date of Construction:	1860, Moved to present site late 1930s
Architect/Builder:	William Allen
Building style/Influence:	Vernacular
Materials:	Frame
Number of Bays:	Five
Roof Type:	Side gable
Building Height:	One and one half storey
Alterations:	Move to current property in late 1930s; veranda removed (1980); roof repairs (2006), windows replaced (1992)
Landscape/setting:	Fenced lawn, specimen trees, assorted shrubs
Heritage Value:	Heritage

The main facade is divided into five bays with a central doorway and two windows on each side. The doorway has a three light transom. The walls are clad in shiplap siding with plain accenting cornerboards, frieze and water table. A boxed cornice with a returned eave is found on each gable end. Each gable end has an inset brick chimney. A simply designed one storey verandah once ran across the full width of the principal elevation but has been removed.

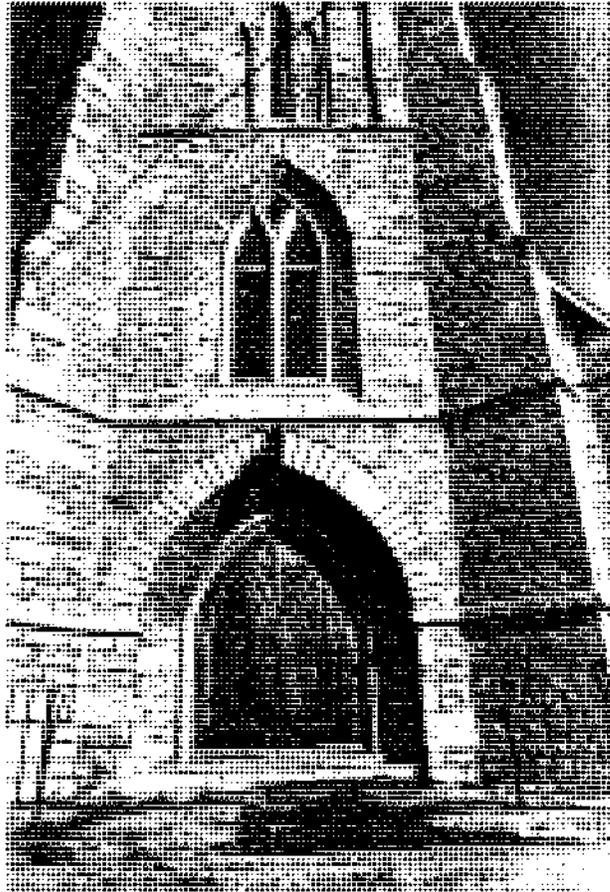
In order to prevent the decay of lower masonry units make sure the surface water drains away from the building. Never spread rock salt near masonry as this will accelerate decay of both stone and brick .

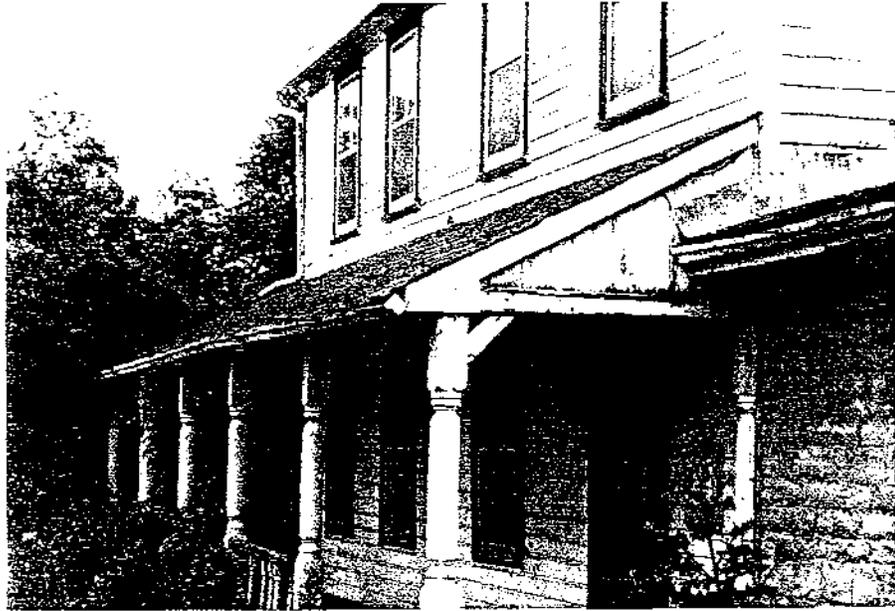
A proper roof inspection should be carried out annually. Sound flashing and operational downspouts and gutters are critical to the long term maintenance of this feature whether it is built of wood, metal or asphalt.

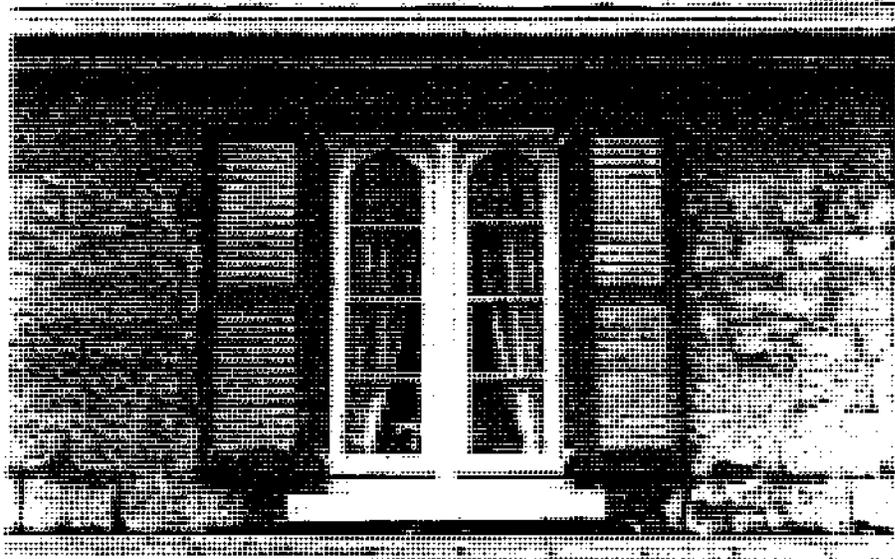
Maintain the original windows and repair rather than replace. Restore shutters to operational use whenever possible. New shutters should always match the original dimensions and method of construction.

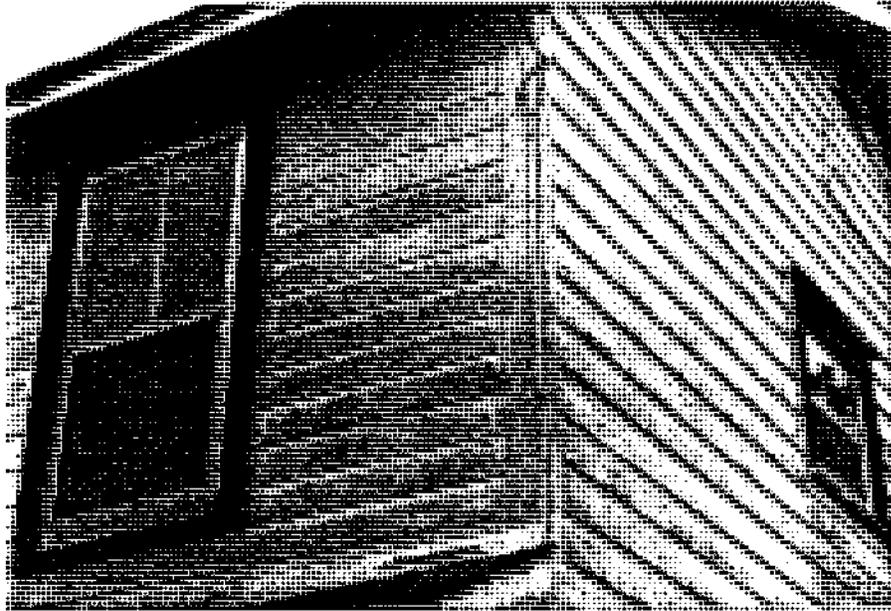
Wood siding must be kept weather tight. Regular cleaning and painting will be necessary to preserve this form of cladding.
