Property Inventory Evaluation

Lower Union Street

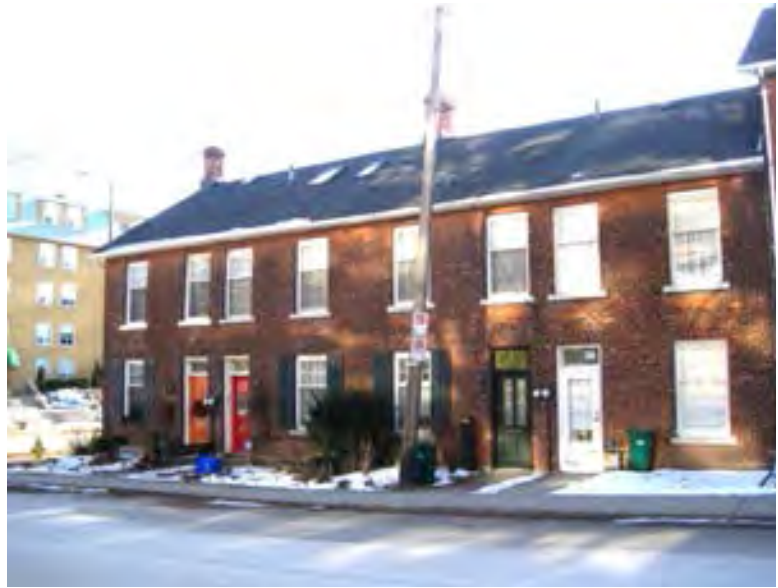
30-32-34-36 Lower Union St

This red brick building is comprised of 8 bays containing four units. Its design elements are representative of row houses built for labouring families in the 19th-century: a flat façade, minimal setback, side gable roof with centred chimneys, and symmetrical fenestration. The entranceways to these units are paired, with square-headed doorways and small rectangular transoms. Each of their three windows features an appropriate multi-paned window arrangement, having replaced the previous 2/2 double hung windows that once occupied these openings.[†] The 30 Lower Union residence contains 6/9 windows; the remainder have 8/12.

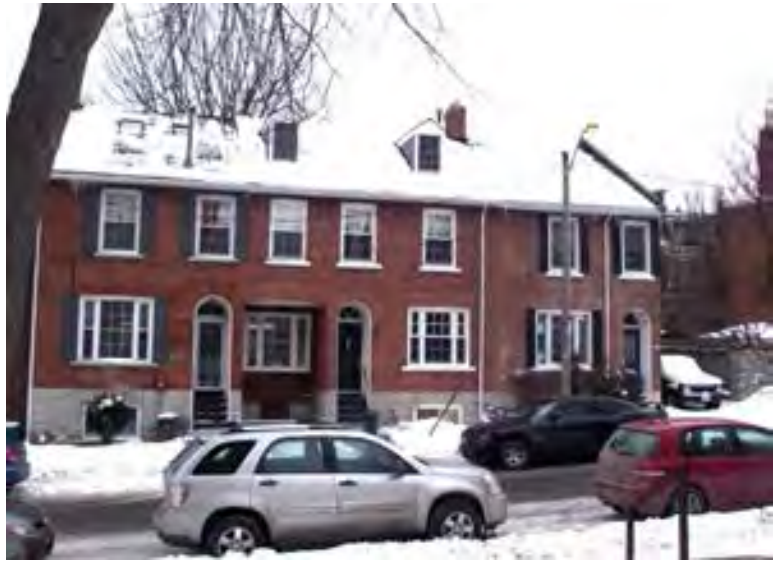
38-42 Lower Union Street

This is a more elaborate version of the mid-19th century row houses which they abut, and with which they are flush in setback. A distinguishing characteristic of this terrace is that, owing to slope of the street, the exposed part of its foundation is graduated. As such 38 Lower Union has a much taller foundation than 40 and 42. All three units feature basement windows with flat arches.

A carriageway that once divided 38 and 40 has been filled in, and a sunken entranceway has been added. Above the entrance is a 12-piece rectangular window with 4-piece sidelights, matching the first-storey windows of each unit. Because these features are recessed, the carriageway entrance remains an important design element of this building.

Each main entrance is recessed, flanked by plain wood reveals, and accessed by stairs that are flush with the façade. Their fanlight transoms contain 3 lights each, divided by thin radial arms. Plain stone sills support each window; the second storey windows are rectangular and 6/6.

The building's side-gable roof is raised above that of its neighbour on the southeast side. Its other end terminates at a firewall. Brick chimneys extend from the southeast

side of 38 and 42 Lower Union. Dormers above the 40 Lower Union units are recent relative to the age of the building.*

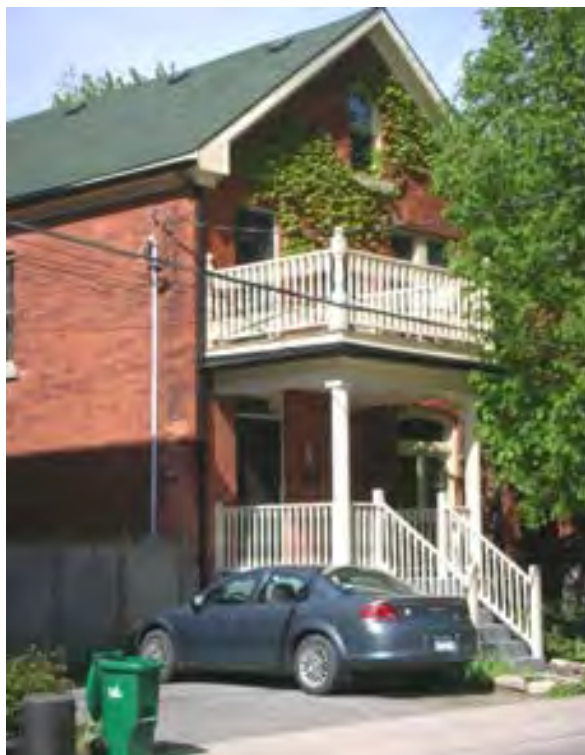
The 64 Lower Union Street building is a 2½-storey, 2-bay brick structure with a front-gable roof, set on a rusticated stone foundation. The building's front entrance contains a small rectangular transom. It is approached by a moderately-raised concrete porch with turned-wood porch and staircase balusters. The porch roof, which has a plain entablature, serves as a second-storey balcony and is supported by fluted columns. The balcony balustrade matches the one found on the porch, but contains turned-wood newel posts with ball tops. The façade's fenestration includes a pair of tall rectangular windows under a slightly-rounded transom on the first storey. A similar pair of windows, above these and on the second storey, does not have a transom. A window with a half-rounded top is located under the front gable of the façade. All of the windows rest on ashlar sills.

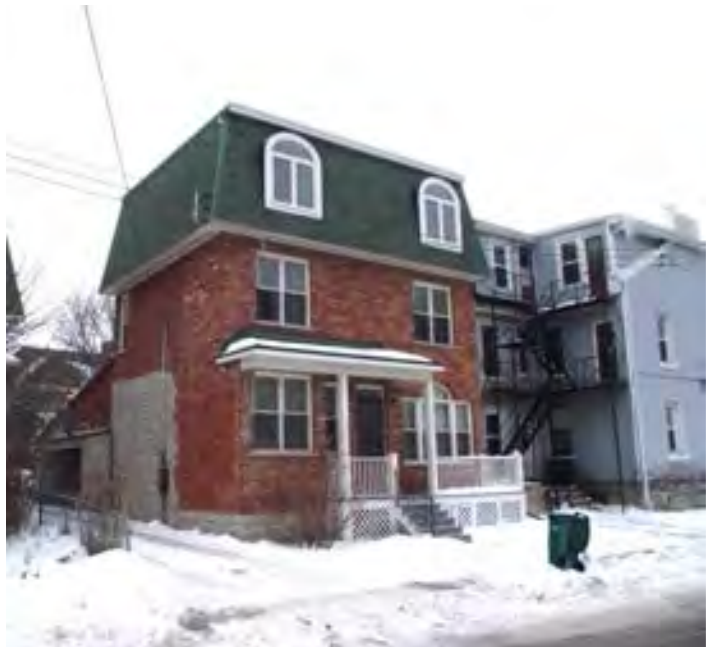
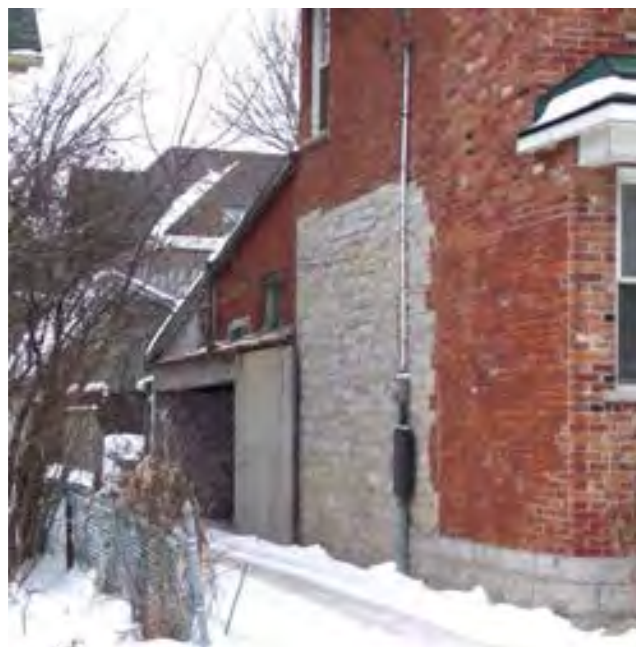
67 Lower Union Street

This building has evolved from a rear extension to the neighbouring 160 King Street East residence. Maps by Innes and Gibbs illustrate that this extension was in place by 1865, but not prior to 1850. The façade of 67 Lower Union projects from this extension. Remaining parts of the extension, and successive alterations, appear on the building's northwest elevation. Still present are a 1-storey stone wall, a rear brick and wood extension with a shed roof, and a carriage / auto port with wood plank walls.

The present façade of the building has undergone several stages of development.

The 1892 fire insurance map indicates that 160 King East had two in-line 2-storey extensions of brick at the time. A 1-storey wood addition, with a brick veneer, faced Lower Union. It was one bay wide. By 1924 the brick veneer had been removed, but the addition remained. In 1947 this arrangement was unchanged. Unfortunately, the 1963 fire insurance map does not illustrate the buildings on this block.

It is likely that the present building was extended from, or replaced, the addition facing Lower Union; while incorporating elements of the original 160 King East extension. The bulk of the building is comparatively new with respect to the original structures it is built around. Its third storey emulates a mansard roof, and a Palladian window occupies its southeast first-storey bay. In this case, the façade elements do not contribute effectively to the character of the building's context.

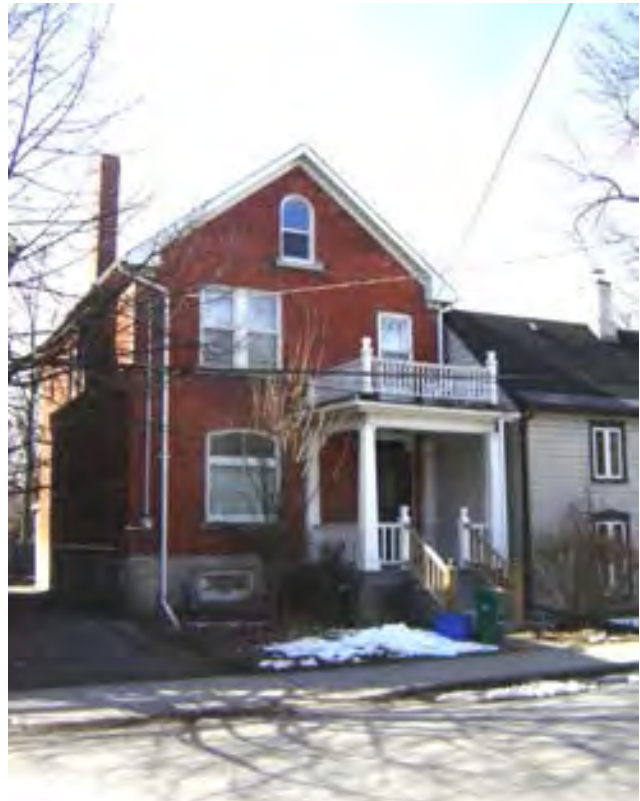
The 68 Lower Union Street building is a 2½-storey, 2-bay brick structure with a front-gable roof, set on a rusticated stone foundation. The building's front entrance contains a small rectangular transom. It is approached by a moderately-raised porch with squared porch and staircase balusters. The porch roof, which has a plain entablature, serves as a second-storey balcony and is supported by wood pillars. The balcony balustrade matches the one found on the porch. Both contain square newel posts with ornamental tops. The façade's fenestration includes a 4-piece window with a rounded transom, in two pieces, on the first storey. A pair of rectangular 1/1 windows on the second storey are divided by a wide, plain, wood mullion. A window with a half-rounded top is located under the front gable of the façade. All of the windows rest on ashlar sills.

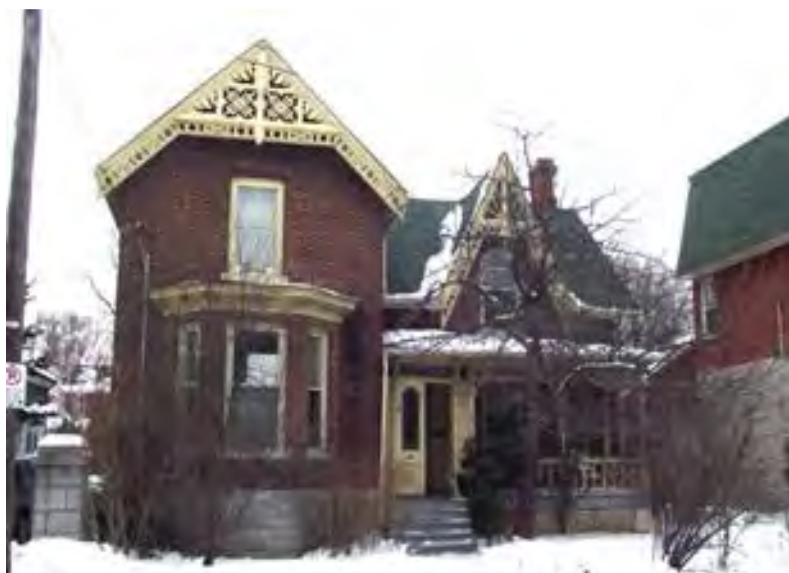
69 Lower Union Street

“This three-bay brick house with an irregular plan is built on a high stone foundation. The eastern section, one and a half storeys, has a steeply pitched roof with a high, sharply pointed gable in the centre front containing a round-headed window.

“The western section projects towards the south with gable end to the front and a less steeply sloped pitch to the roof. There is a bay window in the first storey and a single window in the second storey. The door is in the central bay.

“The most distinctive feature of this house is the ornamental exterior woodwork in a design which was very popular in the 1880’s. The most elaborate design is in the peaks of the two front gables, above the horizontal element or ‘collar’ tie. The finials are fitted into this collar and the bargeboard follows the eaves and the base of the tie. The circle and cross design of the bargeboards appears also in the trim of the verandah.*

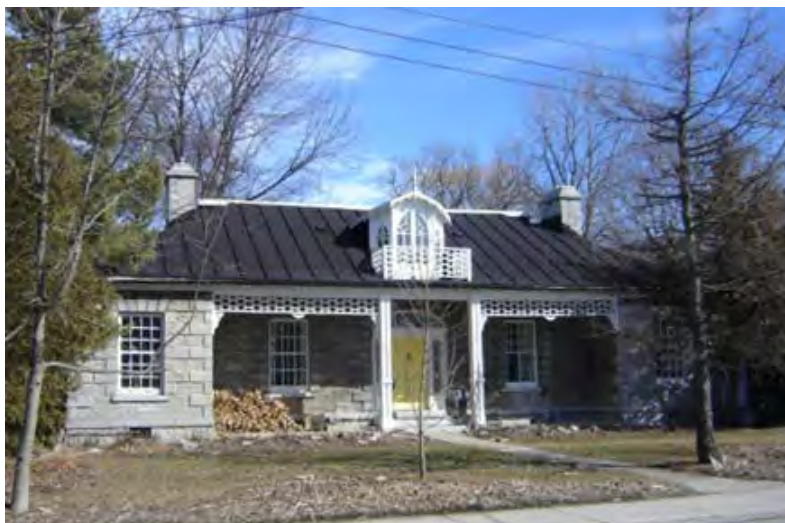
75 Lower Union Street

“This five bay cottage of hammer-dressed stone has a central three bay umbrage. The ribbed metal, low hipped roof has a fine three windowed Gothic dormer in the front centre, with railed balcony. The recessed verandah or umbrage is roofed integrally with the house. The roof has pairs of wide stone end chimneys.

“In the central bay is the entranceway with an elliptical fanlight and side lights with a complex arrangement of glazing bars. The door has eight fielded panels. The large windows have twelve over twelve double-hung sash and those under the umbrage have fancy borders. All windows have projecting ashlar quoins, as do all corners. Trelliswork borders the eaves of the umbrage. The dormer has bargeboards and a pendant.*

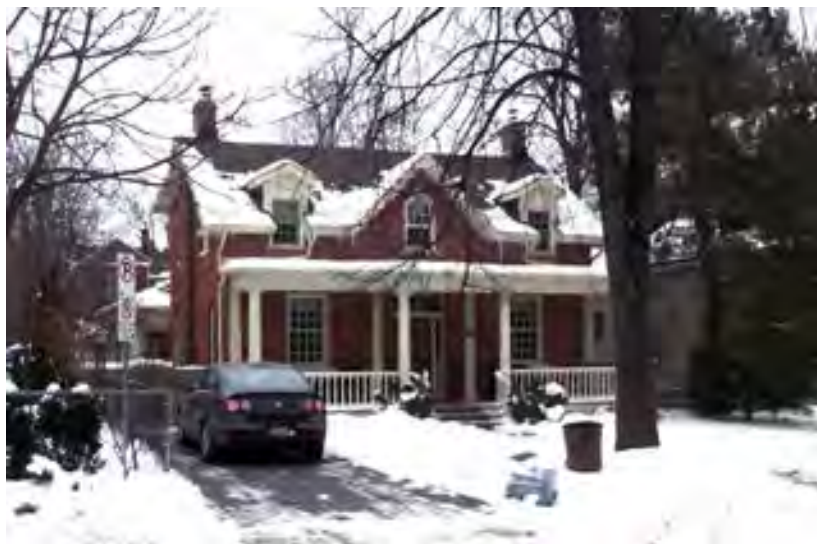
81 Lower Union Street

“This storey and a half brick cottage, three bays wide, has a low pitched gable roof with end chimneys. The front line is broken by a wide central gable and flanking narrow dormers with steeply pitched, overhanging gable roofs. In the gable and dormers are Gothic pointed-arched windows. The central gable has simple moulded bargeboard.

“In the central bay, the entranceway has very narrow side lights, a rectangular transom with central glazing bar, and a four-panel door with metal grillwork in the upper panels.

“A frame porch across the entire façade has a pitched roof supported by four Doric pillars and corresponding pilasters against the house.

“A balustrade with turned spindles links the columns. *

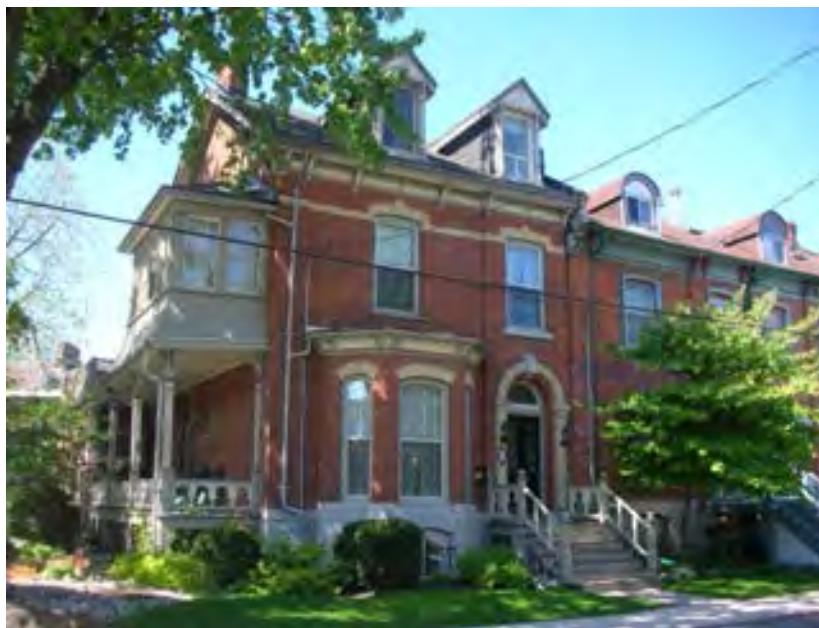
The 82 Lower Union Street building is a 2½-storey structure with two bays, set on a tall stone foundation. Its design elements exhibit a high degree of craftsmanship and artistic merit. The foundation contains a nearly-square basement window with a solid ashlar voussoir. It supports a 3-tiered bay window with angled returns on the first storey of the building's southeast bay. Each section of the bay contains a tall, 1/1 window with simple wood trim. Just below the bay's flat roof, a wood entablature, featuring scrolling wood brackets, tapers inward from its projecting eave. A series of wood brackets also support the eaves of the main roof, spaced across a simple entablature with recessed rectangular panels.

The use of dichromatic brickwork characterizes the style of this building. Its main walls are comprised of red brick. Yellow brick voussoirs have been used above the bay windows, each creating a slight arch. The main entrance also features half-round arch of yellow bricks with an ashlar keystone. It is supported by brick pilasters with tiered

capitals, comprised of the same. The arch houses a half-round transom with etched patterns in its glazing. The main entrance is fronted by a wood porch, and a set of wide wood stairs with square wood balusters and square newel posts with ball-tops. Wood brackets, paired to create keyhole patterns, are found under porch railing.

The two windows on 82 Lower Union's second storey are each tall, 1/1, and rectangular. Their upper portions are also accented with yellow brick surrounds. These extend to form a string course across the building's facade. The building's northwest bay protrudes slightly, matching a brick pilaster along at its southeast corner.

Above each bay there is an ornate dormer with a front gable roof. The tympanum of each pediment contains a centred column of turned-wood, separating wood panels with elaborate, curvilinear designs. Each pediment is supported by scrolling, fluted, wood pilasters on its face, and scrolling brackets at each upper, outer, side.

The southeast elevation of 82 Lower Union features a balcony, the roof of which supports a second-storey sunroom. The sunroom has a shingled hipped-roof, and horizontal wood panels below a series of adjacent, 1/1, rectangular windows. A small rectangular window is located along this wall, just above the roof of the sunroom. The porch balustrade matches that of the front entrance, featuring keyhole designs accented by dots and horizontal grooves. The porch roof is supported by fluted wood pillars on square bases. Scrolling brackets are found at the top of each pillar. Dentils decorate the entablature between these. The balcony entranceway opening contains a slightly-arched transom. It is flanked by a 4-piece window, also slightly arched, and a small rectangular window on its Lower Union Street side. The building's rear extension supports a roof-top balcony.

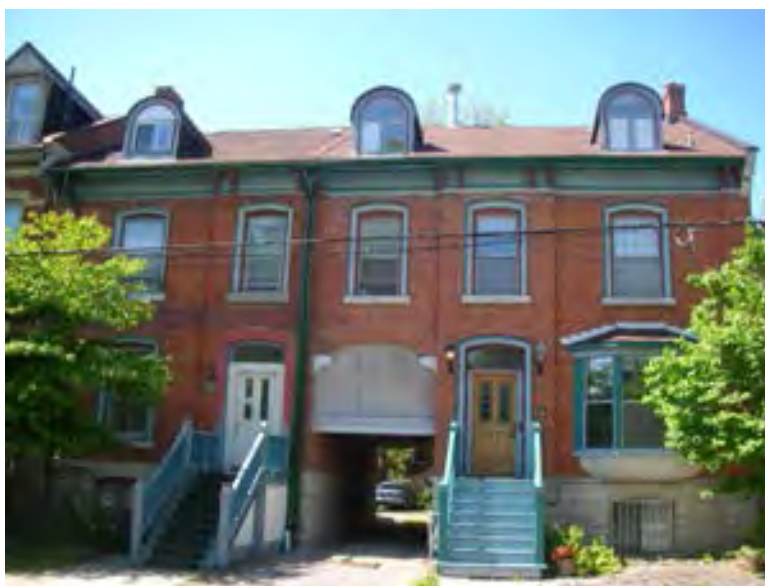
The 84-86 Lower Union Street building is a 2½-storey brick double-house with a high stone foundation, a side-gable roof, and a central carriageway. The main part of each unit is two bays wide. A suspended second storey, above the carriageway, belongs to the 86-unit. Each of the building's five second-storey bays contain a slightly-arched, rectangular, 12/12 window. Each window has a plain wood frame; rests on an ashlar sill, and is slightly recessed behind wood surrounds of moderate thickness. A plain wood entablature above these windows features upper and lower strips of half-round moulding. Paired sets of scrolling wood brackets divide the bays under the building's cornice.

The front entranceways, which feature wide slightly-arched transoms, are raised above the building's tall stone foundation. Each is fronted by a small wood porch, approached by a wood staircase. Each staircase is flanked by wood balustrades with square balusters, and square newel posts with dome-shaped tops.

The roof contains three round-headed dormers, placed above the outer and central bays.

The outer bay of 84 Lower Union's first storey contains a slightly-arched window with surrounds matching those found on the second-storey windows. Below this window, set in the building's tall foundation, is a large, nearly-square basement window topped by a solid, single voussoir stone.

The 86 Lower Union building has a prominent oriel window, with a shingled, hipped, roof, on the first storey of its outer bay. It is comprised of three main sections. The return sections are angled and contain 9/9 windows with thin wood glazing bars. The main window facing Lower Union Street contains a 12/12 window with matching bars.

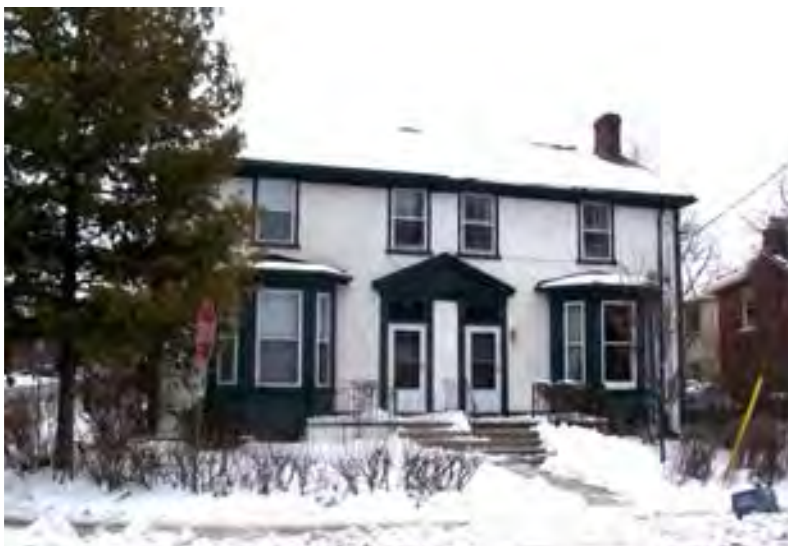
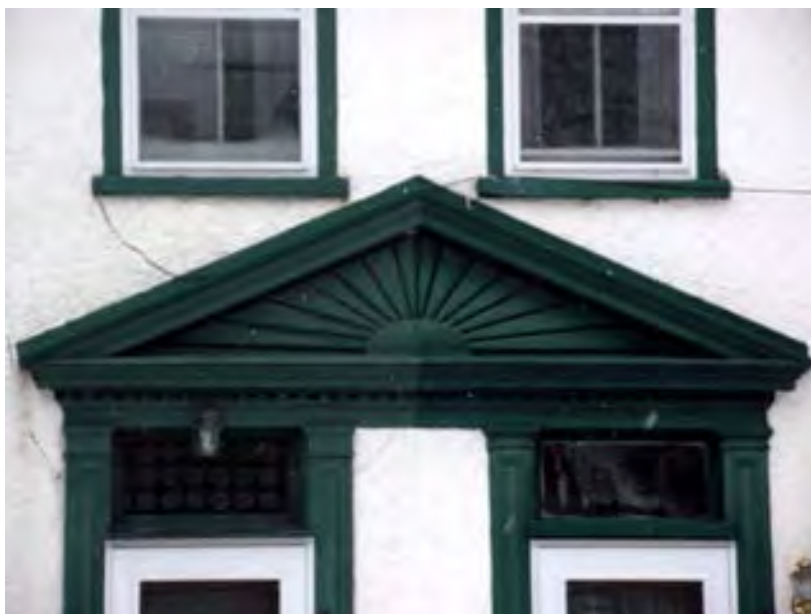
87-89 Lower Union Street

This 4-bay, 2-storey wood house, with a white roughcast exterior, occupies an important corner location to which its historic character is well suited. This early-to-mid 19th-century building has a side-gable roof over its two, 2-bay units. A brick chimney rises from each end.

Both units feature a wood outer-bay window with a hipped roof, and angled returns with lower wood panels containing square recessions. A squat, rectangular basement window is located in lower face of each bay window. Of note are the building's denitied pediment hood, which tops both entranceway doors, and is supported by pilasters with trim reliefs. Rectangular transoms over each door contain circular motifs. The pediment tympanum features a broad sunburst design.

Each bay of the second storeys contains a rectangular 2/2 window with simple wood trim.

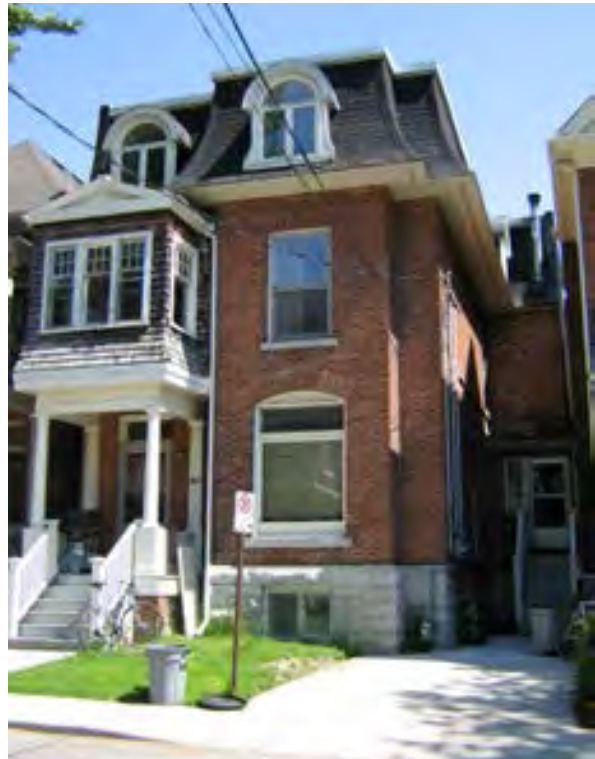
The 93 Lower Union Street building is a narrow, 2-bay, 2 ½-storey brick residence set on a high stone foundation. One of this building's distinctive features is its mansard roof, which is not depicted on fire insurance maps up to 1963. The structure's original roof was probably hipped like those of 101 and 103 Lower Union, with a gable topping its tower. This interpretation is consistent with the building's overall Queen Anne features, which include its offset massing; a small, square front porch supporting an upper balcony, and a slightly-projecting tower.

The first-storey tower window has wood trim with dentils above and below the glazing. A hinged rectangular transom is located under its mild arch and brick voussoirs. The entranceway has a rectangular transom with simple wood trim. The porch fronting it has simple columns on square bases with recessed panels. The columns support a porch roof with a plain entablature, lined with dentils just under the cornice.

An extension to the southeast side of the building, added by 1915, is set back from the façade and contains a separate entrance with a wood staircase.

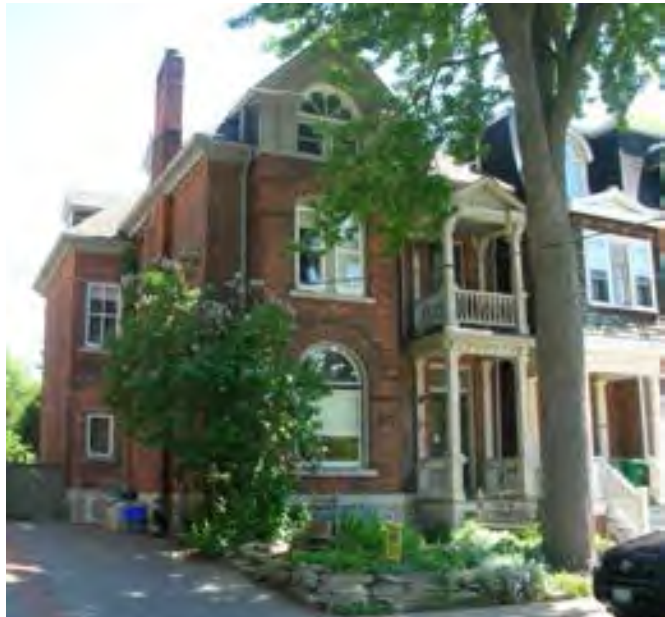
101 Lower Union Street

The 103 Lower Union Street building is a 2½-storey brick structure with characteristic Queen Anne features. These include a recessed tower on its southeast bay, the tower's ornate gable, the building's hipped roof, a wood front porch and balcony, and the building's offset rear massing. The construction of this building displays a high degree of craftsmanship and artistic merit.

The tower's first storey contains a large, plain window on an ashlar sill, topped by a half-round transom with leaded tracery. This window features a brick Romanesque arch leading to parallel brick courses across the remainder of the tower. A similar arch and set of string courses is found on the tower's second storey. However, its opening contains only a mild arch above a pair of tall, rectangular 1/1 windows on an ashlar sill. These windows are divided by a wood column and topped by a wood panel featuring a sunburst pattern.

The tower's gable is highly decorated. It contains paired wood pilasters supporting the roof's return eaves. The returns feature dentils matching the gable's remaining roofline. The main openings contain a pair of rectangular windows openings. Above these is a

half-round transom under a recessed and tiered wood hood. The transom contains four radiating, tear-drop shaped, lights.

The building has a nearly-square front porch. Its front door has a plain rectangular transom. A balcony above the porch has a gable roof that contains a sunburst design. It has return eaves, and dentils along its bargeboard and entablature. Both the balcony and balcony roof are supported by simple wood pillars and pilasters, with square bases that contain recessed panels and upper dentils. Those on the balcony are topped by sets of heavy wood brackets. The porch roof entablature contains a distinct pattern of half-circles and round reliefs. The porch and balcony balustrades contain turned wood balusters.

The rear portion of the building contains a section offset to the northwest. It has a plain window on the first floor, and a 4-piece window on the second, facing Lower Union. Both windows have simple wood trim and ashlar sills. A dormer facing northwest tops this part of the structure's hipped roof. A very tall, partly-embedded brick chimney is located along its northwest elevation. The chimney features decorative string courses and a tiered brick pot.

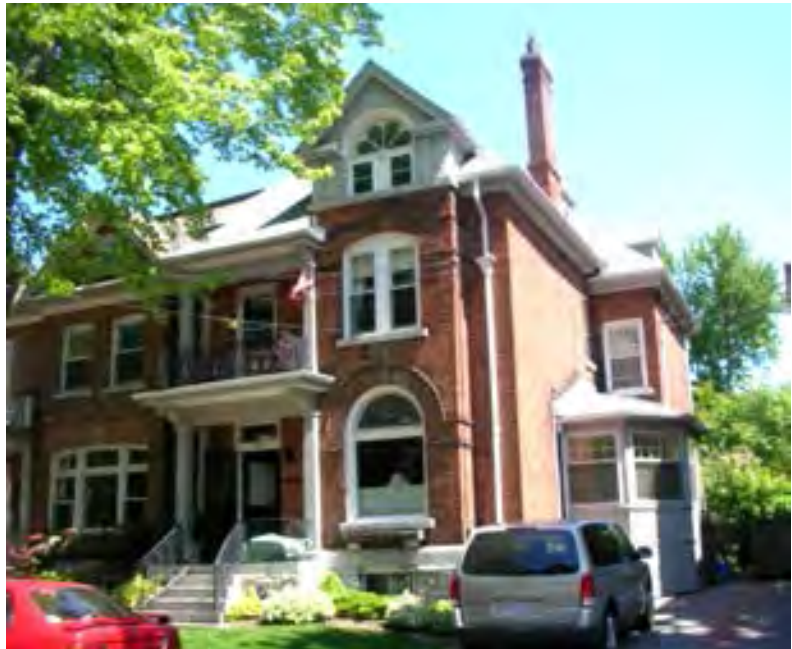
103 Lower Union Street

The 105 Lower Union Street building is a 2½-storey brick structure with basic Queen Anne features. These features include a recessed tower on its southeast bay, the tower's ornate gable, the building's hipped roof, a wood front porch and balcony, and the building's offset rear massing. The construction of this building displays a high degree of craftsmanship and artistic merit.

The tower's first storey contains a large, plain window on an ashlar sill, topped by a half-round transom with leaded tracery. A second stone sill, below the first, is supported by stone brackets. This window features a brick Romanesque arch with parallel brick courses across the remainder of the tower. A similar arch and set of string courses is found on the tower's second storey. However, its opening contains only a mild arch above a pair of tall, rectangular 1/1 windows on an ashlar sill. These windows are divided by a thick wood mullion and topped by a wood panel containing a sunburst pattern.

The tower's gable is highly decorated. It contains paired wood pilasters supporting the roof's return eaves. The returns feature dentils matching the gable's remaining roofline. The main openings contain of a pair of rectangular windows openings. Above these is a

half-round transom under a recessed and tiered wood hood. The transom contains four radiating, tear-drop shaped, lights.

The building's front entrance features a nearly-square front porch, which is approached by a converging, curvilinear staircase of finished stone. The front door has a plain rectangular transom. A balcony above the porch is covered by a projection of the building's main roof. Both the balcony and balcony roof are supported by simple wood pillars and pilasters with heavy wood brackets. The porch and balcony balustrades are iron, with circular motifs at their top and bottom ends.

The rear portion of the building has been slightly offset to the southeast. It contains a tall rectangular window, with wood trim and an ashlar sill, in the second storey facing Lower Union. In front of the offset there is a large wood bay in five sections. The structure has a very tall, inset, brick chimney along its southeast elevation. This chimney features decorative string courses and a tiered brick pot.

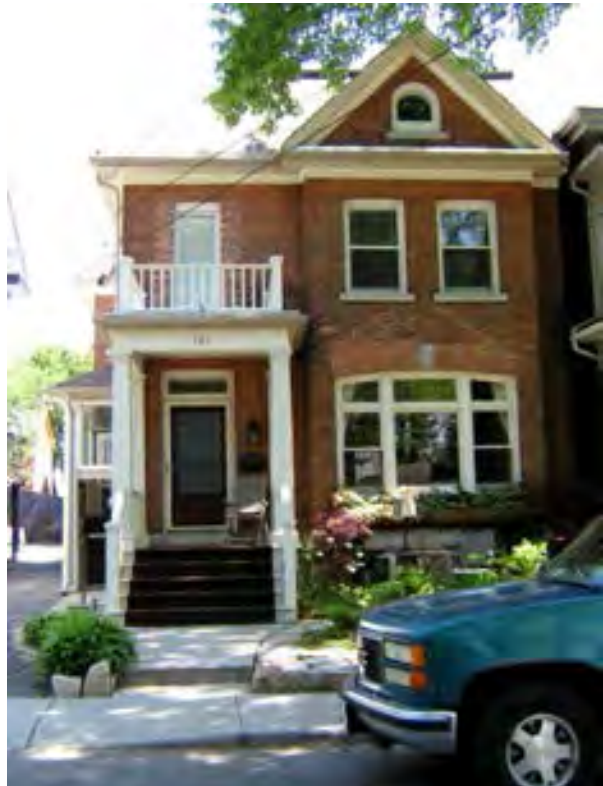
The 105 Lower Union Street building is a 2½-storey brick structure with basic Queen Anne features. These features include a projecting tower on its southeast bay; the tower's upper gable, the building's hipped roof, a wood front porch with balcony, and the building's offset rear massing. Although this building is less elaborate than its neighbours at 93, 101, and 103 Lower Union, its similar design supports them contextually and contributes to the streetscape.

The 105 building's projecting tower is topped by a gable with a deeply-recessed brick face, and a recessed half-round window with wood trim and an ashlar sill. Dentils line the gable bargeboard. The tower's second storey paired 1/1 windows with simple wood trim and ashlar sills. Differences in the brickwork, on the tower's first storey, indicate that some form of modification has been made here since the building was erected. The nature of this modification is unknown. The present opening on this level consists of a large plain window, with two large 1/1 sidelights. Each of these has plain transom with a slightly curved top which, together, form the overall opening's slight arch. The windows have heavy wood trim, including plain wood pilasters and transom bars. An ashlar keystone is centred above this opening.

The building's northwest bay contains a front entrance door and rectangular transom with thick, plain wood trim and a transom bar. The entrance is fronted by a square wood porch, and approached by a wood staircase. The porch has a roof, supported by plain wood pillars, which serves as a second-storey balcony. The porch and balcony balustrades contain square balusters and square wood newels posts with simple, flat tops. Brickwork around the balcony door suggests that the door has been replaced.

The rear portion of the building's main massing has been slightly offset to the northwest. It contains a hinged square window on the second storey, facing Lower Union, and has wood trim and an ashlar sill. A wood canopy with a hipped has been added below this to shield a sunken side entrance. Closer to the front of the building, the northwest elevation features a tall oval window with a brick surround which serves as a front entrance sidelight.

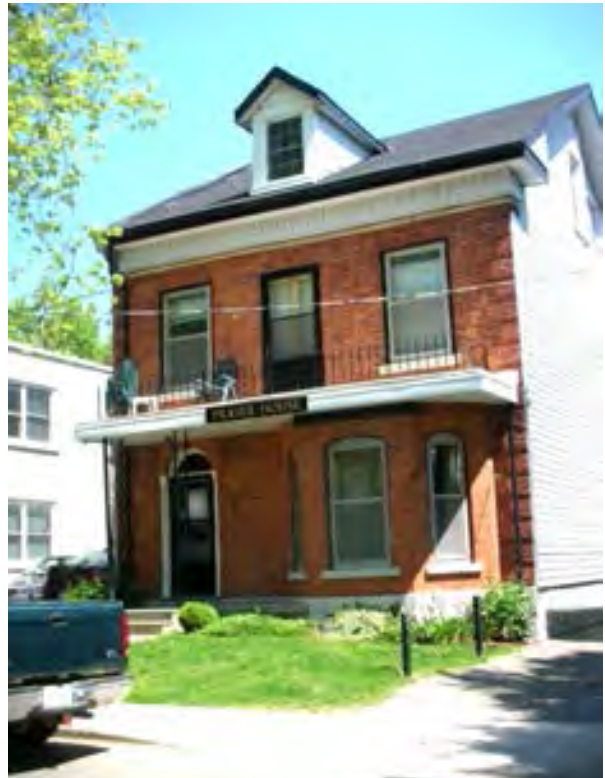
111 Lower Union Street

This 2½-storey, 3-bay structure is characterized by its bold rectangular massing; a predominantly flat façade, projecting brick quoins, a side-gable roof, and its relative lack of ornamentation. The bay window with angled returns appears on a 1904 pasted amendment to the 1892 fire insurance map, but may have been in place earlier. It contains tall rectangular windows on ashlar sills, topped by slight arches. The building's front entrance is set under an arch, with a half-round transom that contains a floral motif. The three second-storey openings are centred over each bay. The centre opening has been converted to a balcony door; it is flanked by large rectangular windows on stone sills.

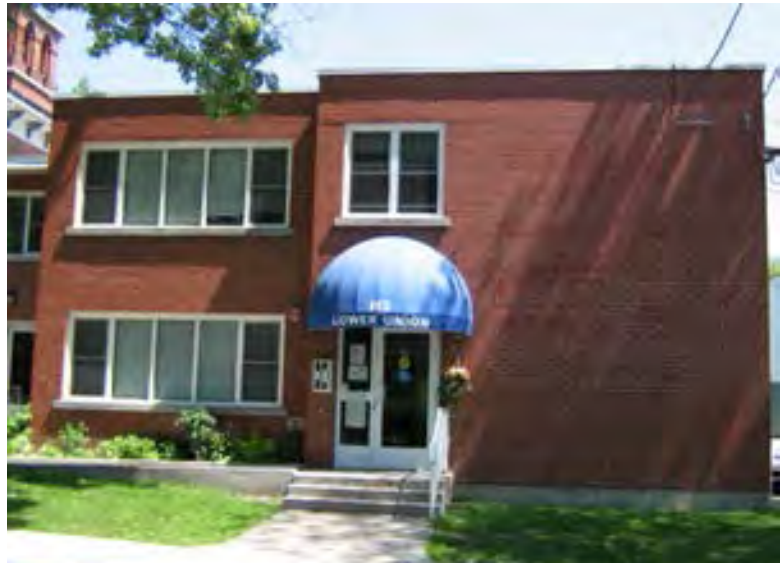
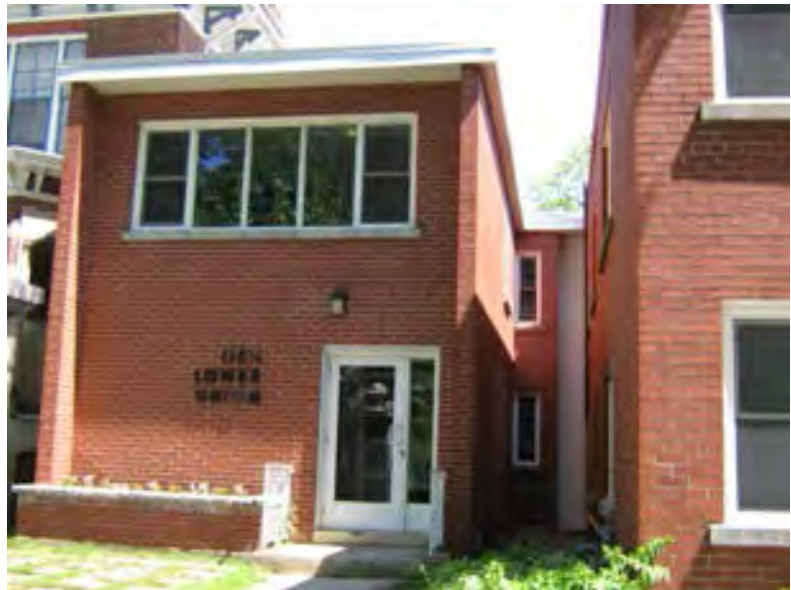
113 Lower Union Street

The 113 and 113½ Lower Union Street buildings were erected in 1955. Their design values are out of character with the architectural style of both the surrounding properties, and with the Old Sydenham Heritage Area in general.

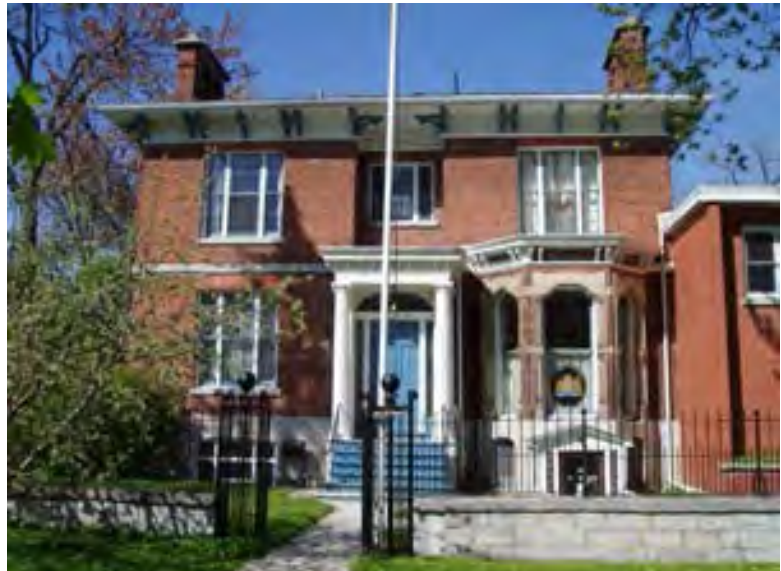
115 Lower Union Street

“This three bay, two-storey brick dwelling has a central bay umbrage, an ashlar string course and sits on a high stone foundation of hammer-dressed stone. The central door has a semi-elliptical arched fanlight and is protected by a ... portico with Doric columns supporting an entablature with brackets under the cornice.

“The bay window, probably a later addition, has a flat roof in each of the three walls and a decorated entablature supported by six pairs of colonnettes with a variety of capitals. All of the other windows on the façade are Venetian type – a central window flanked by narrower ones, set under elliptical arches.
