Property Inventory Evaluation
Gore Street

Property Inventory Evaluation – Gore Street

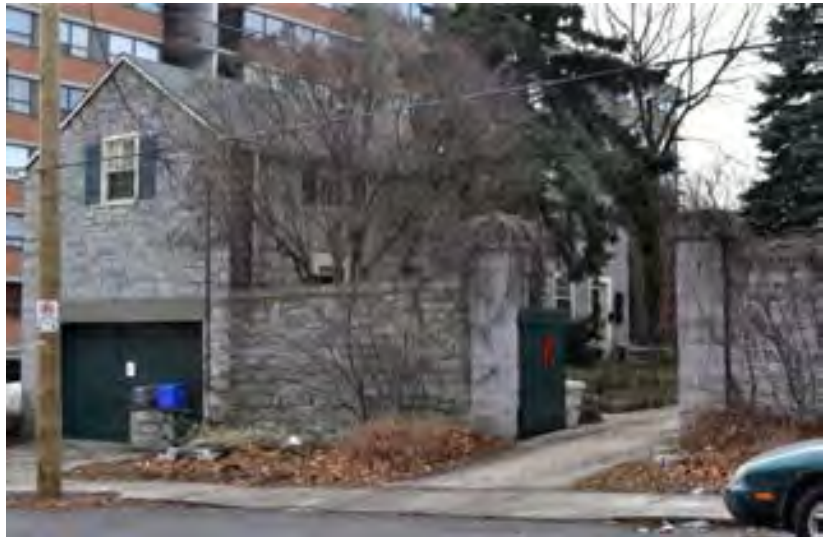
Defining attributes of this property include the tall rough limestone stone wall, with ashlar columns flanking its entrance, which runs along Gore Street and abuts the 50 Gore building; as well

as the courtyard created by the structure's setback from the 191 King Street East building. Further attributes include its stone composition, its 1½-storey rectangular massing, the unbroken side-gable roof with chimney, the multi-paned pattern of its windows; and general placement of its fenestration, including the wide arch and stone hood on the building's King Street elevation.

View from Gore Street

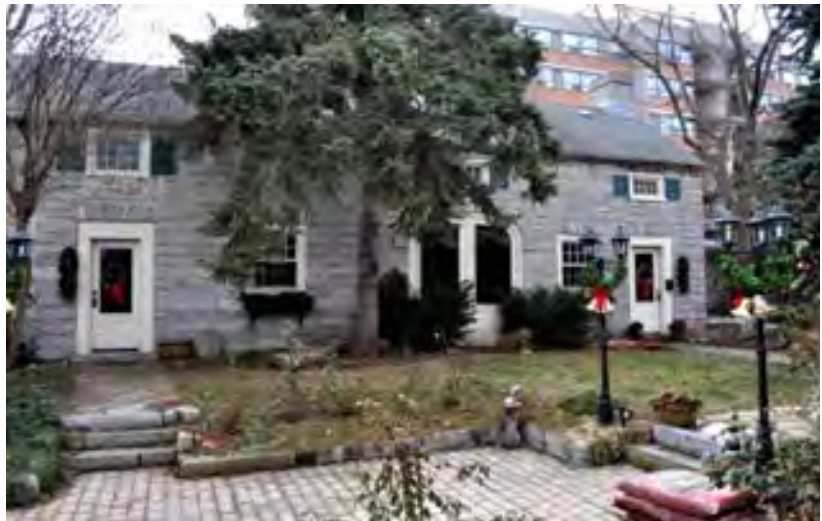
Northeast Elevation

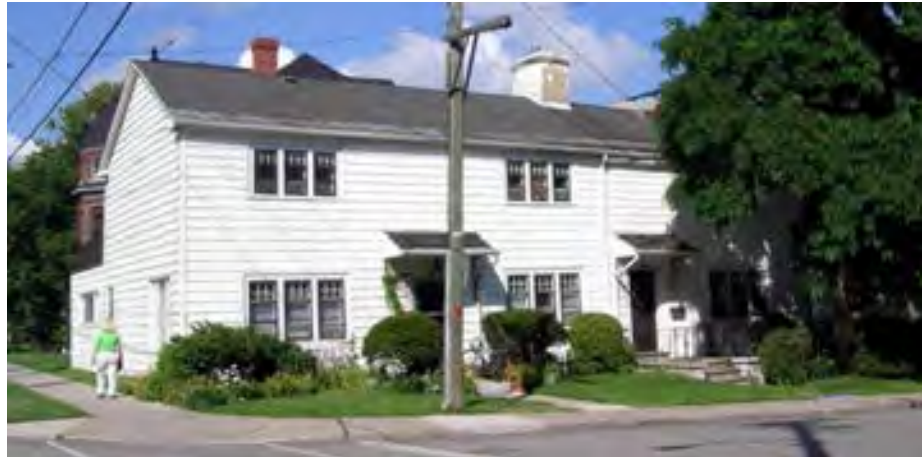
57-59 Gore Street

The property has physical/design value. Character defining elements that reflect this value include its scale and massing. Originally the house was a small one and a half storey building of plank construction, later covered with weatherboard of clapboards. The property was later enlarged adding the western section. In 1875 a second storey was added with various additions made since then. The dwelling is now clapboard with three triple window groups in both the first and second storey of the main façade. The two doors between the triple windows are protected by wooden canopies. The gable

roof with eaves returns now has only one large chimney in the centre. The ends have irregular fenestration, a group of four windows to the east, a triple window to the west and additional windows in the later additions.

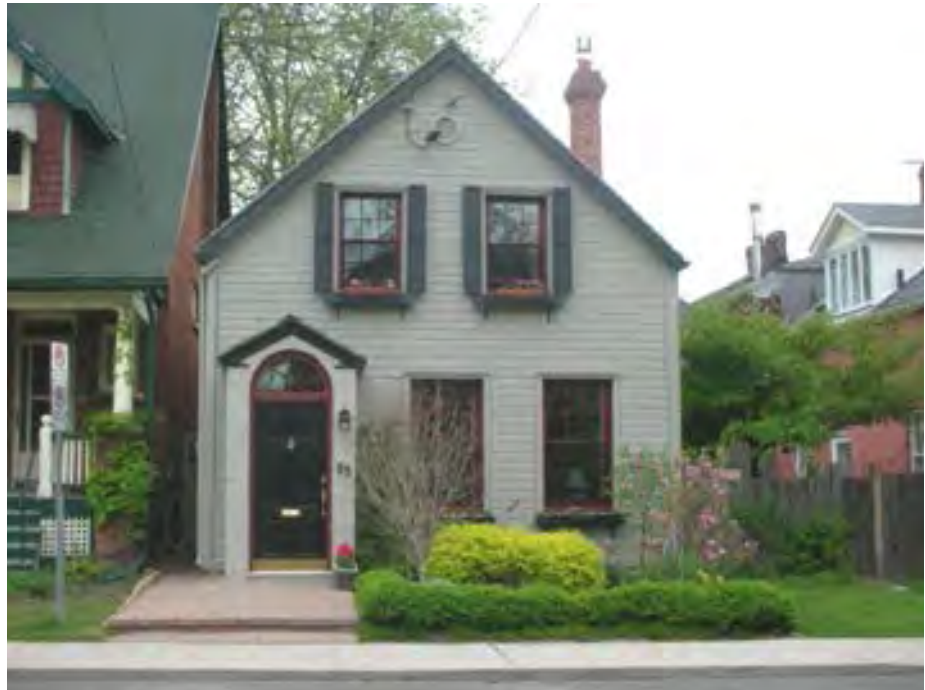
The present 65 Gore Street building contributes to the character of the Gore Streetscape, and that of the Old Sydenham Heritage Area, through its simple 1½-storey massing, symmetrical fenestration, minimal setback, wood siding, and front gable roof. The building has two rectangular window openings on each storey. Those on the first storey have a 6/1 window pattern. The upper windows are 6/6. An enclosed entranceway contains a fanlight transom with wood tracery. A tall brick chimney, with a tiered brick pot and wide brick base, rises from the building's southeast side.

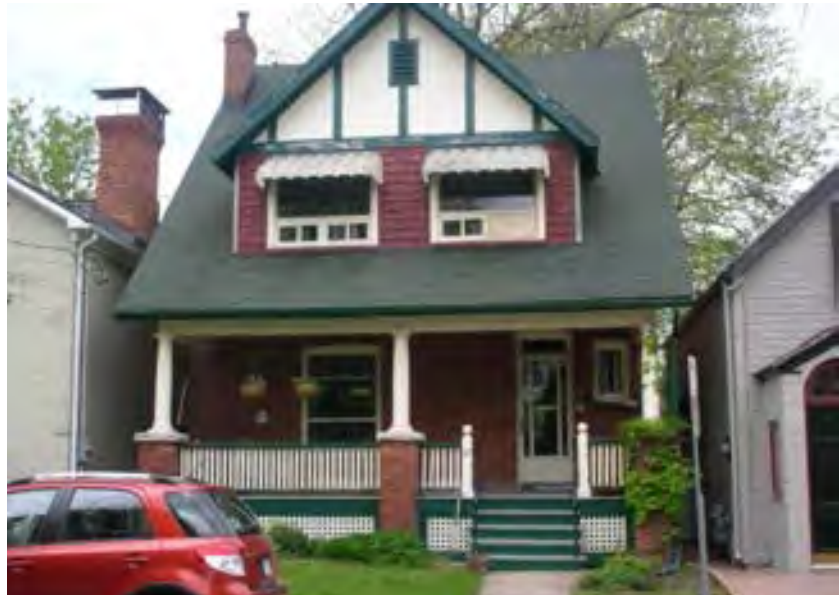
The 67 Gore Street building appears on a pasted amendment to the 1904 fire insurance map, updated in 1915. This building has an exceptionally tall side-gable roof above its first storey. It features a large gable-roofed dormer, with Tudor-style stickwork, wood shingles, and two large rectangular window openings. The roof projects heavily over the lower storey, sheltering an embedded wood balcony. The front of the roof is supported by wood columns on square brick bases and stone caps, joined by a simple wood balustrade with closely-spaced square wood balusters. Ball tops crown the newel post leading to the balcony. This structure reflects the evolution of Sydenham Heritage Area architecture in the early 20th century. It is a good example of a modest vernacular building which departs from the more traditional and popular Georgian, Victorian, Queen Anne, and Romanesque Revival buildings found throughout the area.

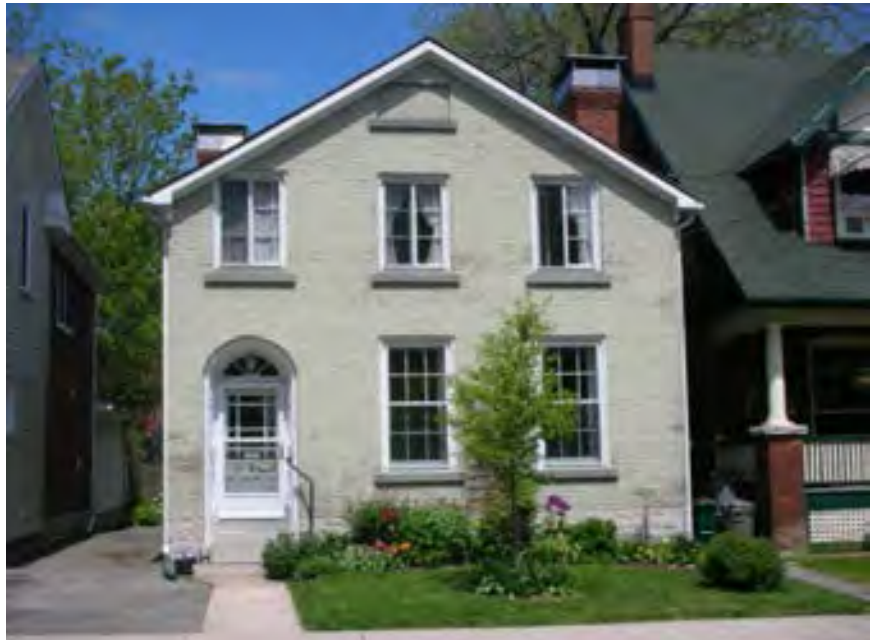
73 Gore Street

The design, massing, setback and composition of this building are appropriate to the Gore Streetscape. Its design attributes include its flat façade, brick composition, regular fenestration, ashlar window sills, and its front gable roof. The building's main-storey windows maintain an appropriate 6/6 window pattern. Those on the upper floor are paired casements, with glazing bars that create 3 sections each, and smaller flanking sidelights. The building's front entrance is deeply recessed, with paneled wood reveals and a fanlight transom. This building has exceptionally large brick chimneys: one toward the northwest rear of the building, and one along its southeast elevation.

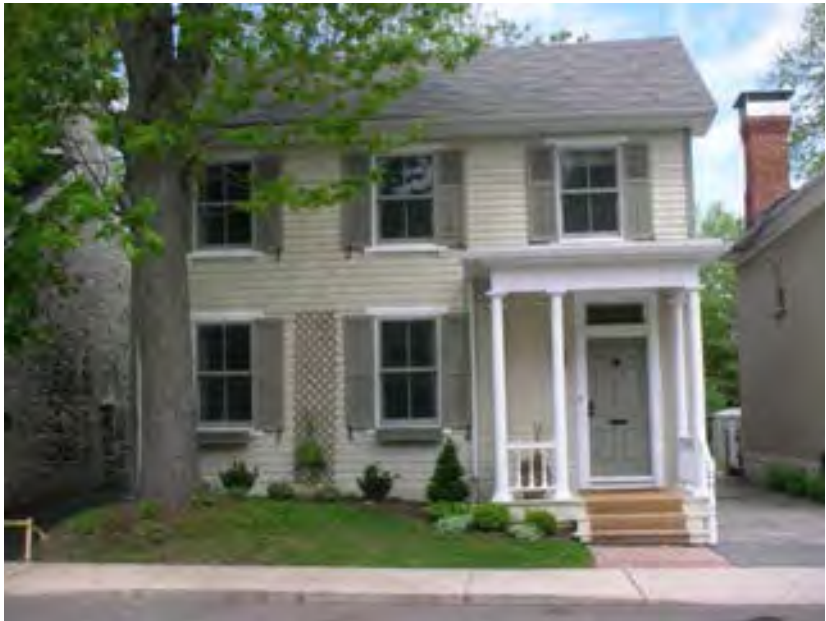
Although clad in newer materials, the 75 Gore Street building is a 2-storey wood structure which may date to 1850 or earlier. The building's rubble stone foundation is consistent with an early-to-mid 19th century structure, and a building with similar massing appears at this location of Gibbs' map of 1850, and on the 1865 Innes map. A 2-storey brick addition was added between 1875 and 1892.

Character defining attributes of this building include its rubble stone foundation, regular fenestration, and its side gable roof. The building's window openings might reflect its original, or much earlier, square-headed shape and configuration.

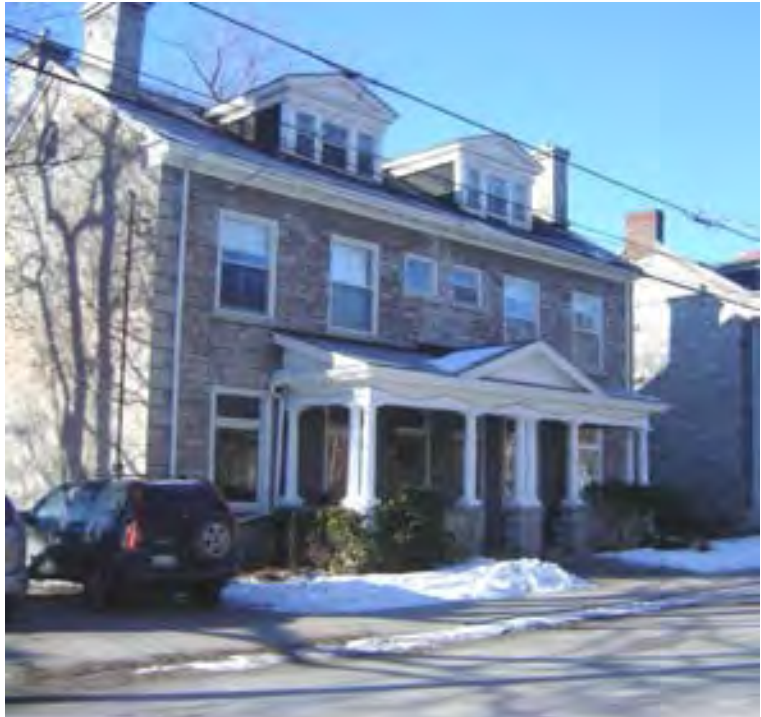
76-78 Gore Street

This hammer-dressed stone building has ashlar window sills and quoins. Large rectangular windows are located in the outer four of its six bays. They have simple wood surrounds of moderate size: those on the first storey have rectangular transoms with tracery. The inner two bays contain two front entranceway doors with rectangular transoms. Smaller, wide and rectangular windows occupy the second storey above these. The building has a wide front porch, with a simple entablature and modillions, spanning its inner four bays. The porch has a wood shed roof, with a projecting pediment and plain tympanum. This roof is supported by singular and paired wood

columns; one pair, resting on a stone base, divides the two porch entranceways. A matching stone wall completes the porch.

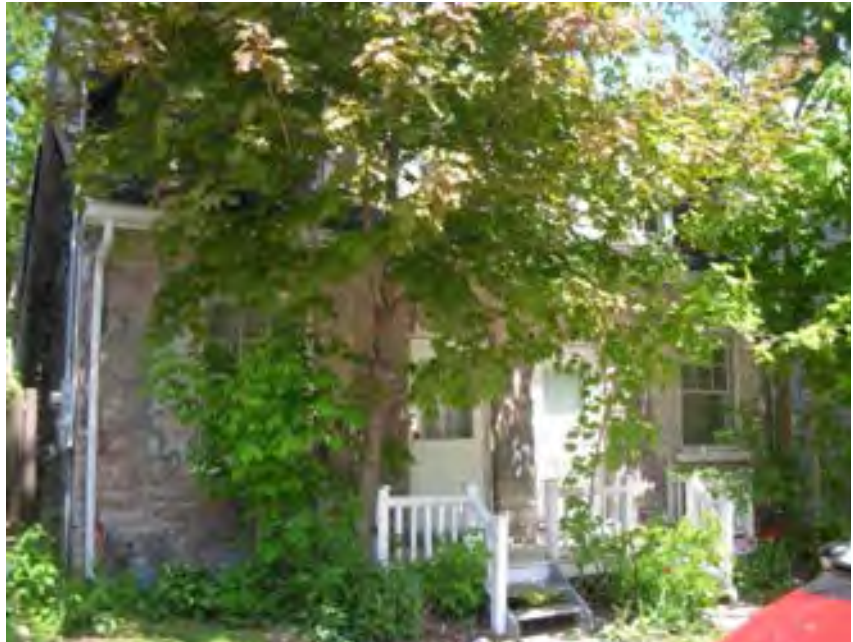
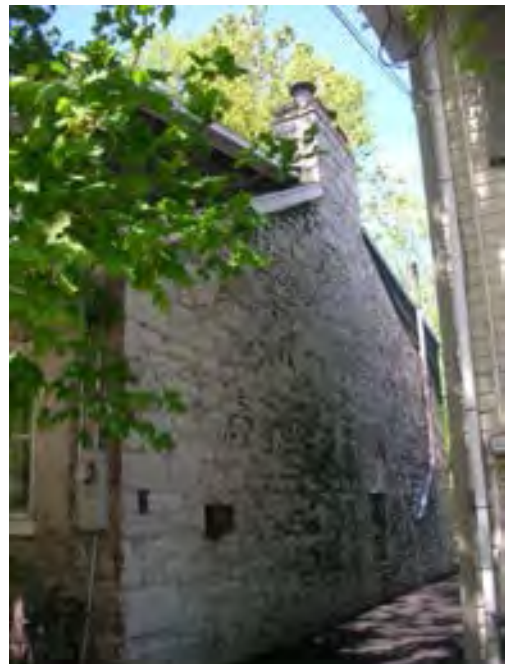
Southeast elevation

The most distinct features of this double-house is its coursed rubble stone walls. Each of its outer two of four bays contains a large rectangular window, presently with a 6/1 window pattern. A doorway is located on each inner bay. Their wood-plank outer doors appear to be of significant age. Wide chimneys rise from each side elevation of its side-gable roof. Full-width dormers have been added to front and rear of the building.

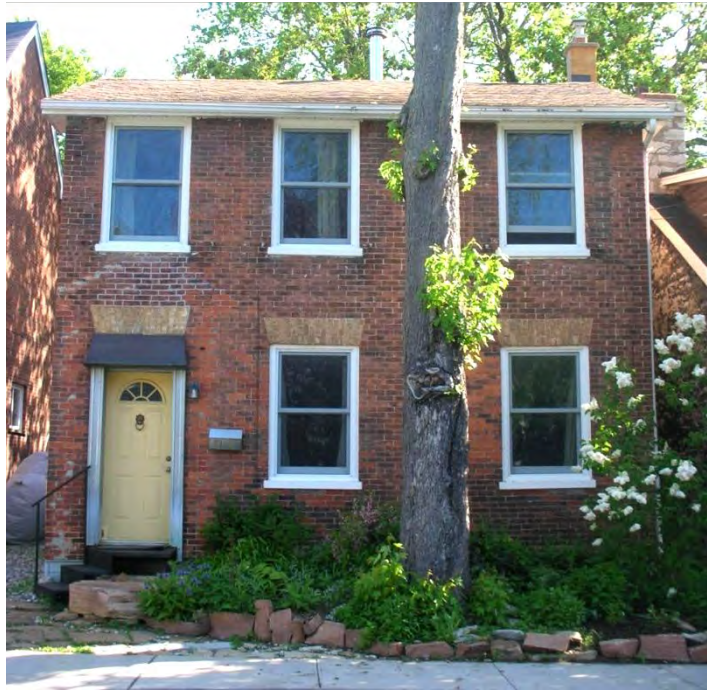
81 Gore Street

Alterations to the brickwork indicate that this structure once had a pediment-topped hood over its front entranceway. It is now topped by a flat arch of yellow brick, matching those found above the two rectangular windows on the southwest bays of its first storey. The upper storey contains three rectangular windows.

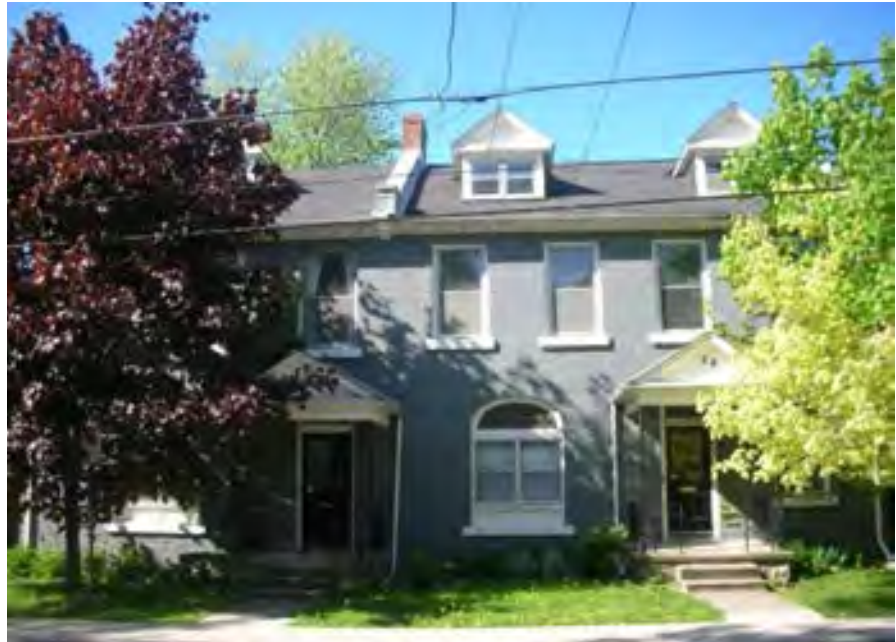
82-84 Gore Street

This 2½-storey brick building is generally plain, bold and symmetrical, with minor ornamentation. The 82 unit contains two bays, compared to 84's three. A short firewall, rising to a brick chimney, divides the units along the building's side gable roof: the same is found at each end of the building. Wood dormers, with pediment tops and deeply recessed wood tympanums, are found on the front of the roof: one over 82 Gore, and two over 84. Each unit contains a large first-floor opening, with paired windows over a wood panel and ashlar sill. These windows are topped by arched transoms with stained glass and floral tracery. To their northwest, each unit contains a rectangular entrance opening with a rectangular transom, set under a basic wood hood with plain pediment tops and supported by iron rails. The first storey of 84 Gore's extra bay

contains a tall rectangular window on an ashlar sill. Matching windows are regularly placed along the second storey. The roof is lined with modillions.

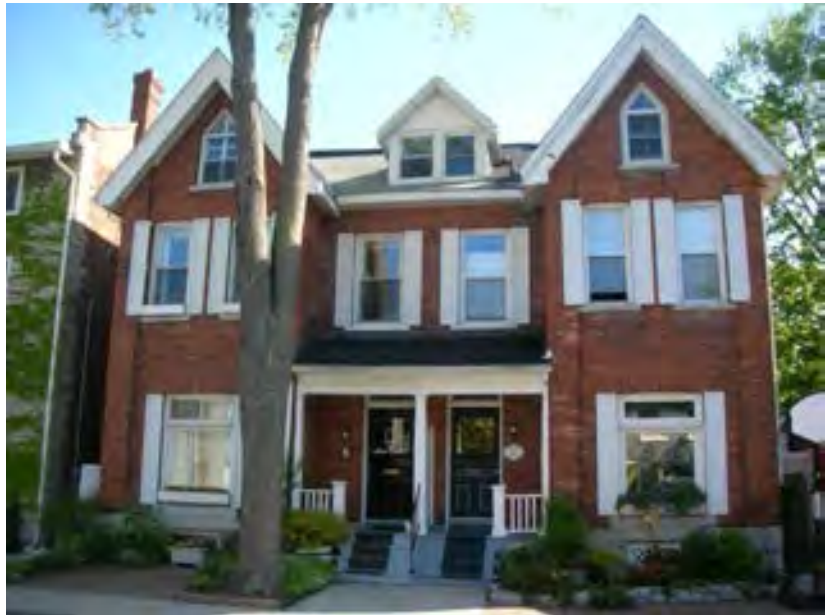
83-85 Gore Street

This building has design value. Its physical attributes include the gable-topped towers that project from each of its outer bays; its brick composition, stone foundation, and the wood porch across its inner entranceway bays. Paired rectangular windows, on the second storey of each tower, rest on ashlar sills. Matching windows occupy each inner bay of the second storey. Openings in each gable contain small rectangular windows with triangular transoms. Between the towers, a gable dormer with paired windows rises from the roof. Windows on the first storey of each tower have ashlar sills flush with the façade: they rest on an ashlar base course that divides the building's course limestone foundation from its first storey. These windows have wide rectangular transoms. Each front entrance contains a panelled wood door with a large plain light, and a rectangular transom. The wood balcony has a shed roof and simple entablature supported by a central wood pillar and flanking pilasters.

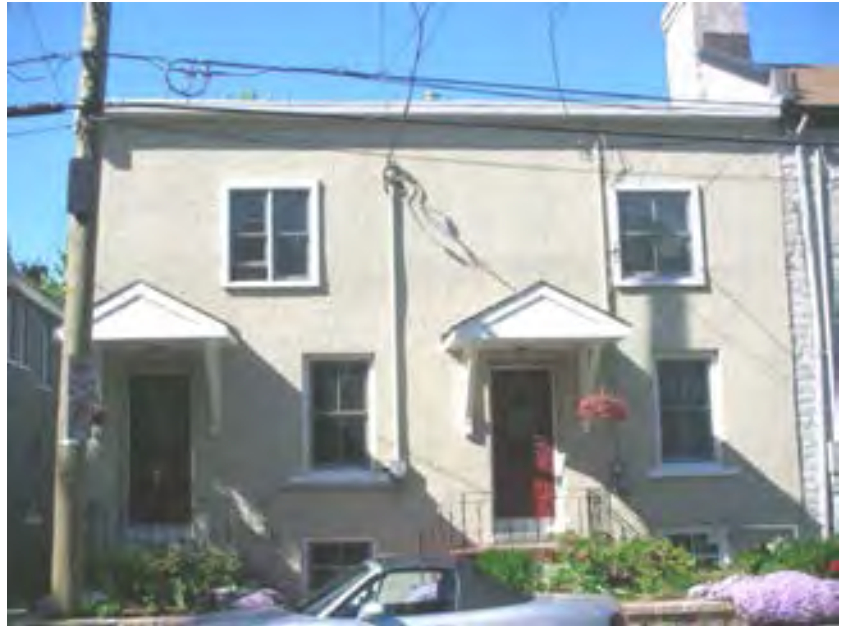
88-90 Gore Street

A 1½-storey stone double-house is depicted at this location on the 1892 fire insurance map, and on Brosius' map of 1875. It does not appear on an Ordnance map of 1868. The present building is likely the same structure, with a roughcast exterior added, and raised to 2-storeys, sometime after 1947. A photograph published in 1980 shows that this alteration took place by that time.* This structure blends well with the 92 Gore Street building, to which it is attached. It continues the flat façade, shallow setback, and regularly-placed fenestration of that earlier stone structure.

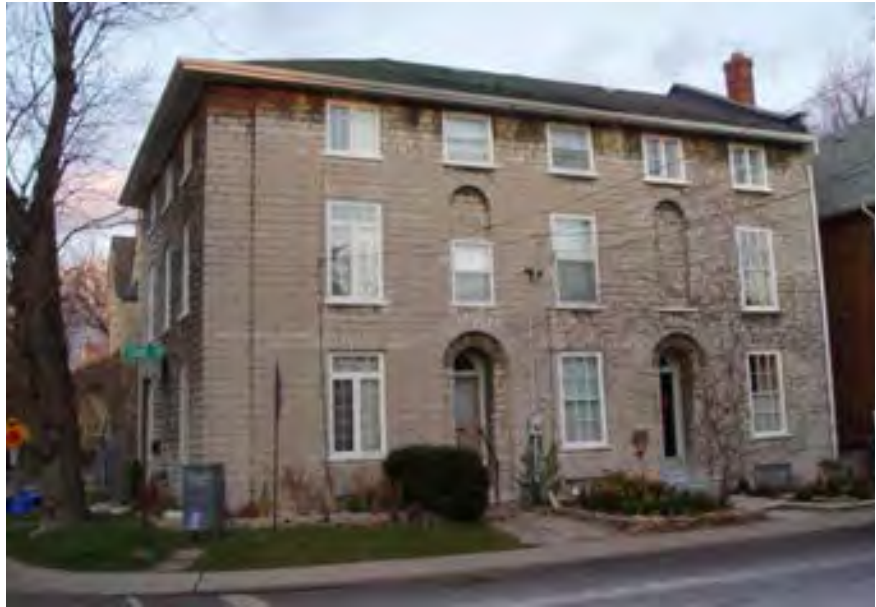
89-91 Gore Street
Built: 1842

This 5-bay, 3-storey house is built of hammer-dressed limestone with a recessed border along its northwest corner. Flanking its central bay are two recessed, round-headed entranceways with fanlight openings. Above each entrance is a tall and narrow blind arch. The northwest arch contains a square lower window. Relatively new, multi-paned window units have been installed throughout the building.[†] Small square windows line the upper storey of this building's Gore and Wellington Street facades. The remainder are tall and rectangular. The southeast elevation wall is brick. It is topped by a gable parapet and a brick chimney. The roof facing Wellington Street is hipped.

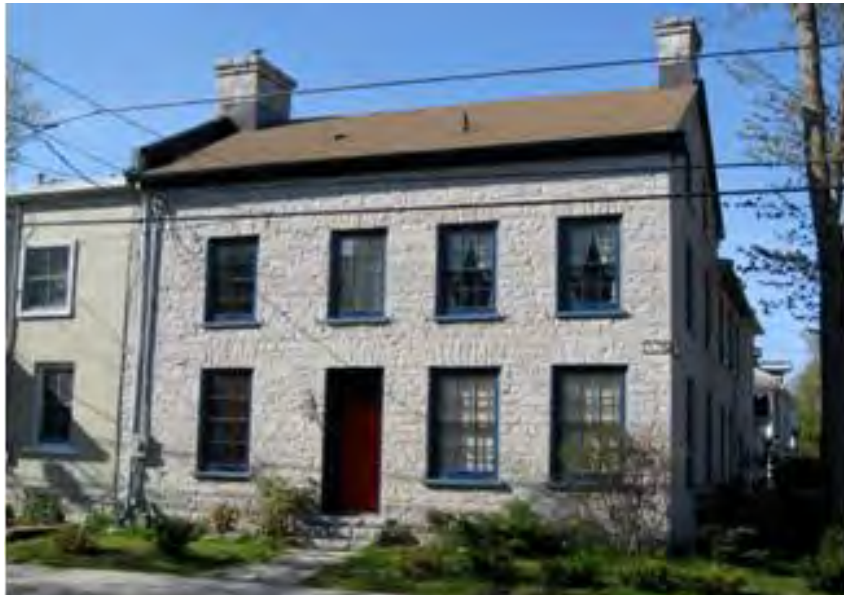
92 Gore Street

This 4-bay, 2½-storey structure was originally built as a double-house. It has an entranceway and rectangular transom in the third bay from Wellington Street. In 1980, when this building was last assessed, the entrance was on the furthest bay from Wellington. The remaining openings on both exposed elevations contain 6/6 windows with wood surrounds. Two of these windows occupy the Wellington Street gable end. A heavy stone chimney rises from each side of the building's roofline. The southeast chimney is the larger, and rises from a firewall which divides this structure from the 88-90 Gore Street building. This building's Wellington Street carriageway is topped by an elliptical arch: it is an important feature of the building, and one of several such underpasses found throughout the Old Sydenham Heritage Area. *

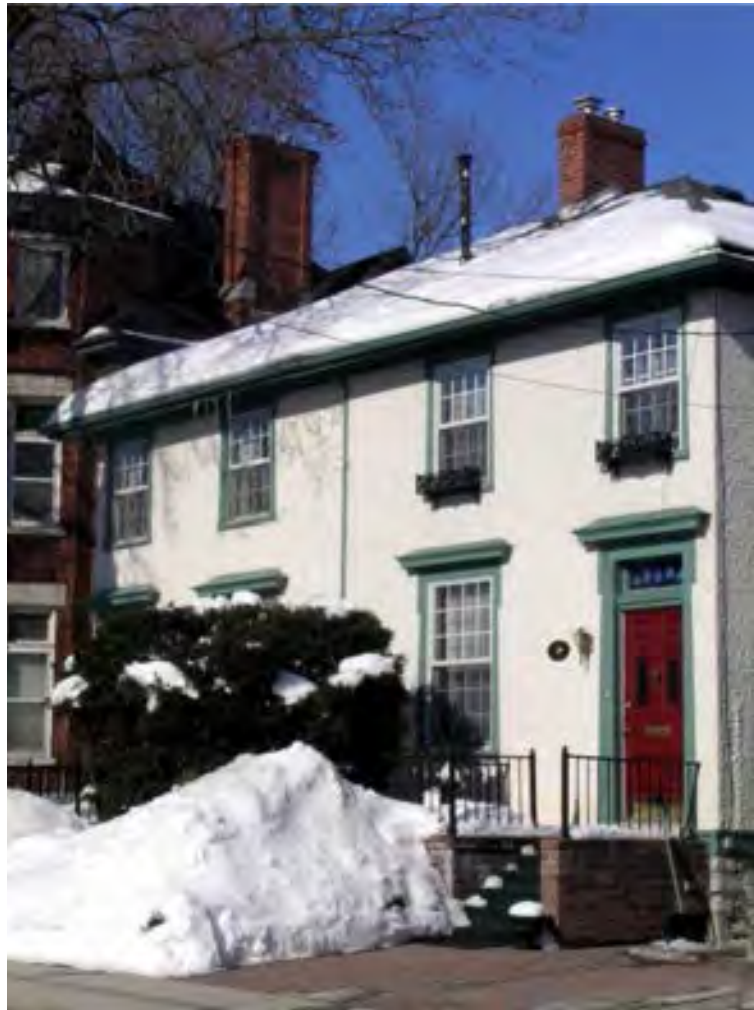
103-105 Gore Street

This building's design values include its 2-storey, 4-bay construction wood construction with a flat façade, hipped roof, centred brick chimney, and symmetrical fenestration. Eared surrounds on the windows and doors, derived from the Classical tradition, are relatively rare in Kingston. Its first-storey windows and doors feature curved shallow hoods. The front entranceways, located on the outer bays, have rectangular transoms. The façade windows maintain 8/8 and 12/12 window patterns.

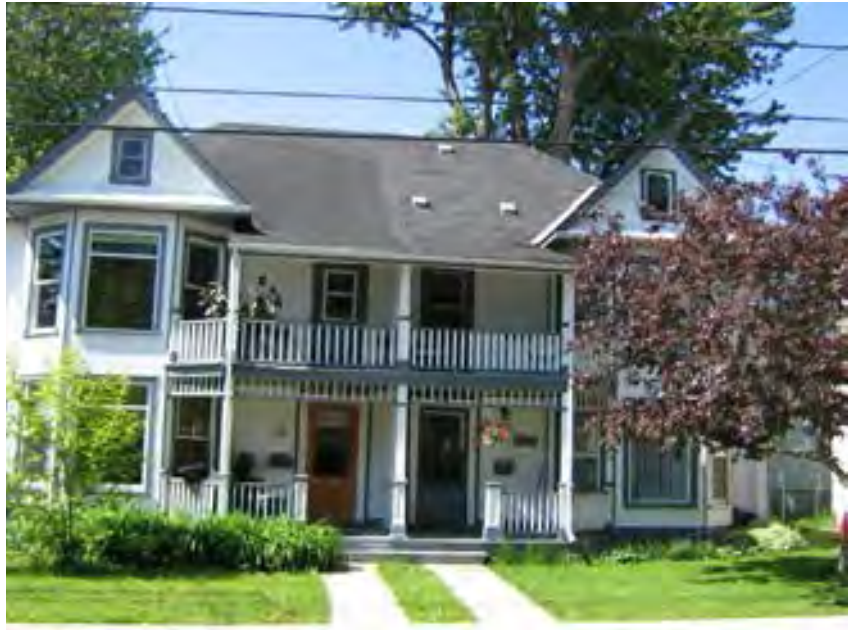
104-106 Gore Street

This building's design attributes include its 4-bay wood construction; its hipped roof, central balcony with angled returns, and its outer bays with large window openings and gable tops. Each gable contains a small 1/1 window and a wood face, set above a projecting ledge. The front porch and balcony roofs are supported by square wood pilasters. The balcony roof is an extension of the building's larger hipped roof. Entranceway and balcony doors, with simple wood surrounds, are located in the inner two bays of each storey. The square newel posts, and closely-spaced square balusters, contribute to this building's neat, rectilinear appearance. A hanging balustrade with turned-wood spindles lines the porch roof.

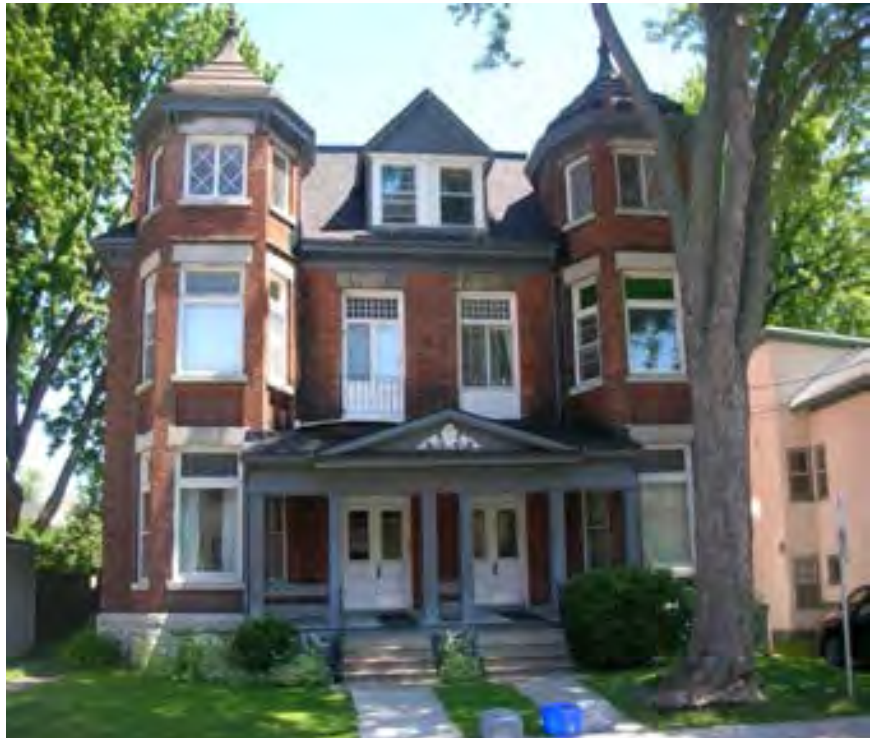
107-109 Gore Street

This 2½-storey brick double-house, with twin towers, was built in 1894 for merchants James and William Minnes. It is a good example of how a variety of roof structures, and façade projections, can be combined symmetrically. The building has a hammer-dressed stone foundation, and ashlar sills and lintels. The main roof is hipped. The end bays are 3-storey towers, projecting from the façade as bay windows. They are inset as they rise above the main roof line. Each has a pagoda roof supported by paired brackets. The towers contain single windows in the foundation, and three windows in each level above it. The first and second-storey windows have transoms; the third-storey windows are smaller, with diagonal glazing bars. Slightly recessed brick panels are located below the second-storey windows.

The central bays have double-door entrances in the first storey, and French windows with transoms in the second. On the front slope of the roof joining the towers is a gable-roofed dormer with two windows flanked by pilasters supporting a flat hood. Above these the gable has a wood face containing fish scale imbrications.

The entrances are protected by a shed-roofed wooden porch extending between the tower projections. Its twin entranceways are divided and flanked by wood pillars rising to a plain entablature. A low-rising pediment over the entranceways contains a wood tympanum with a decorative relief.

Rising through the roof at each side is a large brick chimney with ashlar course, vertical grooves, two stepped-brick courses, and three chimney pots.*

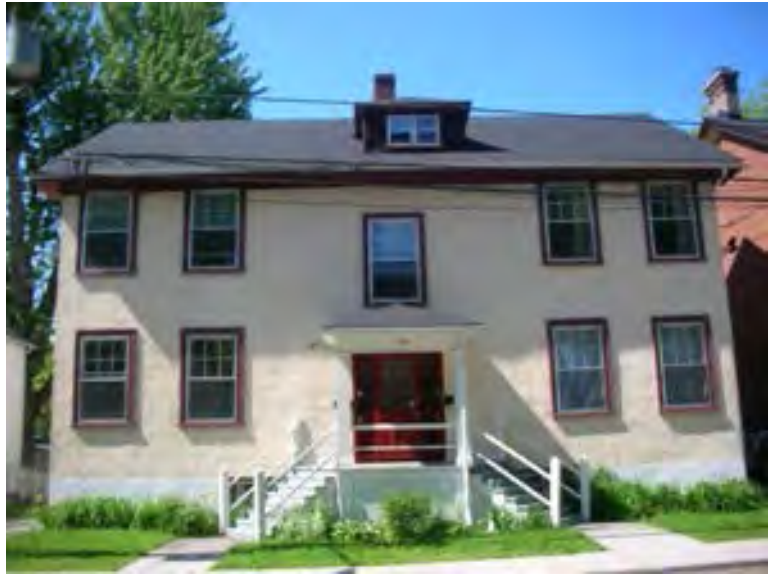
The 112 Gore Street building is a 2-storey wood and roughcast structure. It has a flat façade, side-gable roof, and symmetrical fenestration. The building presently has a centralized front entrance that is approached from high wood porch, with a hipped-roof

portico and angled side staircases. The façade of 112 Gore contains nine windows on its main two storeys, eight of which are evenly-placed on each storey of the building's outer four bays. Each of these windows has simple wood surrounds and plain wood sills. They have a 6/1 window pattern. A matching fifth window is located at the 1½-storey level above the front entrance pediment. A dormer on the roof above this is slightly offset to the northwest. It has a small set of paired windows and a hipped roof. A brick chimney rises from the centre of the building.

Two windows in the building's foundation are inset from the outer bays, toward the entrance. The northwest and southeast elevations of 112 Gore Street each contain a single window on the first and second storeys. These match the main façade windows. A pair of similar, but slightly smaller windows is located under each side gable. A large rear extension to this building was added after 1963. It replaced a platform related to industrial use, after 1915.

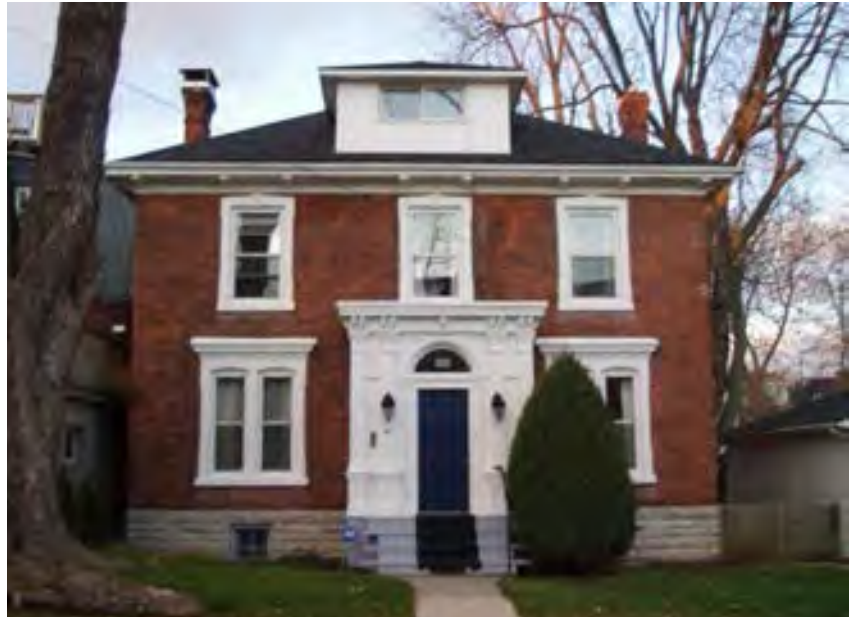
115 Gore Street

This 3-bay, 2-storey brick building has a base of hammer-dressed limestone. The low-hipped roof has, on its front slope, a central hipped roof dormer with a pair of small windows. Wide brick chimneys with stepped capitals are inset at each side of the roof, which is supported by brackets and a cornice with dentils.

The end bays on the first storey have pairs of narrow sash windows with heavy wood surrounds, topped by a flat hood with tiered, dentil-lined cornices. The windows are recessed in their surrounds, under wood keystones. The three second-storey windows also feature heavy wood surrounds, with recessed windows and mild arches with wood keystones. The first-storey central bay contains the main entrance, now protected by a wooden portico with a flat roof. The porch rests on a foundation with small vertical slits.

The front of the portico has a door and fanlight surmounted by a keystone and set between twisted columns. The door surrounds is set between pairs of square columns set on paneled piers. The capitals of the columns are surmounted by paired brackets which support the moulded cornice. Between the brackets are panels. Each side of the portico has two round-headed openings with mouldings at the level of the fanlight base and decorative elements repeating those of the facade.

The east side has the chimney breast at the centre and towards the rear, a window in each storey. The sash windows have ashlar sills and plain inset wooden surrounds. The west side has no openings.

To the rear is a small one-storey brick wing. It has two dormers in its mansard roof. *

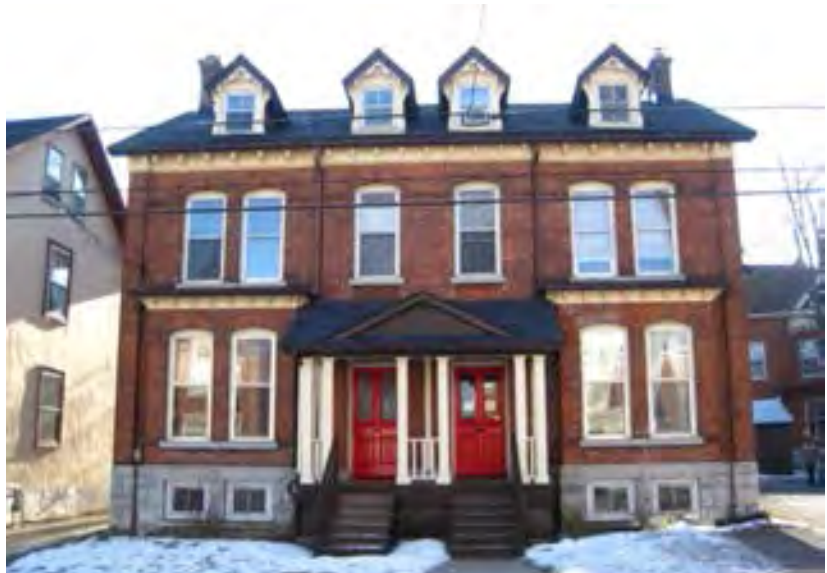
116-118 Gore Street

The property has physical/design value. Character defining elements that reflect this value include its scale and massing. Other elements reflecting its physical/design value include the dwelling's two bay two and a half storey brick construction, stone foundation, and windows joined by a common stone sill and joined decorative brick dripstone effect. The entranceway in central bay is adorned by a transom over double doors. The gabled roof is adorned by gable-roofed dormers over each bay and end chimneys with stepped brick caps. There is a small one-storey brick addition towards the rear.
