**The Barriefield
Heritage Conservation District
Plan Review**

**THE BARRIEFIELD
HERITAGE CONSERVATION DISTRICT PLAN**

PART II: APPENDICES

Prepared for
The Corporation of the
Township of Pittsburgh

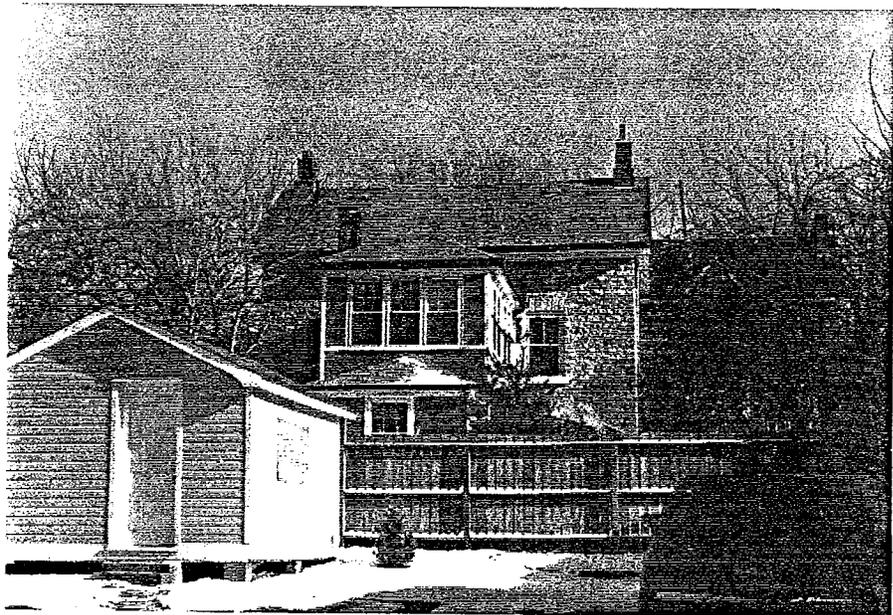
Address: 210 Main Street

Building Type:: brick; end gable; 3 bays; 1 & 1/2 storeys

This plain red brick building built on a fieldstone foundation has a medium pitched side gable roof. The projecting boxed eaves are returned on the side elevations. The front elevation is arranged in a typical three bay fashion with a central door and side windows. The window sills are limestone. At one time all windows had operable exterior wooden louvred shutters. The present enclosed porch is a more modern addition replacing an earlier structure which ran the entire width of the facade. The main entrance door has a two light transom.

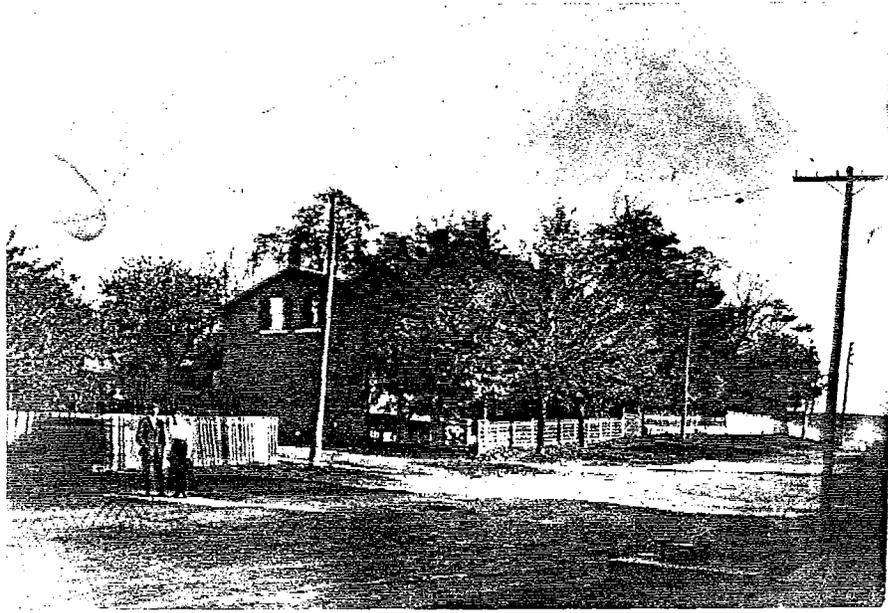
Address: George Medley House, 215 Main
Street; (formerly 205 and 5 Main Street)

Building Type: frame; front gable; 2 bays; 2 storeys

The main section sits on a coursed rough-faced limestone foundation and is clad in shiplap siding with accenting cornerboards. The boxed eaves and soffit lack ornamental detailing. The side front entrance has a small gable portico which consists of turned supporting posts, separate semi-circular arches fixed between each post as a decorative element and side railings with turned balusters. The window sash consist of typical late nineteenth century 2/2 lights. An early historical photograph shows that a number of windows had exterior louvred shutters on the main block.

The rear wing is also clad in shiplap siding. It has a one storey hip roof side porch with plain squared supporting posts with a plain square balustrade and hand rail on the south elevation. A one storey shed roof addition has recently been-constructed behind the two storey rear wing.

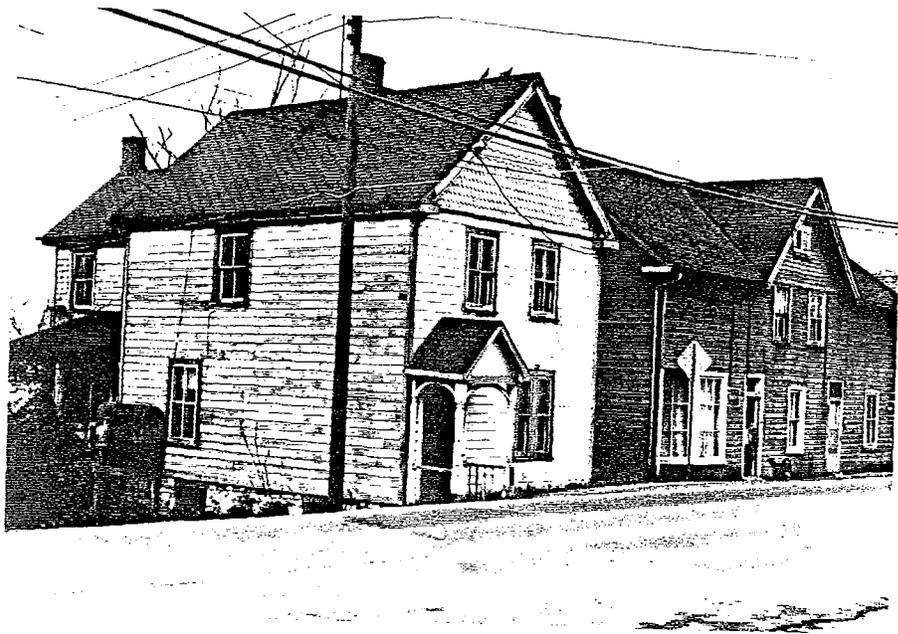
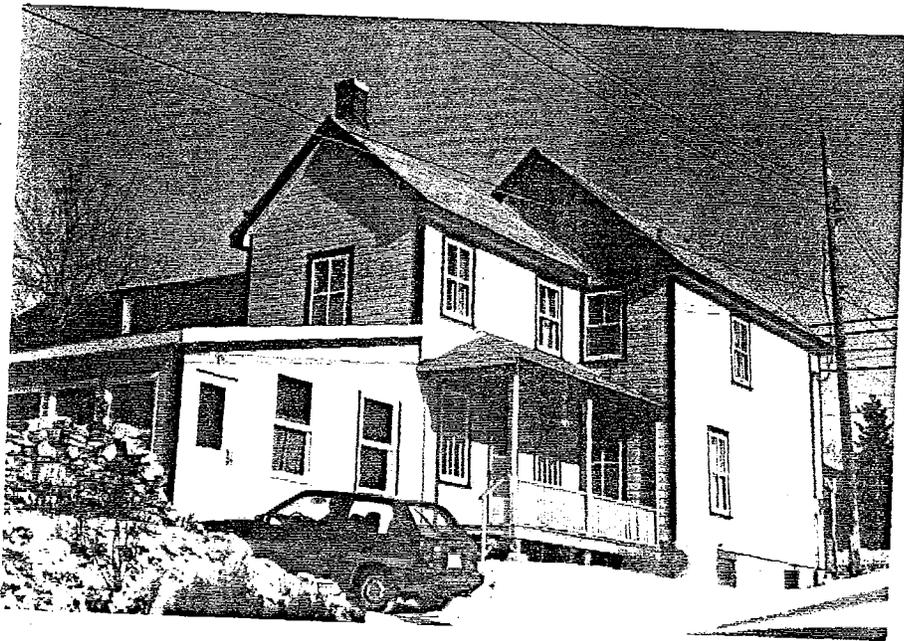
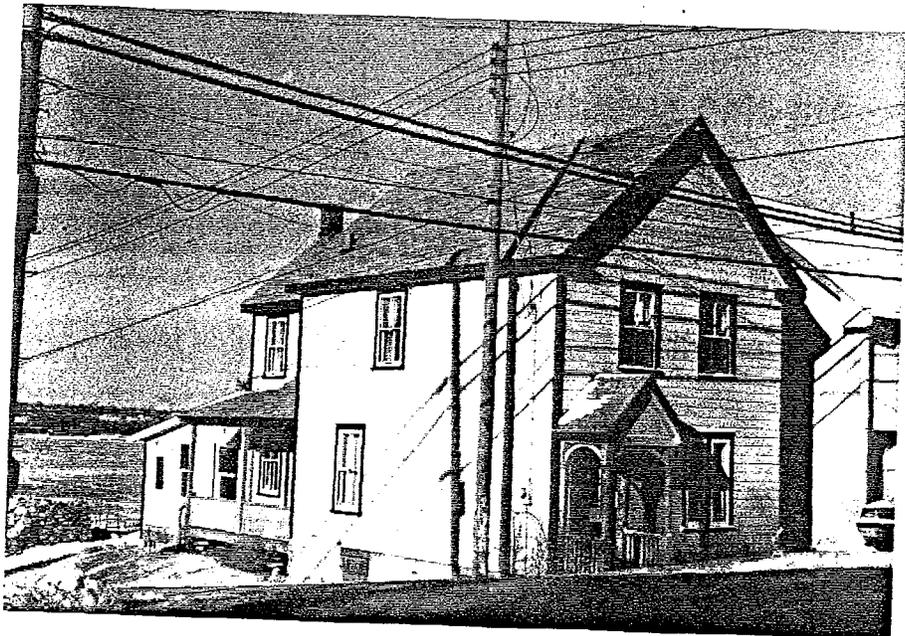
Address: 217 Main Street
(formerly 207 ; and 7 & 9 Main Street)

Building Type: frame; central front gable; formerly
commercial/residential; 5 bays; 2 storeys

Rectangular in plan, the principal axis of this structure runs parallel to Main Street. It has a high pitched gable roof with a large central gable on the front elevation. The original eaves were returned on the side gables. At one time the gable was ornamented with a decorative fascia which has been replaced. The decorative wooden shingle work is still extant. The siding was originally shiplap with accenting end boards on the corners. Presently the shiplap siding on the front elevation has been covered over with vertical board cladding at the second storey level. The two original brick chimneys located on the end gables have been demolished and the original cedar shingle roof has been replaced by asphalt shingles.

The southeast corner of the building has a recessed entrance door and a typical shop display window with fifteen lights indicating its early mercantile use. The front elevation at street level is divided into five bays with alternating doors and windows. At one time a retractable awning covered the shop window and entrance. Each door has a single transom overhead. An incomplete brick veneer wall covers the shiplap siding on the north side.

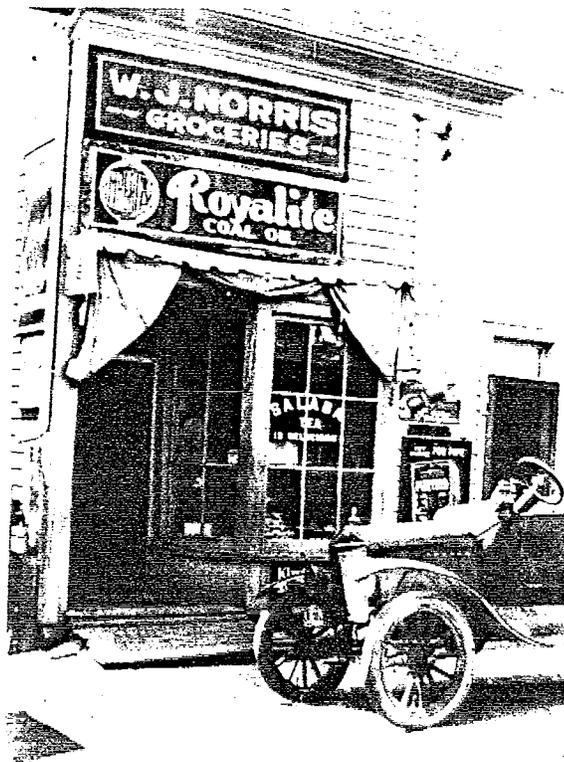
Address 223 Main Street
(formerly 211 & 213)

Building Type: limestone; side gable; 3 bays; 1 & 1/2 storey

The roof has two wooden gable dormers sided with shiplap cladding which are probably later nineteenth century additions. The original roofing material was wooden shingles. A small frame enclosed vestibule is located at the main entrance door. The first floor windows on the main facade once had exterior louvred shutters. The masonry of the south elevation shows the outline of two former second floor windows since blocked in with rubble.

A full width open verandah once stretched across the front facade. It had a simple shed roof covered with a metal batten roof, plain chamfered supporting posts with a boxed base, decorative fretwork at the top of each post, a wooden floor and a handrail and trellis-style enclosure along the edges. At one time a one storey frame and stucco building stood on the south end of the building. As well, A one-and-a-half storey limestone extension was also built on the north end probably by the mid 19th century.

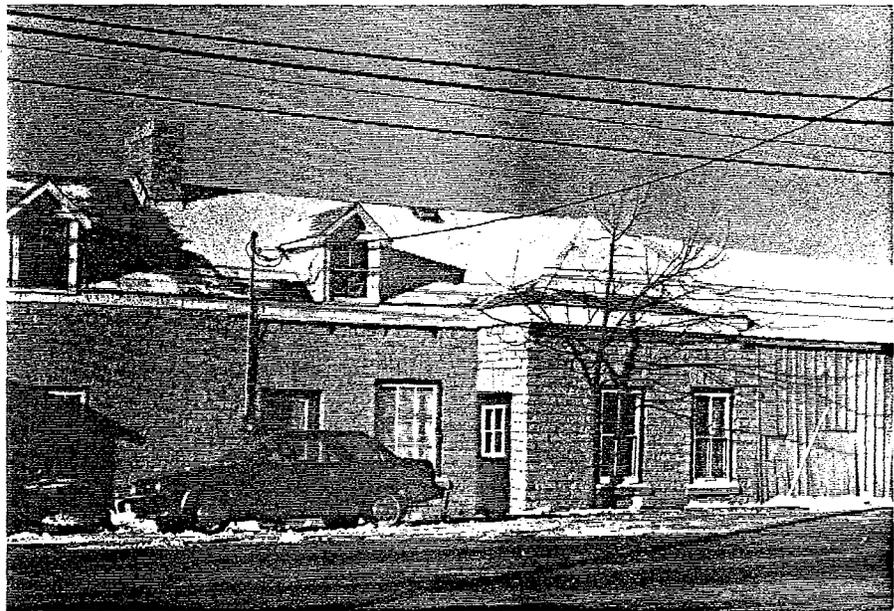
Address: 226-228 Main Street
(formerly 208 and 210; 8 and 10 Main St.)

Building Type: frame; side gable; double house; 2 storeys

Relocated to its present position in the late nineteenth century, this double frame house was apparently placed on the foundations of an earlier 1816 structure which had been destroyed by fire. Its rectangular plan is placed with the long axis oriented to the street. Two storeys high, it has a medium pitched side gable roof with a boxed returned eave on each side wall. A plain frieze board is located below. The original central brick chimney has been removed and two modern outside concrete block chimneys have been built on each side elevation. The original roofing material was wooden shingles.

A one storey open verandah with supporting turned posts and decorative brackets runs the full width of the main elevation. Some of the original brackets on the posts have been removed. Exterior louvred shutters once framed all of the window openings but have also been removed. Extant decorative corner boards once accented the original shiplap siding which is now covered by modern synthetic cladding.

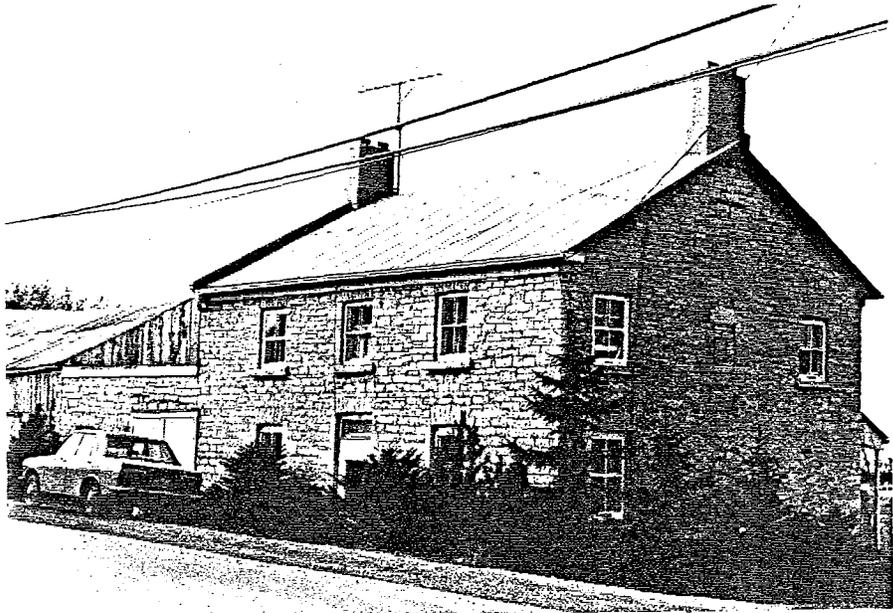
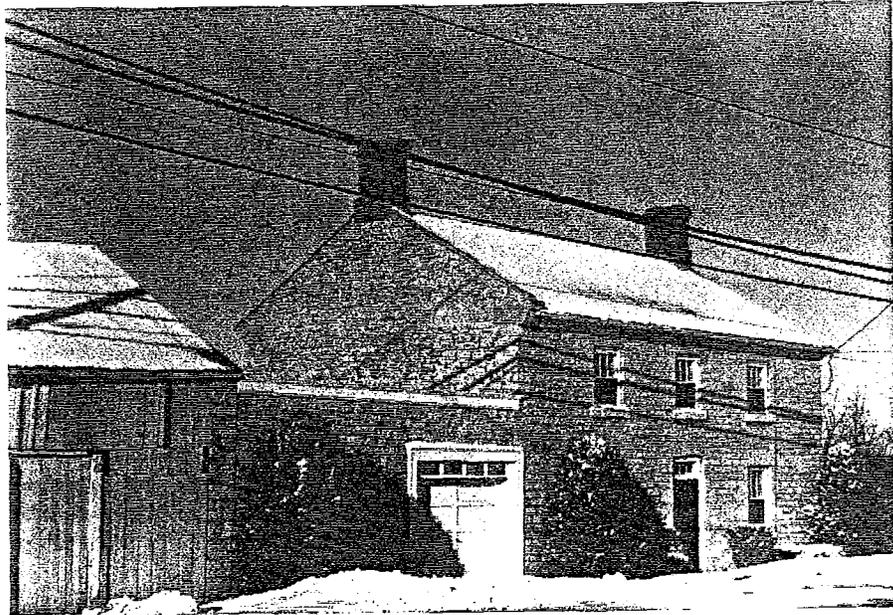
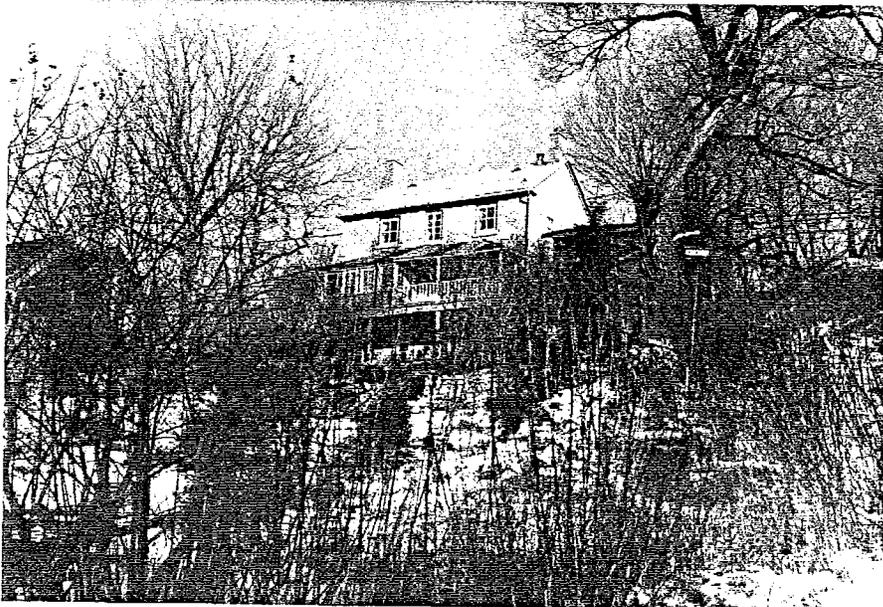
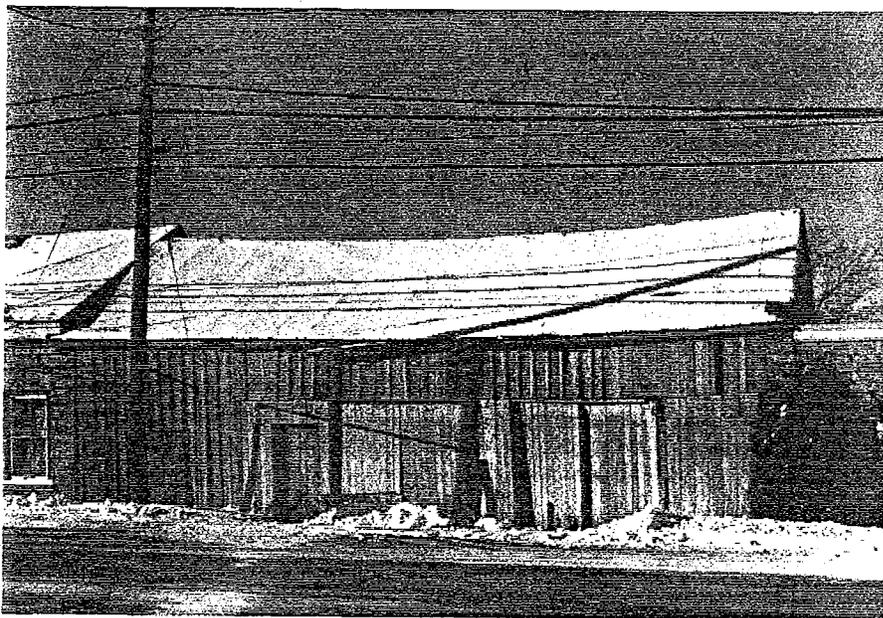
Address: Willowmere, 239 Main Street
(Formerly 217 and 17 Main St.)

Building Type:: Limestone; side gable; 3 bays;
originally 1 storey, raised to 2 storeys

Once known as the Richmond Hotel, this building was erected in 1818-1819 by John Hendry as a one-and-a half storey single dwelling. The roof was raised to its present two storeys later in the nineteenth century. The original roofing material was wooden shingles. Rectangular in plan with the long wall parallel to the street, the main facade is divided into three bays with a central doorway. The central window on the second floor is a casement window in contrast to the other double hung units. The steeply pitched side gable roof has a metal batten roof with two brick end chimneys. Each gable end has a returned eaves.

A full width one storey verandah with a metal batten roof runs across the main elevation. It has turned supporting posts, decorative brackets and fretwork, and a handrail with turned balusters. The first floor window openings have quoins. A one-and-a-half storey frame shed once stood on the south end but has since been removed for a driveway. At one time a decorative post and wire fence immediately in front of the verandah separated it from the roadway.

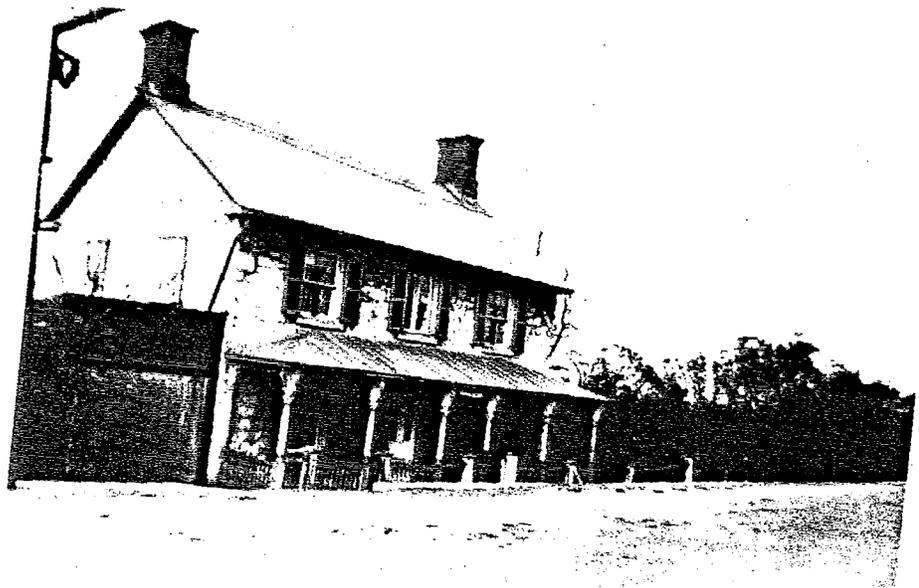
Address: 247 Main Street
(formerly 219 Main St.)

Building Type: stone & frame; truncated hip roof; 3 bays;
originally 1 storey , now 2 & 1/2 storeys

Recently restored, this building was originally built in 1830 as a one storey unevenly coursed limestone cottage with a square plan. The present structure is two-and-a-half storeys in height due to the 1928 addition of a frame second storey and attic by the Hewitt family. The roof is a high truncated hip with a central front gable dormer and two large stone chimneys located on each side elevation inset for the eaves. The main facade is divided into three bays with a central doorway. Built into the slope of the land, the basement wall in the rear of the house is fully exposed. A stone addition extends from the rear of the building. The main entrance door is covered with a frame vestibule with a gable roof.

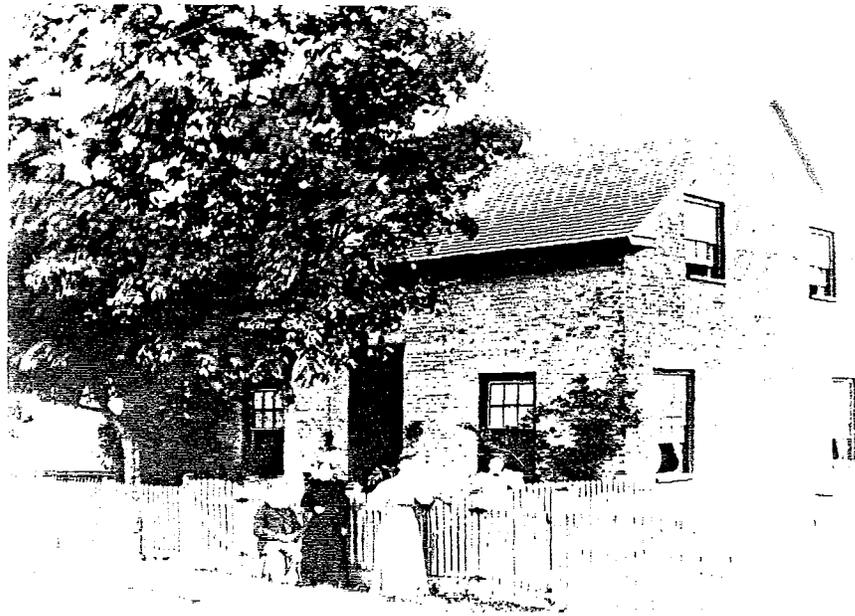
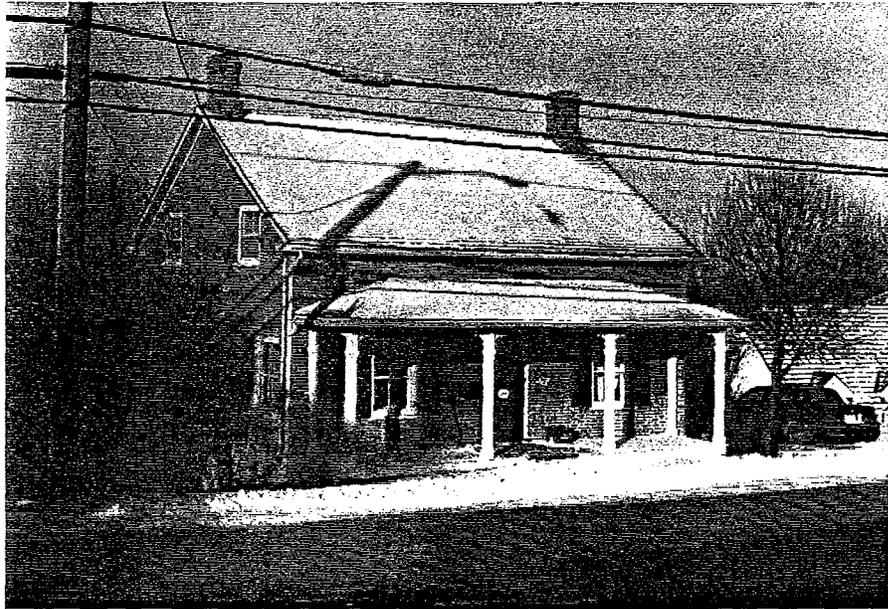
Address: John Marks House, 273 Main Street
(formerly 229 Main St.)

Building Type: log & frame; side gable; 4 bays; 2 storeys

A one storey verandah runs across the full width of the main elevation and down the south elevation. The supporting posts are turned. At one time the verandah was enclosed by a railing and spindle balustrade. The roof of the verandah was

originally covered with wooden shingles as was the main roof of the house. An off- centre brick chimney is located on the roof ridge of the main house while the rear wing and the side stone addition also have brick chimneys. The wooden siding in the gable peak on the north facade has an outline of what appears to have been a former semi-circular window.

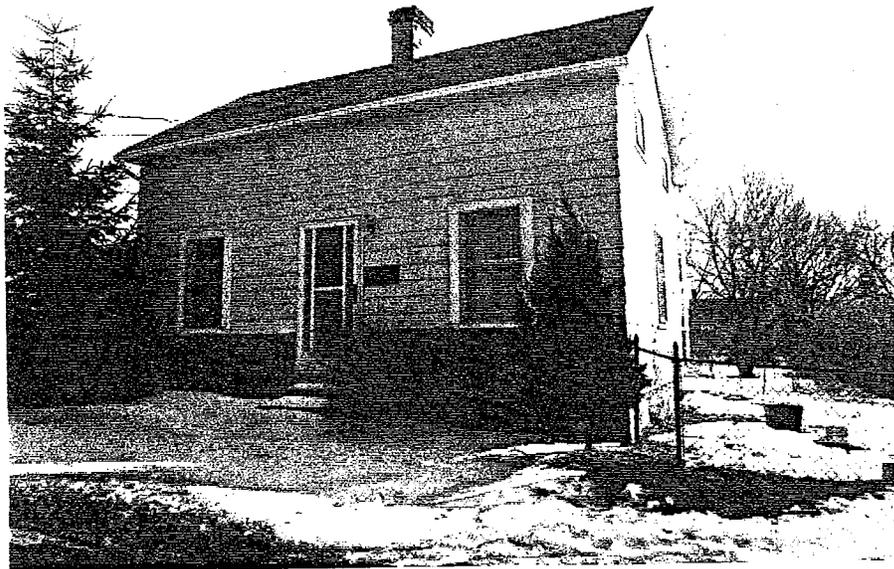
Address: 406 Wellington Street

Building Type: frame; side gable; 3 bay; 1 & 1/2 storeys

Built by John Tisdell in the late nineteenth century on the southwest corner of Wellington and Drummond Streets, this one-and-a-half storey frame house has a side gable roof and a three bay main facade with a central door and two flanking side windows. The cornice is boxed with a returned eaves on the gable ends. The east facade which faces Drummond Street has a rear one-and-a-half storey addition with a one storey side porch.

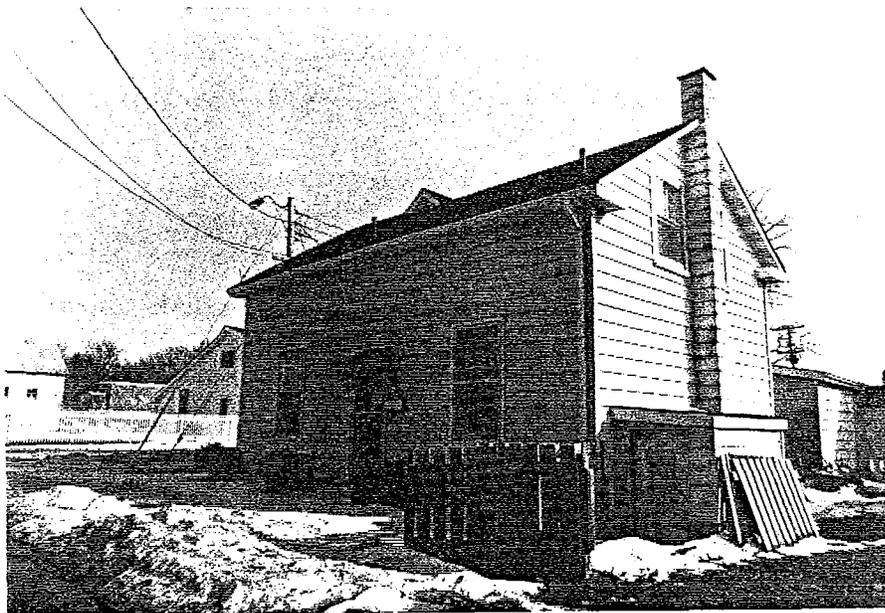
Address:: 412 Wellington Street
(formerly 10 Wellington St. .)

Building Type: frame; side gable; originally 5 bays;
1 & 1/2 storeys

Originally situated on the corner of Highway 2 and George Street, this one-and-a-half storey frame dwelling was moved to its present location during the 1930s. The main house is rectangular in plan with its long side facing Wellington Street. Several additions extend from the rear of the building.

The main facade is divided into five bays with a central doorway and two windows on each side. The doorway has a three light transom. The walls are clad in shiplap siding with plain accenting cornerboards, frieze and water table. A boxed cornice with a returned eave is found on each gable end. Each gable end has an inset brick chimney. A simply designed one storey verandah once ran across the full width of the principal elevation but has since been removed.

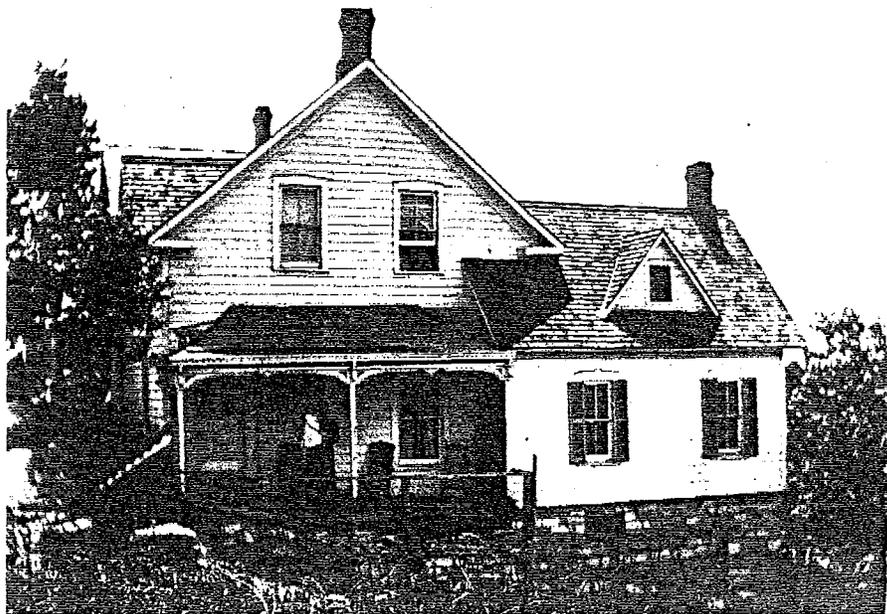
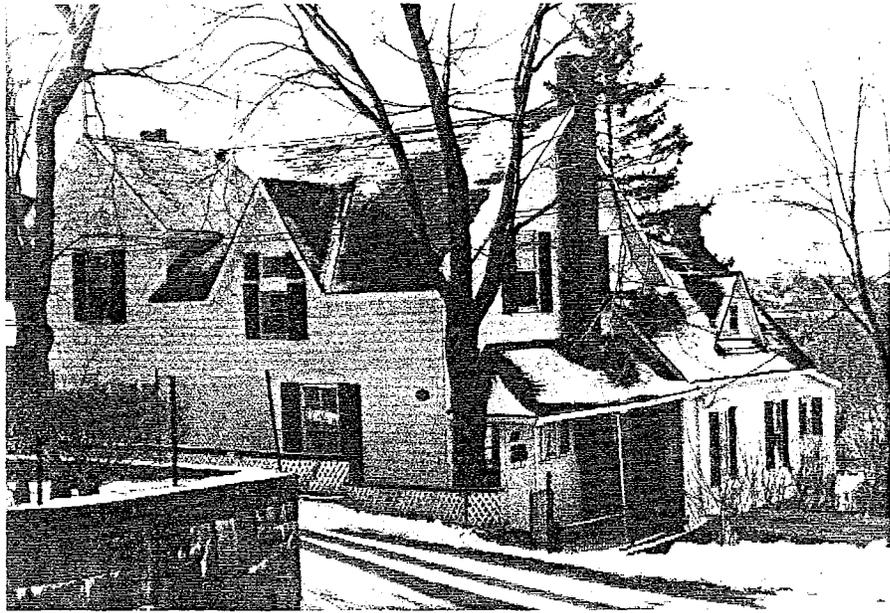
Address: 406 Regent Street

Building Type: brick; front gable; 2 bays; 2 storeys

The overall design and plan of the house is reminiscent of the house at 402 Regent St. which was built around the same time. It is a narrow two storey brick structure with a front gable orientation and typically has a side hall entrance and interior floor plan. The brick is laid on a limestone foundation in a stretcher bond while the one storey brick addition is laid in a common bond. The first floor of the main facade which faces Regent Street has a single side entrance and a double window similar to 402 Regent St. The second floor has two single, closely placed window openings in the centre of the facade. The steeply pitched gable roof was originally covered with wooden shingles. The boxed eave has a slight curve at the bottom end on both the front and rear gables creating the ornamental effect of an arch.

The one storey front porch is not shown on the 1908 Fire Insurance Plan and would appear to be a slightly later addition to the building. It has a hip roof with doric supporting columns and a railing with balusters. Three frame outbuilding are associated with the house consisting of a privy, a driveshed and a storage shed.

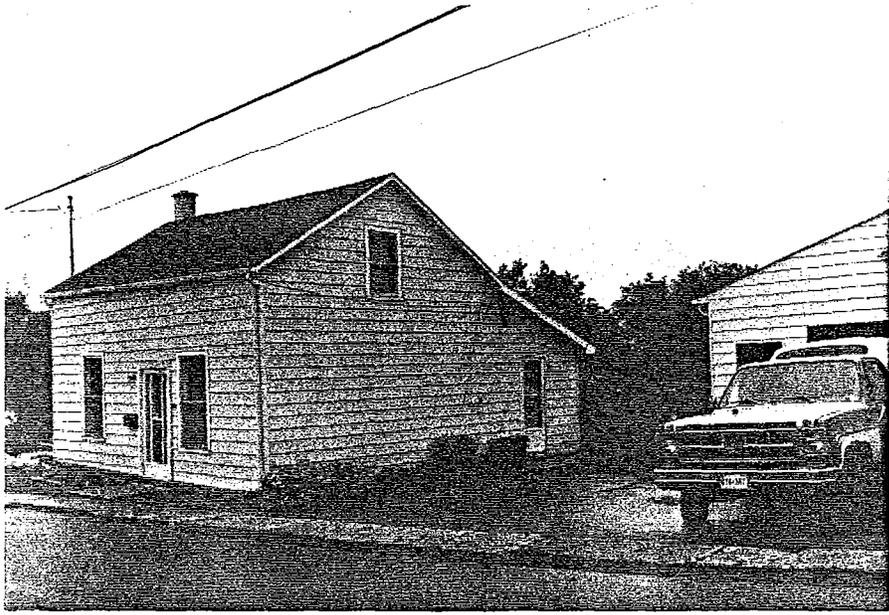
Address: 421 Regent Street

Building Type: frame; side gable; 3 bays: 1 & 1/2 storeys

Believed to have been constructed by local labourer George Batten after 1874, this small one-and-a-half storey frame vernacular cottage is rectangular in shape and has a low pitched side gable roof. The main facade is divided into three bays with an off-centre main entrance door. A small one storey addition extends from the rear giving the structure an "L" shaped plan. Originally clad in wooden siding the structure now has modern aluminium siding. The window and doors have been replaced with modern units.

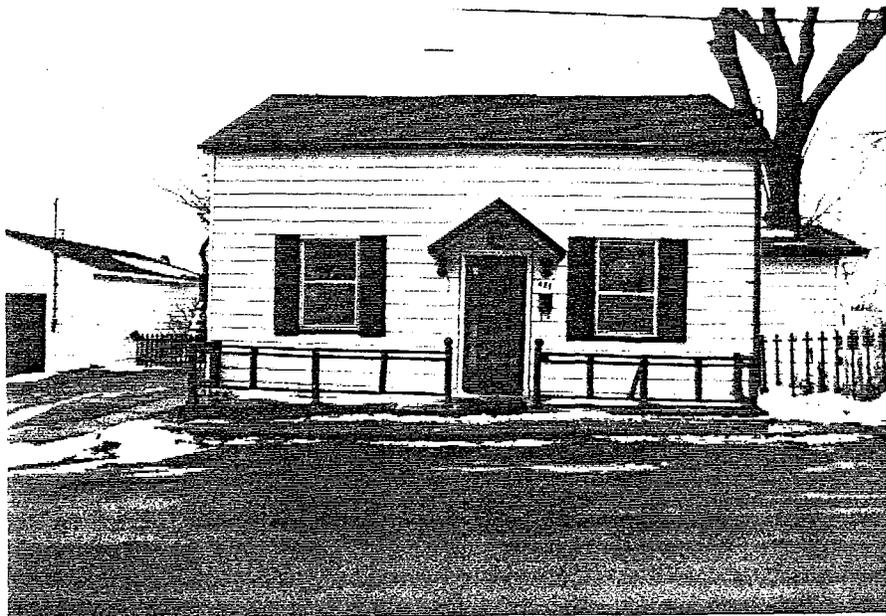
Address: 423 Regent Street

Building Type: frame; side gable; 3 bays; 1 & 1/2 storeys

Newly restored, this building was erected circa 1880 by George McAllister. It is a typical vernacular frame building, one-and-a-half storeys, medium pitched side gable gable roof and a three bay main facade with a central entrance. Two brick chimneys are inset on each end gable. A third chimney runs up the rear wall internally. The eaves have a wide overhang on the front section and are flush on the rear addition. The siding is shiplap with accenting cornerboards, watertable and simple but intrinsic wooden window and door trim with a projecting hood.

A one storey shed roof addition was added to the full width of the main building prior to 1908 creating a "saltbox" appearance. Each side elevation of the main building has two second storey windows and one northerly placed first floor window. The property has been enclosed with a wooden picket fence highlighting the corner property.

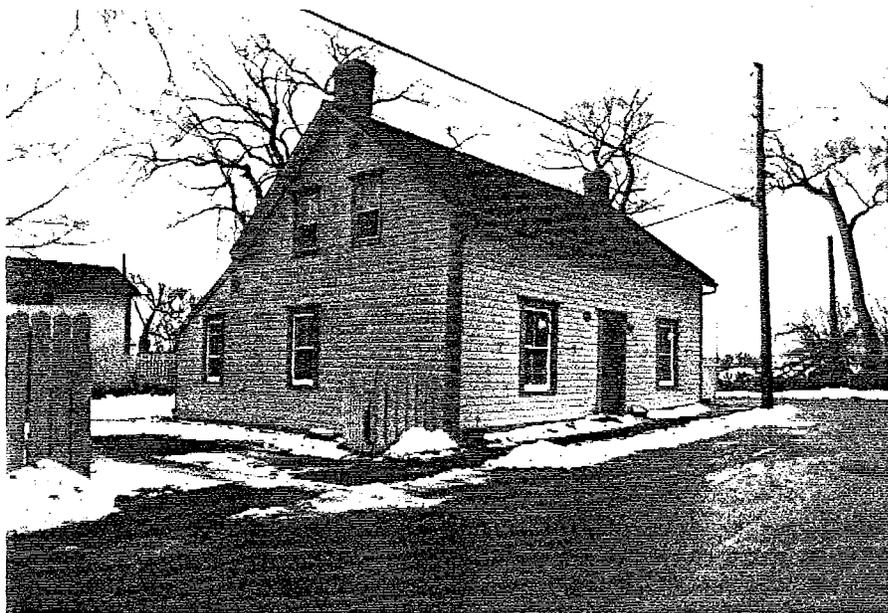
Address: James Medley House, 230 James Street

Building Type: stone; central front gable; five bays;

photograph shows a smaller open wooden porch with a railing and balustrade around the edge and down the front stairs.

A one-and-a-half storey stone addition on the rear of the house was raised during the recent renovations and an upper storey of board and batten was added.

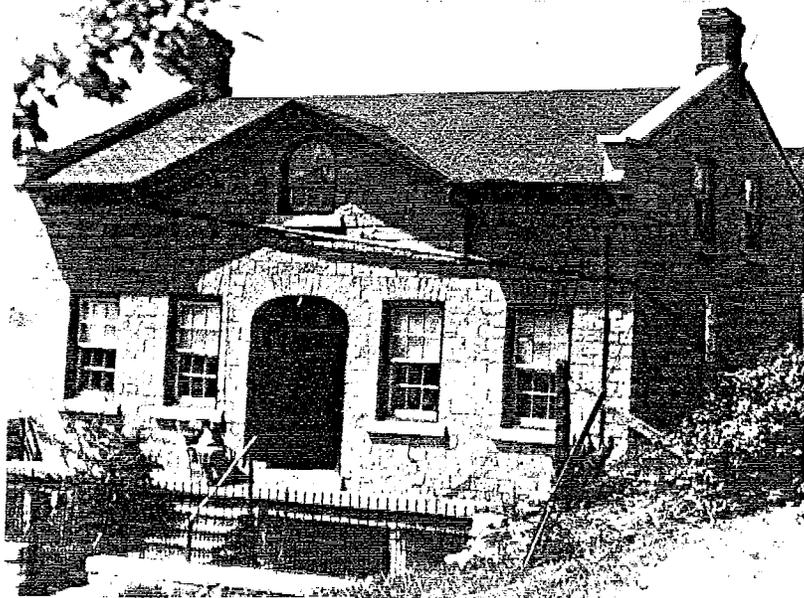
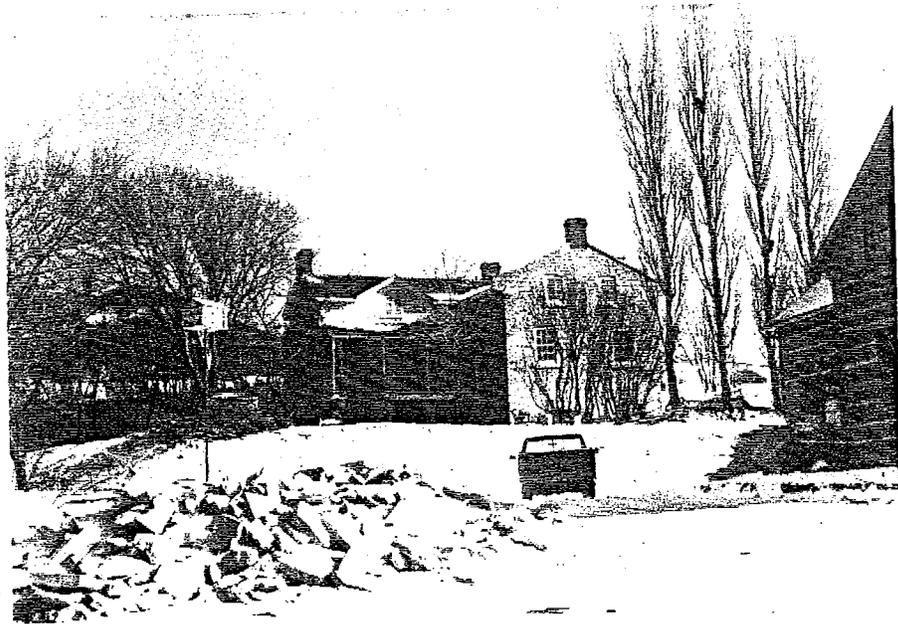
Address: Sharman House, 232 James Street

Building Type: frame; hip roof with central front gable; 3 bays;
2 storeys

In 1863 Jacob Sharman, a local carpenter and boat builder, purchased village lots 2 and 3 which included a small one storey frame house dated circa 1820 built by John Ferguson. It is believed that Sharman incorporated this earlier dwelling in the present structure. The present two storey frame building is square in plan with a three bay front elevation and central door. The medium pitched hip roof has a central front gable. This gable has a semi-circular gothic-style window which has recently been restored as well as decorative looped vergeboard and a pendent/finial at the peak. The original clapboard cladding has been covered over with modern aluminium siding. At one time an open verandah with trim similar to the vergeboard stood on the front elevation. The venetian style window openings on the ground floor of the main elevation are part of circa 1860s renovation while the window sashes are modern additions.

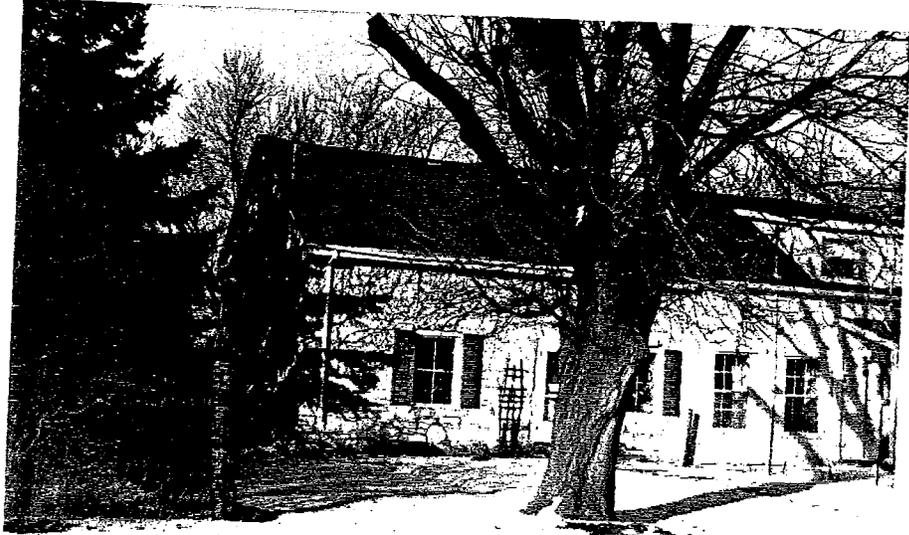
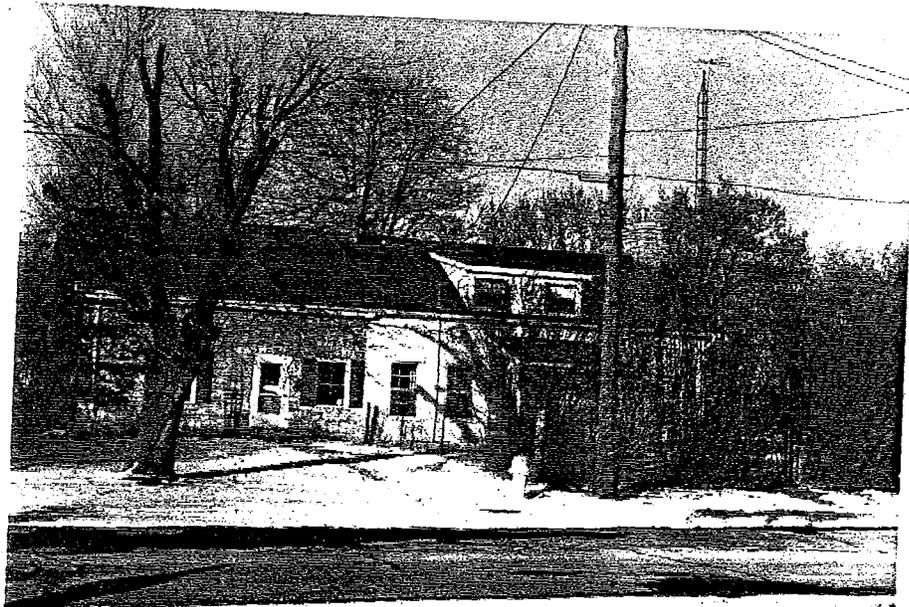
Address: 248 James Street

Building Type: stone covered with stucco; side gable with later central shed dormer; 5 bays; 1 & 1/2 storeys

The two houses are similar in building material, plan, roof structure and height. Built in limestone rubble, the one-and-a-half storey structure at 248 James Street has a medium pitched side gable roof and a five bay front facade with a central doorway and two windows on each side of the entrance. The exterior stonework has been stuccoed. The window openings at 248 are rectangular in shape and longer than 246. The 6/6 lights in the window sash have been retained. The entrance door has multi-paned rectangular sidelights with a lower wooden panel. A modern shed dormer has been added to main elevation.

According to the 1908 Fire Insurance Plan, 248 had a full width one storey verandah across the front facade. It has been replaced by a shed roof portico over the entrance. The one storey rear addition to the house existed on the Fire Insurance Plan of 1908. A large stone chimney is located between the two houses slightly inside the wall of 248. A second stone chimney is found on the east end of 248.

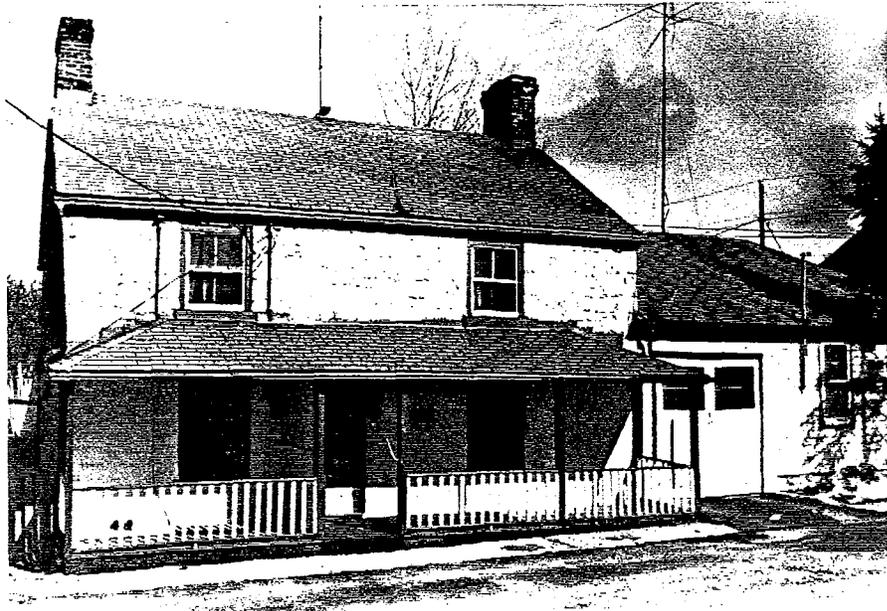
Address: 18 Drummond Street

Building Type: frame; side gable with later shed dormers; 3 bays;
1 & 1/2 storeys

Located on the east corner of Drummond and Wellington Streets, this frame house is believed to have been constructed between 1830 and 1840. It has a rectangular plan with a side gable roof and a central brick chimney. The roof line has been raised on the front elevation from the original one-and-one half storey to two storeys. The main elevation is divided into three bays with an off-centre entrance door and two flanking picture windows, one on each side. An older rear addition and a more recent side addition have altered the overall configuration of the original structure.

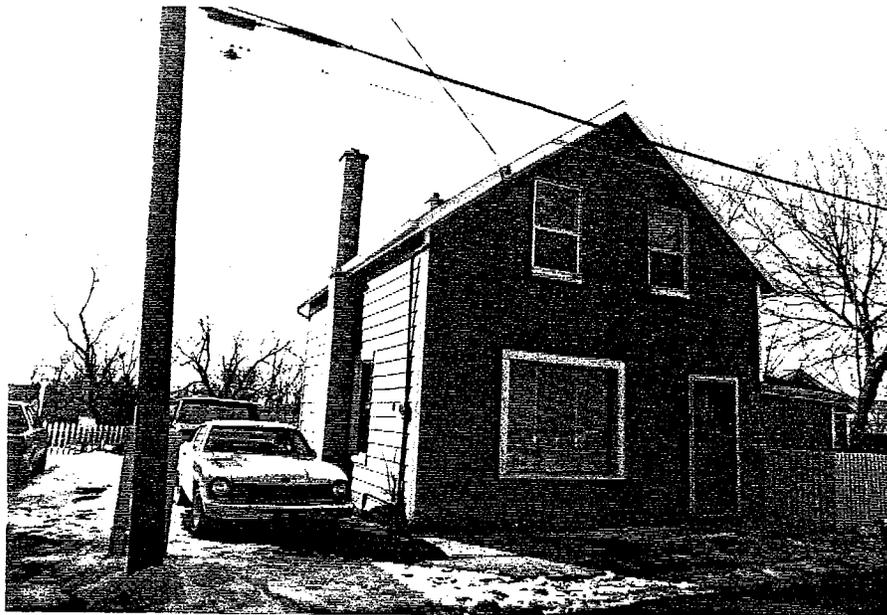
Address: 9 George Street

Building Type: frame; front gable; 2 bays; 1 & 1/2 storeys

This house was also constructed by local builders William and Frederick Allen in the late nineteenth century. It consists of a one-and-a-half storey front gable with a side entrance. The main elevation was probably divided into two bays originally but the side window appears to have been blocked up. The steep gable roof has a boxed eave and a returned eave. Once clad in wooden siding, the house is presently covered with aluminium siding. A one storey enclosed vestibule is located at the front entrance.

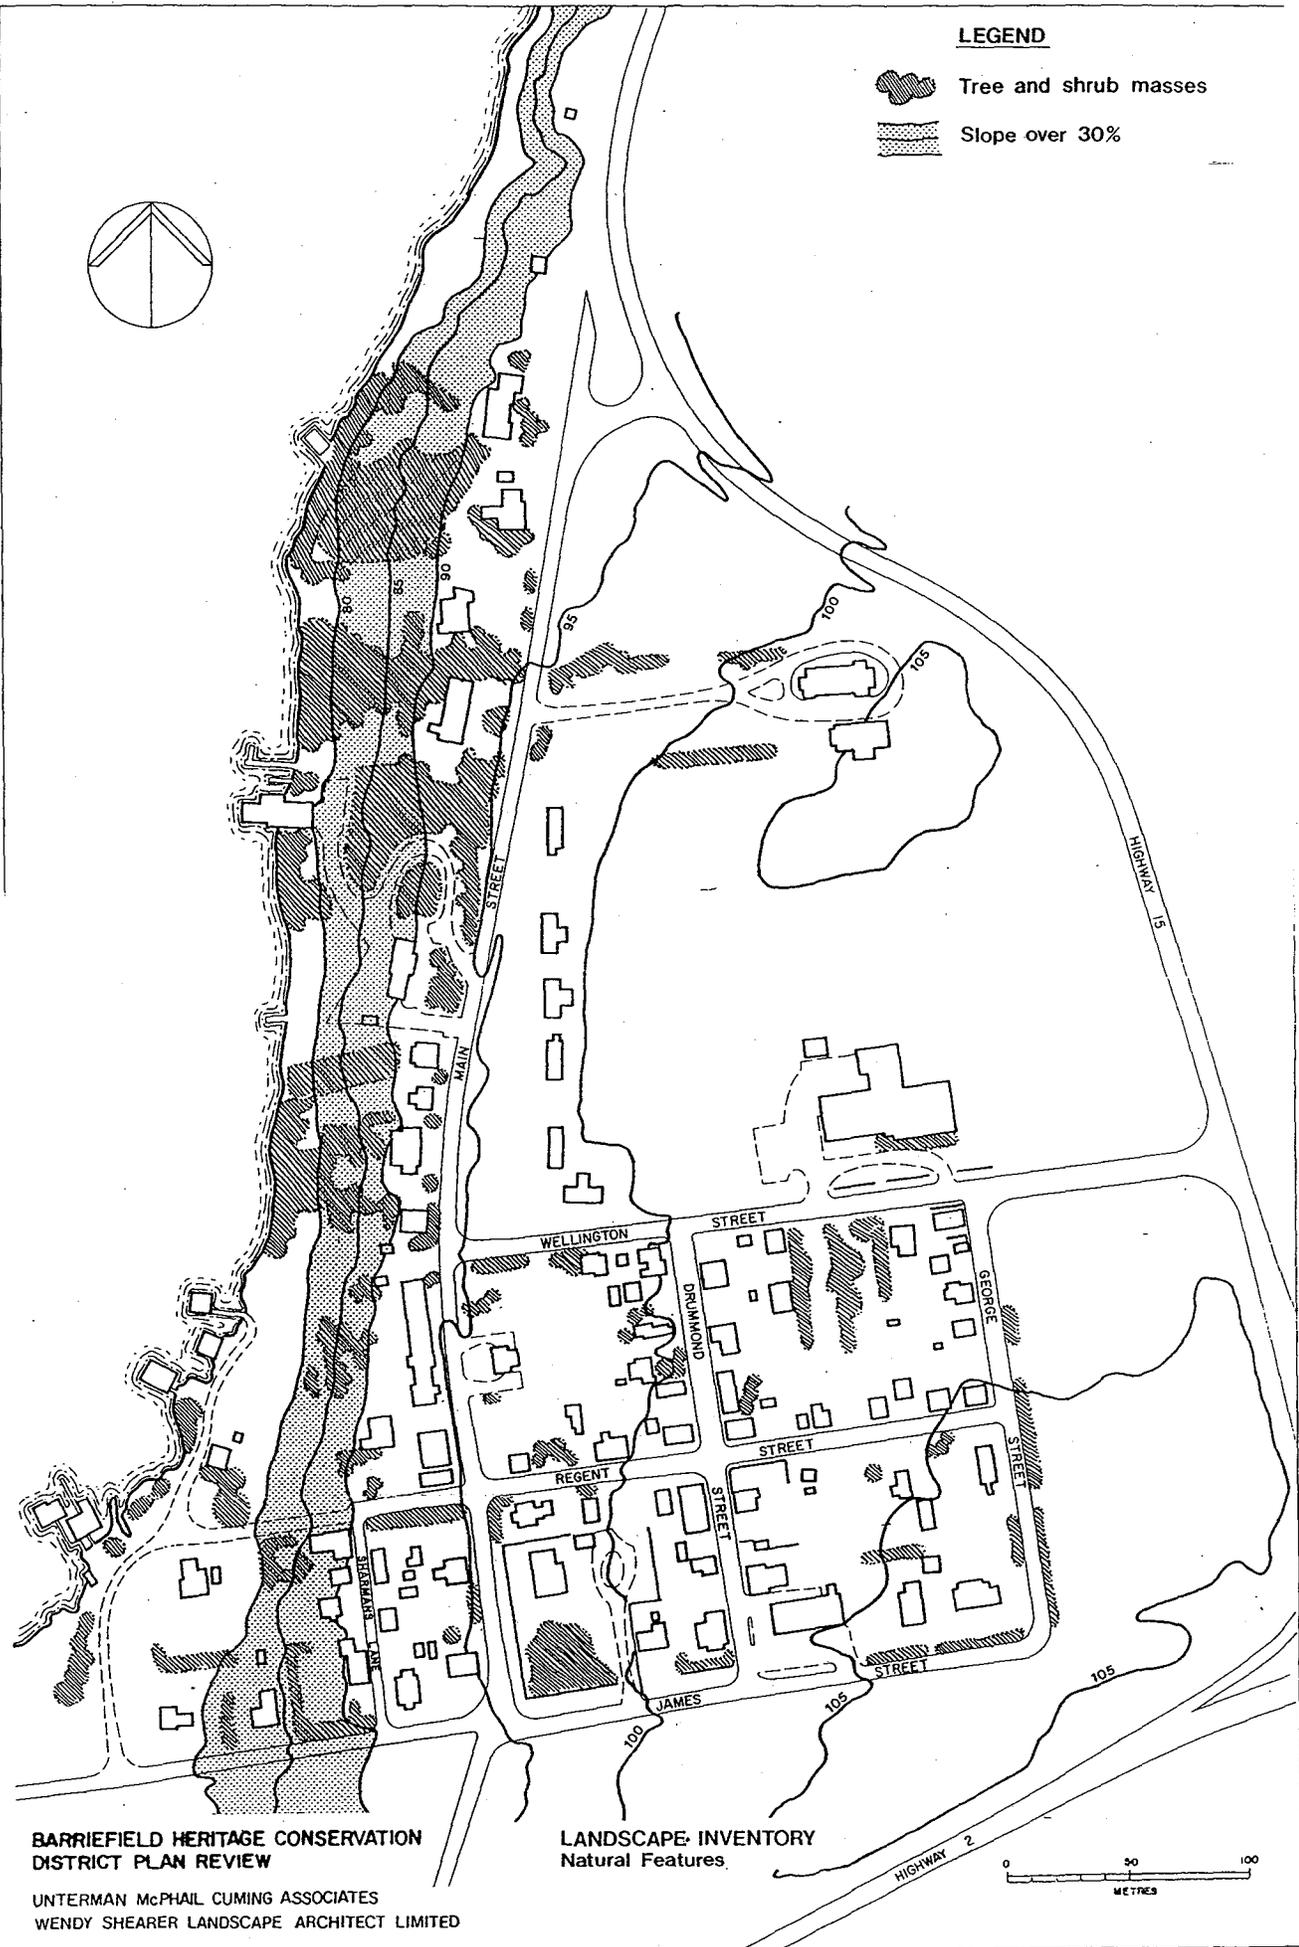
**LANDSCAPE INVENTORY
Natural Features**

Slope over 30%

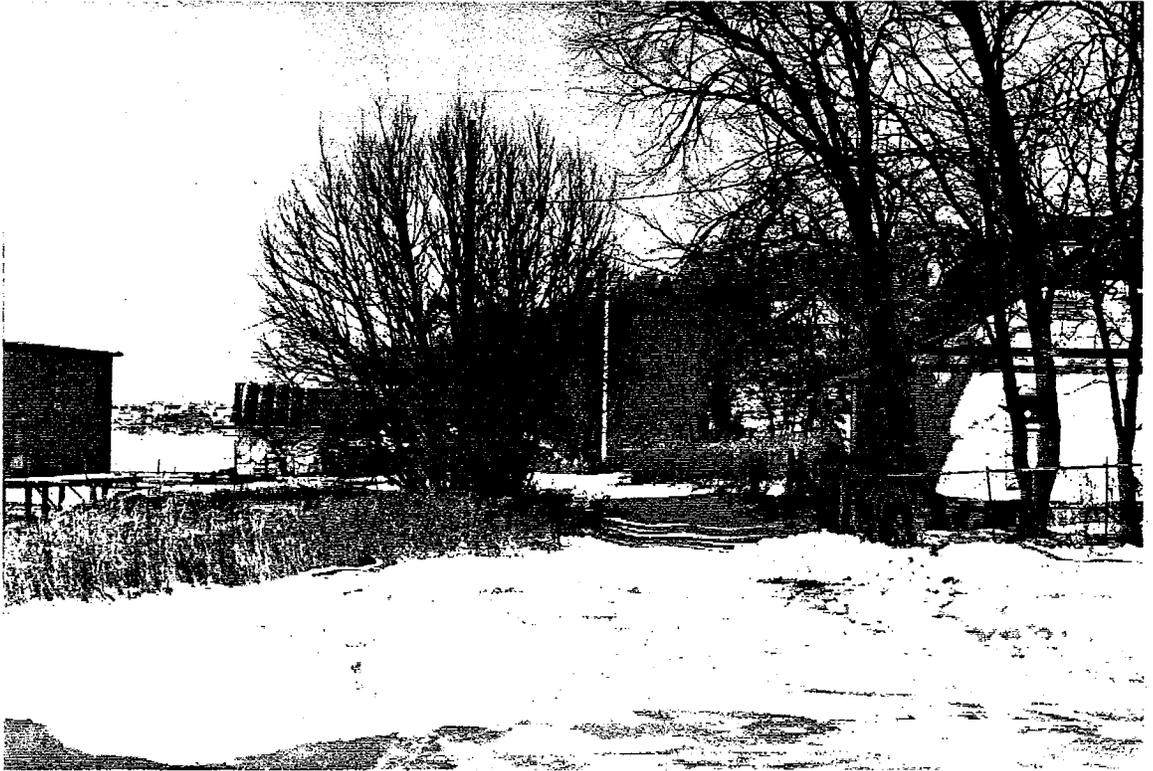
Landscape Unit 1

Native willows and wetland grasses mark the edge of the river and the extent of seasonal flooding.
