**The Barriefield
Heritage Conservation District
Plan Review**

**THE BARRIEFIELD
HERITAGE CONSERVATION DISTRICT PLAN**

PART II: APPENDICES

Prepared for
The Corporation of the
Township of Pittsburgh

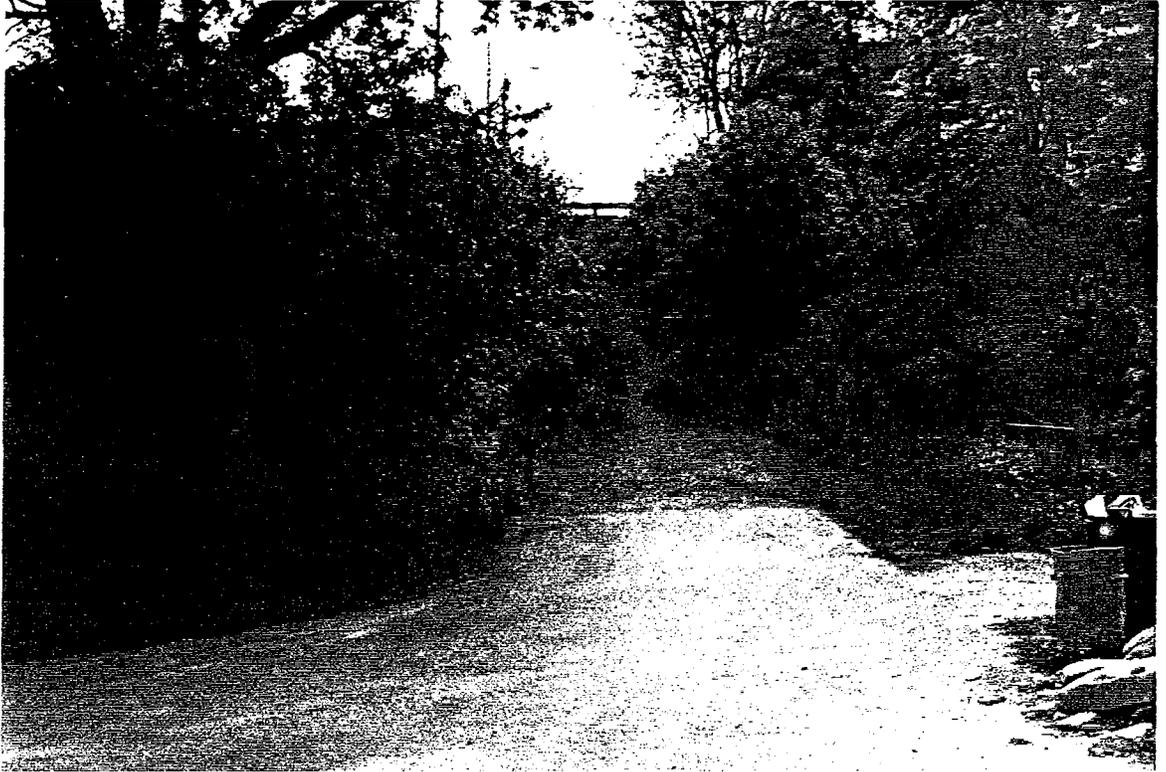
Landscape Unit 2

The Regent Street extension provides informal public pedestrian access to the river's edge.

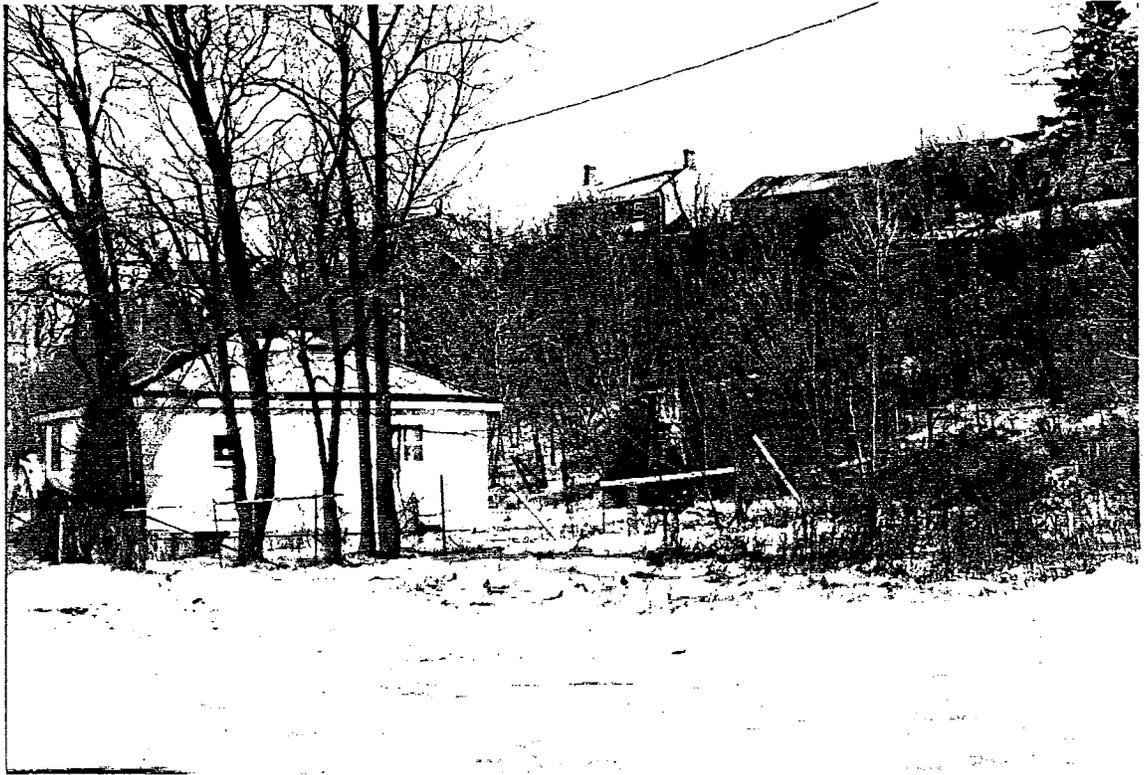
The long slope is visually prominent in winter.

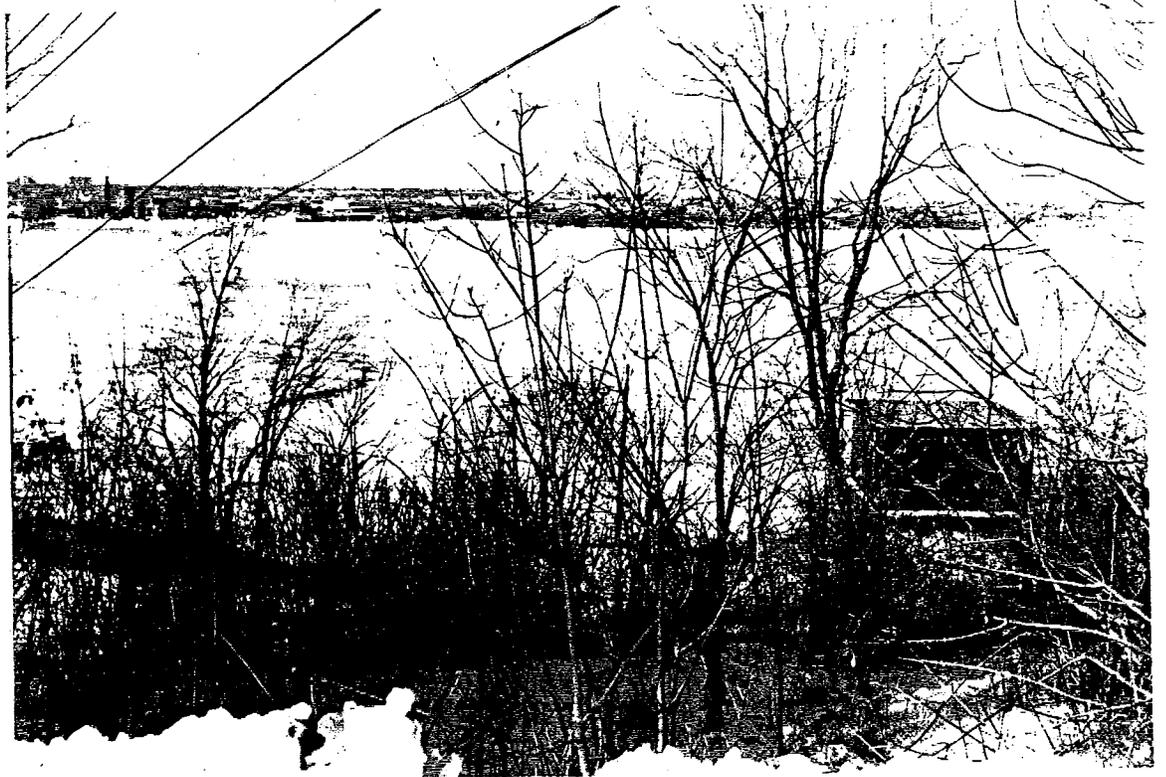
The foreground vegetation frames the distant view to Kingston.

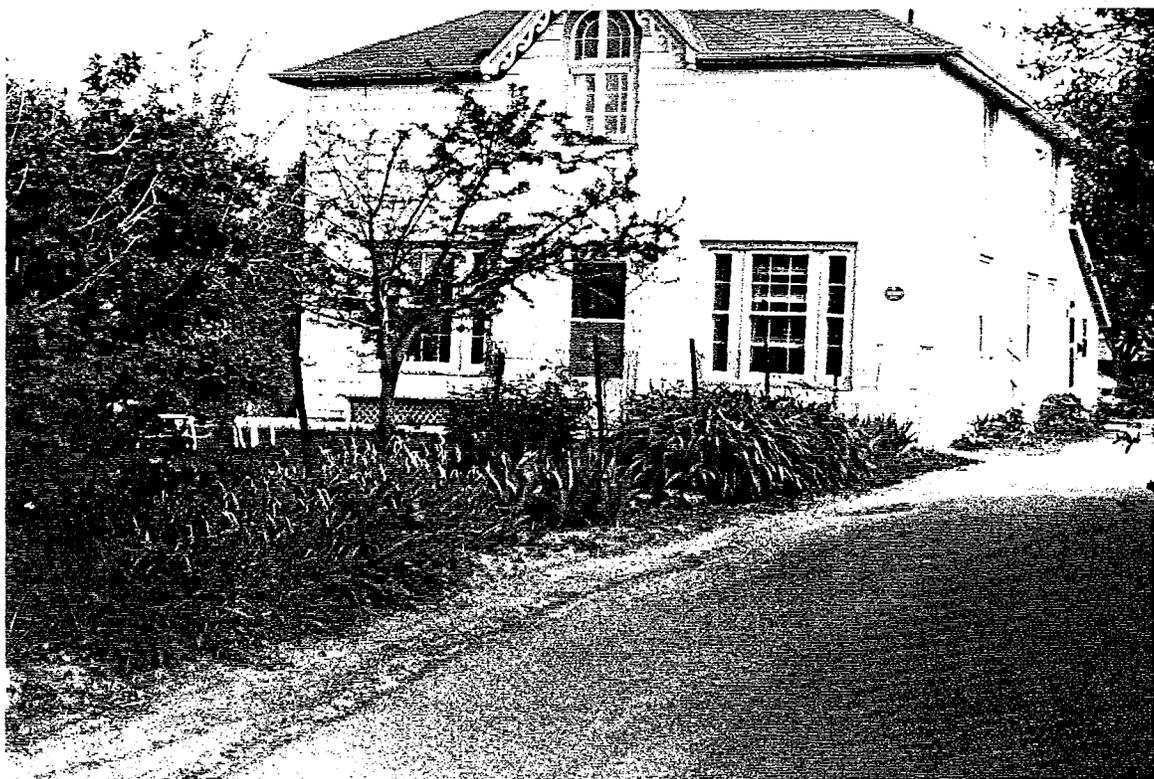
Landscape Unit 3

Perennial planting beds accent the intimate scale of Sharman's Lane.

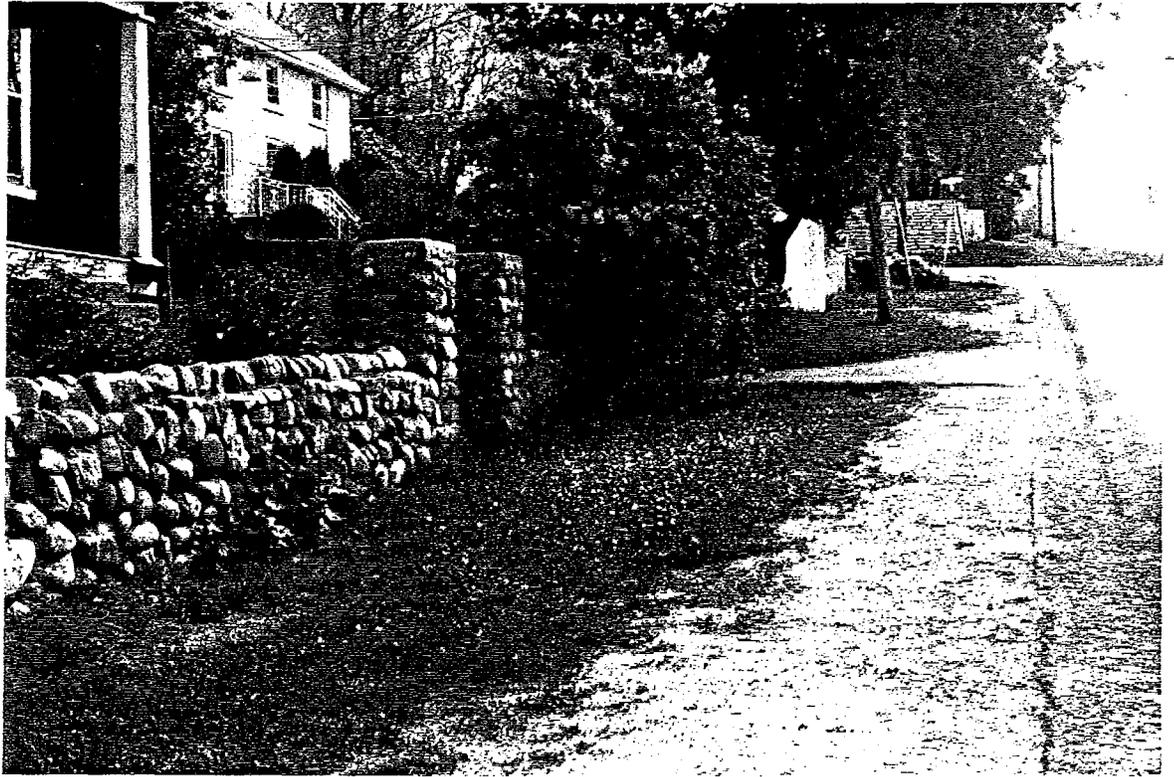
Stone fences and lilacs define the front property line. The uneven edge of the paving is a common feature of the village.

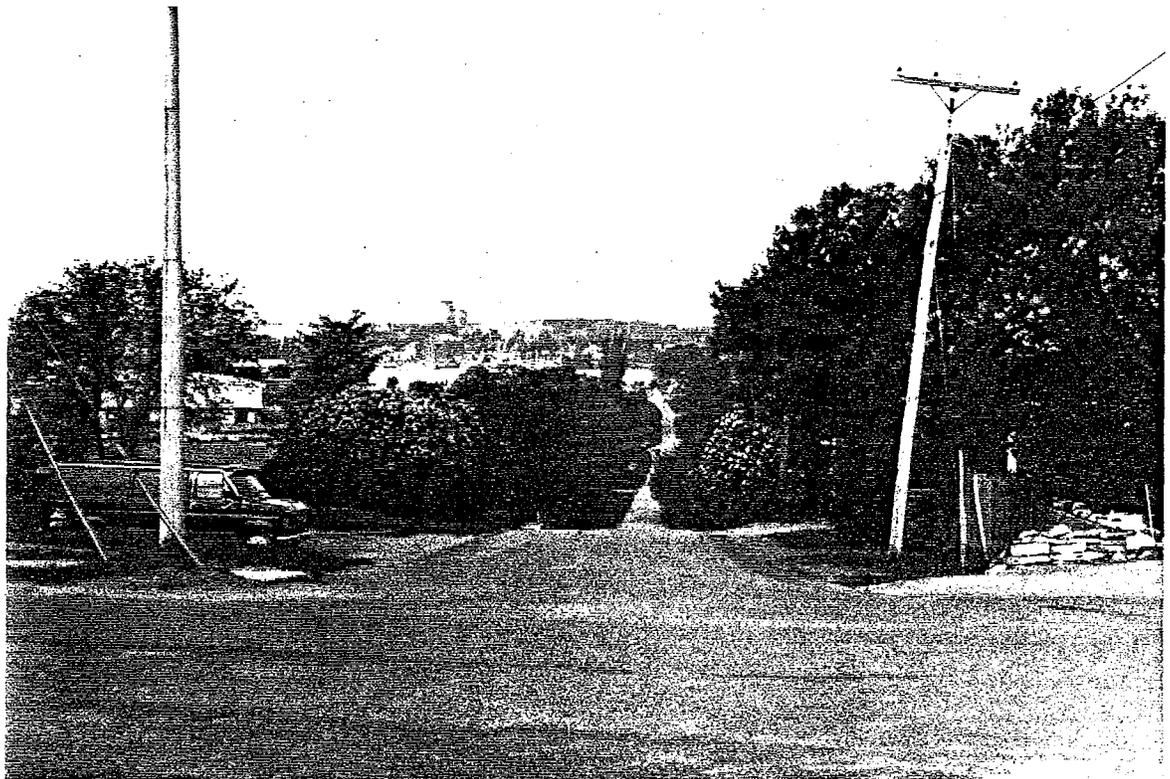
Mature lilacs along James Street frame the view to Kingston.

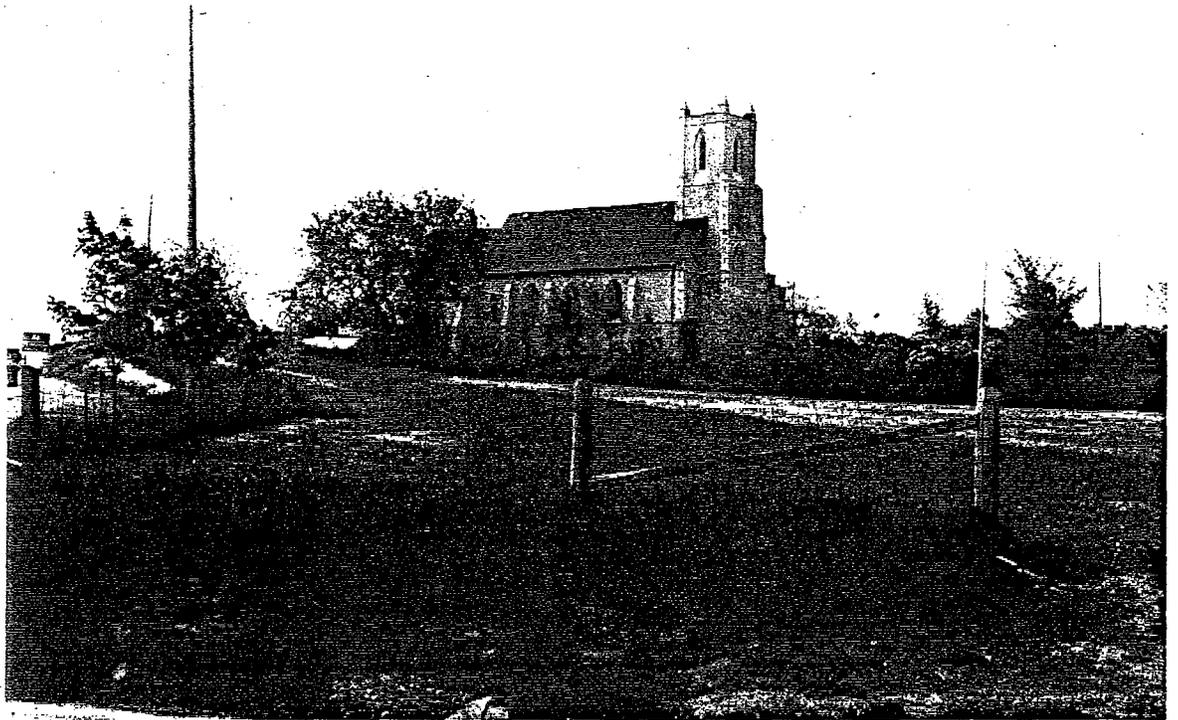
Landscape Unit 4

The church dominates the view from the northern approach in contrast to the open space in the foreground.

The most prominent building in the district, St. Mark's Church, is highly visible from a distance especially upon approach from Kingston. The open space surrounding the church contrasts with its immediate landscape setting which includes decorative stone walls and pillars marking the entrance and a grove of walnut trees at the road. These landscape features create an inviting approach to the church and are a distinctive landmark at the entrance into the district.

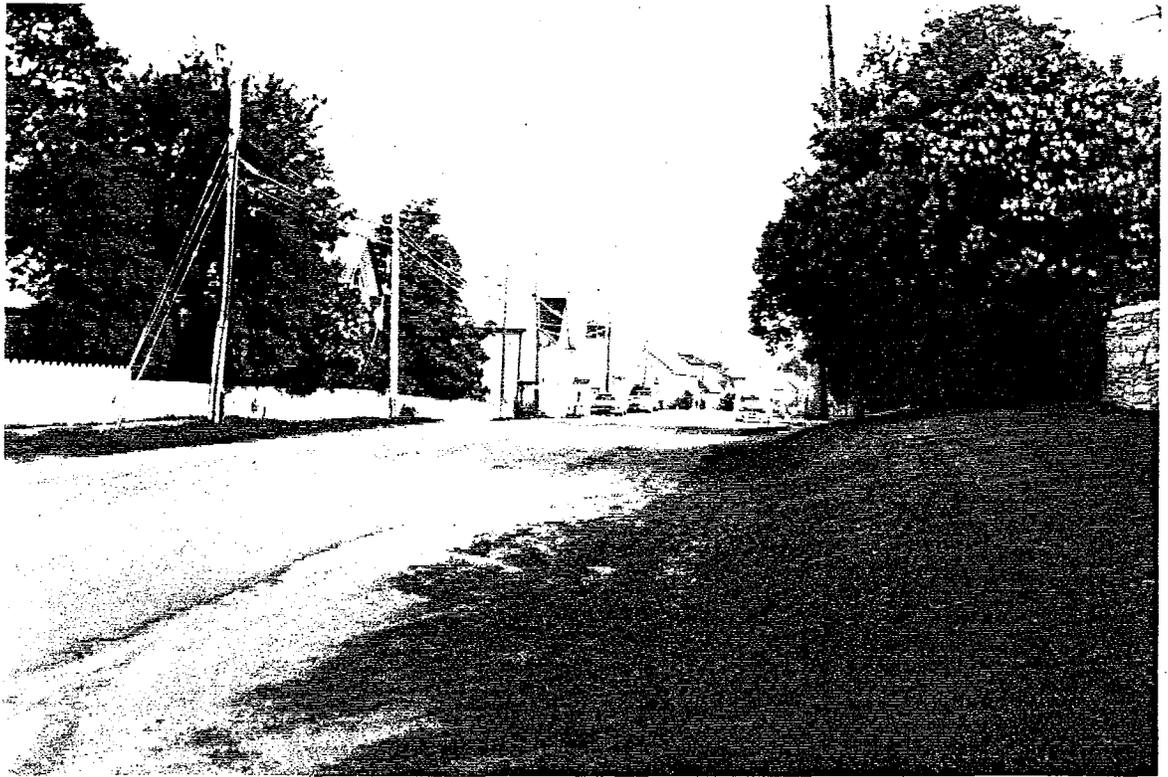
Landscape Unit 5

The lines of the property fences and mature trees and shrubs define the edge of Main Street.

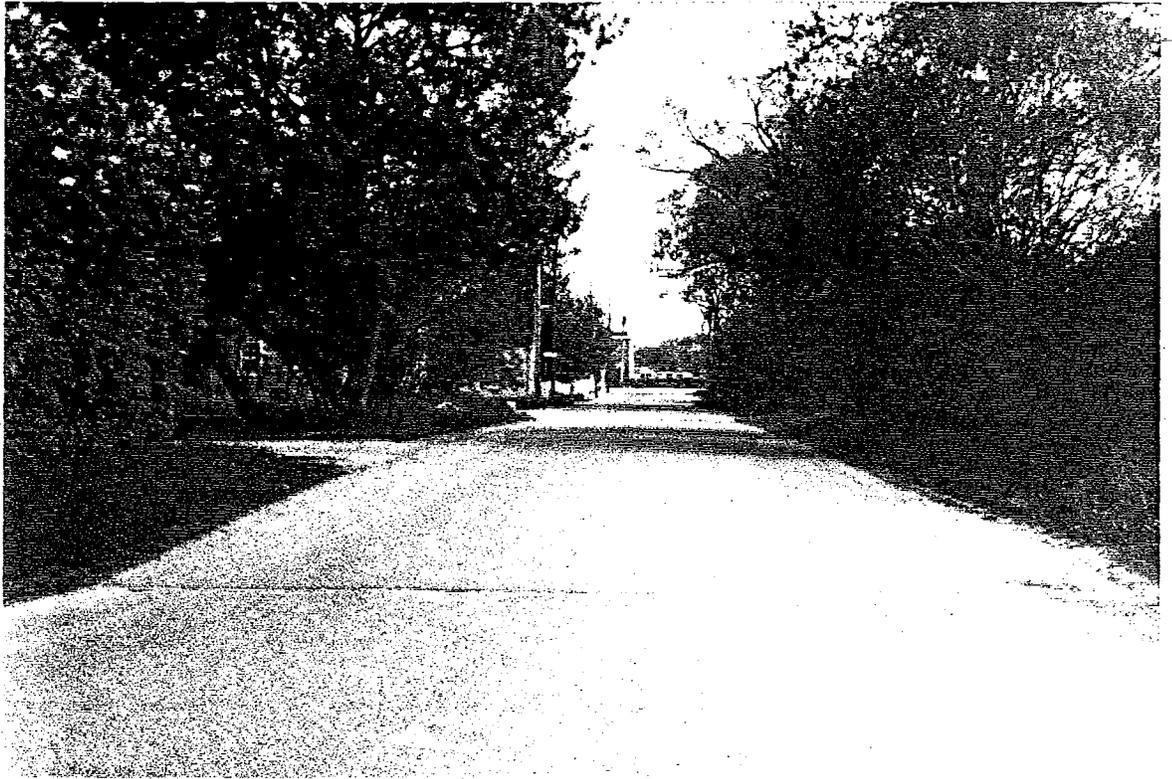
The mix of tree species and the grass-ditches are important features of George Street.

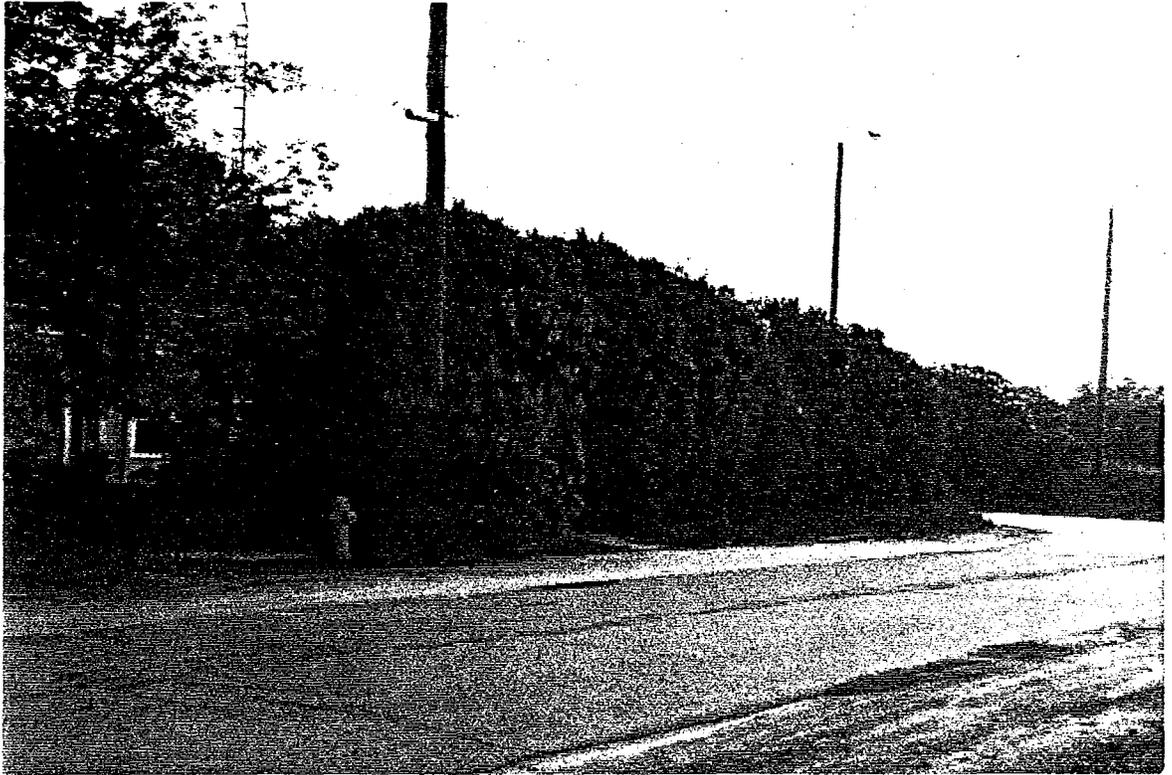
Glimpses of the front facades of the historic houses are made through openings in the hedgerow at the edge of the street.

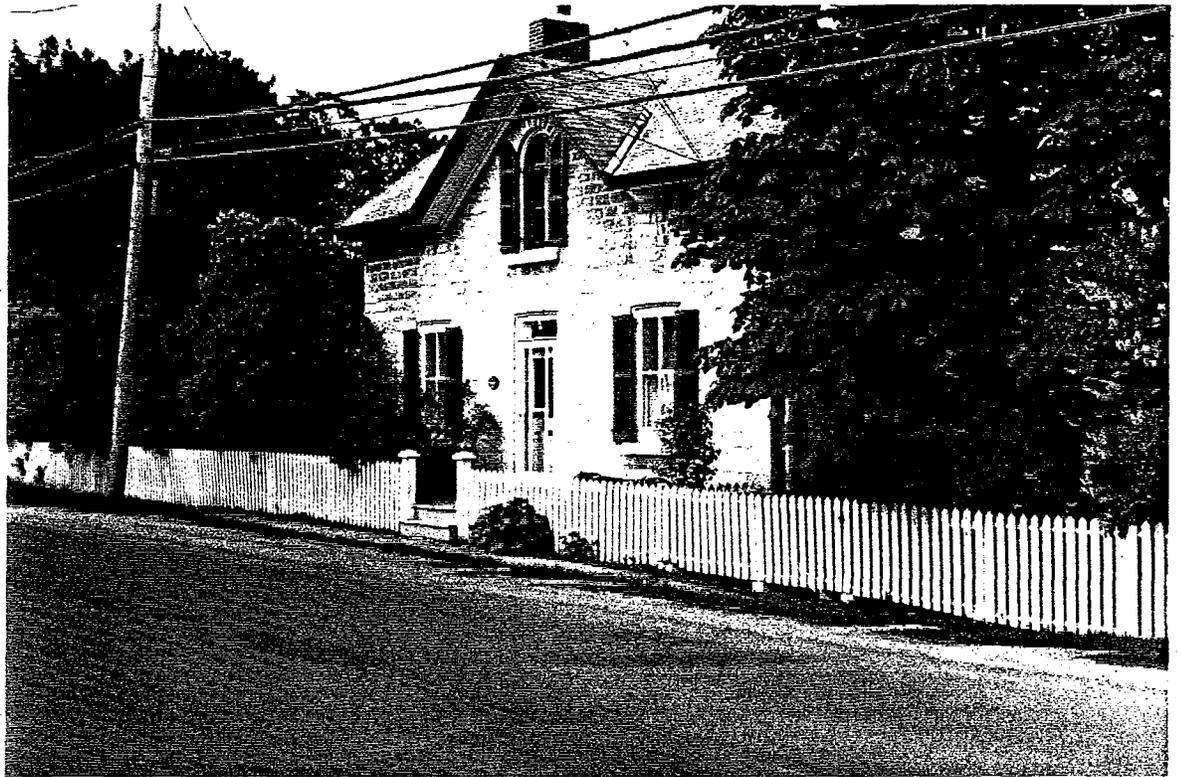
The narrow setback of the historic houses and the front yard fencing create a strong edge to the public space.

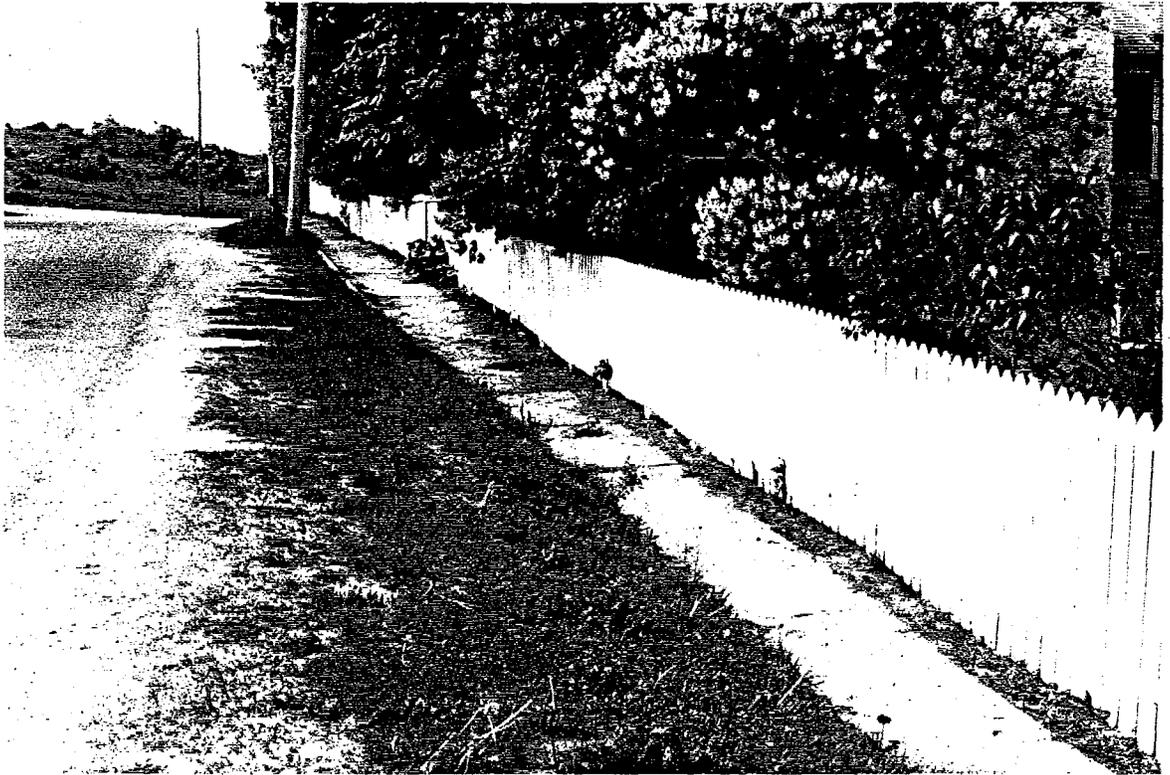
The uneven edge of the paving and the narrow sidewalk are important characteristics of Main Street.

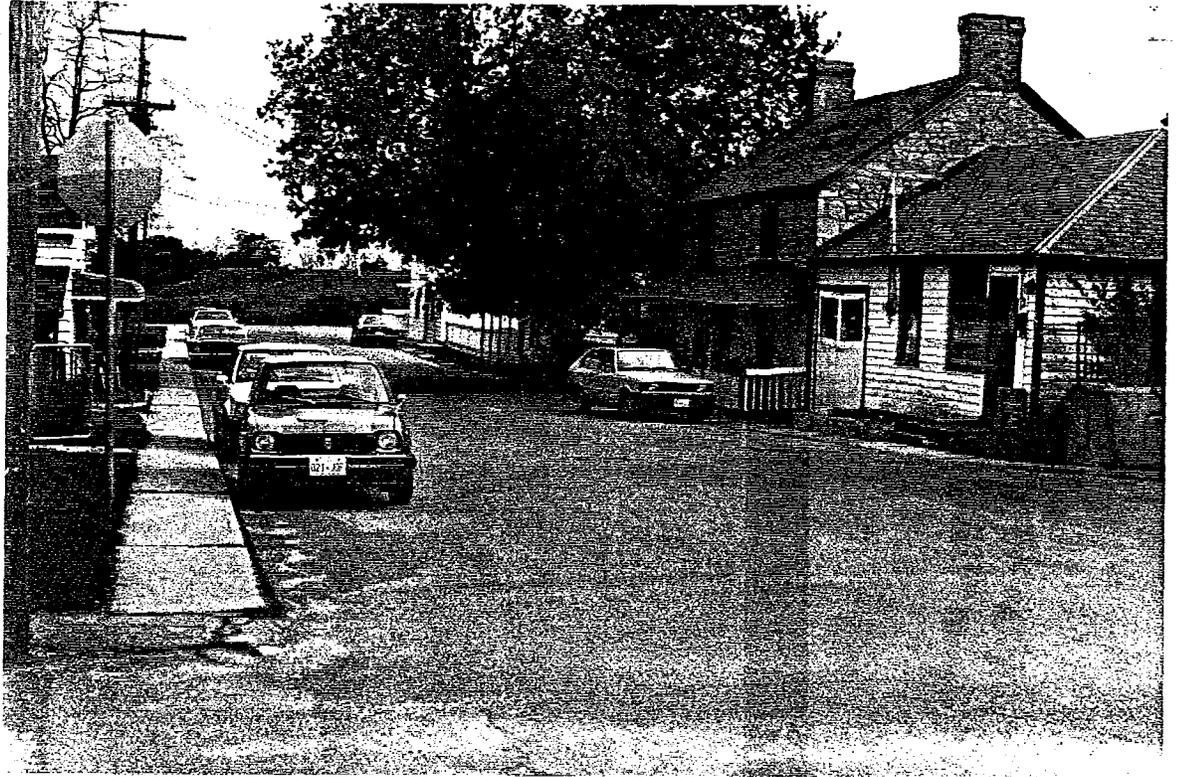
In the village core the building setbacks are minimal and the front porches become significant elements in the streetscape.

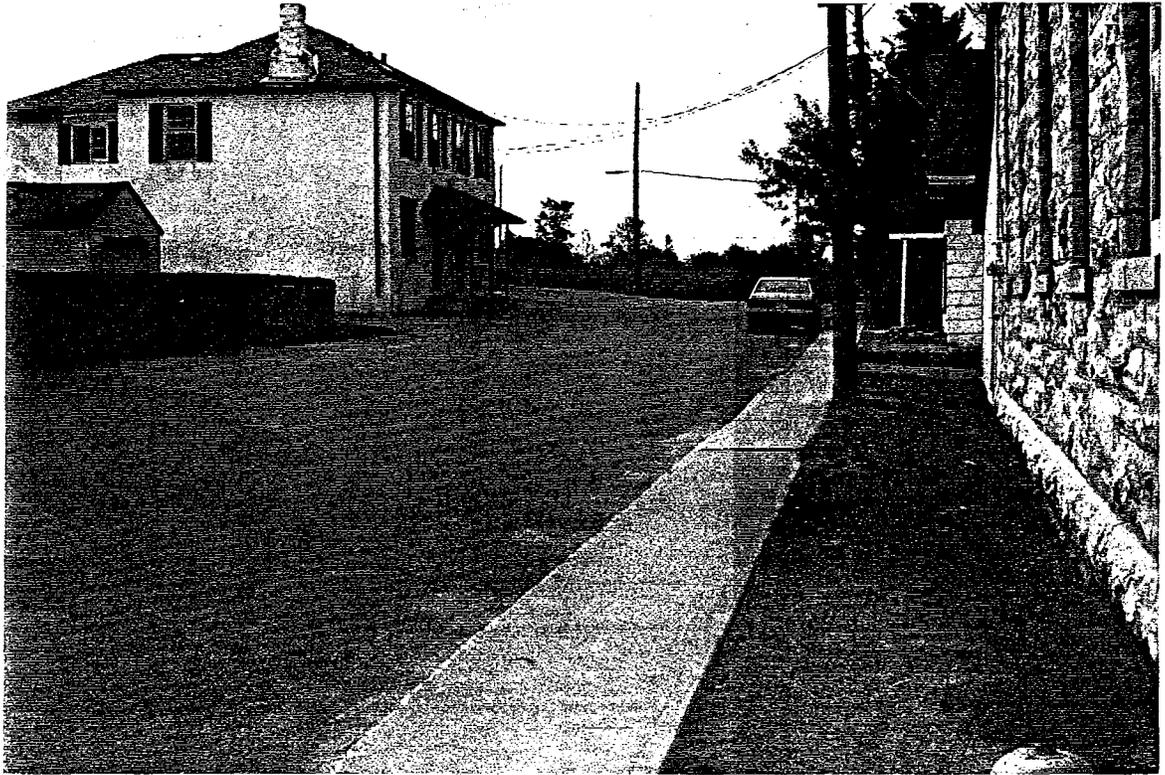
The corner of James and Drummond Streets lacks definition.

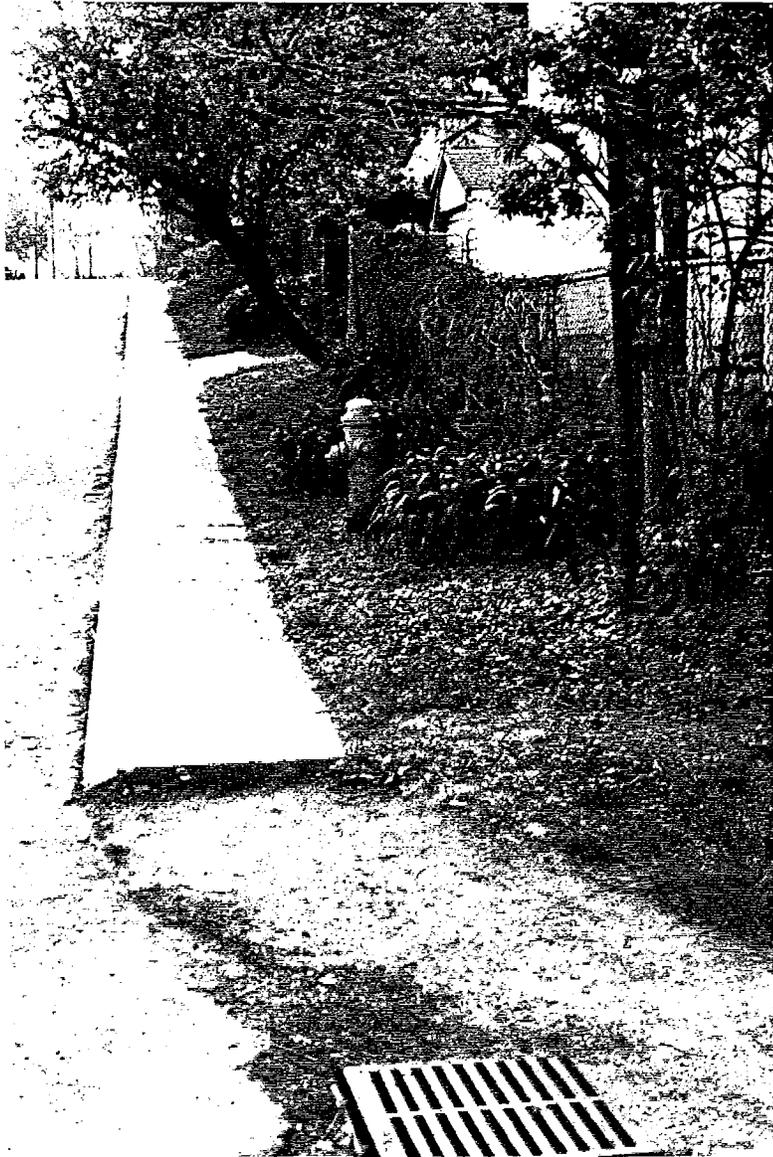
The proximity of fencing and plantings to the street reinforces the intimate scale of the district core.

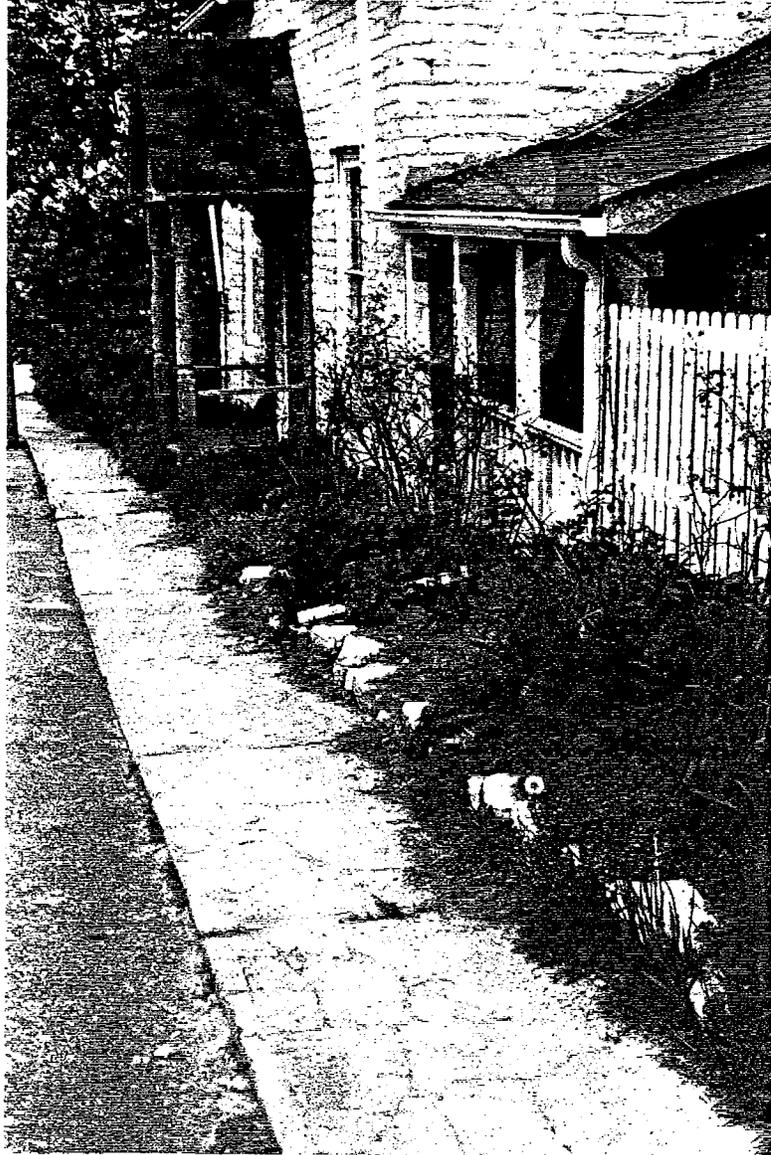
The soft planted edge of the private space creates a detailed foreground along the street.

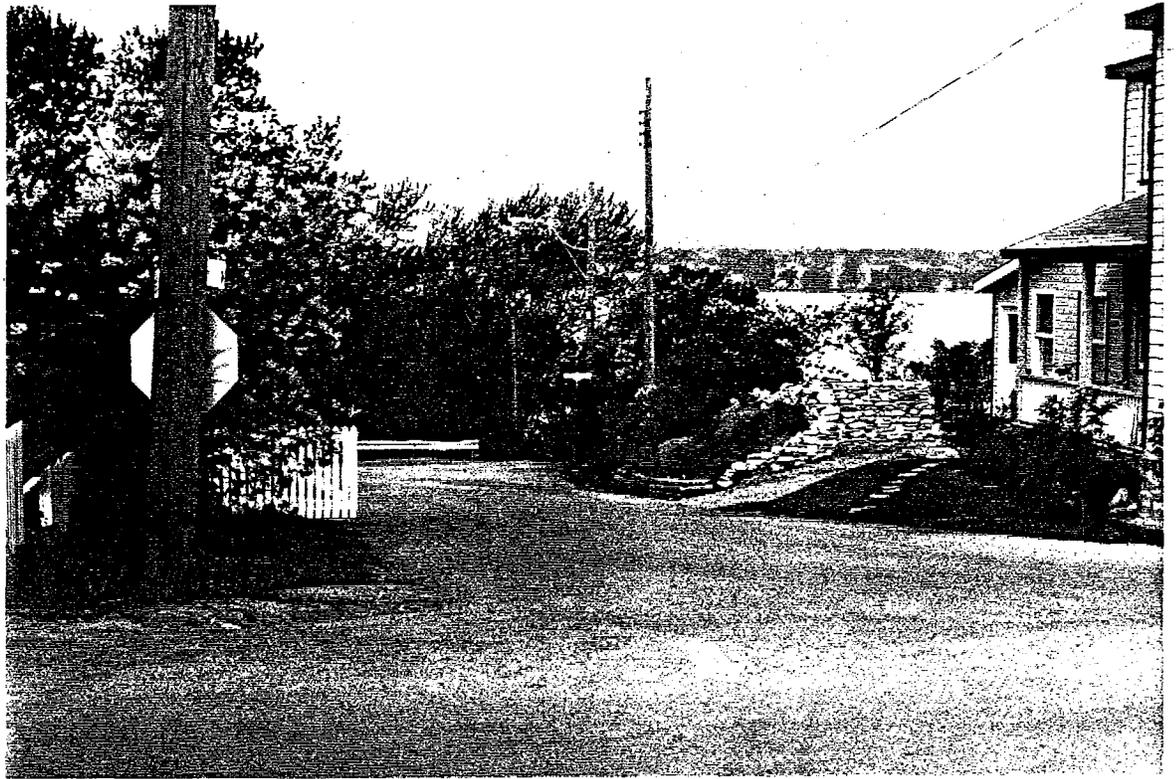
The Regent Street road allowance provides a visual link to the river and distant Kingston.

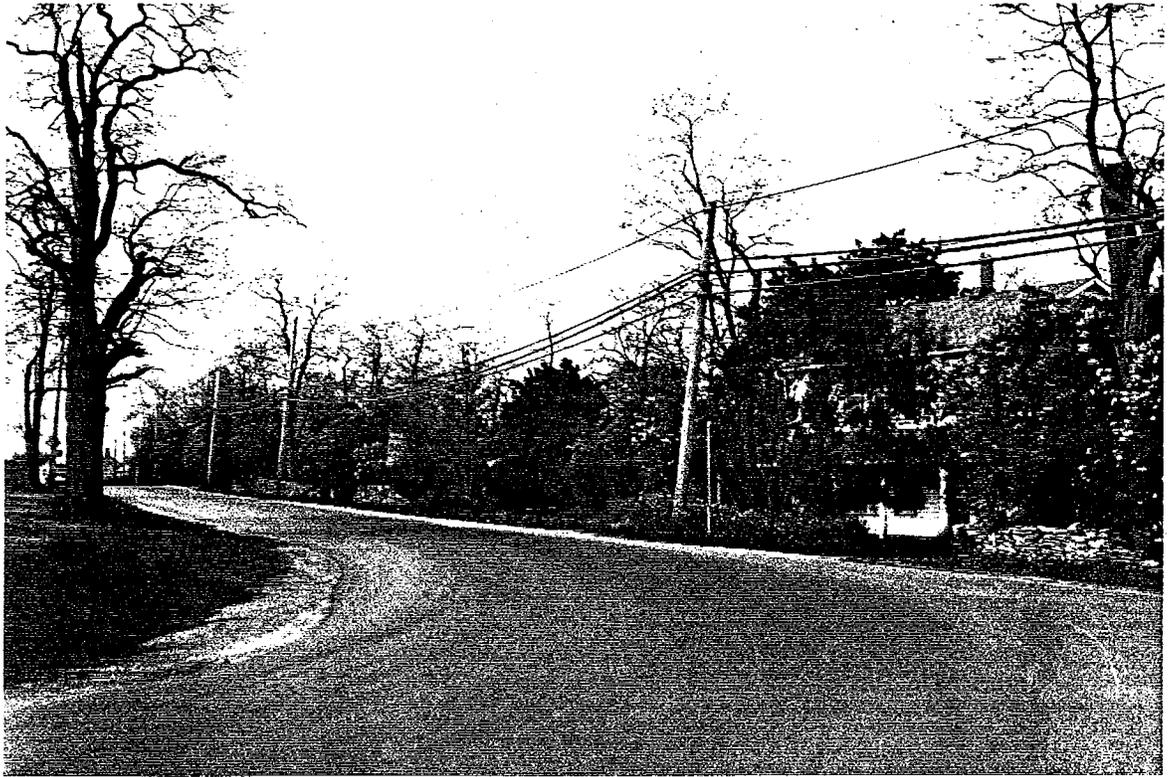
The northern entrance into the district is strongly defined with mature trees, shrubs and stone fencing.

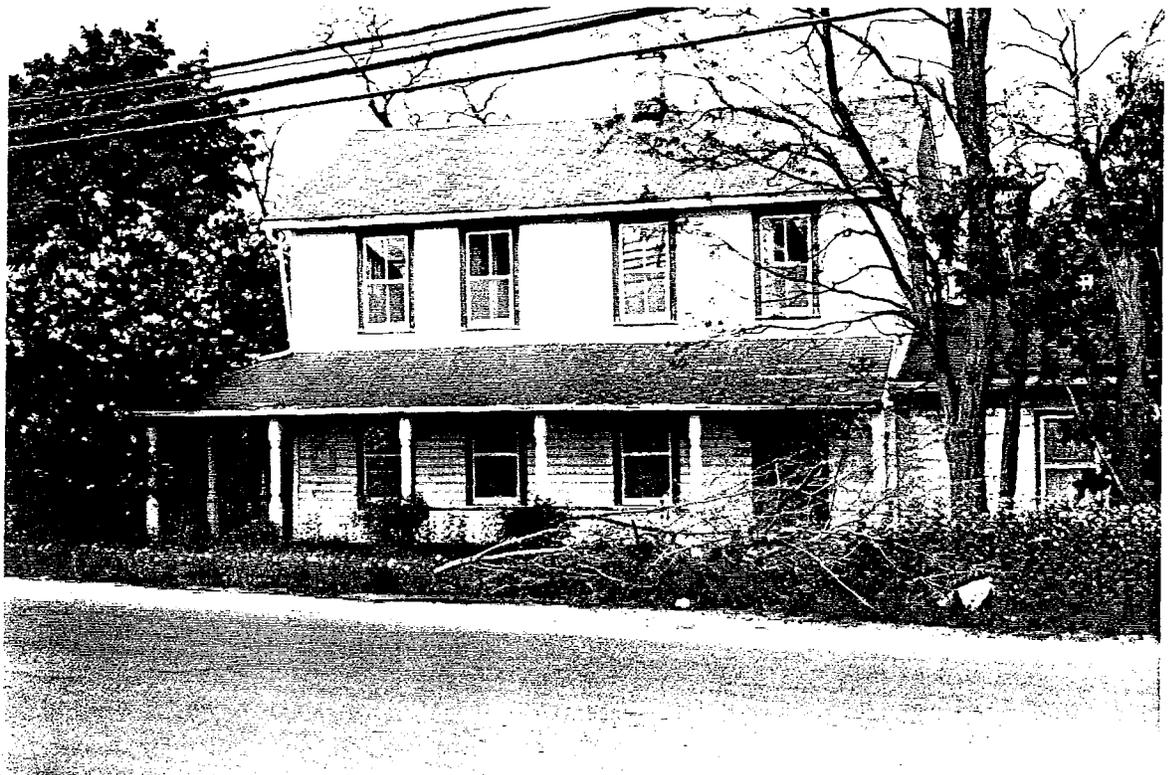
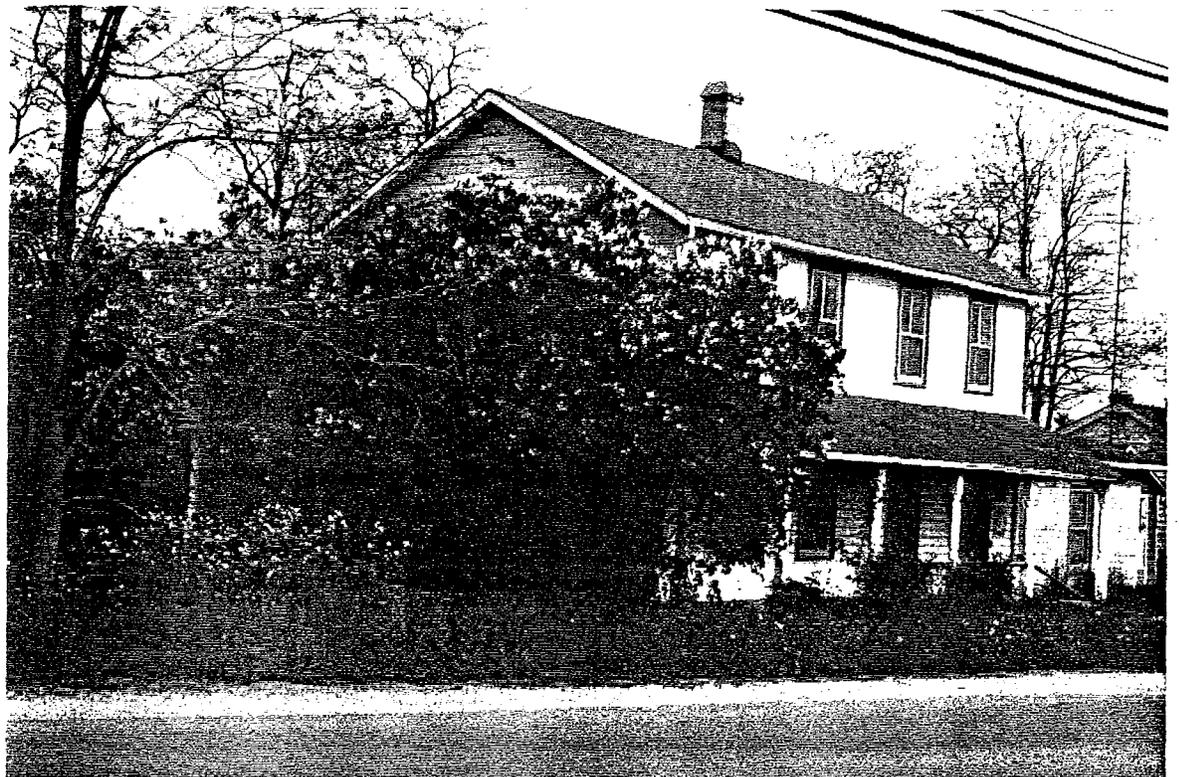
The landscape treatment of the front yard is characteristic of the late 1800s and is now an important historical remnant in the district. The yard was originally defined with wood and wire fencing at the street.

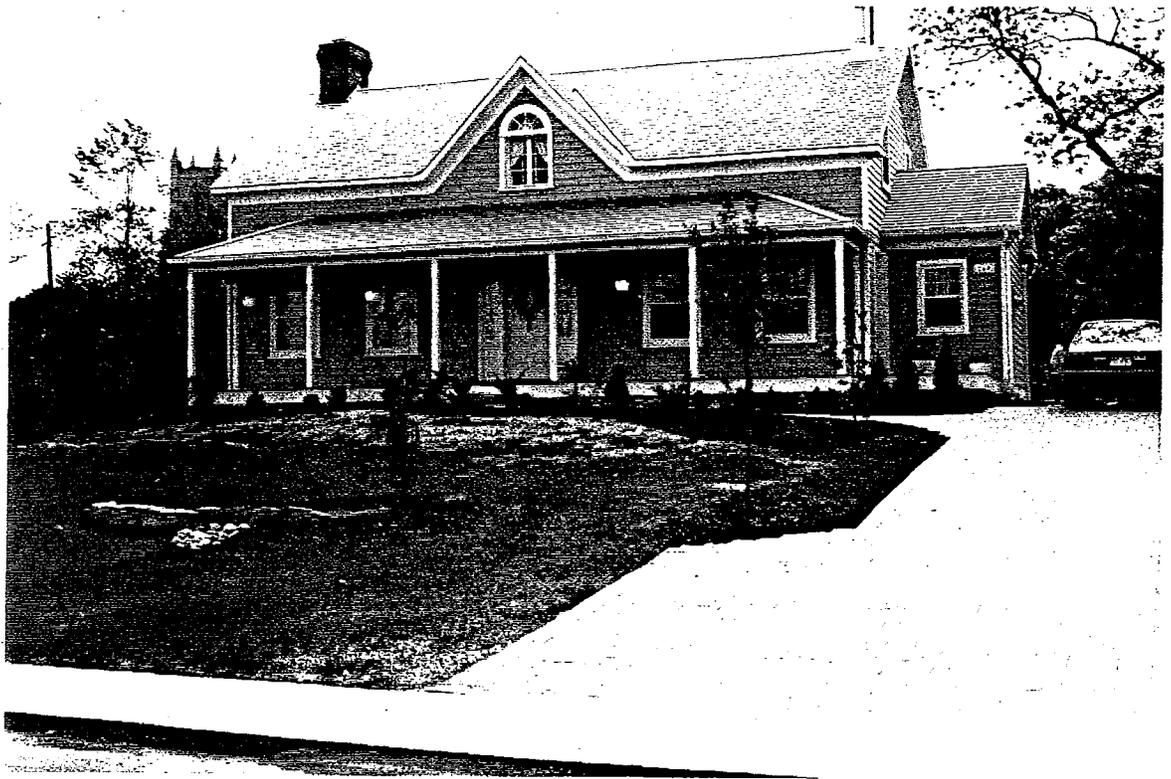
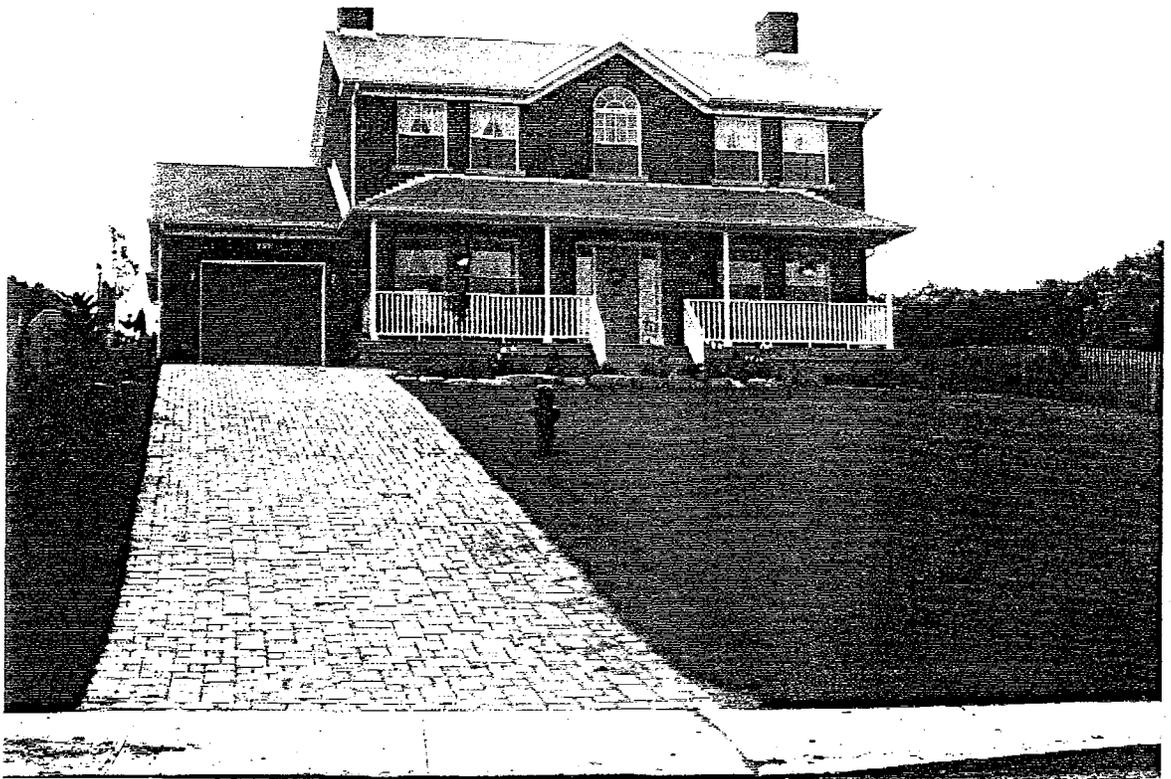
The modern residential landscape treatment consists of low foundation planting beds, deep open lawns and wide interlocking stone driveways. The entire facade of the house is visible from the street.

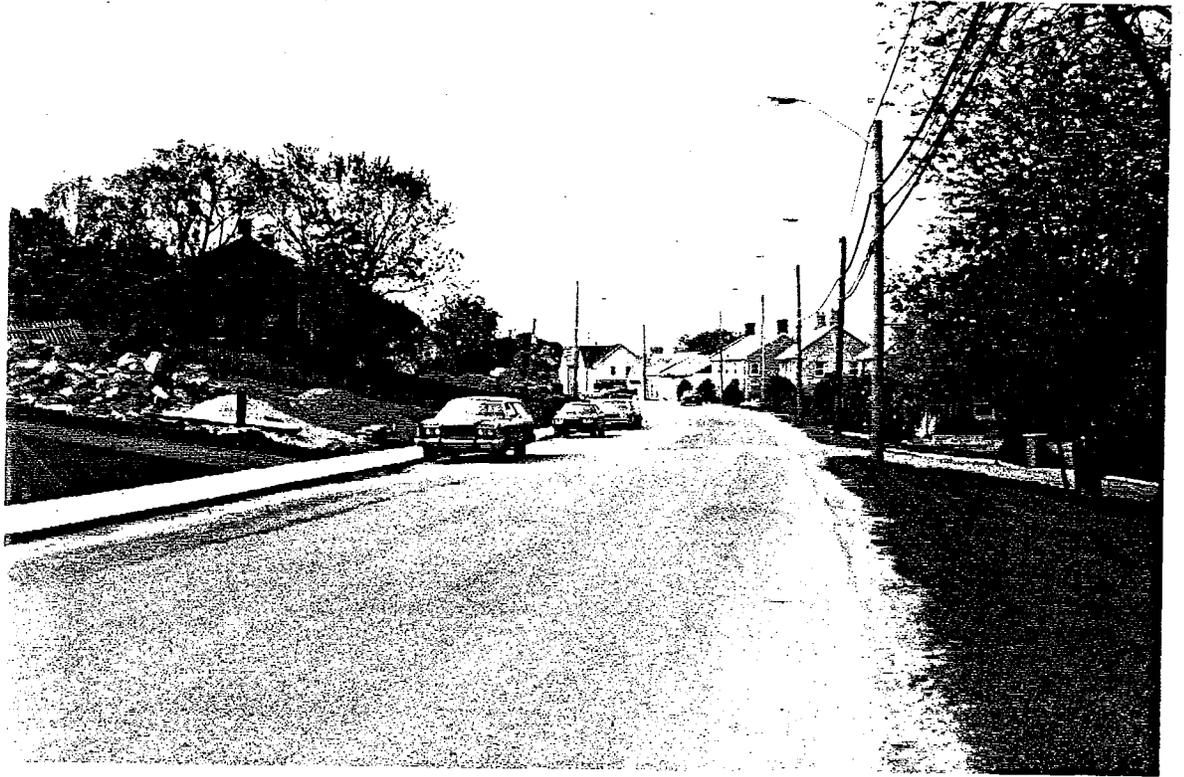
The east edge of the street is clearly defined by a curb faced sidewalk. The west side has an uneven border and is accented by mature trees and shrubs. The front facade of each residence is visible through breaks in the linear screening along the road.

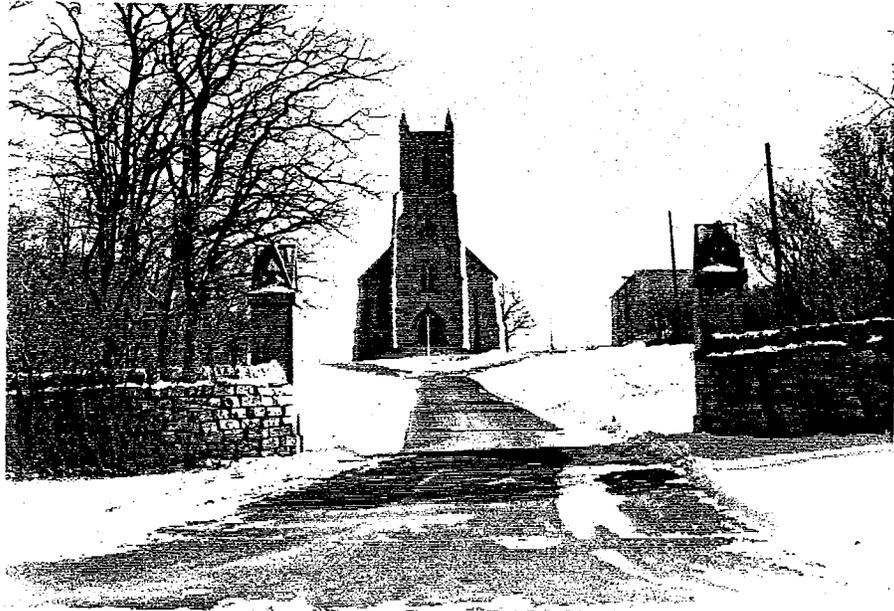
The slope of land and the surrounding open space reinforce the prominence of the church tower.

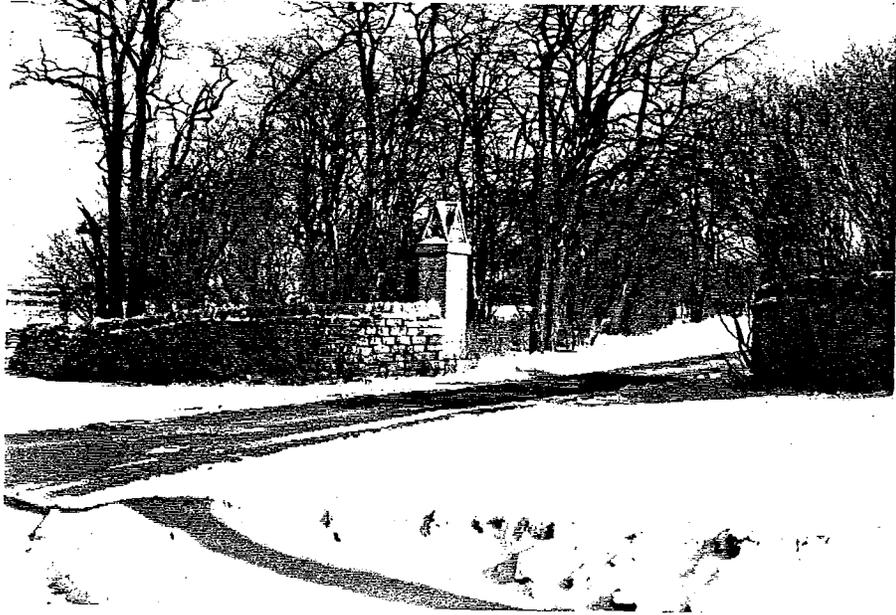
Together, the historic stone wall, pillars and nut grove constitute an important entrance feature.
