**The Barriefield
Heritage Conservation District
Plan Review**

**THE BARRIEFIELD
HERITAGE CONSERVATION DISTRICT PLAN**

PART II: APPENDICES

Prepared for
The Corporation of the
Township of Pittsburgh

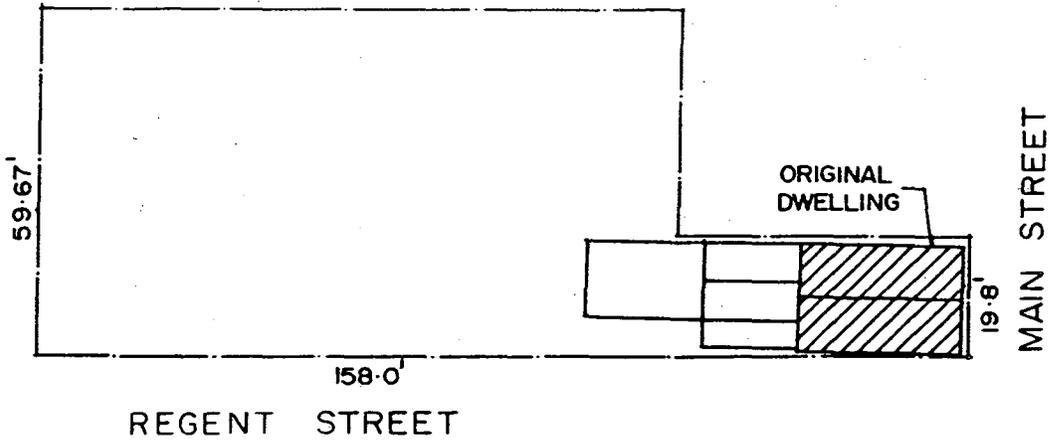
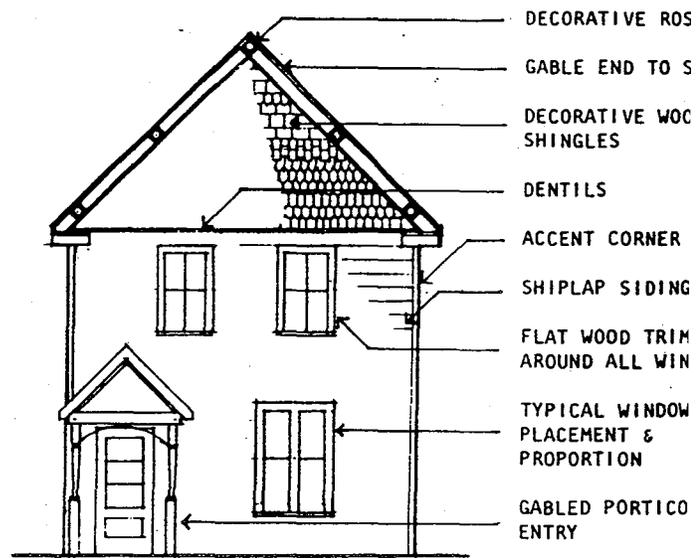
FRONT ELEVATION

The roofline of the first two storey addition, built in the nineteenth or early twentieth century, steps down from the original, and the addition is set back from the building face. These two factors distinguish the addition from the original building in a satisfactory manner.

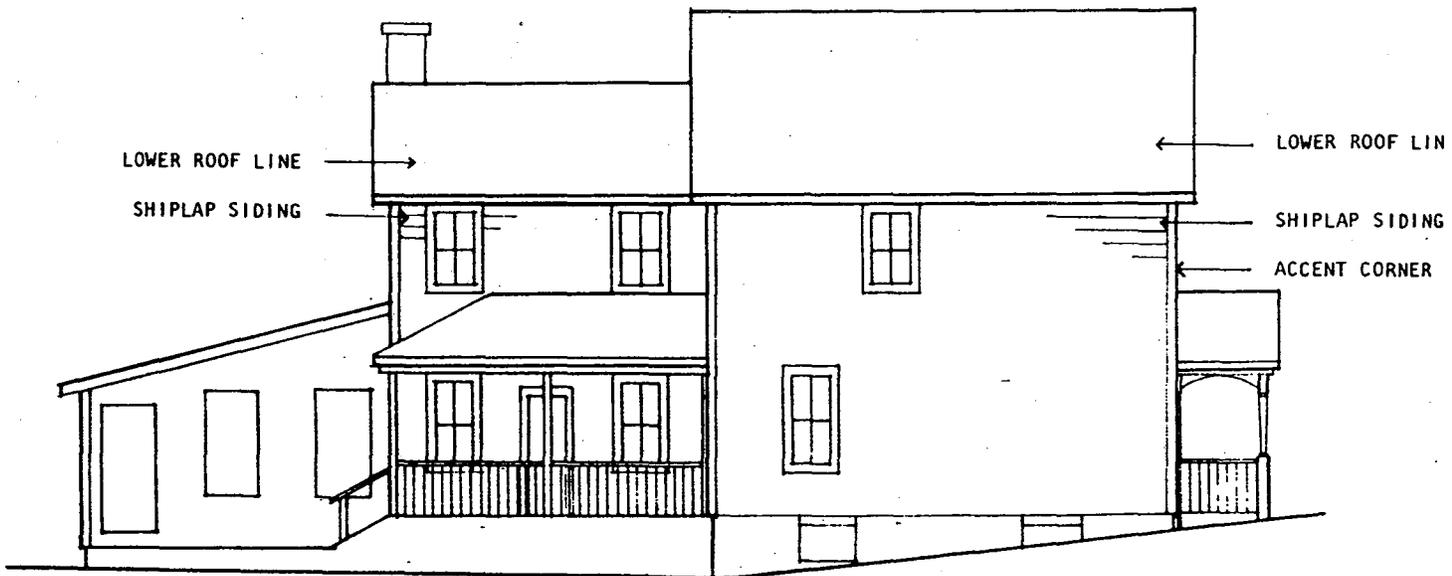
SIDE ELEVATION

The second one storey shed addition, built within the past year, steps down again to the rear of the building and is an acceptable form of addition, built in compatible materials, and simple detailing which does not conflict with the original building.

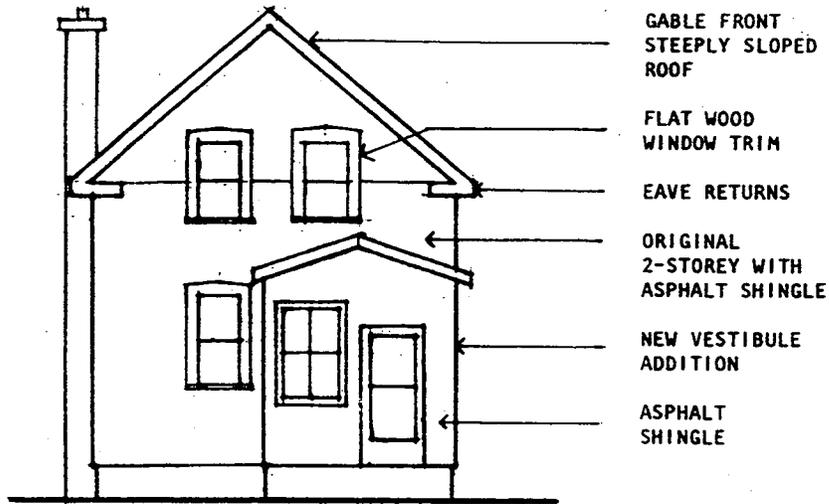
FRONT ELEVATION

Two frame additions have been added to the rear of the building. These "tail" additions are in keeping with the original building form. The roof steps down in two stages from the roofline of the original and therefore reduces the impact of the mass of the addition area. This is a satisfactory form of addition for this building type.

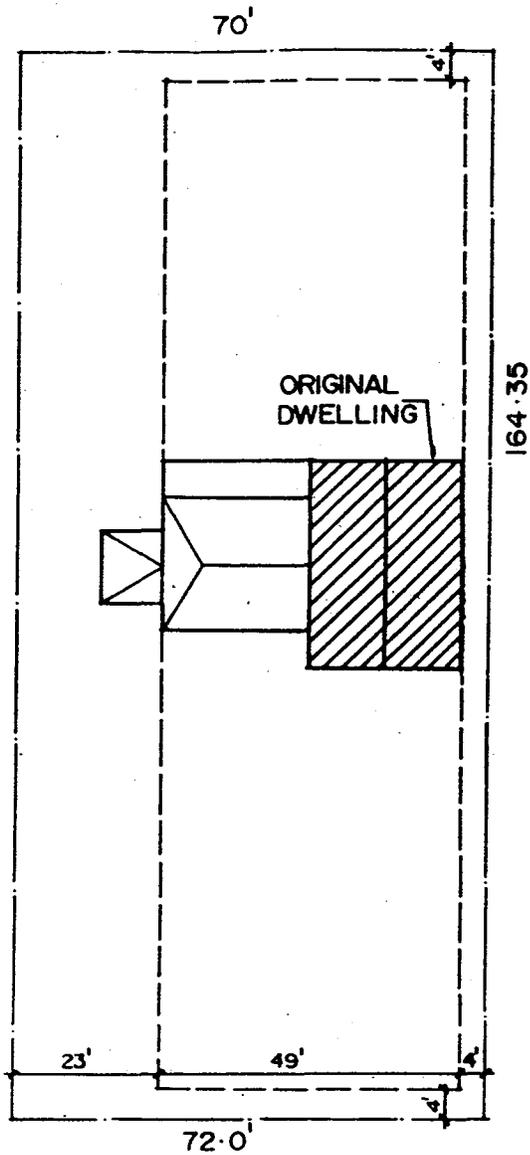
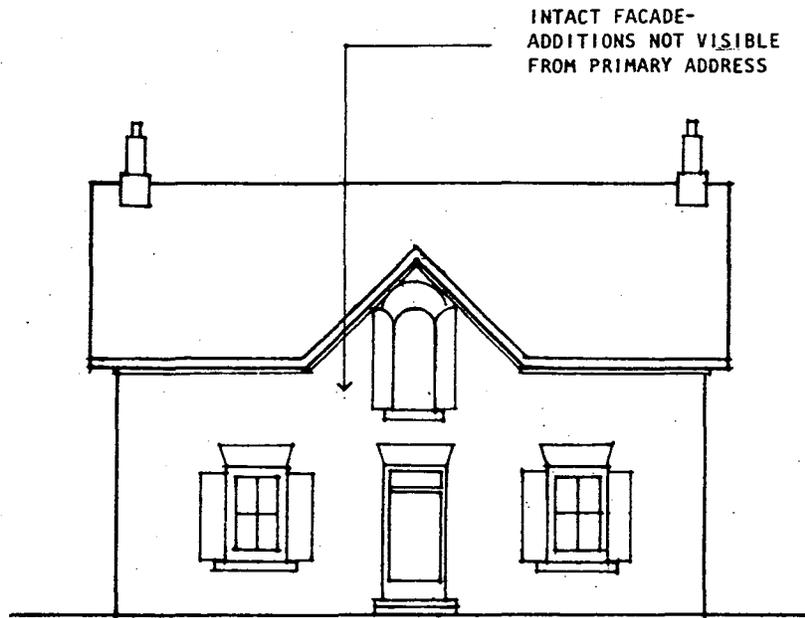
FRONT ELEVATION

The scale and overall massing for the additions do not detract from the original building, and make a positive contribution to the streetscape on regent street.

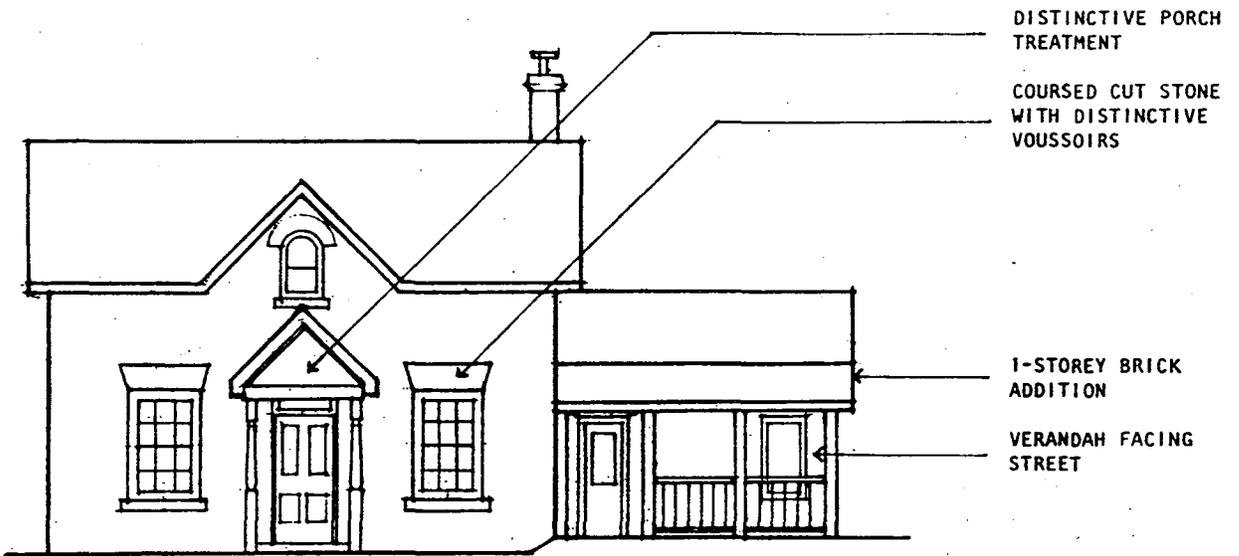
FRONT ELEVATION

- When it is not possible because of site restrictions to add to the rear of this particular building type, satisfactory additions may be made to the side walls of the existing building.
- It is always preferable to build to the rear of the existing building.
