## **Property Inventory Evaluation**

### **Bagot Street**

## Property Inventory Evaluation – Bagot Street

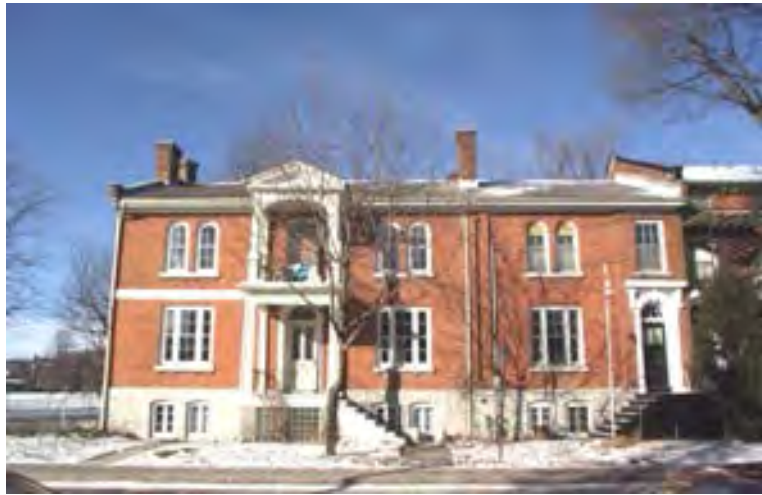
### 90-92 Bagot Street

The 90-92 Bagot Street building is a two-storey red brick double house built by architect William Coverdale in 1856. It is prominently placed on the north corner of Bagot and West Street, overlooking City Park and Queen's University. These buildings have physical/design value not only for their individual architectural elements, but also as a coherent whole. Coverdale's style is displayed through distinctive architectural hallmarks, including the use of roll mouldings and a detailed cornice with medallions. The units' first storeys have Venetian windows, while their second storeys contain pairs of round-headed windows. All sills have corbelled brick brackets. Segmentally arched windows are found in the building's high stone foundation, below the base course. The 90 and 92 Bagot Street units are divided by a pilaster with a central round-headed groove. Gable end parapets are found at each side of the roof.

The 90 Bagot Street unit consists of the building's left three bays. Its angled side wall is parallel to West Street. It has a central, semicircular arched entranceway containing a recessed door with a roll moulding surround. The central bay also has a two-storey frame porch with a classical entablature, which has a second-storey door providing access to the porch. Two pairs of brick chimneys sit at either end of the 90 Bagot Street unit. There is irregular fenestration with a small round-headed window under the gable peak of the West Street wall, angled to the street line. A three-bay, two-storey, flat-hooded brick wing extends from the unit's rear wall.

The 92 Bagot Street unit consists of the building's right two bays. This two-bay section is accessed by a doorway in the north-east bay, which has a small entablature hood-mould supported by consoles, and a single window in the second storey directly above it.

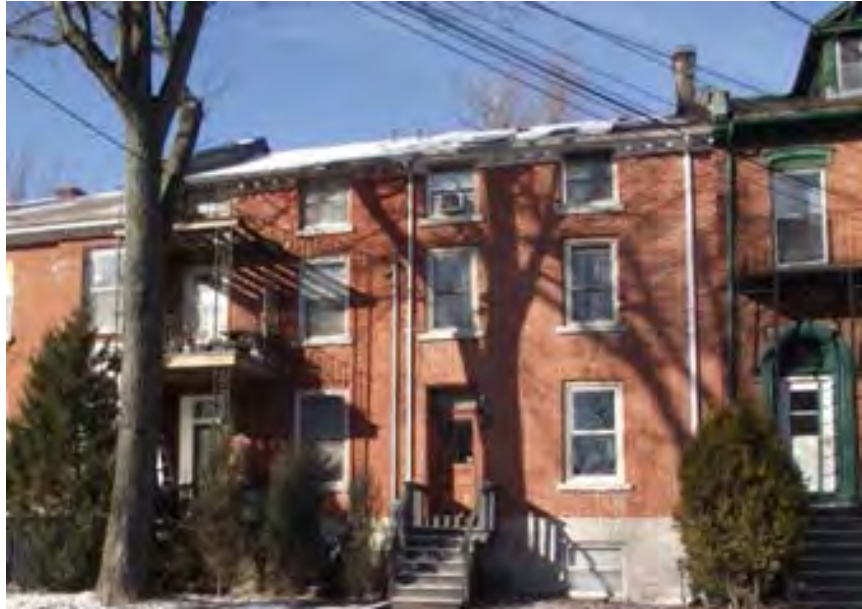
### 94-96 Bagot Street

The 94-96 Bagot Street building is a two-and-a-half storey red brick double house. This building has design/physical and contextual values owing to features that contribute to the longer row of buildings, running from 90 to 104 Bagot Street, of which it is a part. Its massing, setback and composition are compatible with these neighbouring structures. Each unit is two bays wide, with a recessed entranceway on its southwest bay. The entranceways are topped by rectangular transoms, and flanked by wood sides with recessed wood panels. The building's fenestration is rectangular and symmetrical, with tall openings on its first and second storeys. Squat windows are located in the northeast bays of each unit's stone foundation. Openings on their upper half-storeys are truncated at the building's roofline, breaking the flow of its bracketed wood cornice. The building was erected for dry goods merchant Patrick Harty, no later than the fall of 1859.\*

This half of the building contains simple rectangular balconies projecting from the second and upper-half stories of its southwest bay. These wood balconies feature iron balustrades and supports containing Greek key motifs.

The transom above the 96 Bagot Street entranceway door contains the unit's street number in gold. A modest brick chimney is located at the apex of its side gable roof, flush with a firewall belonging to the adjacent 98 Bagot Street building.

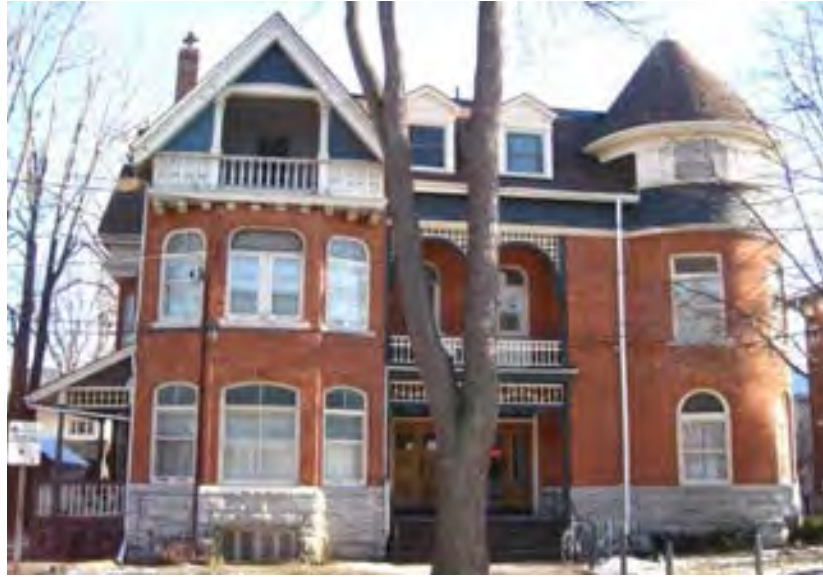
### 97-99 Bagot Street

Joseph Power of Power & Son called for building tenders for this double house in the June 12, 1890 *Daily British Whig*. The signed detailed drawings for “Semi-detached Residences on Bagot Street for Messrs R. E. Kent & W. MacNee” are in Queen’s University Archives.\* This building is of design/physical value for its high-quality design. The architect has captured variety by contrasting the forms of each half of the building, while retaining harmony through the use of red brick walls, grey course limestone and painted wood trim. The style is typical of the very late 19<sup>th</sup> century, with aspects derived from the British Queen Anne style. The 97-99 Bagot Street building has historical value as a fine example of the Power & Son firm’s work. It has contextual value because of its significant visual contribution to the streetscape.

This half of the house is dominated by a two-storey bay window surmounted by a frame gable with a recessed balustrade balcony, partly supported by brackets. The generously sized windows permit a minimum of solid wall. To one side is a wooden verandah with spooled trim, while on the other side (in the house’s centre) is a two-storey recessed verandah shared with 99 Bagot Street. It is well ornamented with spooling. On the roof over this centre portion is a pair of gable dormers – one for each half of the house.

In contrast to 97 Bagot's bay window, 99 Bagot features a round corner tower topped by a conical roof, under which is a partial ring of windows. Noteworthy are the decoratively treated shingles, curved rectangular and round-arched windows with stained glass transoms in the tower, and well crafted brickwork. The verandah on one side lacks the ornamental treatment found on the side verandah of 97 Bagot.

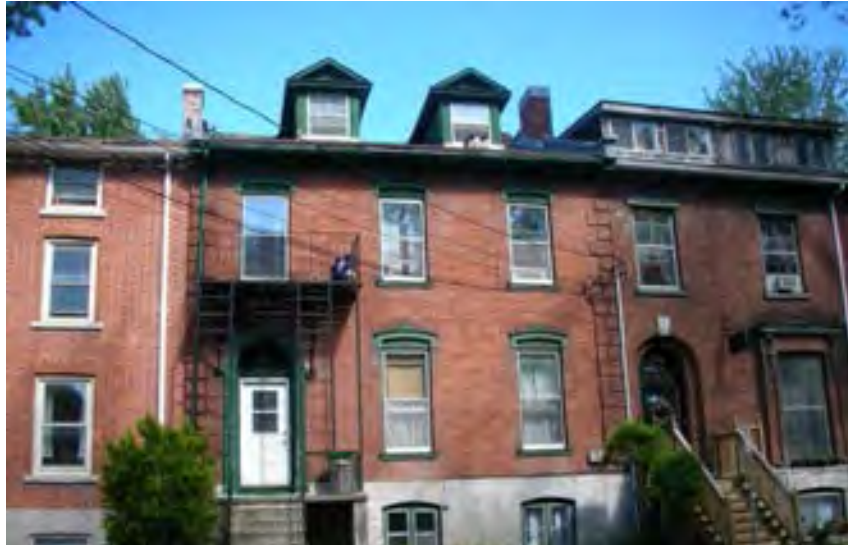
### 98 Bagot Street

The façade of this building dates to at least 1873, when hardware merchant Edwin Chown had the adjacent 100-104 Bagot Street buildings erected, with which this building's style coheres. Chown and his family were living in a house on this property no later than the fall of 1859, but it is not known whether the present structure incorporates part of the earlier one, which was setback further.\* The Chown family gained a reputation in Kingston as prominent hardware merchants, and as proprietors of a local foundry, which contributes to this structure's historical value. The 98 Bagot Street building has physical/design value for its modest use of ornate elements, complementing its otherwise basic design. Its contextual value derives from the integration of its design with the 100-104 Bagot Street units, and because of its massing, setback, and composition are compatible with the larger row of buildings, running from 90 to 104 Bagot Street, of which it is a part.

The 98 Bagot Street building is a three-bay, two-storey brick structure. It is separated from adjacent units by brick quoins of alternate widths. The building's front entrance features roll moulding, and a half-round transom. The entrance is recessed behind a rounded brick arch with a decorative keystone. Slightly arched windows in the building's foundation contain paired 1/1 windows, divided by a simple mullion. Two dormers with plain pediment tops and simple pilasters project from the roof. The building's remaining fenestration is consists of tall, rectangular and symmetrically-placed windows. Hoods above each of these windows feature elaborate floral designs.

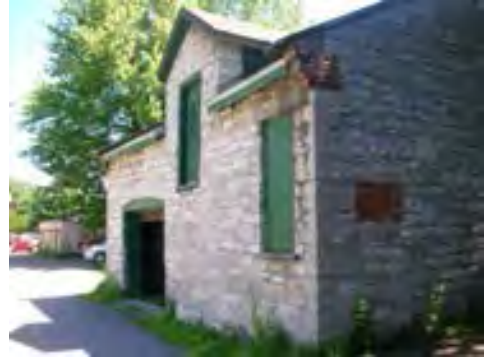
### Coach House (Lily Lane):

A one-and-a-half storey coach house is located behind the building, facing the Lily Lane. This building's two stone walls face the alleyway and West Street. Its other walls are brick, indicating that the original stone structure was once expanded. The alleyway façade of this building contains a wide vehicle door with stone voussoirs. It has a side-gable roof, with a projecting gable-roofed dormer that contains a wood-plank door with wood trim. The West Street side of the building contains an additional, tall and rectangular window-opening that has been boarded-up. A firewall is located on each side of the building, which was once adjacent with other outbuildings along the alleyway. This building appears to be different from the one indicated on Brosius' 1875 map. It does appear on a version of the 1892 Fire Insurance map of Kingston, which was updated in 1904.

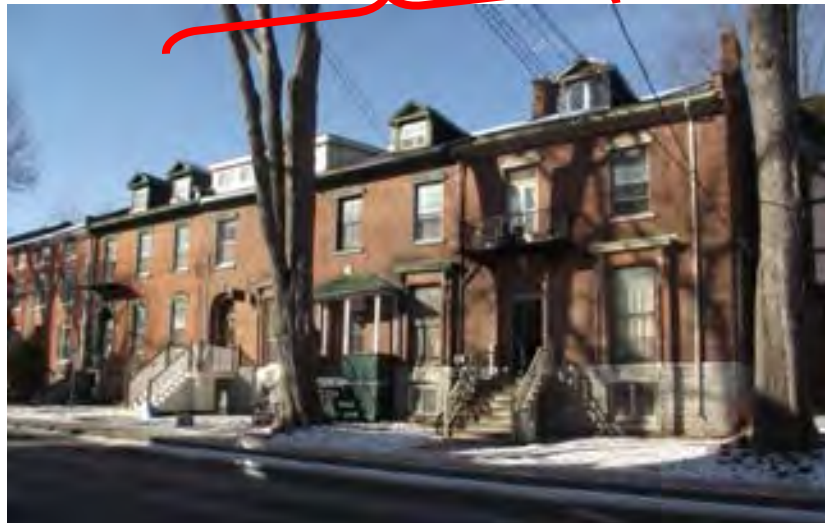
### 100-104 Bagot Street

The two-bay, two-and-a-half storey brick buildings at 100, 102 and 104 Bagot Street are collectively known as Park Place. This name dates to at least 1904, but may have been adopted as early as 1873, when hardware merchant Edwin Chown had these buildings erected.\* They have physical/design value for their individual architectural elements, and as a whole. Their contextual value derives from their coherence with the adjacent 98 Bagot Street building, and from their compatibility with neighbouring buildings. The composition, setback and massing of 100, 102 and 104 Bagot compliment that of the larger row of buildings, 90 to 104 Bagot Street, of which they are a part.

The front entrance of each unit is located on its southwest bay. They feature half-round transoms and are recessed behind two-tiered brick aches with decorative keystone. Each northeast half contains a slightly protruding rectangular bay window, containing a large, 2/2 full-height opening. These are topped by shallow roofs with simple wood entablatures, supported by tall scrolling brackets with floral motifs. They bay projections extend to grade through their stone foundations, which contain wide, slightly arched basement windows. Each of the unit's second-storey windows rests on an ashlar sill. They are topped by peaked hoods with winged and circular designs. Above these windows, a row of wood brackets support the roof's overhang.

A full-width dormer of no heritage value spans the roof of 100 Bagot Street.

The 102 Bagot Street unit had a wood porch which covers the building's arched front entrance. Its transom has been removed and/or covered by this structure. A gable dormer with a wide opening and flanking pilasters is located over the northeast bay.

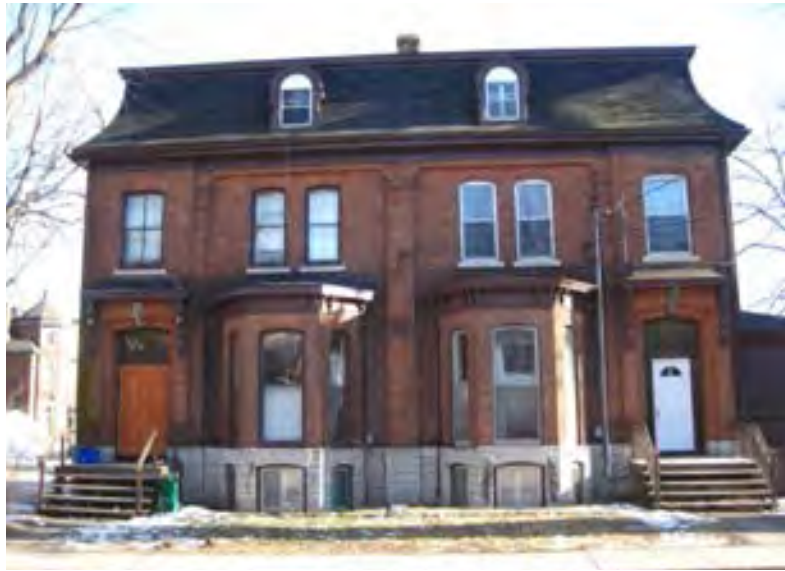
### 107-109 Bagot Street

The studied symmetry of this double house, once known as Wellesley Place, is in marked contrast to its immediate neighbour built almost twenty years earlier. Here the style, typical of the 1870s shows in the mansard roof and bay windows. This whole block of red brick houses illustrates a developing style from the 1856 house at the corner of West Street, this 1874 dwelling and the high Victorian 1891 house between them. This house was built for Felix Shaw by architect John Power. A verandah was added later by William Newlands.

This two and a half storey brick double house set on a high stone foundation has a bellcast mansard roof with large central brick chimney. The main façade is divided by a central brick pilaster rising to a brick entablature. Each dwelling, two bays wide, has slightly projecting end bays containing the entrances above flights of steps. The paneled doors and rectangular transoms, under radiating brick voussoirs with ashlar keystones, are recessed and protected by a flat hood supported by brackets. There is a single window in the second storey above each entrance.

The central bays each contain the first storey bay windows with angular walls rising from the projecting foundation. The basement bays have three windows with segmental arches. In the first storey the window sills rest on the stone foundation and the bays are topped by a decorated wooden frieze with dentils and paired brackets under a boxed cornice and low hipped roof.

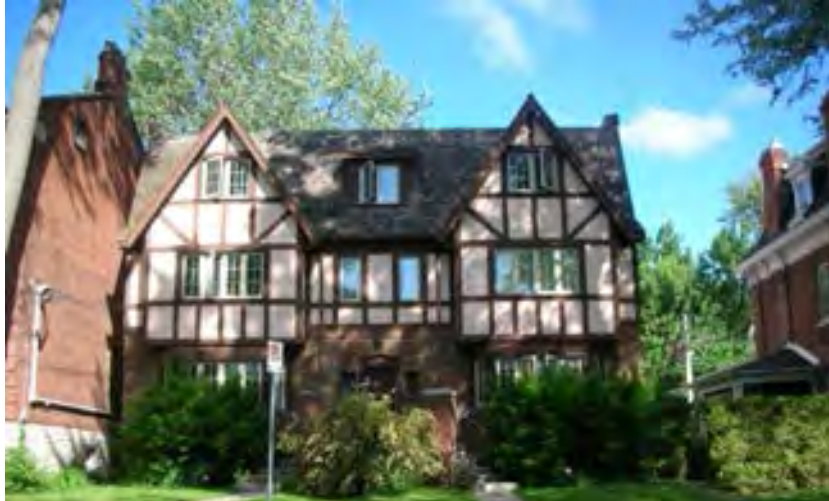
The 110 Bagot Street building is a large, 3-storey, 3-bay brick and wood structure designed in the Tudor style of architecture. Most of the roof of the building is flat. But it has a very steeply-sloped, wood-shingled, front section, which covers the façade of the building's third storey. Two massive gable-dormers project from the outer bays of the front roof. Their upper sections contain 9-piece, paired, casement windows. A small, slightly-projecting dormer, with matching 8-piece windows, is located between them on the middle bay. Each larger dormer extends through the building's second storey, incorporating box-like projections on each outer bays. The projections contain rows of four, 6-piece casement windows. Two matching windows are located between the projections. The dormers, projections, and the remainder of the second storey, feature half-timbering that characterizes the building's Tudor style.

The first storey of the 110 Bagot Street building has a multi-coloured brick exterior, which is also characteristic of Tudor architecture. Its front entrance is located in the middle bay, below a row of vertical brick voussoirs that form a peak. The front entrance door is flanked by two small, rectangular windows with diagonal muntin bars. These windows are supported by sills comprised of vertical bricks, set at a protruding angle. The concrete front porch has an curved staircase at each side. It is flanked by brick pillars with flat stone tops. An iron balustrade spans the front of the porch between the pillars.

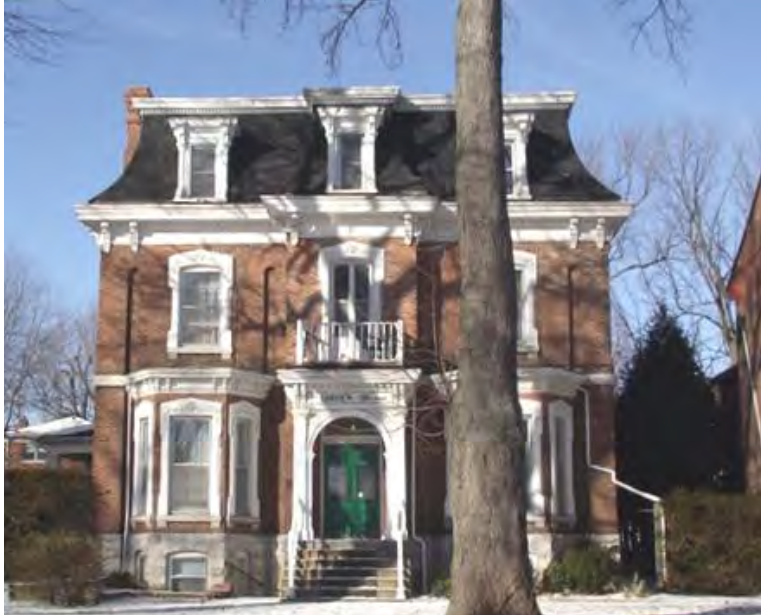
James Minnes, a prominent merchant, in 1875 was assessed \$5000 for an unfinished house on this lot. In both scale and wealth of decoration, it is in contrast to the smaller terraces and double houses near-by and provides an important visual focus at the end of Gore Street.

William Newlands 'plans for improvements' show the addition of a two-storey rear wing.

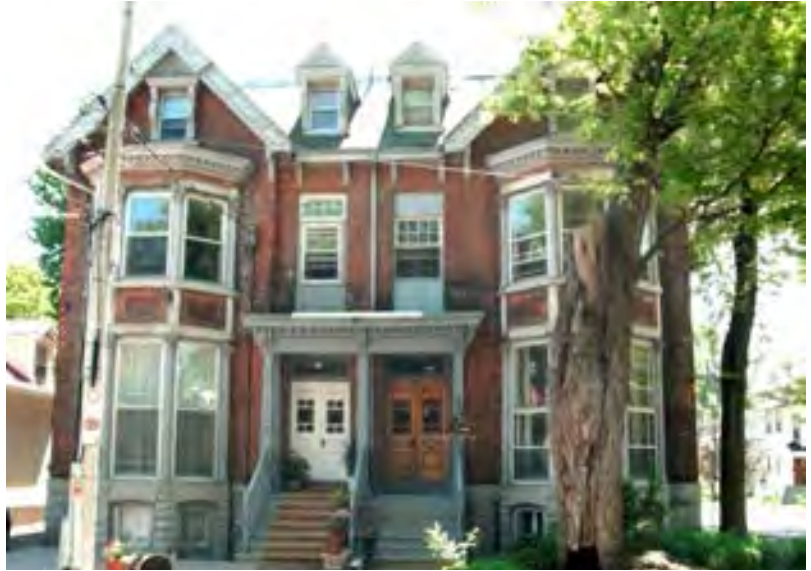
This large two-storey brick house is a prominent and important building located at the corner of Gore Street, facing Bagot. It was erected no later than 1888, as it appears with occupants in the 1889 street directory of Kingston. Its first known occupants were a jeweller named John Smith (117), and Mrs. Francis Lawson (119). Reverend George Ferguson bought the property in 1913, and is still listed as a resident of 117 Bagot in the 1923 directory.

The 117-119 Bagot Street building is a 4-bay, 2½-storey brick double-house on a tall stone foundation. A prominent feature of this building is its two, 2-storey bay windows, located at the ends of the façade. Each protruding bay is narrow and three-tiered, with angled returns. The windows in each tier are tall, 1/1, with simple wood surrounds. Those on the first storey are significantly taller. The first and second storeys of each tier are separated by an inset panel with checkerboard brickwork. Fluted columns flanking each tier feature Corinthian capitals. The tall, full-basement levels of the towers contain inset 2-piece casement windows topped by a solid stone voussoir. Gable ends above the towers' flat roofs feature scrolling brackets which support heavy, simple wood hoods over 1/1 windows. A sunburst design is nestled under the apex of each gable's bargeboards, above the hood. The bargeboards have a series of rectangular and square recessed, wood panels.

Sunbursts are also found on the tympanums of each of the dormer on the roof of each inner bay. These dormers also have heavy wood brackets flanking their 1/1 windows. Further wood brackets are found under the middle bays' cornice, and supporting the outer gable bargeboards.

frieze and cornice. The front entrance doorways each contain wood double-doors with recessed wood panels and an arrangement of 2/1/2 lights. Each inner bay of the second storey contains windows which have replaced balcony doors.

The 117 unit's Gore Street elevation contains a gable over the rear third of the building. Its bracketed and hooded window match those found on the façade. A dormer, also matching those found on the façade, is placed slightly toward Bagot Street from the dormer. The roof overhang along this elevation is supported by heavy wood brackets. Recessed basement windows matching those of the façade are found along foundation wall; two of which are paired near the centre of the wall, while two are set closer to its outer reaches. The remaining fenestration consists of 7, 1/1, windows on stone sills. Two of these are paired on the main storey under the Gore Street gable.

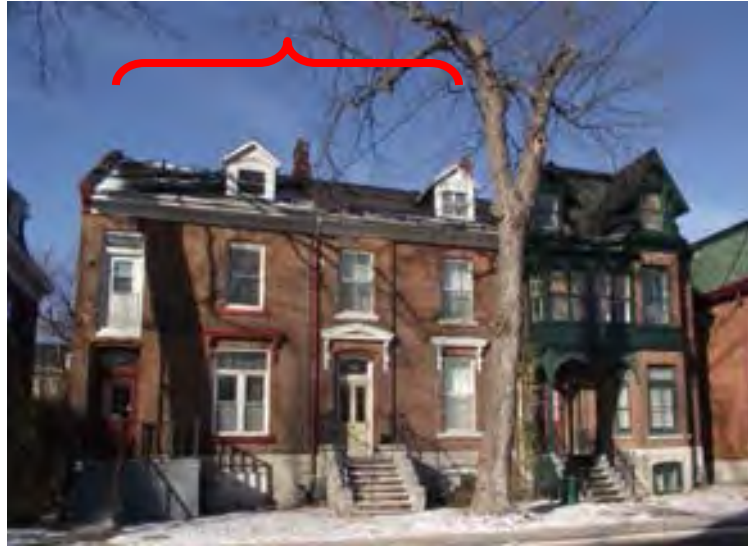
In 1875 this lot was purchased by John McMahon, who owned the adjacent lots 62 and 63 on Sydenham Street. McMahon is alternately listed as a carpenter, contractor, and builder in directories and censuses. He built the 23 Sydenham Street house, behind this one, in 1866.\* McMahon likely had this building erected shortly after buying the land. It is not clear whether 124 Bagot Street was erected in the same year, as an original part of this row of houses. The 1881 street directory indicates that all three units were occupied by 1880. At that time the tenant of 120 Bagot Street was George Sears, while 122 was occupied by a Mrs. J. Riddell. In 1883 McMahon divided the property and sold the three units to separate owners.

This 2½-storey, 4-bay, brick double-house sits on a tall stone foundation with slightly-arched window openings. It has a side-gable roof, with a gabled dormers above each unit's northeast bay. Each dormer contains a square window and a wood face. Recessed panels above these windows form blind transoms with elliptical arches. A brick chimney is centred on the apex of the building's roof, between the two units. Each unit has a slightly-projecting entranceway bay, with doors recessed behind two tiers of brickwork, and a large transoms containing their street addresses. Shallow wood hoods, supported by tall, scrolling wood brackets, are found above each northeast bay window on the first storey.

façade has been altered over time, leaving a door and transom on the second storey. The balcony has since been removed. But the wood porch and staircase, which replaced concrete stairs and stone walls leading to the front door, remains. Brick pilasters flanking its first-storey window appear to have been removed when the window was replaced.

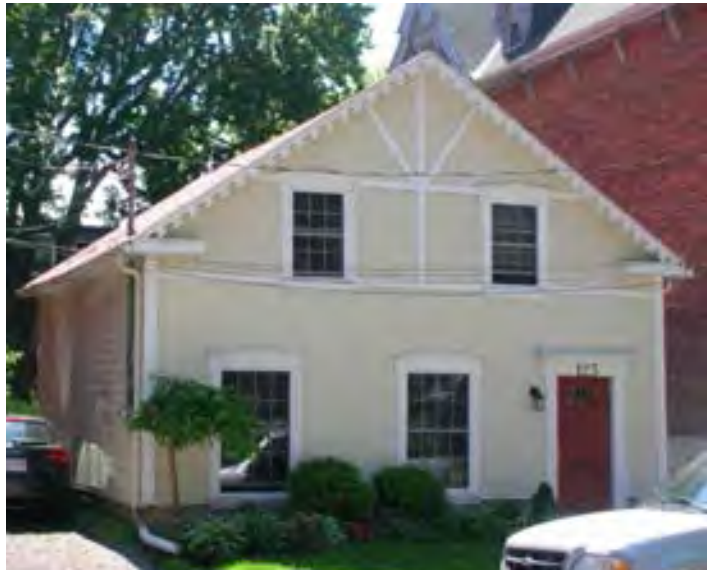
The 123 Bagot Street building is a 3-bay, 1½-storey wood structure with a stuccoed façade. The present façade windows and door are modern. An 8/8 window pattern has been retained on the two first-storey windows, which feature slight peaks on their plain wood headers with drip moulds. The same arrangement is found on the upper storey windows, which are joined by stickwork, and which also form radials under the gable. Jagged wood teeth decorate the front gable, which has large eave returns. The building's front door is wood pilasters and a plain hood with drip mould.

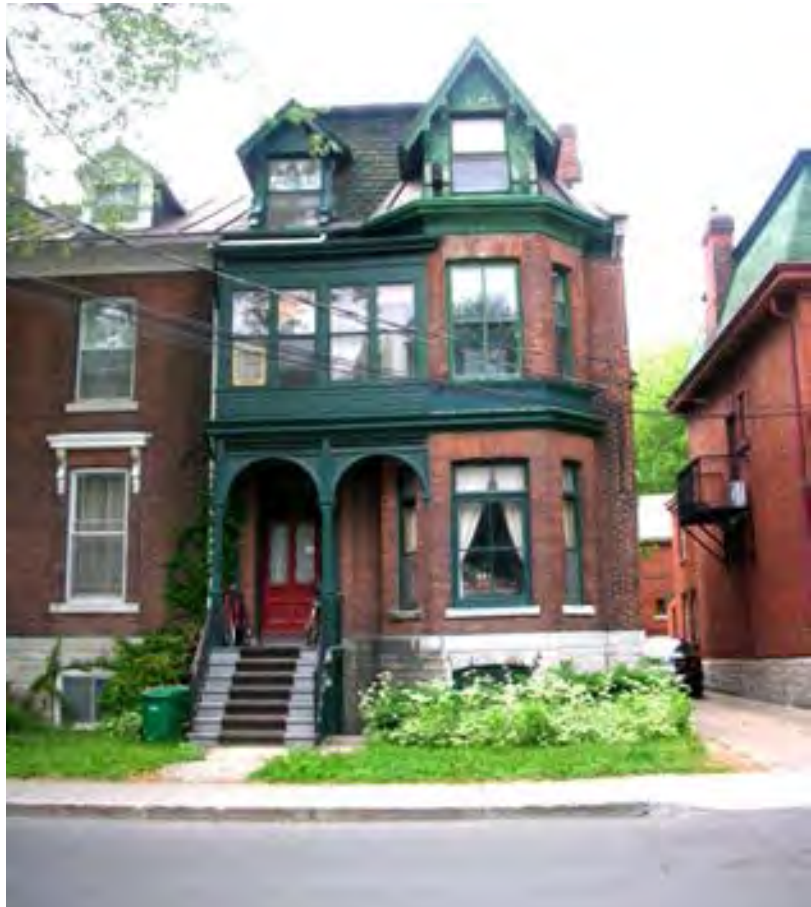
building erected shortly after buying the land. It is not clear whether 124 Bagot Street was erected in the same year, as an original part of this row of houses. The 1881 street directory indicates that all three units were occupied by 1880. At that time the tenant of 124 Bagot Street was a dry goods merchant named George Wilkinson. In 1883 McMahon divided the property and sold the three units to separate owners.

The 124 Bagot Street building is a 2-bay, 2½-storey brick structure built in the Queen Anne style of architecture. Its full-height bay window features large 2/2 windows, with brick keystones, facing Bagot Street, and tall 1/1 windows on each angled return. The first-storey windows are topped by plain rectangular transoms. A slightly arched window is located in the tall foundation of this bay. The bay forms a tower through the addition of an ornate wood dormer above it. The dormer's steep gable end is supported by two sets of large wood brackets, flanking a 1/1 window. A matching, smaller, dormer is located on the southwest bay of the building's side-gable roof. This dormer is supported by two side-brackets and two that are forward-facing. The two dormers have

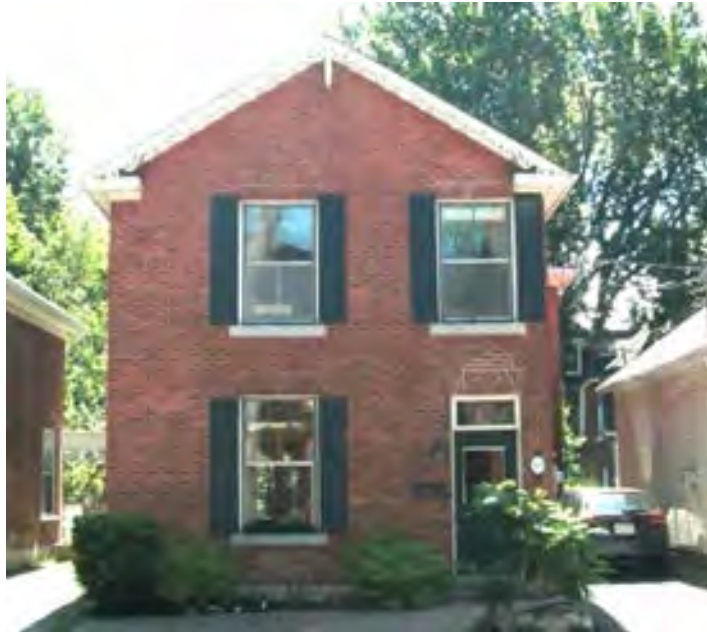
The 125 Bagot Street building is a 2-storey brick house with an offset rear extension. Its façade consists of two bays. Rather than being centred, the fenestration of each bay is set toward the southwest side of the building. The structure is generally plain, with little ornamentation. However, elaborate bargeboards along the front gable roof feature a series of S-shaped scrolls, and a wood pendant hanging from its apex. The front entrance contains a plain rectangular transom. The front elevation of the structure's offset rear extension contains a single window on the second storey, and glass-blocks in place of a previous window on the first. All of the windows are set on stone sills.

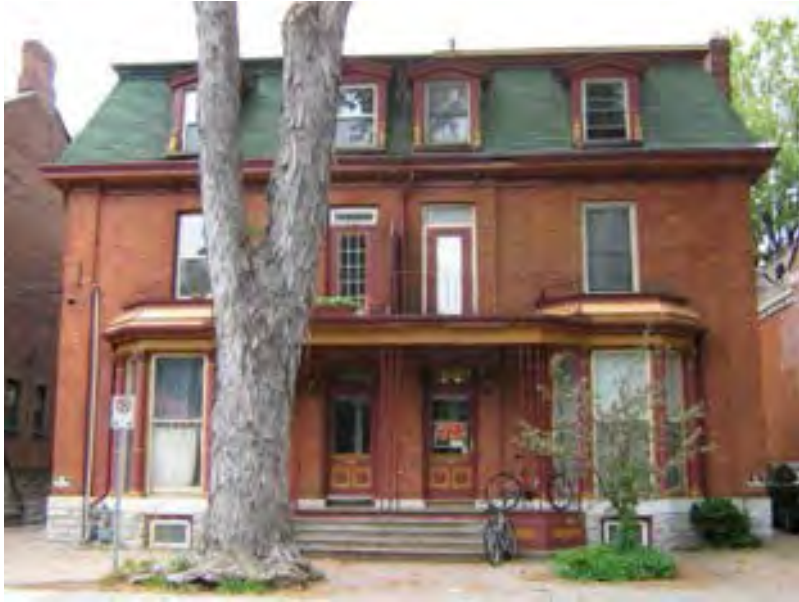
This building was erected in 1871 for John McKelvey and Samuel Birch, owners of a plumbing and steam fitting shop on Brock Street.\* McKelvey also served as Kingston's mayor in 1877.

The outer sides of each unit contain bay windows with flat roofs, below tall rectangular, second-storey windows. Each bay contains full-heights 1/1 windows flanked by wood columns with Corinthian capitals. Dentils line the cornice of each bay roof, which is recessed behind slanted tiered, slanted panels. A window is located in the foundation of each bay window's front section.

A common front porch and balcony extends past the building's middle two bays, receding at angles where they cover the bay windows' inner returns. The porch is fronted by a wide concrete staircase. A balcony above this, accessed by second-storey doors with rectangular transoms, is supported by ironwork matching its balustrade.

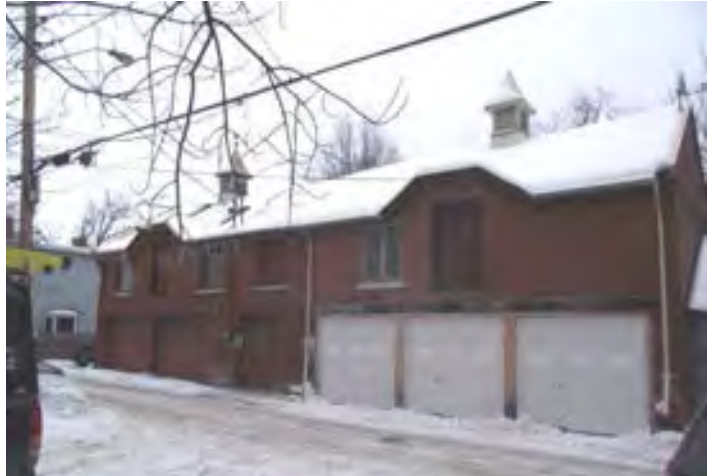
### Stable Building (Lily Lane):

A brick pilaster is found at each outer side of the building's façade. Brick chimneys, flush with each outer elevation, are located half-way back along the building's main massing. The 128 Bagot Street unit features a small iron balcony, with a balcony door and a small window, on the second storey of its side elevation. The building's main massing converges at an angle to meet its long, slightly-narrower, two-storey brick extension to the rear.

An important stable building is located behind the 128-130 Bagot Street building, facing Lily Lane. This 2-storey, 7-bay, brick structure presently houses five automobile garages, with modern garage doors. The middle bay of its first storey still contains an old vehicle door, comprised of vertical wood planks and attached by long metal hinges. Its second, companion door, has been replaced with a modern residential one. The second storey above these doors contains a large window opening, presently boarded-up, above an ashlar sill.

The centre of each set of three bays features a low, hipped-gable along the front roofline, and a tall-pyramidal louver above this hip, at the peak of the roof. The first and second storeys of the building's alleyway façade are divided by a heavy wood stringcourse, which once provided structural support for its original coach doors. On that side of building located behind 128 Bagot, these have been replaced with a set of three adjacent, modern, garage doors. An opening below the hipped gable, originally constructed for a set of second-storey doors, has been boarded-over. To its northeast is a window opening with a stone sill. It now contains a modern replacement window.

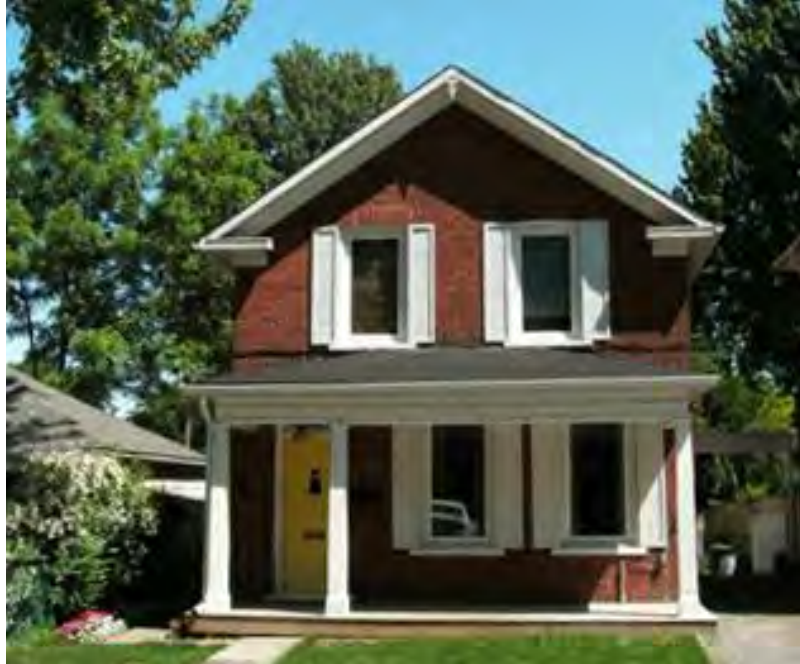
The 129 Bagot Street building is a 2-storey brick house with simple ornamentation and rectilinear features. The building has short decorative pendant at the apex of its front gable roof. The roof has return eaves, and a strong overhang with a series of small dentils. The cornice and entablature are otherwise plain. The structure's large plain windows, and flanking shutters, are of no heritage value. The first-storey façade features a full-width open balcony with plain wood pillars.

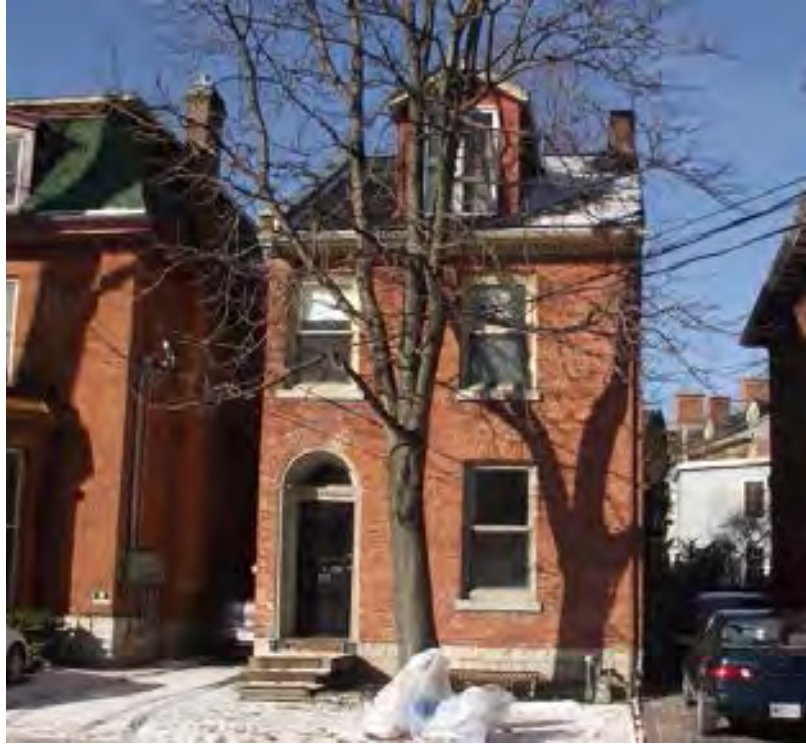
A building appears at this location on H. F. Walling's map of 1860. Martin Dolan had acquired the property in 1856, and likely had the structure erected shortly thereafter.

The 132 Bagot Street building is a narrow, 2-bay, 2½-storey brick structure on a stone foundation. Its first-storey south-western bay contains a deeply-recessed front door, with a half-round transom under a brick arch. The entranceway's wood reveals contain recessed panels. A dentil-lined wood bar divides the entrance between the door and transom, and along each return. The wood front door contains a large, plain, light over a series of recessed rectangular panels. A tall 1/1 rectangular window on an ashlar sill is located on the second storey above the entrance. Matching windows are located on each storey of the building's north-eastern bay.

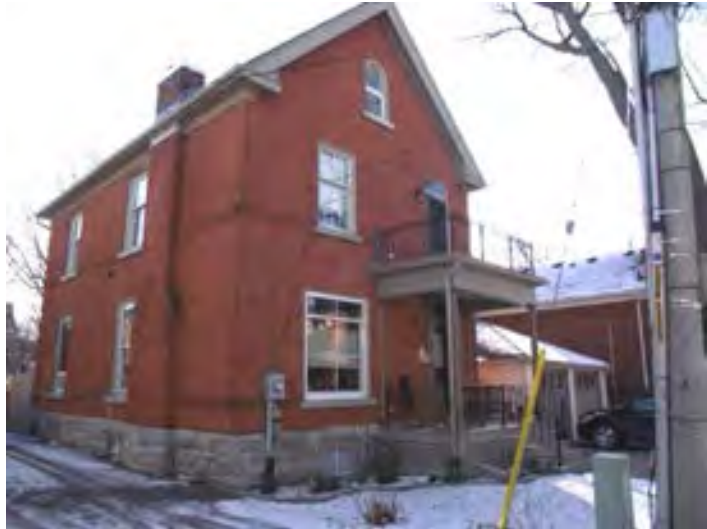
The 133 Bagot Street building is a 2-bay, 2½-storey brick building on a stone foundation. The building's front gable roof contains a small half-round window with a hinged lower section, set on a stone sill. A single window with plain wood trim is found on each storey of the building's northeast bay; the lower window being significantly larger. A basement window is located in the foundation of the façade below these. The wood front entrance door is flanked by heavy wood pilasters and topped by a plain rectangular transom. The entrance is located on a porch in front of the southwest bay. Its roof is supported by thin, plain columns. The balcony which the roof supports has a simple iron balustrade and a rectangular transom above its door.

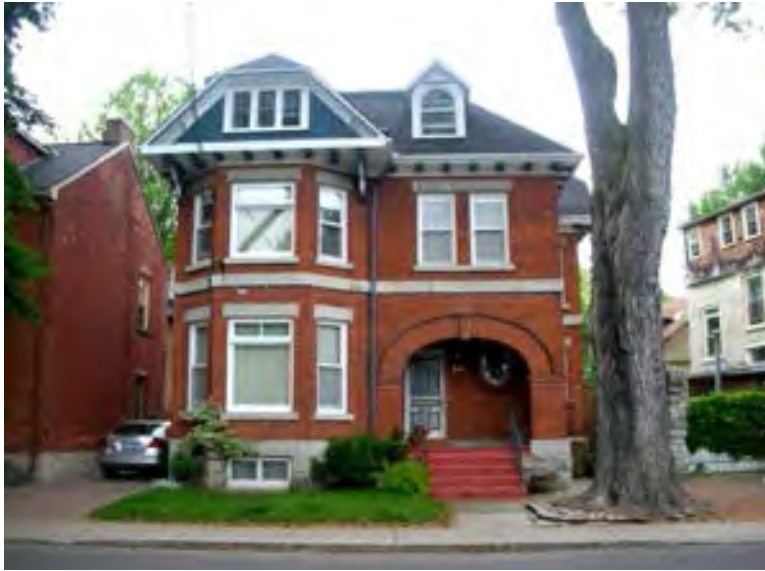
This building was erected for a blacksmith named William Cockburn, who purchased the property from Mary Mills in 1906.\* It first appears in the 1908-09 directory, and was constructed in the interim.

The 136 Bagot Street building is a 2-bay, 2½-storey, red brick building on a stone foundation. It exhibits the bold, heavy look common to many Romanesque Revival buildings, and includes a broad brick Romanesque arch above its front-porch entranceway. The arch features a rounded brick drip mould and engraved stone keystone. It is supported by wide pilasters with curved stone capitals. A concrete staircase fronts the building's recessed porch. The balcony's northwest side features an elaborate oval window. This window has a large, two-tiered brick surround, heavy wood trim, and a stained-glass window with thick tracery.

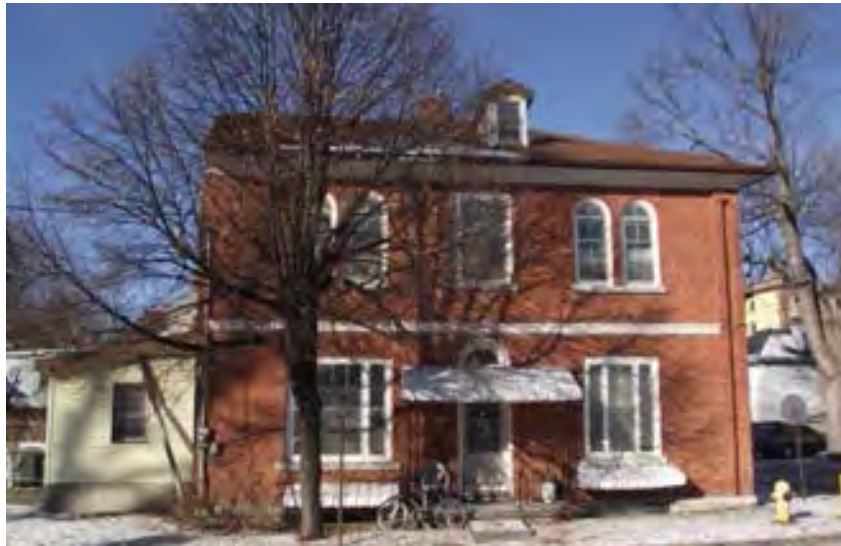
The property records for this Bagot Street property are complicated by the number of divisions and structures it contains. It was briefly owned by John A. Macdonald, Kingston lawyer and Canada's first Prime Minister. If previous research is accurate, the 144 Bagot Street building was erected prior to the 108-110 Bagot Street, which is attached to it and erected c. 1857. An interpretation would be that the building was erected for Charles Greenwood in c. 1852 after he purchased the lot from Macdonald.\*

The 144 Bagot Street building is a 2½-storey, 3-bay brick structure with limestone walls along its southwest side and rear elevations. This structure has a hipped roof, a shallow stone foundation, and a brick pilaster marking the corner of its façade and Earl Street elevation. The pilaster features a round-headed recessed channel. A wood string course with a projecting upper lip spans the façade and Earl Street elevation, dividing the building's two main storeys.

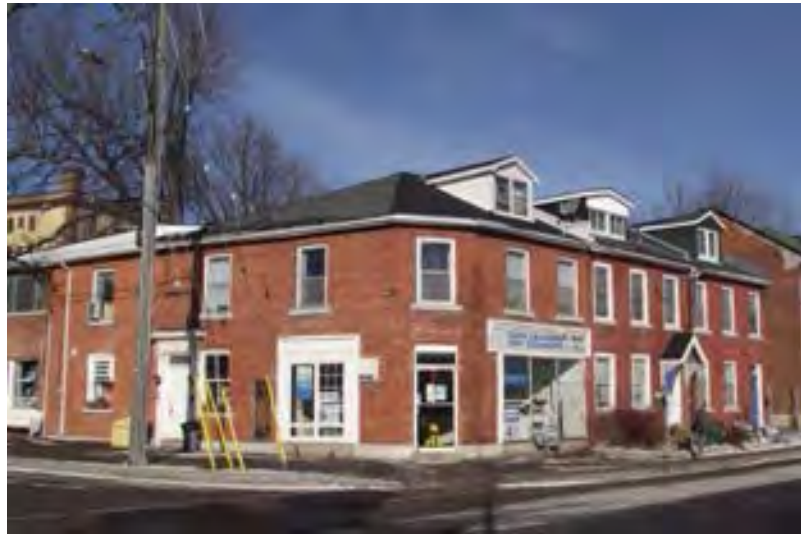
Despite the changes undertaken at 152 Bagot as a result of its conversion for use as a coin laundry this brick row is a relatively early terrace which has retained its general form and much of its mid 19<sup>th</sup> century detailing. It represented an ambitious project in its time as all three units appear to have been constructed as a single building campaign. The brickwork, with stretcher bond face, is well executed incorporating the angled corner readily into the general coursing and providing complex voussoired flat arches at all first storey openings. The hipped roof form is the appropriate resolution of the angled corner at Earl, creating a picturesque effect with a parapeted gable at its other end. Fire parapets, now covered in metal, separate the units and are supported on stone corbels. The west chimney is covered in 'chipboard' at the parapet junction of 152 and 154 with a brick stack with corbelled cap between 154 and 156. The roof of 154 still retains its later 19<sup>th</sup> century metal batten seam roofing.

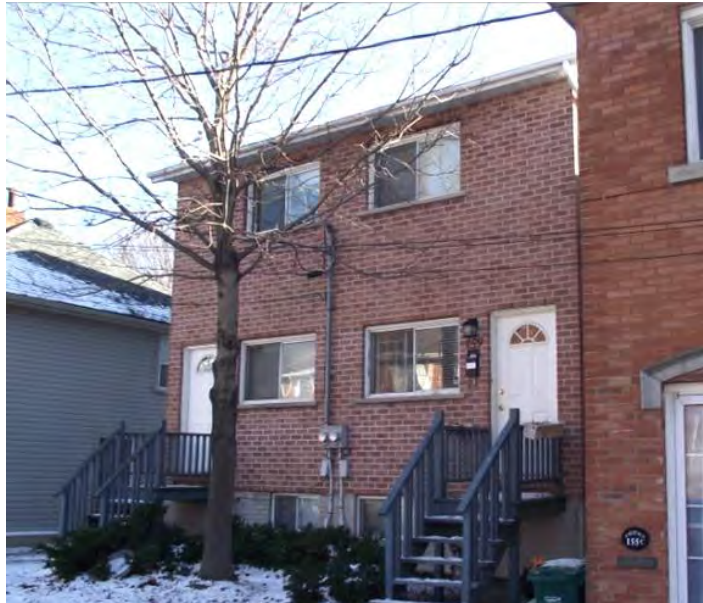
A square 1½-storey wood structure is shown at this location on the 1892 fire insurance map. It is not known whether the present building is related to the earlier one. The present 159-161 Bagot Street building (which involves two separate properties) does not exhibit any contributing design or contextual values.

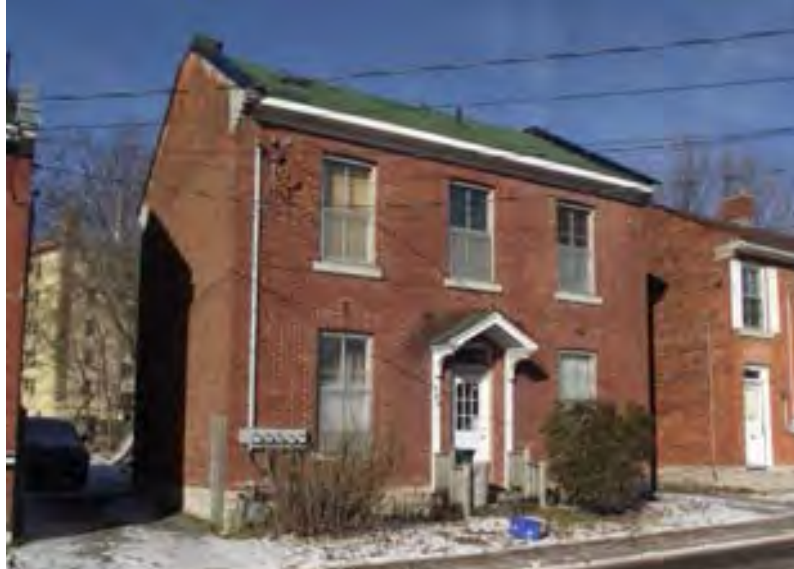
The building is an unadorned three bay two storey brick structure laid up in stretcher bond on a hammer dressed limestone foundation which retains much of its original fabric. It has a parapeted side gable roof with the parapet supported by moulded cut stone corbels at the eaves. The window and door openings are all rectangular with complex voussoired flat arches at the first storey and simple voussoirs above. The windows have limestone sills. The windows appear to retain their original 4/4 double hung sash (suggesting a construction date no later than 1885). At some point iron tie rods have been inserted, apparently at the 2<sup>nd</sup> floor structure.

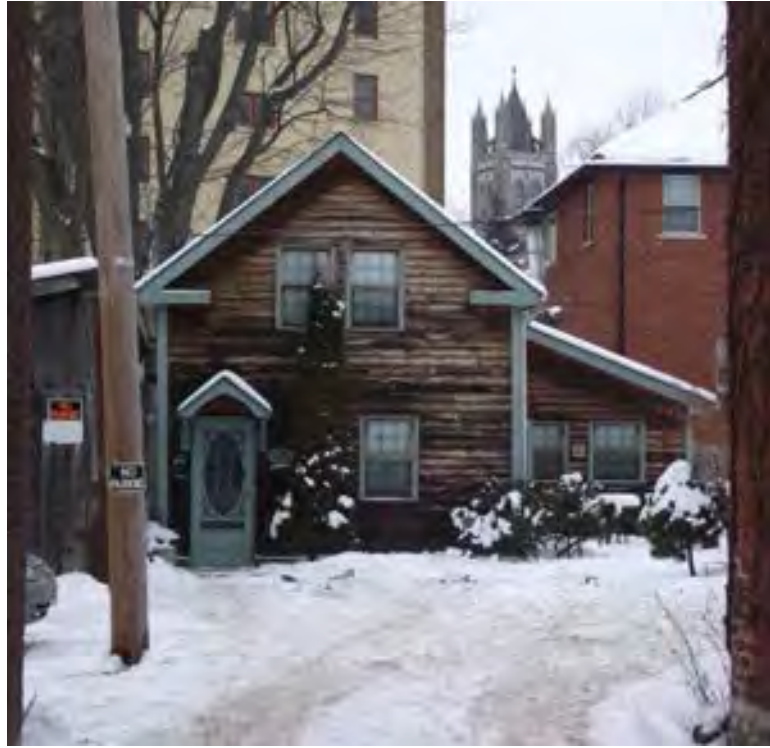
Though the style and materials of the façade of 160A Bagot - front gable with returned cornices, wood siding with cornerboards and double-hung multipane windows - suggest a mid 19<sup>th</sup> century date of construction documentary evidence indicates it was built in the late 19<sup>th</sup> century (see following section). Likely, in providing workers' housing for the bakery,

what would have, by then, been considered modest standard wood-frame construction was utilized. The building was originally rough cast likely as fire protection for a residence so close to the bakery and this has been removed in recent years. The current shiplap siding may have originally been the sheathing for the furred out stucco but confirmation would require closer examination. It is the only frame dwelling on the Block.

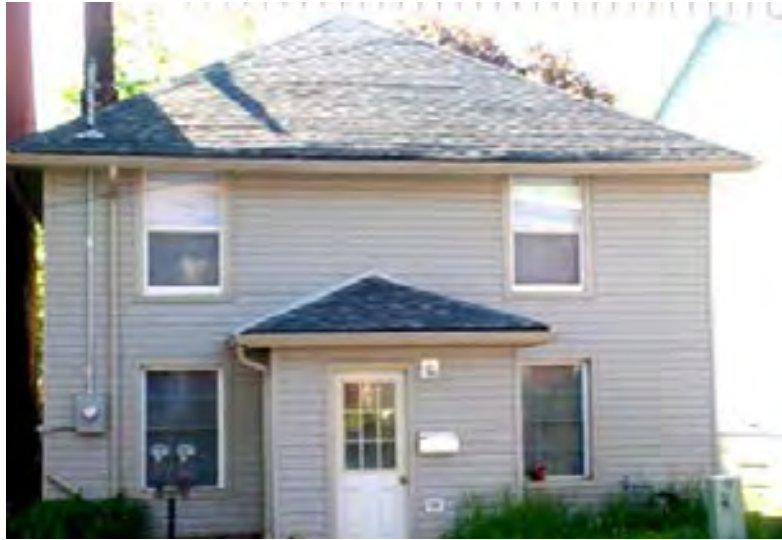
The 163 Bagot Street building is clad in modern materials of no heritage significance. The location and footprint of the building suggest that an older 2-storey wood dwelling could exist underneath the exterior of the present structure. That building was erected between 1856 and 1865. By 1924 it was clad in brick.

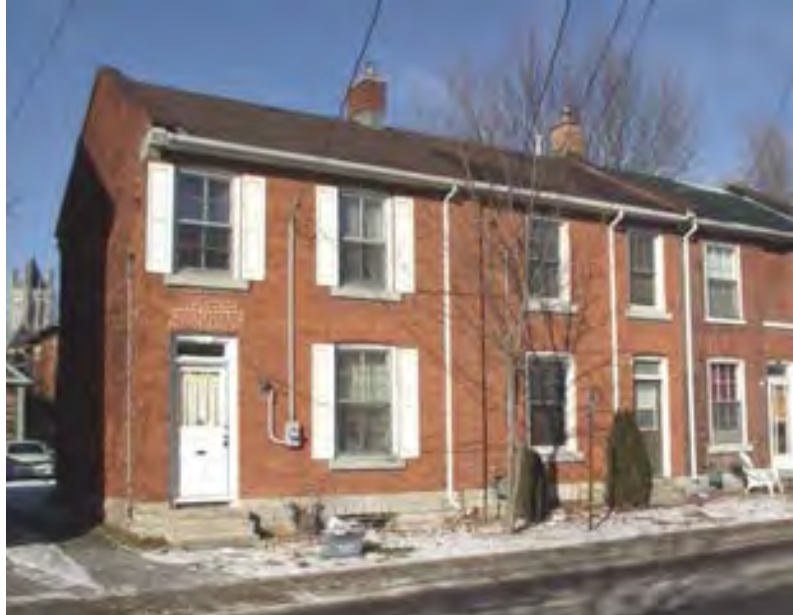
This building extends the row which includes 168 Bagot and 170-172 to the east generally approximating the scale and detailing of 168. The two units mirror each other, with two bays each with the main entrance at the respective 'outside' bays. 164-166 Bagot is a well-built three bay, side gable town house. The parapets walls are supported by moulded cut stone corbels. The brickwork is laid up in stretcher bond. The window and door openings at both storeys all have cambered arches with those on the first storey composed of complex voussoirs. The brick walling rests on a scrabbled, regularly coursed limestone foundation. The original wood window type appears to be the 2/2 units remaining at 164 and unlike 168 there are limestone sills at both storeys.

The double house does not appear on the 1865 Innes Map nor corresponds to the Brosius view (1875) though the construction details do suggest a pre 1875 date. The building is definitely in place by 1892. It may have replaced earlier (likely frame) buildings as suggested by the Gibbs' map of 1850.

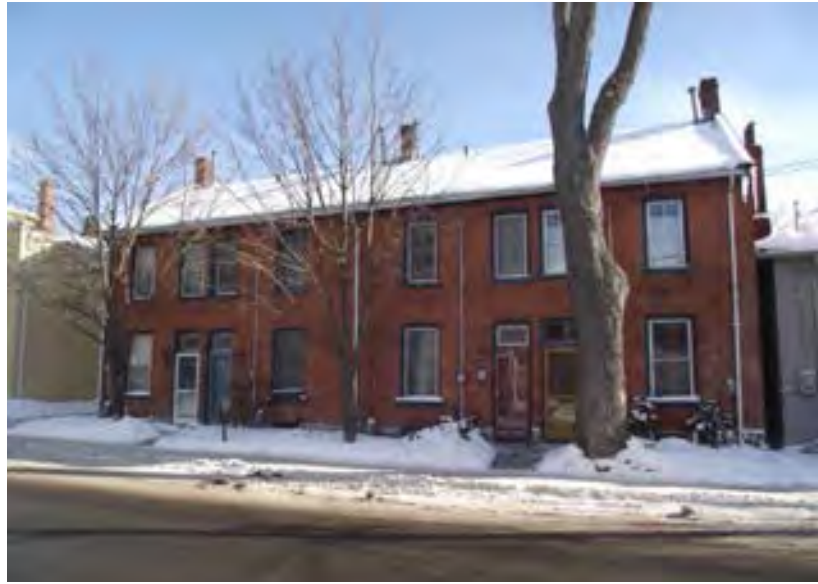
Each 2-storey unit of this building features a narrow front entrance on one of its two bays. A plain rectangular transom tops each door. Three 4/4 windows, two of occupy each bay of the second storey, complete the fenestration of each façade. The windows have simple wood sills and are topped by brick flat-arches. Flat-arches are also found above the entranceways, and basement windows of each unit. This structure was originally wood and roughcast, but the façade and side elevations were given a brick veneer by at least 1892. The entire structure was clad with brick by 1908.

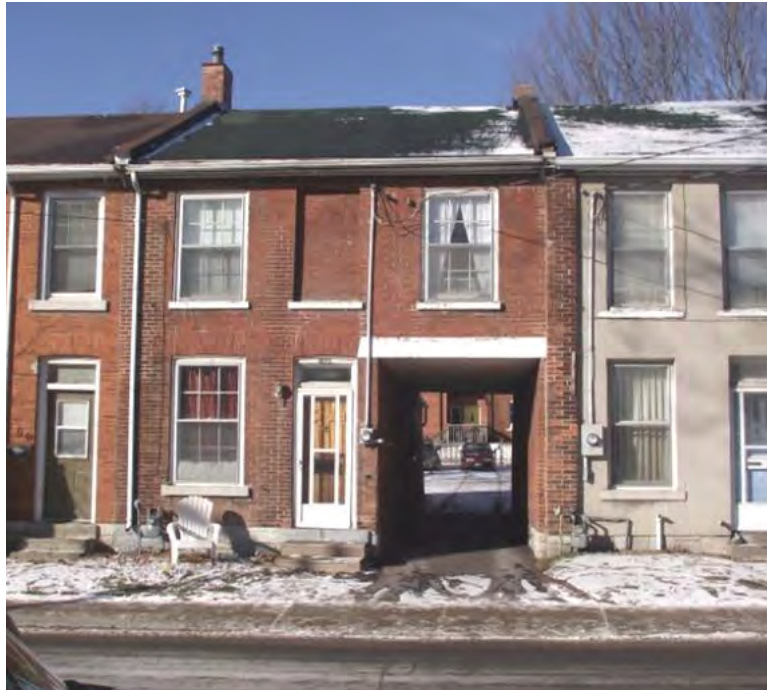
This building appears to be the earliest in a long row of brick structures which includes 164-166 Bagot to the west and 170-172 to the east. 168 Bagot is a very well built three bay, side gable town house. The parapets walls are supported by moulded cut stone corbels. The brickwork, though generally laid up in stretcher bond features a course of bond bricks just above the arches of the first storey openings. The window and door openings at both storeys all have cambered arches composed of complex voussoirs. The brick walling rests on a limestone rubble foundation. The building retains a wood soffit and frieze with heavy wood roll, a feature it shares with 170-72. The wood window surrounds remain in place (though one opening has been infilled with brick) and the 6/6 double hung sash typical of the mid 19<sup>th</sup> century. The door has a rectangular transom. The carriageway is obviously an important and distinctive feature with the heavy timber lintel cut to fit the angle of the door arch where it is supported. The buttress/pilaster may have been added at the time of the construction of 170-172.
