## **Property Inventory Evaluation**

### **Bagot Street**

## Property Inventory Evaluation – Bagot Street

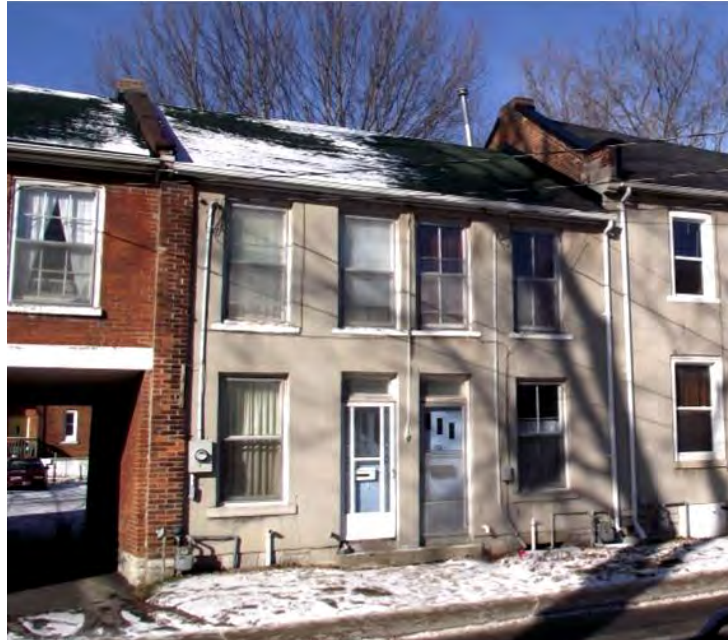
The appearance of the façade of this originally solid brick double house has changed a great deal due to the application of stucco in the later 20<sup>th</sup> century. However in scale, rhythm of openings, nature of roofline and remnant detailing it still retains the character of the row of which it forms a part. It shares the same wood soffit/cornice detail as 168 (featuring heavy wood roll) and the narrow wood sills at the 2<sup>nd</sup> storey windows (limestone at the first storey) though the size and shape of the actual openings are slightly different than its neighbour. The roof, which shares a parapet on stone corbel with 168 at the south simply abuts the gable and parapet wall of the taller 174-176 Bagot to the north. The window and door openings have flat arches which, no doubt, are voussoired and the doors have rectangular transoms. The limestone foundation is exposed above grade and appears to be coursed rubble.

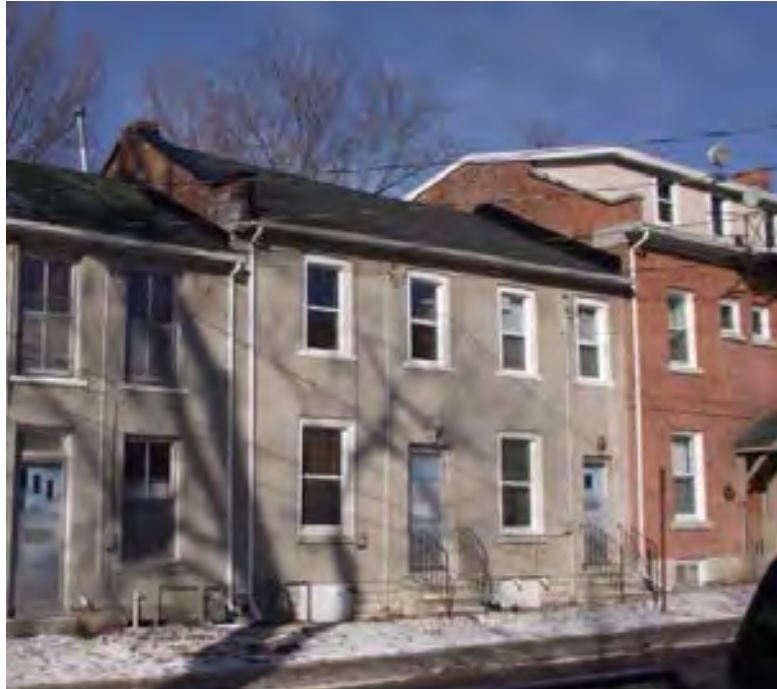
The appearance of the façade of this originally solid brick double house has changed a great deal due to the application of stucco in the later 20<sup>th</sup> century. However in scale, rhythm of openings, nature of roofline and remnant detailing it still manifests the essential character of the streetscape. The window and door openings have flat arches which, no doubt, are voussoired but it appears that the rectangular transoms at the doors have been infilled. The limestone foundation is exposed above grade and appears to be coursed, roughly squared rubble with a scrabbled finish. Its brick roof parapet at 172 is supported by a cut stone corbel and has a chimney (stack now lowered) at the peak.

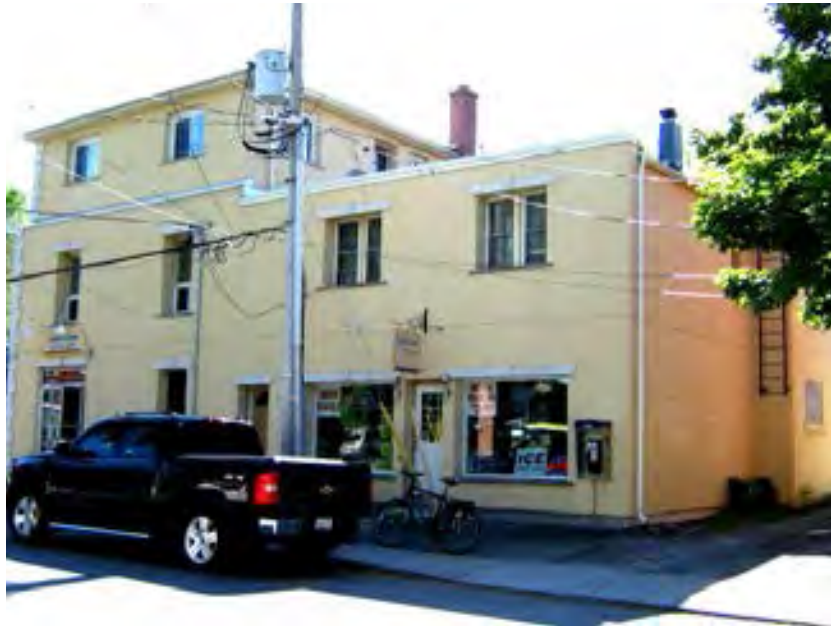
The 175 Bagot Street building is a flat-roofed 2-storey extension to 100-102 William Street: a stone building that appears to have been erected by 1850.<sup>†</sup> This stone extension, with a flat façade, shop windows, and upper apartment unit(s), is clad with the same roughcast finish as the main building and, according to fire insurance maps, was added sometime between 1947 and 1963. Its exterior finish, flat façade, and rectangular fenestration, are consistent with both the main structure and those features found on the 170-176 row houses, immediately across Bagot Street.

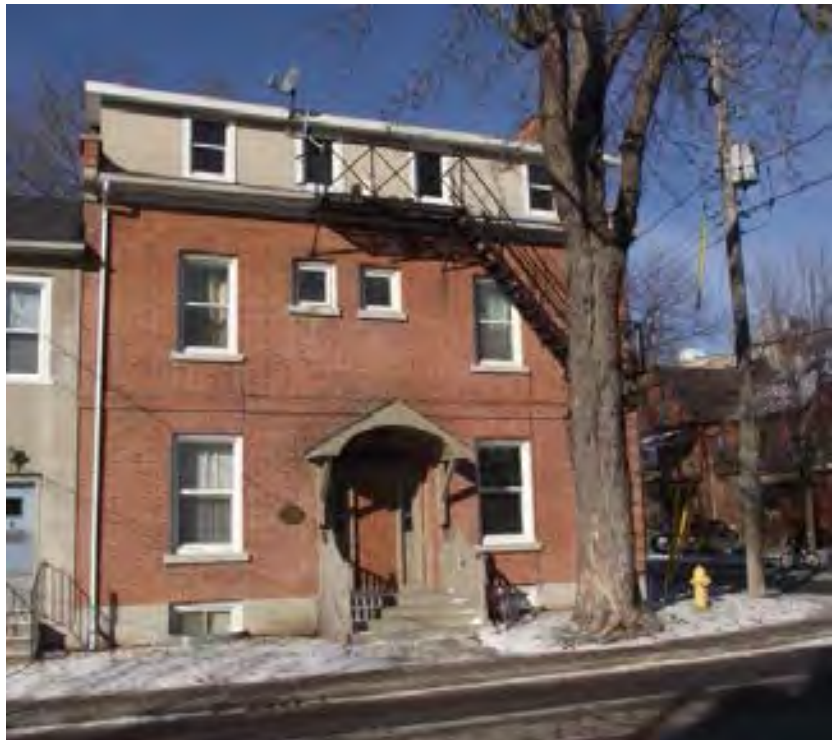
While the brick walls have been sandblasted and many of the windows and the main door and much of its surround replaced, this remains a mid-19th century brick structure of note. The first storey is constructed in true Flemish bond, relatively rare and typically associated with fine early brick construction while the 2nd storey and gables are done in a freer version with bond bricks more widely spaced but at both levels the corners are finished with Queen's closers. The brick walling rests on a stone foundation of regularly coursed hammer dressed limestone.

Despite the replacement of most of the main entrance treatment in modern materials what appears to be the original elliptical fanlight still remains. Opening placement at the Bagot Street façade is asymmetrical although this seems to reflect changes over time. Several openings have been closed in and, what appear to be, bathroom windows inserted. The Brosius 1875 'Bird's Eye 'View' shows symmetrical three bays on Bagot Street but no door. This is of interest as there is a bricked in door opening at the middle of the three symmetrical bays on William Street which now appears as a niche. It is possible that the building had two entrances, or perhaps the entrance was moved at different periods in the building's history. Certainly the brickwork of the arch above the fanlight at the existing location has been completed in the traditional manner and does not readily betray a Colonial Revival renovation.

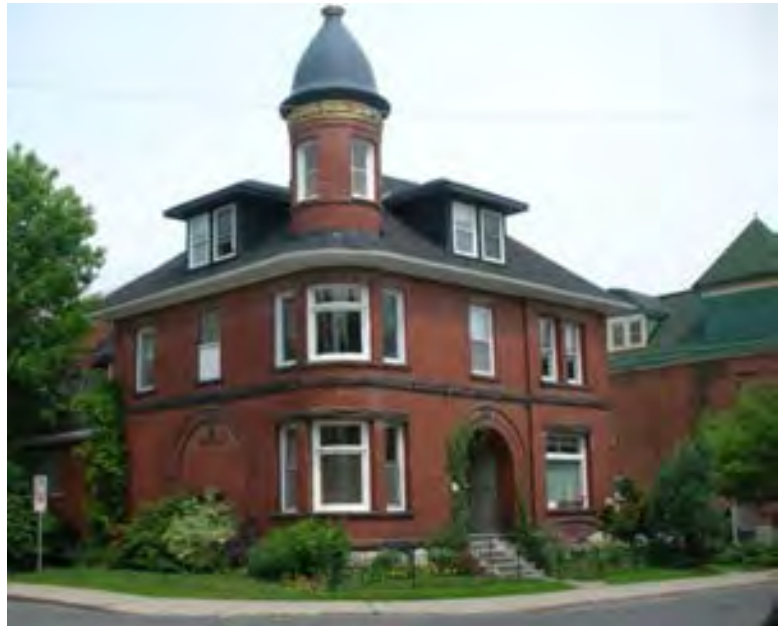
This large Romanesque Revival structure features a rare, broadly-rounded, corner facing the Bagot-William Street intersection, and a tall, round tower with 1/1 windows and a Moorish top. Each of the building's exposed elevations – facing Bagot and William Streets – feature large Romanesque arches. The Bagot Street arch covers a deeply recessed entranceway with double-doors at its entrance and a transom with leaded tracery. The William Street arch covers a brick panel that at one point contained a short rectangular window. Each arch has an elongated decorative stone keystone, terminating at its bottom in a scroll. A third arch, without a keystone, is found above the basement window of the Bagot Street outer bay.

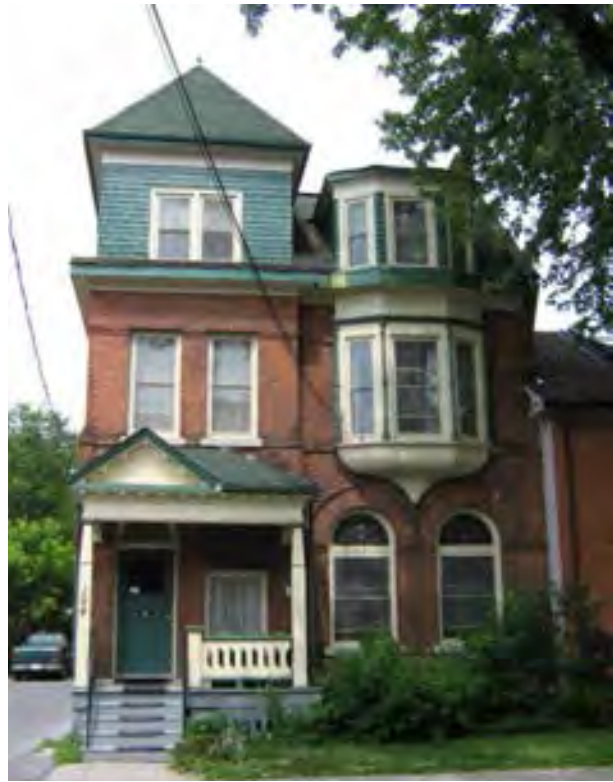
The house at 194 Bagot is a significant and impressive structure built in the Queen Anne style, featuring Romanesque elements. An outstanding feature of this building is a wood oriel window, situated on the second storey of its north-eastern bay, which supports a flat-roofed dormer with a similar three-tiered profile. Below these is a set of windows on stone sills, with Romanesque brick arches and fanlights. Each fanlight has elaborate stained-glass glazing with leaded tracery forming, in part, a floral pattern. The front entrance has a fanlight with a similar arch, although its view has been truncated by the addition of the present porch.

The porch features a slanted roof and pediment gable. Dentils line the pediment porch roof cornice. A square window beside the front entranceway door likely replaced a larger window during alterations. This window, along with two rectangular windows and a paired set of the same in the tower facing Bagot Street, form a deliberate contrast to their arched counterparts.

The south-western elevation of the building has been exposed to Bagot Street since the neighbouring structure at 192-194 Bagot was removed, sometime after 1963. Brick string courses found on the façade of the building extends approximately 1/3 of the way along the building's depth. Fenestration along this side of the building is irregular. It includes a rectangular window on the second storey, which has since been filled-in. Two short rectangular windows beneath this opening also have stone sills: one of these has

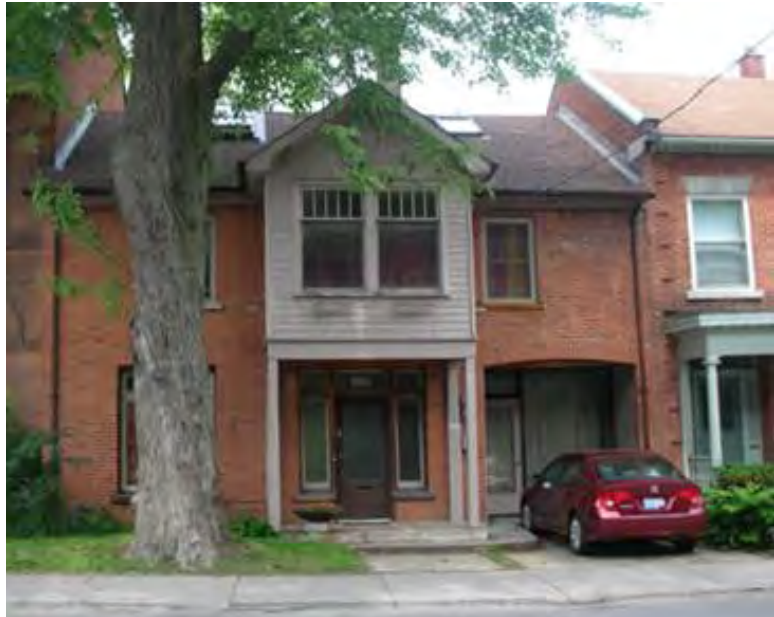
The 1892 fire insurance map shows this building as a wood double-house with brick veneer and a common entrance in the middle of its three bays. The property, along with 194 Bagot Street, appears to have been home to a different structure used as a boarding house until 1889. The present building has undergone a series of alterations. The southwest upper window is supported by a stone sill, but its north-eastern equivalent has a wood sill as a result of renovations: fire insurance maps indicate that between 1915 and 1924 that section of the house was converted to a car port. The 1963 fire insurance map shows that it had again been converted, this time to a business office. It is possible that the oversized single pain of glass, and relatively modern door, were installed at that time.

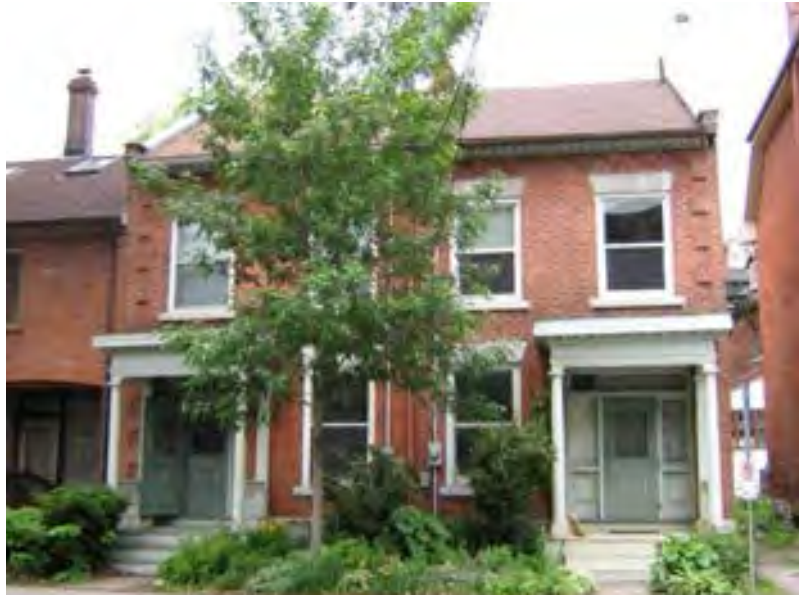
Former Kingston mayor John Counter sold this property to William Coombs in August of 1848, who in turn sold it to a grocer named Francois Xavier Lachance in 1882. A mortgage from the Ontario Building Society the following year suggests that the building might have been erected for Lachine at that time.

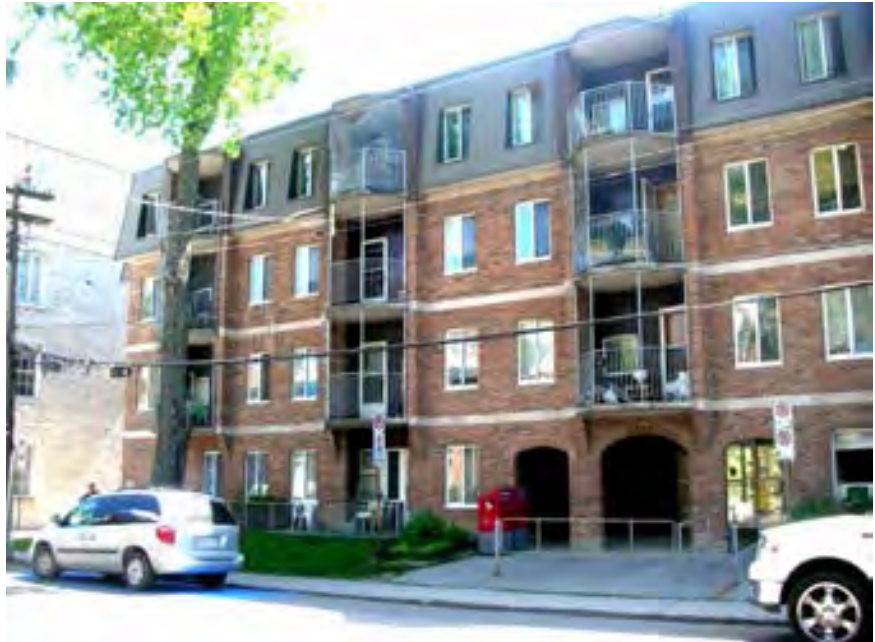
Constructed on the site of an early Roman Catholic enclave including a stone church (facing William Street) and graveyard, this brick-faced structure was built as a housing complex for senior citizens by the City of Kingston in 1976. At the same time, the historic “Bishop’s House” (at the corner of Johnson Street) was renovated as part of the new main branch of the Kingston Public Library (on Johnson Street) by the Kingston architectural firm of Inglis & Sorensen.

Three storeys high plus a metal-covered mansard roof, 205 Bagot Street was designed to respect the architectural forms of the stone “Bishop’s House” -- from which it is separated by an alley -- but to be distinguished from it through the use of red brick with stone detailing. Echoes of the traditional ellipse arches found in the older building are seen in the seniors’ complex in the tripartite main entrance. Traditional row housing is evoked by the vertical pattern of balconies and creates a more individualized effect than is found in many contemporary, large, box-like, buildings. The overall bulkiness is decreased by a recessed corner at Bagot and William Streets.

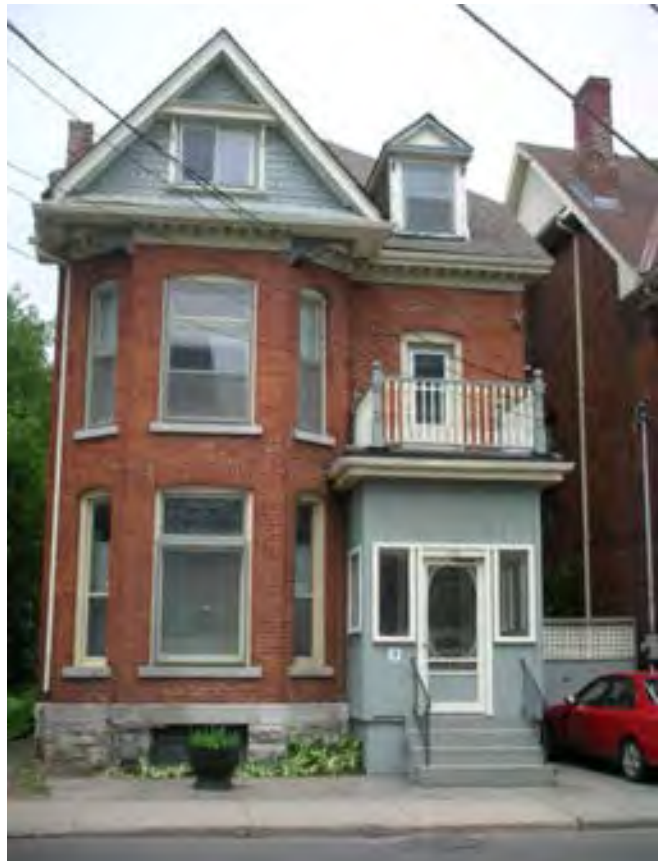
The three buildings at this west corner of Johnson and Bagot Streets were erected at the same time, and with matching features. Together they form a distinct and important set of buildings, located across from the historic Bishop's House / Parish House, and kitty-corner to the large ornate 131 Johnson Street residential building.

The 208 Bagot Street building was constructed according to a basic Queen Anne design, featuring a hipped-roof, a projecting gable, and a full-height bay window. Other features typical of this style are the building's dormer, its vertical massing, and a square second-storey balcony above an elevated front porch. An ashlar base course separates the building's first storey from its hammer-dressed stone foundation and basement window. More ornate elements include the use of dentils under the building's projecting eaves, and carved wing-like brackets on each upper side of the bay window's centre section. The gable contains fish-scale imbrication and a window hood supported by brackets. The balcony balustrade contains turned-wood balusters and newels with ball tops. Four windows on the angled returns of the front southwest bay – two on each storey – are tall and 1/1 with simple wood surrounds. The centre-section windows are wider with rectangular transoms. The lower transom features stained glass with leaded tracery in a roughly floral pattern, circumscribing a diamond-patterned centre. All of the first and second-storey windows have ashlar sills and slightly arched brick voussoirs.

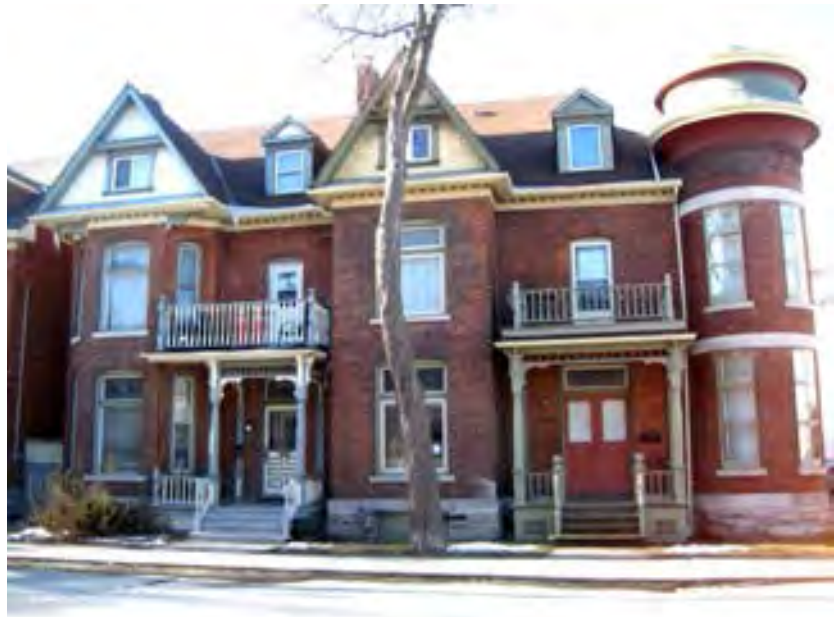
The three buildings at this west corner of Johnson and Bagot Streets were erected at the same time, and with matching features. Together they form a distinct and important set of buildings, located across from the historic bishop's house / parish house, and kitty-corner to the large ornate 131 Johnson Street residential building. The 210 Bagot Street tower is a particularly important defining element of this intersection.

the building's first storey from its hammer-dressed stone foundation and basement window. More ornate elements include the use of dentils under the building's projecting eaves, and carved wing-like brackets on each upper side of the bay window's centre section. The gable contains fish-scale imbrication and a window hood supported by brackets. The balcony balustrade contains turned-wood balusters and newels with ball tops. Four windows on the angled returns of the front southwest bay – two on each storey – are tall and 1/1 with simple wood surrounds. The centre-section windows are wider with rectangular transoms. The lower transom features stained glass with leaded tracery in a roughly floral pattern, circumscribing a diamond-patterned centre. All of the first and second-storey windows have ashlar sills and slightly arched brick voussoirs.
