Property Inventory Evaluation
Earl Street

16, 18, 20, 20.5, 22
Earl Street

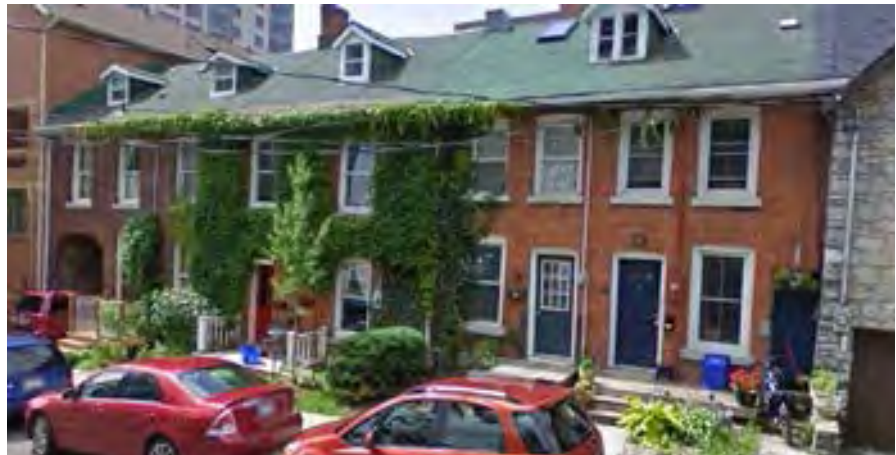
The buildings that
comprise 16 to 22 Earl

Street form a single, uniform, terrace that has physical value for its individual architectural elements, and as a whole. Design differences suggest that these units were erected in stages, but their overall architectural elements remain cohesive. They have adjacent flat facades that form a common, shallow, setback from Earl Street. The buildings share a common side-gable roofline, while both their compositions and their massings are compatible. These modest dwellings have historical value as good examples of early working-class dwellings, as such structures were designed to suit the busier commercial and industrial areas of early Kingston. Their proximity to the waterfront and its shipping activity; to the activity of the locomotive works; and to the city's centre; made these properties choice locations for those who worked in such industries. Maps by Thomas Fraser Gibbs and Henry Vavasour suggest that the entire row had been erected by 1850.

A distinctive feature of 16 Earl Street is its east-side carriageway. The carriageway once provided access to an interior courtyard: a much needed feature in the busier and more congested parts of early Kingston. It is one of several such underpasses that help define the historic character of the Old Sydenham Heritage Area.

The 18 Earl Street building features a round-headed front entrance with matching transom, and mildly-arched window openings. These elements add a slightly more decorative touch, while maintaining the overall simplicity and basic design of the row as

A rare feature of this building is a small, pedestrian underpass at its west end. Cartographic evidence from various 19th-century maps indicates that this walkway was originally uncovered. Unlike 16 and 18 Earl Street, the 20-22 Earl street structure is a wood frame building, with its brick veneer added prior to 1892. The walkway had also been covered-over by that time. The bays of this building are much narrower than others in this row, suggesting that space was already at a premium on this block in the mid 19th-century.

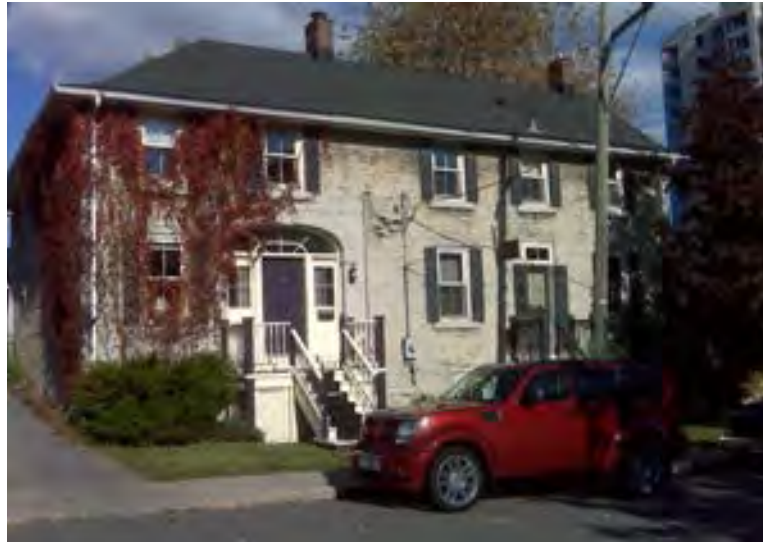
21, 23 Earl Street

The 21-23 Earl Street building was erected as a single dwelling prior to 1850, and possibly before 1832.* The property was originally owned by Richard Cartwright, a United Empire Loyalist who left Albany, New York, for Montreal in 1778. He arrived in Kingston with some of its earliest settlers in 1784. One of the most affluent and well-known Loyalist families, the Cartwrights were granted a large amount of land, including the entire block between Earl, King East, William Street, and Ontario; with the exception of its southeast corner. Richard's grandson, and son of MLA the Honourable Richard Cartwright, was John Solomon Cartwright. A lawyer, judge, and MLA as well, John Solomon erected the adjacent estate at 221-223 King Street East. The close placement of these two early limestone buildings is important to defining the character of this part of the Old Sydenham Heritage Area, which is enhanced by a clear view of the Cataraqui River at the foot of Earl Street.

This house has a west-side gable end and a hipped roof on its west side. The hip was likely created when the building's kitchen wing, extending north from its east side, was

added. An 1850 map by T. F. Gibbs does not show this extension, while one by H. Vavasour, published the same year, clearly does. It is therefore possible that the extension was added at about that time. It has a limestone chimney on its north end, while two brick chimneys are found on its main massing.

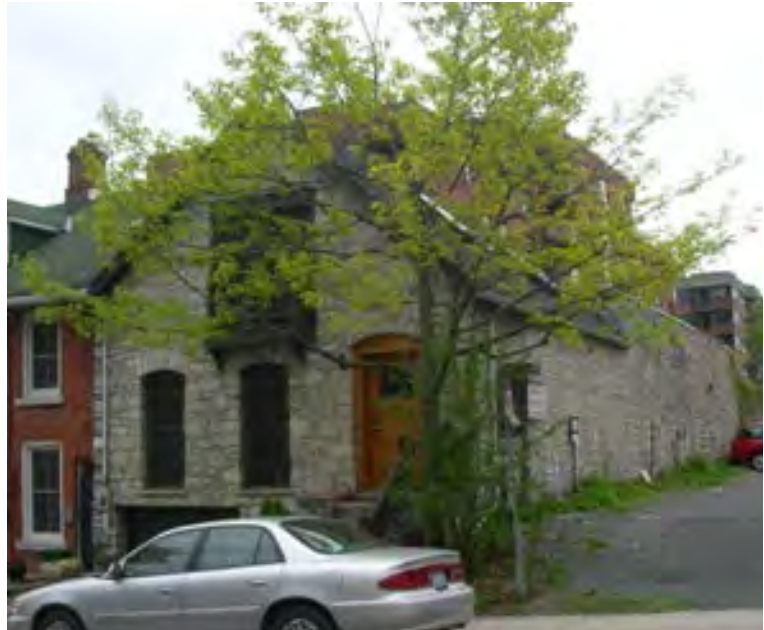
Although it has been well-crafted to appear older, the façade of 24 Earl Street is actually a relatively new modification. Until the last quarter of the 20th-century, this building was a 1½-storey wood frame structure, converted from its earlier function to that of a double house. Although there are some anomalies in the cartographic evidence, one mostly consistent interpretation is that the original structure was erected as a stable, and/or for other industrial usage, by at least 1850.

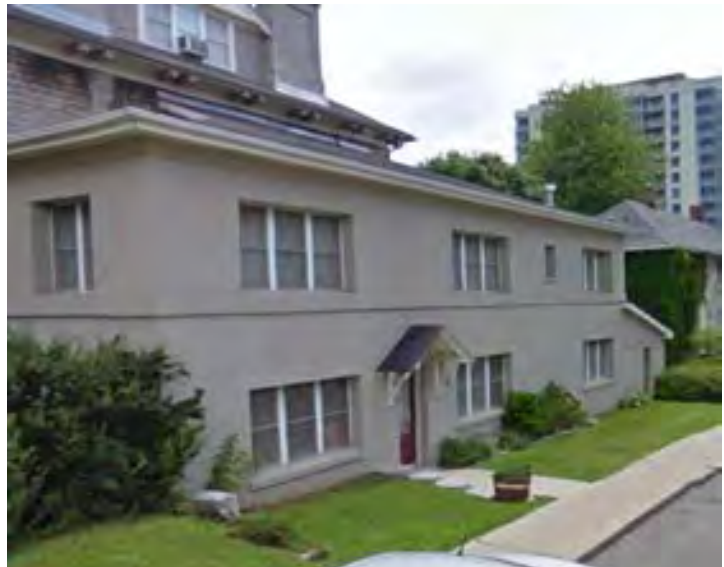
This two-storey house, with minimal ornamentation and rectilinear features, is attached to the south side of an important heritage building located at 221 King Street East. The latter is widely known in Kingston as the former office and residence of lawyer, Judge, and MLA, John Solomon Cartwright and his family. The property was originally owned by his grandfather, Richard Cartwright, a United Empire Loyalist who left Albany, New York, for Montreal in 1778. Richard arrived in Kingston with some of the earliest settlers in 1784. One of the most affluent and well-known Loyalist families, the Cartwrights were granted a large amount of land, including the entire block between Earl, King East, William Street, and Ontario; with the exception of its southeast corner.

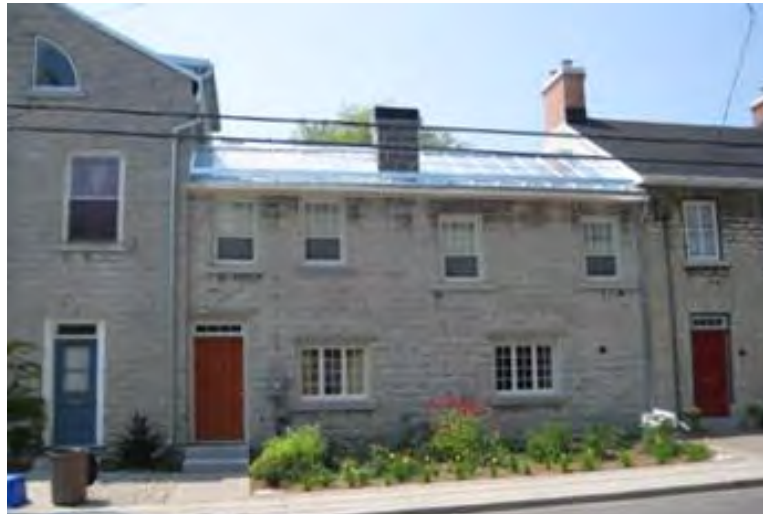
The 44 Earl Street building is valued for its design, historical and contextual attributes. Along with 212 King East and 46 Earl, 44 Earl forms part of an eclectic but appealing stone row at that introduces the lower end of Earl Street at King East, and is one of five stone buildings that define help define the historic character of that intersection. The Earl Streetscape between King and Wellington is lined with buildings from different eras, which utilize a variety of materials and designs. With their box-like designs, the 44 and 46 Earl Street buildings are those which reflect illustrate the earliest and simplest of these built in stone. The 44 and 46 Earl Street buildings also compliment the wood structure at 47 Earl, across the street, which is otherwise similar in design. All three of these buildings now benefit from the absence of dormers which, apart from the chimney on 44, leaves the facade slopes of their side-gable roofs unobstructed.

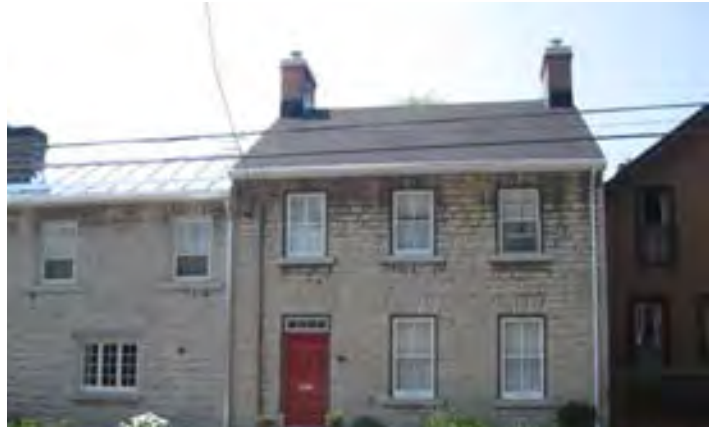
There is some evidence to suggest that the 46 Earl Street building was erected around 1828.* Recent physical inspections of this and the 44 Earl Street building have revealed evidence consistent with the idea that these two structures were erected at approximately the same time.

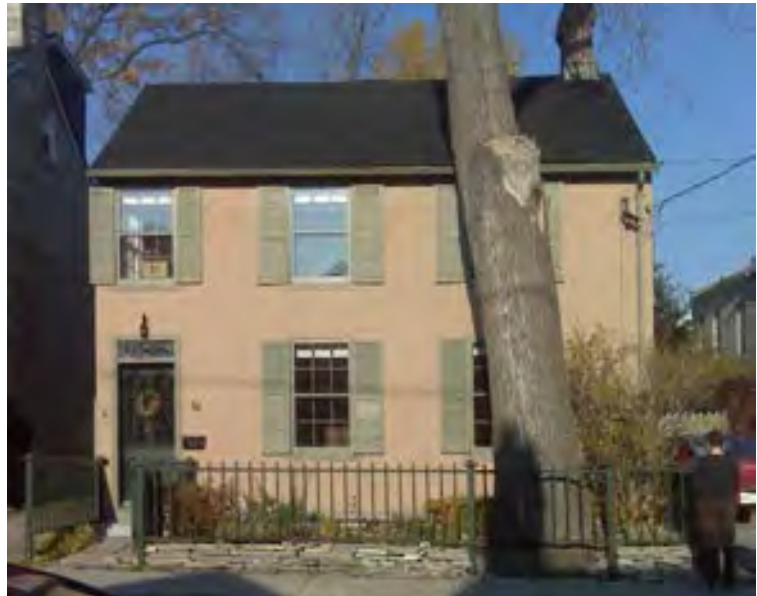
This 2-storey frame residence was built for Mrs. Rachael Sterling, whose boarding house had burned in December of 1840. After it was erected, Sterling continued to take boarders in the present building for about twelve years.* It was originally a double-house which extended east toward Kingston, but that half of the structure was removed sometime between 1877 and 1892.†

This building is valued for its physical and contextual attributes. Its modest design, flat façade, and 6/6 window configuration are largely responsible for maintaining the building's historic character. The Earl Streetscape between King and Wellington is lined with buildings from different eras, which utilize a variety of materials and designs. The 47 Earl Street building contributes to this variety through its simplicity and composition. This frame building forms an appropriate contrast to the stone buildings at 44 and 46 Earl across the street, which are otherwise similar in design. All three structures benefit from the absence of dormers, which leaves the façade slopes of their side-gable roofs unobstructed.

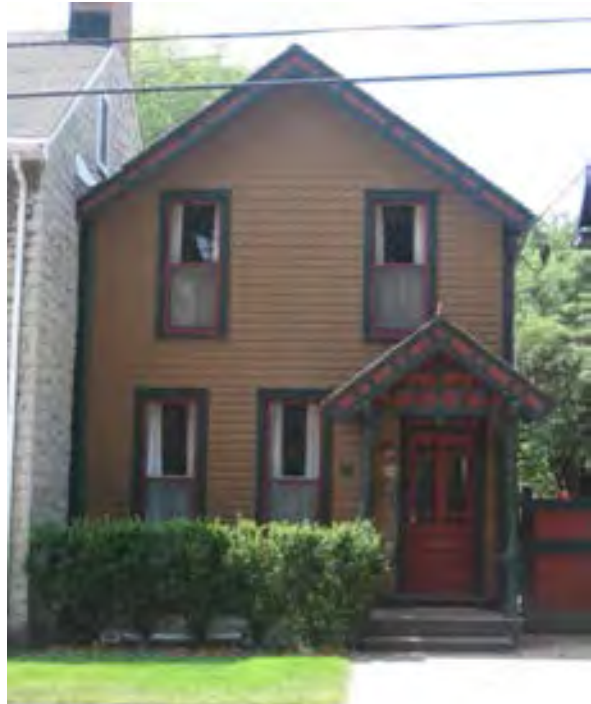
This two-storey wood dwelling, with a front-gable roof, appears on the 1892 fire insurance map without its front porch. Although it has a similar, deep, footprint, it does not appear to be the same structure which appears on Brosius' 1875 map.

The 48 Earl Street building is valued for its design attributes. It features decorative bargeboard and gable trim, as well as fish-scale wood siding on the upper part of its façade. Although the building is overshadowed by the neighbouring 46 Earl stone building, its tall rectangular windows accent 48 Earl's vertical massing.

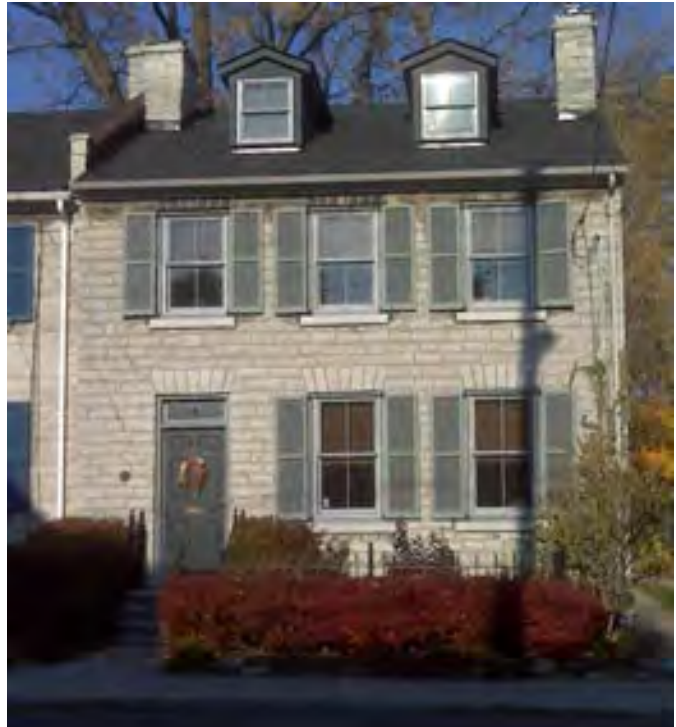
This residence is a simple but dignified building of good proportions. The land on which the house was built was bought by William Johnson in January, 1833 and the first assessment roll (1839) seems to indicate that he was assessed for a building on this site. This two-storey stone dwelling abuts the adjacent building to the west. Its gabled roof with plain raking trim and moulded fascia boards is topped by two limestone chimneys set at each end of the ridge. The Earl Street façade, constructed in regularly coursed rubble stone, is three bays wide with the main entrance in the left bay.* The 49 Earl Street building protrudes only slightly from the neighbouring 53-55 Earl Street double house. As such it forms part of a distinct row of stone houses which share a common setback, side-gable roofs, and compatible massing.

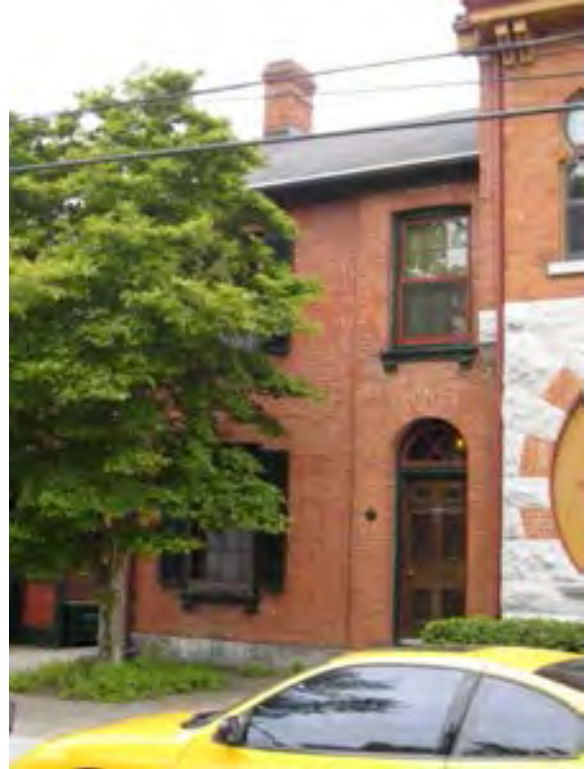
The 50 Earl Street building is valued for its design and contextual attributes. According to Kingston By-Law 89-175, this small, two-storey brick structure was built c. 1875. It now forms an appropriate extension to the neighbouring 52 Earl Street building, erected in 1886. The building's slightly-protruding west bay, with its round-headed entrance; its decorative chimney pot, and its bracketed wood sills, are some of the elements of 50 Earl Street that display a high degree of craftsmanship and artistic merit. The building's 6/6 windows pattern and simple wood trim contribute to its historic character.

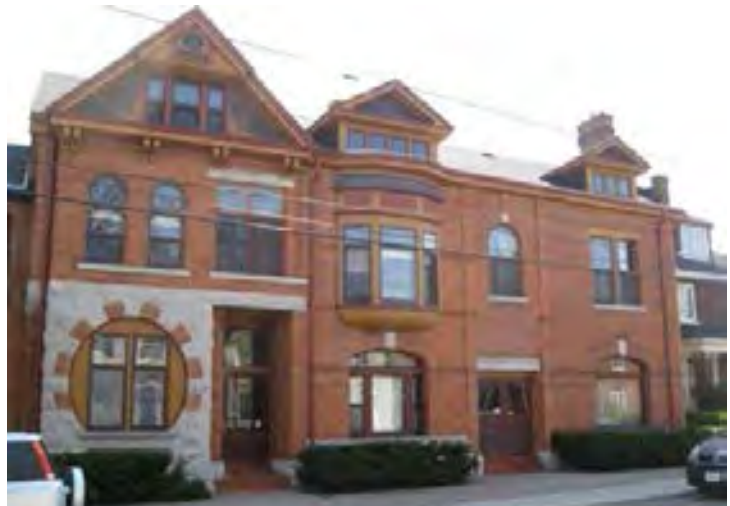
The 52-56 Earl Street building is valued for the its design, associative and contextual attributes.

This building is an important, representative example of Joseph Power's work. His mixture of Queen Anne and Moorish architectural elements, which characterize the 52 Earl Street unit, is distinctive. The same motifs are found on other important Joseph Power buildings in Kingston, including Victoria Terrace at 50-72 Montreal Street, and 197-199 King Street East. The rare combination of 52-56 Earl Street's architectural elements, its characteristic stone circle, and variety of materials that comprise it, makes this building both a prominent and unique element of the Earl Streetscape.*

The recessed entranceway has a decorative glass and wood door topped by a transom with a round stained glass window. A rusticated stone string course provides a lintel for the entranceway. Above it, two stone sills give a strong linear emphasis: one marks a recessed balcony with French doors. The other sill joins two “keyhole” shaped windows which have decorative leaded work in the circular sections.

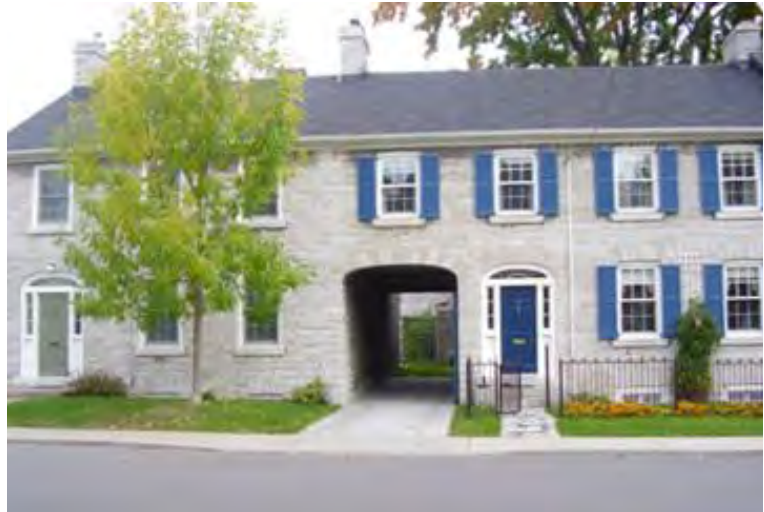
The 53-55 Earl Street building is valued for its design, associative and contextual attributes. Combined with the adjacent 49 Earl Street building, the length of this double house, and its shallow setback, make it a significant part of the Earl Streetscape. The regular and uniform placement of windows along 47, 53 and 55 Earl Street, and their shared low massing, contribute to their presence as an important terrace along Earl Street.

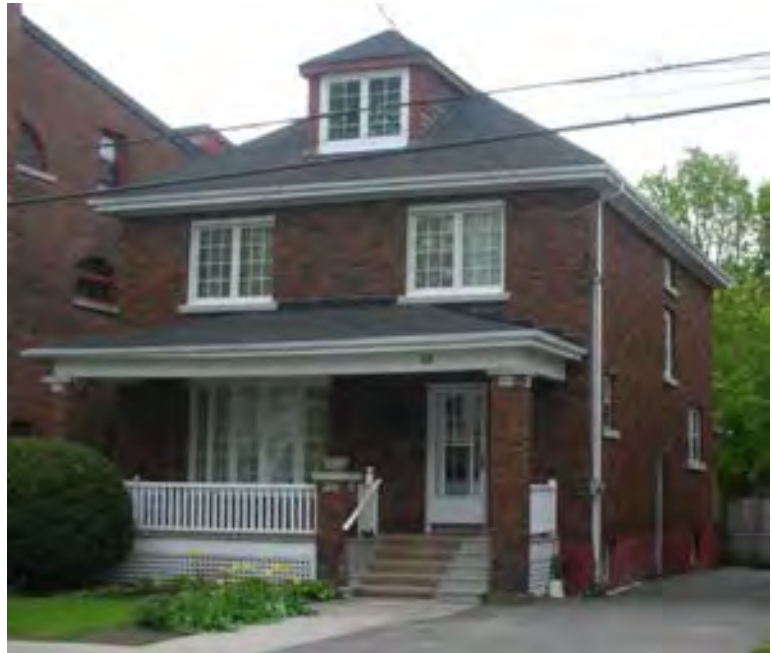
This building contributes to the historic streetscape of Earl Street. Originally constructed in the 1860s, its present design elements date to the second quarter of the 20th century. Those features which contribute to the value of this house include its hipped roof with projecting middle dormer; its full-width front porch, also with a hipped roof and supported by stone columns; and the multiple-pane window pattern.

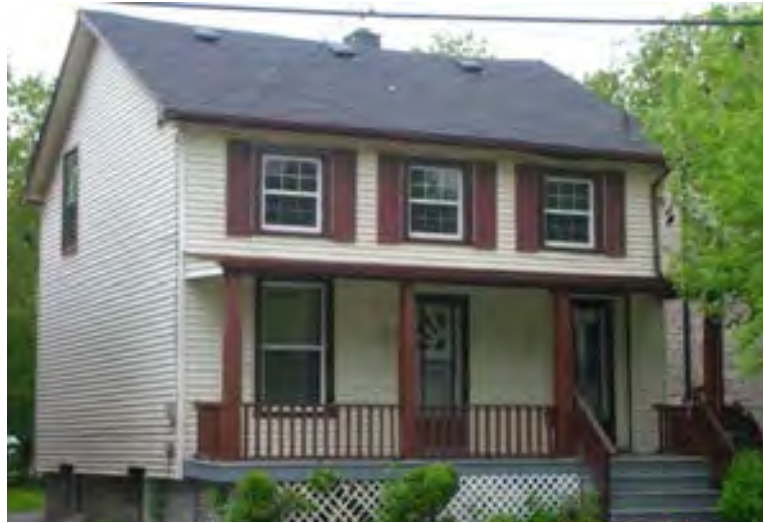
The 62 Earl Street building is valued for its design and contextual attributes. Its clapboard appearance and second-storey 6/6 window pattern help to preserve the historic feel of this 1860s structure. Contributing to this look is the plain front slope of the building's side-gable roof, its full width porch, the simple wood pillars supporting the porch roof, and its stone foundation.

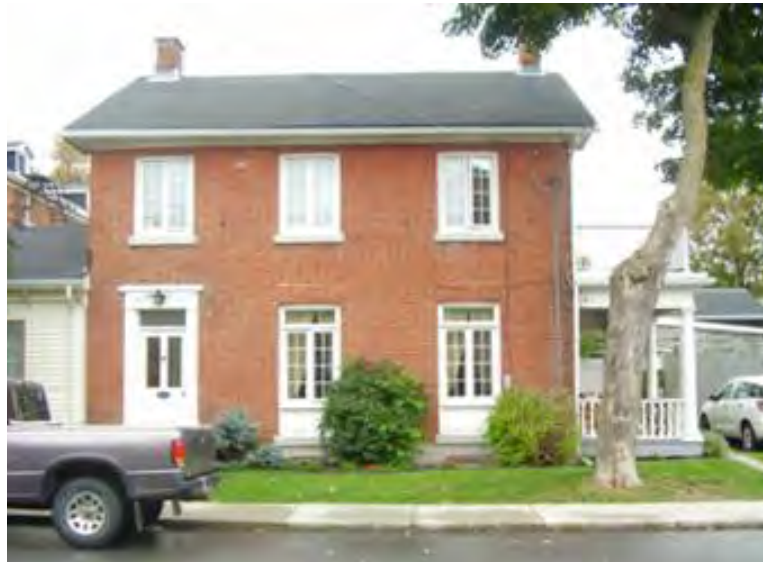
"This brick house was built for Thomas Maxwell, a ship's captain, about 1853. It is not on an 1852 map but it appears in an 1854 assessment roll. Flemish bond is used on the main façade and English bond on the other sides. The low pitched gable roof has a broad overhang with the eaves return, moulded fascia boards and other trim. A brick chimney is inset at each end of the ridge.

"The original door surround has been replaced by a simple wooden entablature supported by delicate pilasters. The transom and long upper panels of the door are glazed. In the lower storey the original French doors have been replaced by double casements with a fixed panel, although the transoms have been retained. Double casements have been used in the second storey as well. All the windows have ashlar sills.*

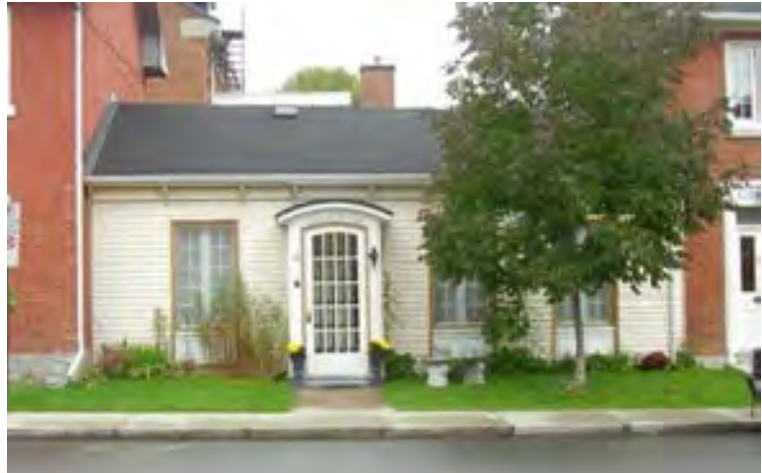
This small frame house was erected between 1875 and 1892.* It is valued for its design and contextual attributes. It is an interesting contrast to the larger brick and stone houses nearby. Its main façade, four bays wide, is of white clapboard. The doorway in the second bay is protected by a later enclosed porch with glazing. On the other bays, the original French doors have been replaced by double casements with a fixed panel below. Under the eaves a row of dentils and a series of S-shaped brackets add elegance to an otherwise simple façade.†

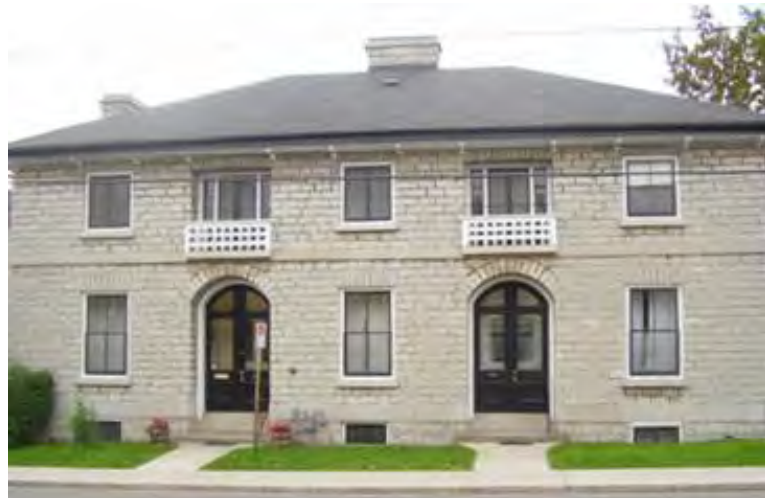
The 66-68 Earl Street building which includes two properties, is valued for its design and its contextual attributes. Its architectural features, combined with its location at the corner off Earl and Wellington Streets, makes it an important and highly-visible component of the Old Sydenham Heritage Area.

This 5-bay, 2-storey stone double house, with its segmentally arched doors and large recessed square windows above, is a slight variation of Kingston architecture of this period. It was built for James A. McDonald, whose wife was assessed for the double dwelling in 1843. The building is comprised of hammer-dressed limestone, with recessed, semi-elliptical entranceways to each side of the central bay. Recessed Venetian windows occupy the bays above each entrance, and are fronted by small frame balconies. There is an ashlar plinth course across the façade and west wall. Brackets are found under the cornice, and the hipped-roof has two wide stone chimneys: one central, the other to the east. The east wall is sparsely fenestrated; the west wall has regular fenestration with a blind arch in the central bay of the first storey and a blind window in the north bay of the second storey. A 2-storey, 2-bay stone wing extends from the rear along Wellington Street. There is a brick chimney on its hipped roof.*

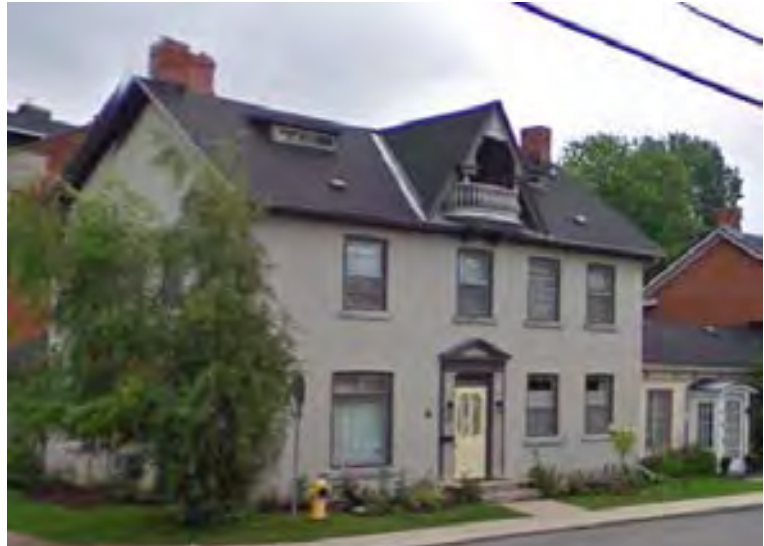
This residence was erected for Christopher Givens in 1847. In 1858 it was sold to Peter Hanley. The Hanley family remained in the house for many years and, as such, it is known to some local residents as the “Hanley House”. Thomas Hanley, a ticket agent for the Grand Trunk Railway depot on the corner of Ontario and Johnson Street, is listed as this building’s occupant in the 1889 directory, along with Thomas A. Hanley, the depot’s telegrapher. That building became known as “Hanley Station”.

Apart from these historical associations, the building is valued for its design and contextual attributes. It has undergone a series of moderate alterations since it was first built, but it remains an important corner building with visual importance to this part of the Old Sydenham Heritage Area. This brick building, painted red for many years, has recently been painted grey in harmony with some of the older stone structures in the area. An important and distinct element of this building is its turn-of-the-century gable dormer, with a peaked-roof and a doorway opening onto a curved balcony supported by brackets.

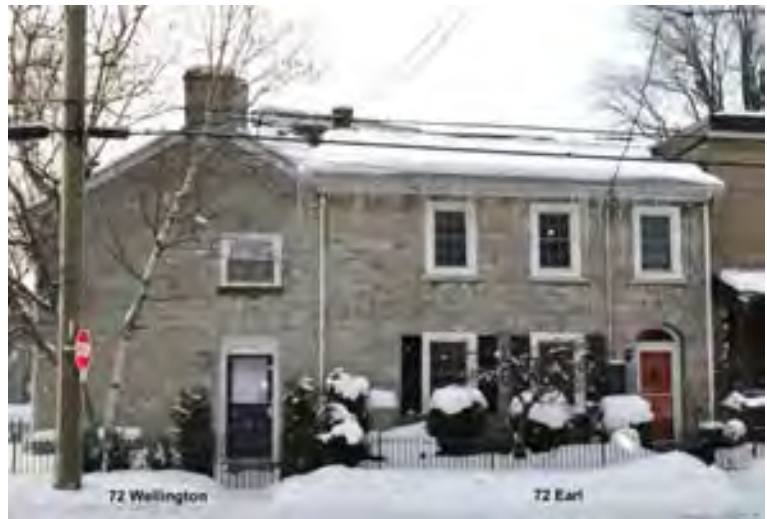
72 Earl Street may date from the early 1840s during the years when Kingston was the capital of the United Province of Canada East and Canada West and housing was in high demand. Its stonework merges with (but appears lightly different from) the end wall of 72 Wellington Street. The footprint of the buildings on the street corner forms an L on maps of 1850. Perhaps one or more were built by Thomas Hunter who bought the lot in 1841 from the Murney family. In 1856, 36-year-old William Sawyer and his family moved in and remained there until his death in 1889.* He was a well known artist and photographer. One of his best portraits is the full length oils of John A. Macdonald hanging in City Hall.

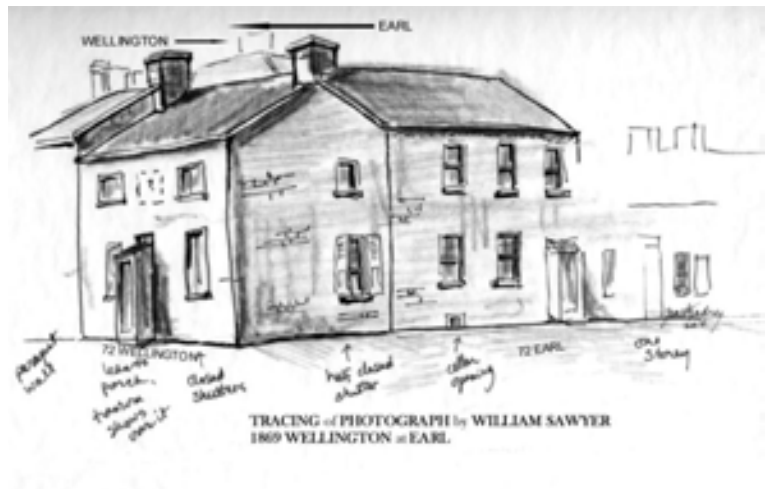
In 1869, he photographed the corner of Wellington and Earl Streets.[†]As the photograph is faded, a tracing is reproduced here.

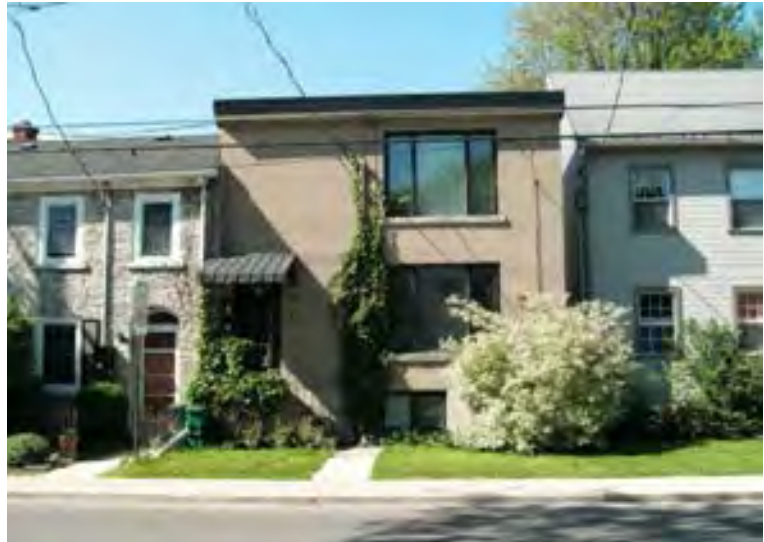
The present 74 Earl Street building is a modern, brick, 3-storey triplex with a projecting flat roof. This building is of no known historical/associative value, and is not considered of architectural or contextual value.

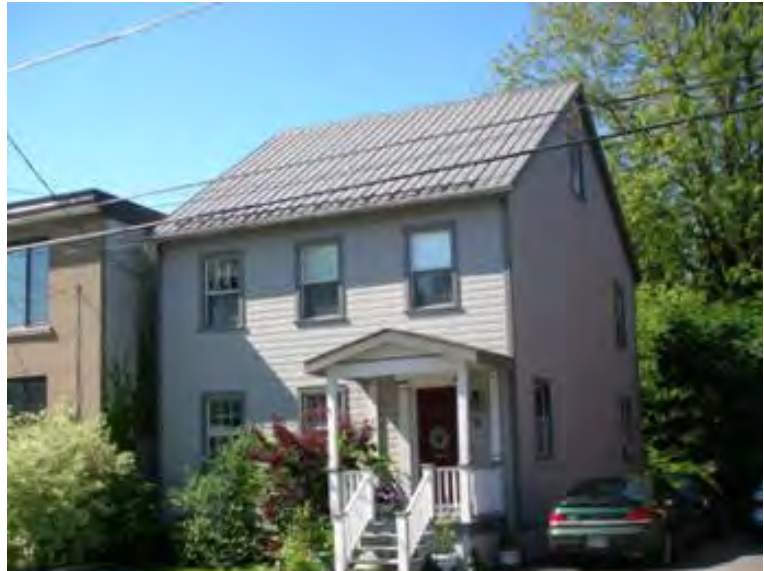
The 76 Earl Street building is a 2-storey, 3-bay wood structure with little ornamentation. The building is clad in modern materials of no heritage value. Its roof, front entranceway, porch, and fenestration are all relatively recent. However, this building retains elements of its original mid-19th century construction, or those of early alterations, which contribute to the heritage character of the Old Sydenham Area.

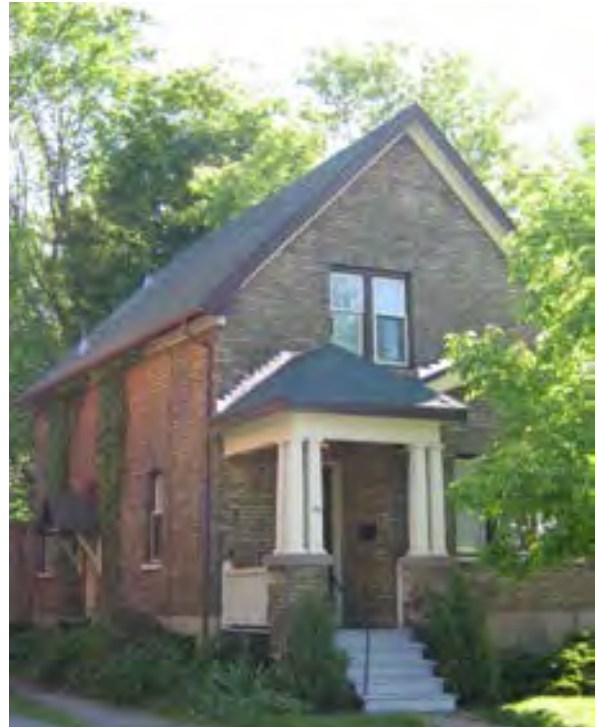
The 79 Earl Street building was constructed in the early 1930s for Robert Chalmers, a government bond salesman, and his wife, Frances. By 1939 it had been purchased by Harry Hart, a manager for Swift & Co. Coal and Wood. This building is a good example of how the vacant parts of many Sydenham Ward lots were gradually filled-in during the first half of the 19th century.

The building's distinguishing design elements include its use of mixed brown and yellow bricks. Its steeply-pitched roof supports tall gable ends. The front gable features a decorative brick diamond comprised of four fingerboard squares. A projecting rectangular bay on the façade's Wellington Street side contains three 3/1 windows. The upper windows are divided evenly into equal panes by vertical glazing bars. A similar window is located above the bay's roof, and a hipped roof that covers a small wood front porch. The building's remaining fenestration matches that of the façade, including two windows found in a shallow dormer, flush with and extending from the exterior wall, found along the building's southeast side. On the northwest side of the building, a side entrance door is covered by a gabled canopy roof supported by wood beams.

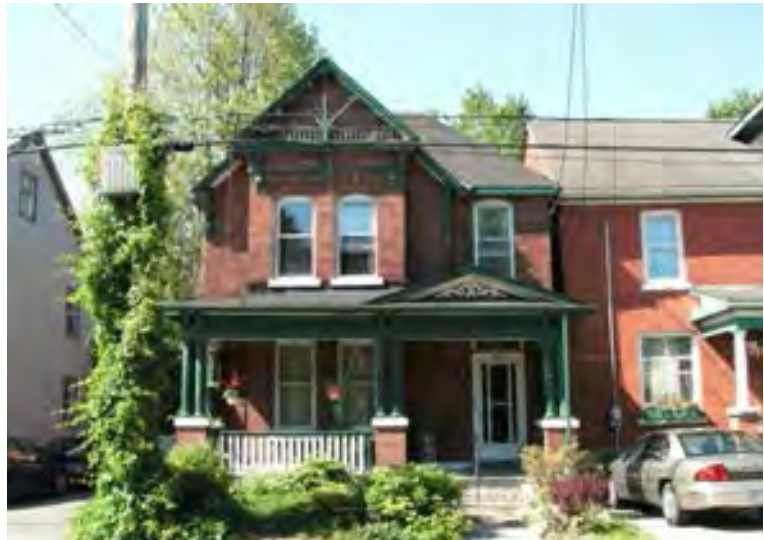
The 80 Earl Street building features many ornate elements that contribute to its historical and contextual values. These features highlight the building's high degree of craftsmanship and artistic merit. This 2-storey, 3-bay brick house has a hipped roof and prominent, protruding, rectangular tower on its southeast side. The tower contains paired 1/1 windows on stone sills, on each storey. Those on the second storey are topped by brick arches, accented with brick keystones. Elaborate woodwork adorns the tower's gable. Its tympanum has a stucco face and features a false balcony with a turned-wood balustrade. Three radial turned-wood arms support the gable's overhang. The false balcony is supported by three heavy wood brackets with decorative scrolls and flutes. The tower gable projects from the top of the building's wider front gable, which covers the southeast two-thirds of the building. The wider gable also features heavy wood brackets at each end.

The building has a full-width wood porch supported sets of three plain wood columns at each side; a set of two near the middle, and embedded wood columns along the façade. Each set of columns has a stone base resting on a brick pilaster. A simple wood balustrade surrounds all but the porch entranceway. The porch roof has a deep overhang with heavy wood brackets and a plain entablature. A pediment is centred over its northwest side, above the porch stairs. Its tympanum contains a scrolling wood relief. The front entrance door is topped by a rectangular transom with stained glass. Above the entranceway door, on the second storey, there is a tall 1/1 window with a slightly rounded top.

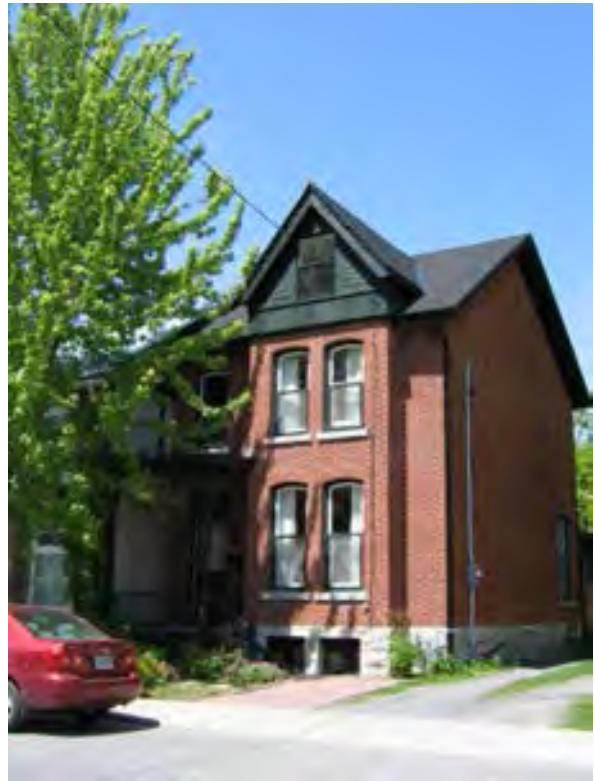
The 81 Earl Street building is valued for its design and contextual values. The building features a projecting tower on its southeast side, topped by a gable containing a simple 2/2 window, and a fish-scale wood face. Paired windows on the main two storeys of the tower are 1/1, with slight arches, and are supported by ashlar sills. Paired, rectangular, basement windows are also found in the stone foundation below these. The building's northwest bay contains a wood porch with a flat canopy roof. Turned-wood spindles comprise its porch and cornice balustrades. The later is supported by curved brackets.

The main entrance features a rectangular transom with an elaborate stained glass design and the building's street address.

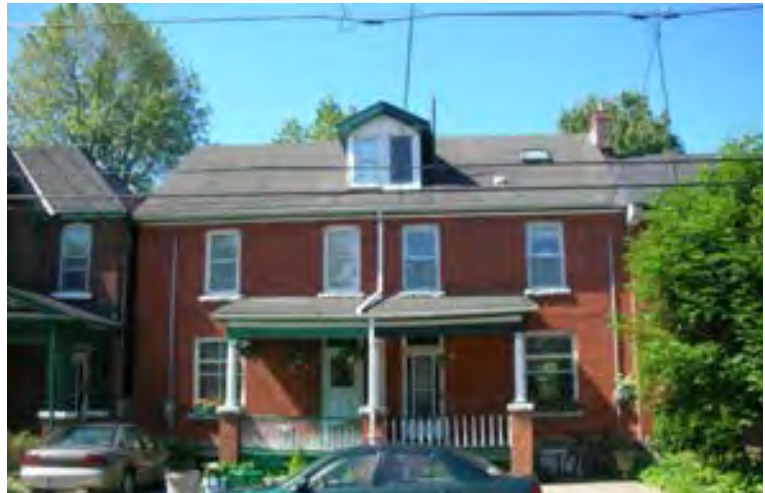
The 82-84 Earl Street building was erected between does not appear on the 1915 version of the updated 1904 fire insurance map. The present structure, which is listed in the 1918 directory, replaced an earlier 1½ storey wood structure that appears on the updated 1911 version of the same map. It appears to have been built for Mary Walsh, the widowed mother of John Walsh, by a possible relation named Thomas Andrew. Andrew acquired the property in 1917, and took a mortgage from Agnes Maule Machar. Machar, a noted Kingston historian and social activist, is well-known for her efforts to provide suitable housing for elderly women with little income. On the same day that Machar discharged Andrew's mortgage, Andrew sold the property and premises to Mary.

The 82-84 Earl Street building is a 2-storey, 4-bay brick double-house with a common front porch in front. The porch covers the two units' entranceways, located on the inner bays of the first storey. The porch is approached from a set of stairs at each side. The forward-slanting, shingled, porch roof is supported by three plain wood columns, with stone bases, set on square brick pillars. Each entranceway has a square transom. All four rectangular second-storey windows are 1/1 with simple wood trim, resting on stone stills. The lower two windows, on the outer bays, are significantly larger. They are plain with rectangular transoms and rest on stone sills. A common dormer centred on the building's side-gable roof contains two 1/1 windows. Each unit has a basement window in its concrete foundation.

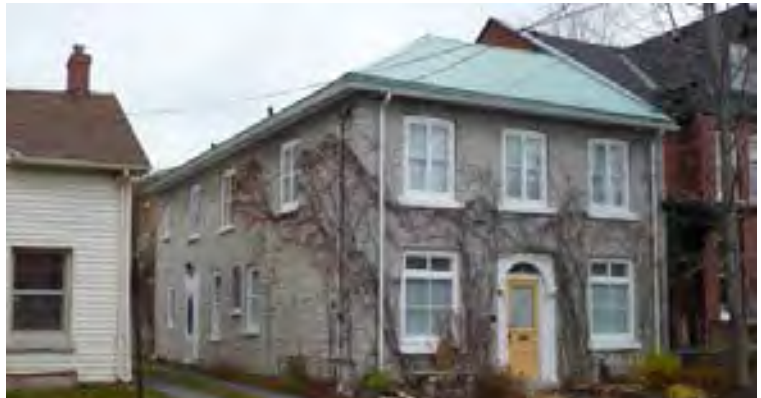
“This two-storey, three bay stone building appears on an 1849 map. Its earliest history is not clear but from about 1854 the first storey was occupied by a series of grocers.

“This roughly coursed limestone building, three bays and two storeys has a hipped roof with a parapet on the east where it abuts another building.

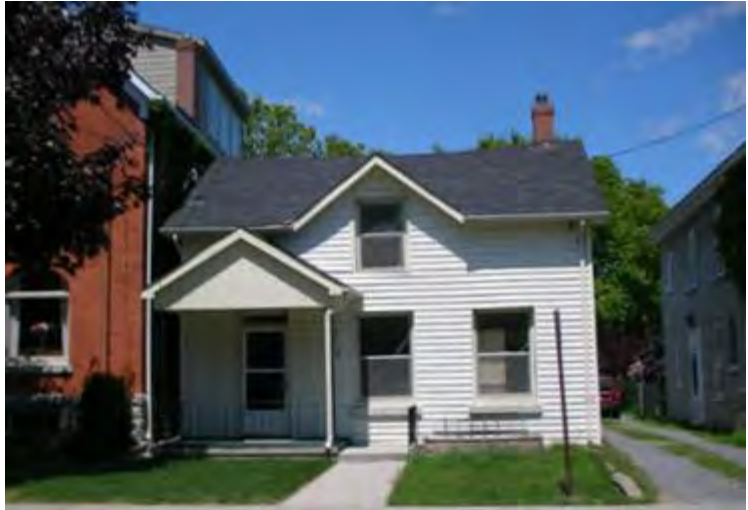
The present building at 87 Earl Street is clad in material of no heritage value. The exact date of this structure's construction has not been determined, although the present building may contain part of a wood structure which had been erected on the site by 1892, and later covered with a brick veneer.* It does not appear on Brosius' 1875 map, which identifies this property as the site of Edward Law Rope manufactory: a distinctly different building.

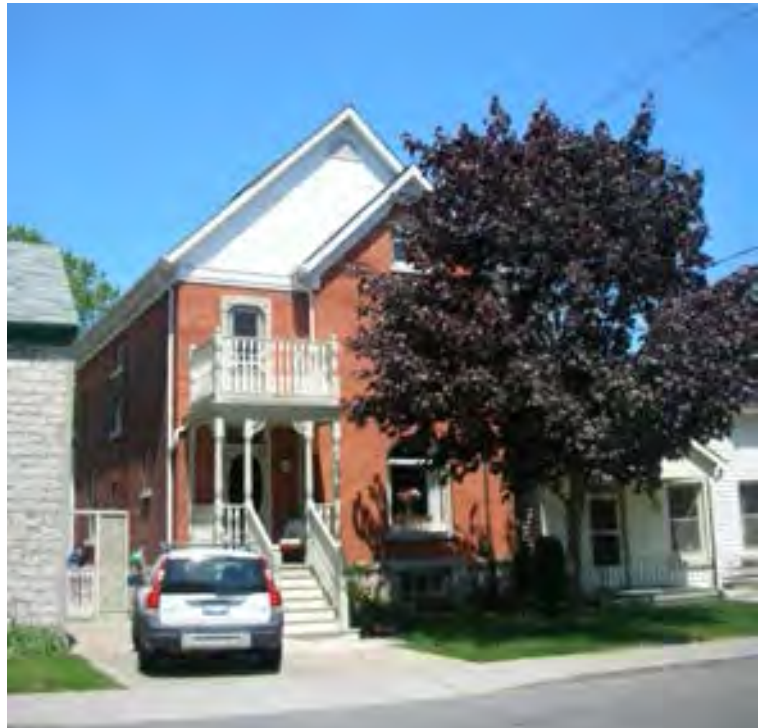
The Earl Streetscape between Wellington and Bagot is lined with structures that vary greatly in design and their years of construction. The 89 Earl Street building reflects the development of the Sydenham Ward in the early 1900s. Until 1911 an older 2-storey stone building, matching and adjoining the adjacent building at 91 Earl Street, occupied this spot. That building was removed when George Boyd, who purchased the property in 1911, built the present structure. By 1927 Boyd owned two automobile garages in Kingston, located at 129 Brock Street and 241-243 Bagot Street.

A number of architectural features contribute to this building's heritage value. Of note is the series of three Romanesque windows, with plain half-round transoms, that occupy the gable and two main storeys of this building's slightly-projecting southeast bay. Its foundation of heavy, hammer-dressed stone provides a distinct, stylish contrast with the building's principle red-brick composition. A keyhole foyer light on the northwest side of the building adds a further, decorative, touch. Turned-wood balustrades on the porch and second storey balcony of the northwest bay add an ornate feel to the building.

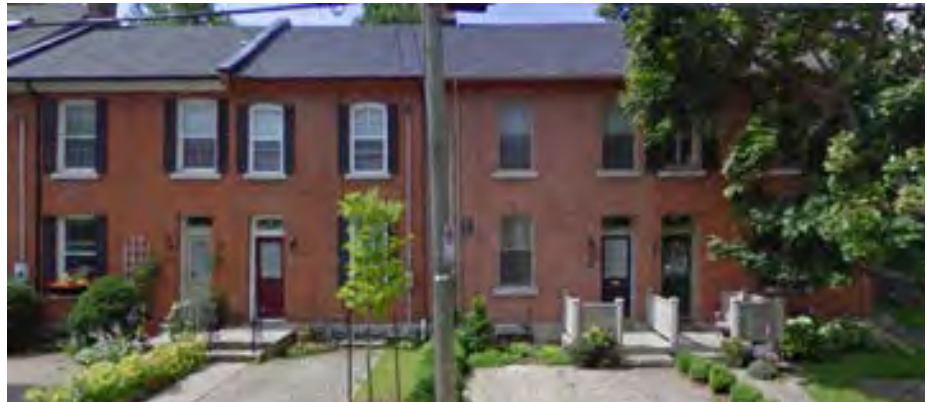
The 90-96 Earl Street property was purchased by Robert Matthews in 1857. His executors, Alex Gunn and R. V. Matthews, divided and sold the land in the 1880s. The present building does not appear in the 1881 Kingston directory, and was likely erected by the executive parties in the spring or summer of 1881.

These buildings are of contextual and design value. They stand-out from the Earl Streetscape as an attractive, orderly row of modest units, with minor decorative touches. Fenestration throughout the building is slightly arched, and topped by soldier-laid bricks. Most windows retain a 2/2 window pattern with simple wood trim. Small transoms accent the front entranceways. The sunken basement window of each unit is not evident, but their stone voussoirs provide a decorative touch near grade level. The roofline of 90-96 is a common side-gable arrangement, unhampered by dormers. Simple brick chimneys stem from its apex at each end; a third is centred between the 92 and 94 Earl Street units. Shallow firewalls are located at each end of the 90 Earl Street unit's roof.

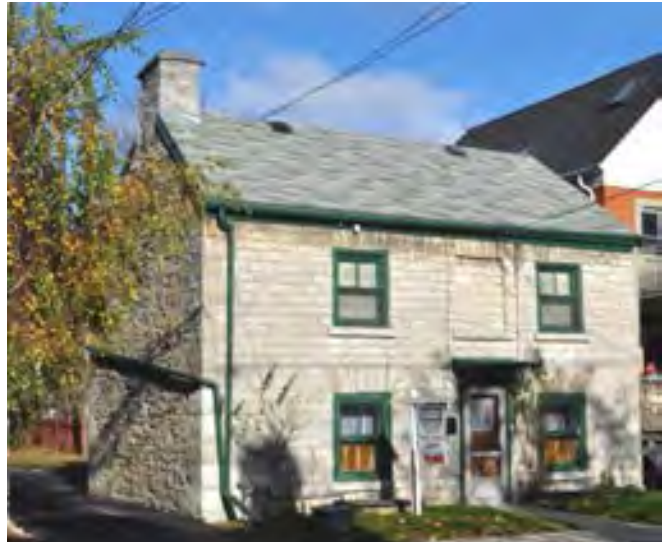
This house is an example of a working-class residence and, as such, does not exhibit expensive refinements or unusual technical innovations. But the survival of the very fabric of this structure over 170 years is testimony to its craftsmanship, despite the numerous tenants it has housed and the challenge to the structural integrity of its east end when a neighbouring stone house was demolished. The asymmetry of the front façade results from interior functional planning but may have seemed less obvious when balanced by the neighbouring two-storey stone house, which is no longer extant.

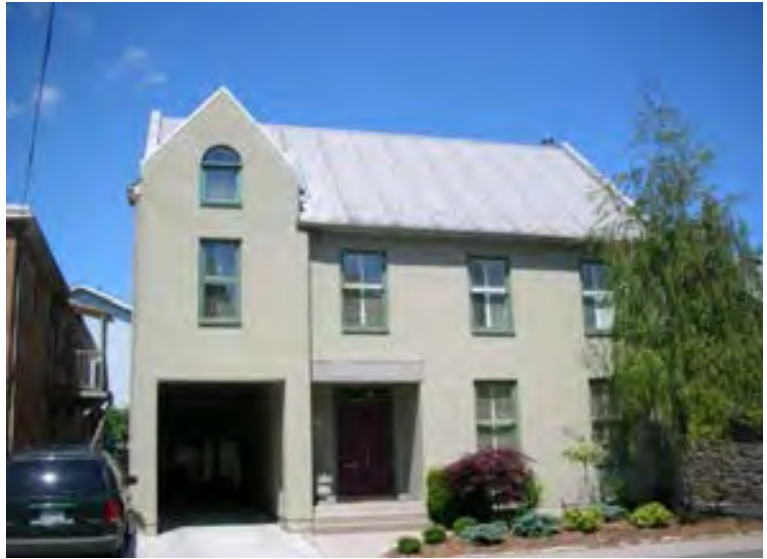
A 2-storey 19th-century wood and roughcast dwelling existed on this site until sometime after 1965. The present building does not appear to be related to that structure. The modern building exhibits some features which blend with the character of the Earl Streetscape, without appearing contrived.

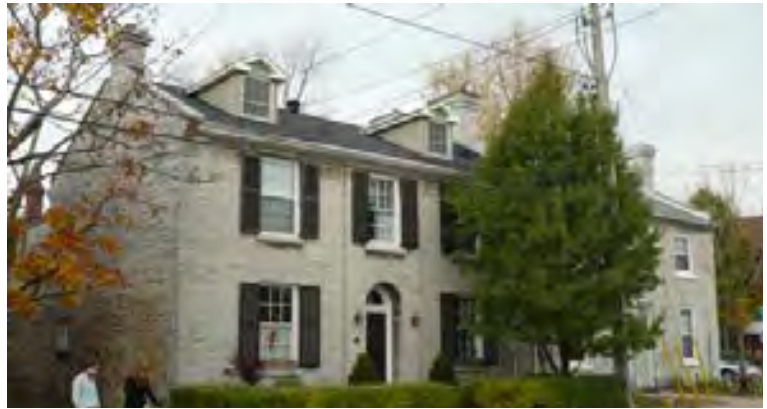
This 3-bay, 2-storey hammer-dressed limestone dwelling was erected c. 1843: about two years after its adjoining neighbour to the northwest. The structure has a round-arched front entrance which shelters a recessed door and half-round transom. The building has slightly projecting corners and a wide ashlar base course. The 6/6 windows contribute to this building's historic character.*

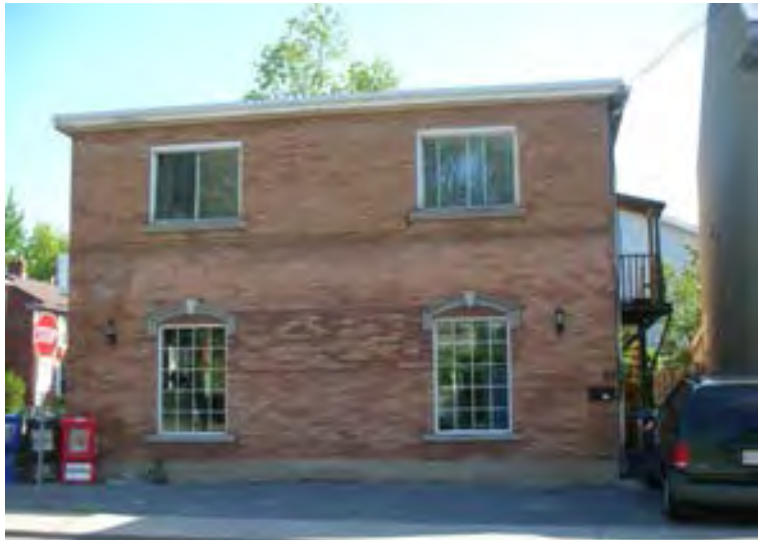
99 Earl Street and 155 (A) and 155 (B) Bagot Street are the three civic addresses within this building, a 2-storey residential and commercial (formerly Andrea's Convenience Store) structure located at the corner of Earl and Bagot Streets. By the early 20th century, but after 1875, a 2-storey wood structure with a similar footprint was located at this corner. It is not certain whether the present structure is related to the earlier one.

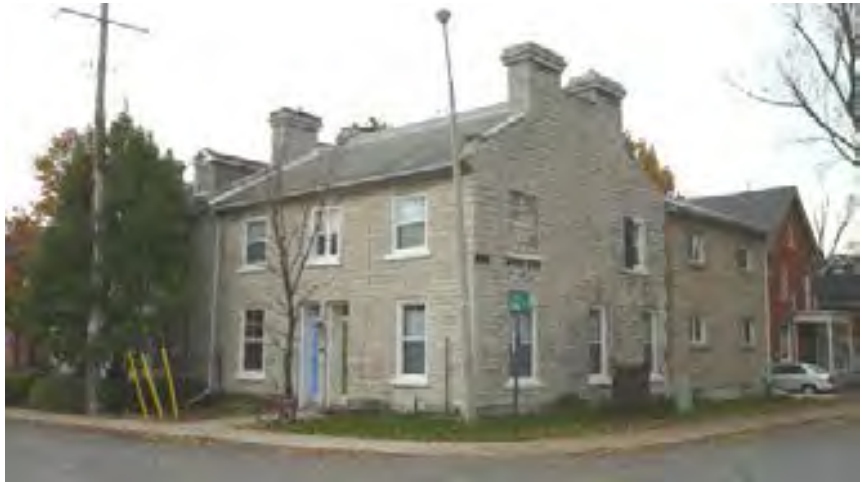
The 100-102 Earl Street building is valued for its historical, design, and contextual values. It is a good example of the buildings erected during Kingston's brief capital period: a time of optimism and economic growth, when one might expect upper-end tenants. The 1841 tax assessment roll lists this structure as unfinished at the time. It originally served, like now, as a double-house. But for a time it was also used for commercial purposes. Thomas Spencer had a grocery store here until 1866 and, at one time, the building also served as an inn.* Its commercial use probably reflected the need to generate revenue after the government left Kingston.

The building's hammer-dressed stone composition, massing, and minimal setback are important to the Earl-Bagot intersection. A striking feature of this house is its dual stone chimneys that rise from its parapeted end walls. The northwest of these is a prominent part of the Bagot Streetscape. The earlier 8/8 and 12/12 window pattern of its outer bays has been replaced, but their stone voussoirs and simple wood trim remain intact. The inner-bay entrances are recessed behind panelled-wood reveals. These entranceways are distinctly narrow, with simple rectangular transoms.
