Property Inventory Evaluation
Earl Street

16, 18, 20, 20.5, 22
Earl Street

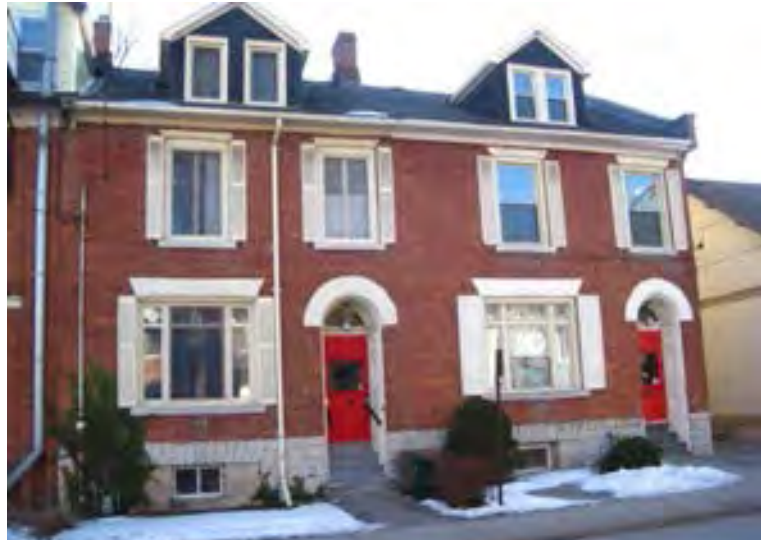
Cartographic evidence, and previous research, suggests that this building might have been erected in 1857.*

This house is valued for its design and contextual attributes. Its massing and setback make it a strong visual part of the Earl-Bagot intersection. These features, and its brick face, are integrated with those of the 144 Bagot Street building to which it is attached. The building's northwest and rear walls are comprised of rubble stone. Of note are the building's entranceways, located at on the northwest bay of each unit, which are recessed under round-headed openings; flanked by panelled-wood reveals, and topped by half-round transoms. Its brick voussoirs and entranceway hoods have been painted in a manner that simulates solid stone. The building has large first-storey windows with tall rectangular sidelights, with transoms above each pane. The second-storey openings are tall and rectangular. Dormers atop each unit's side-gable roof contain paired rectangular windows, the northeast of which is joined by a wood mullion. A brick chimney is centred between the units, rising from the apex of the roof, which also features an outer parapet wall.

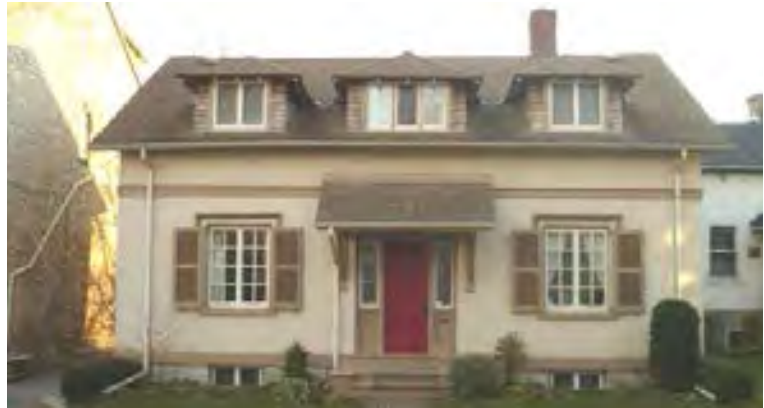
“William Coverdale designed this cottage for Charles Greenwood, a stagecoach agent. Scobell, the builder, began the house in 1849 but the house was assessed in 1852 as ‘unfinished’ although Greenwood had been living in it for two years. This is an unusual and distinctive cottage for Kingston.

“This three bay, one and a half storey, stucco cottage has a central door with side lights and a transom protected by a frame, shed-roofed canopy supported by simple wooden brackets. The flanking windows have casements with eight lights each side, white Tudor dripstone forms over each window and shutters. A frame string course marks the second half storey.

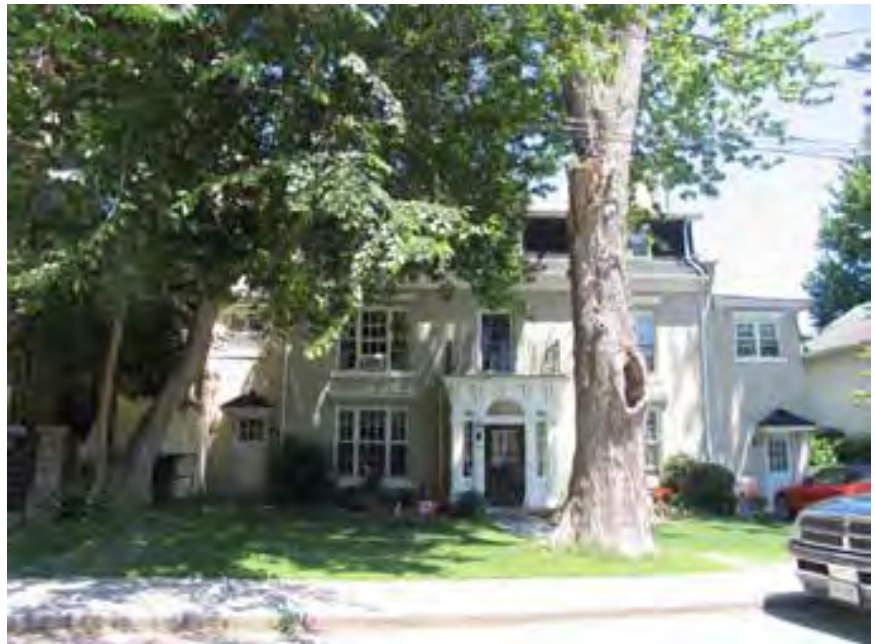
This relatively early stone (now stucco covered) dwelling has no doubt undergone many changes including the addition of side wings and the long shed dormer which does alter the sense of the original roof line and its relationship to the parapet. Still it remains a strong symmetrical composition with the tripartite window units at both stories flanking the centre bay. The tripartite windows are themselves composed of two 4/4 units to either side of a wider opening with a 6/6 sash. These openings all have entablature type hoods. The stylistic influences appear to be Regency and Greek Revival. The vestibule features chamfered columns once again repeating the tripartite form with the semi-circular arched tops of the sidelights and door transom. The paired scrolled brackets have an unusual form and the keystone above the door arch has prismatic relief. There has been an attempt to carry the detailing motifs of the main building into the additions.

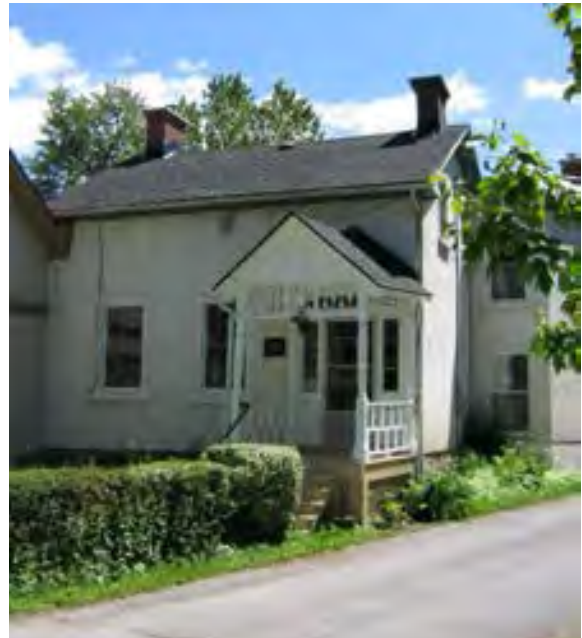
This building's large setback and its offset attachment to the adjacent structure are rare features in the Sydenham Heritage Area. Its façade is flush with the rear wall of the adjacent 114 Earl Street building. In this way the building opens-up and announces the Earl Street entrance to Lily Lane, while at the same time preserving a clear view of neighbouring buildings' side elevation.

This building is unusual in that there is no fenestration on its upper half-storey. But its stucco exterior and cottage-like appearance are appropriate to the laneway context. Twin brick chimneys rise from each side of the building's side-gable peak, slightly insight from each side elevation. The middle and southeast bays of its façade contain replacement windows, but preserve an appropriate 6/6 window pattern. The original windows likely had wood trim and ashlar sills, which have since been capped with metal siding. The building's front entrance, on the northwest bay, is flanked by tall, rectangular sidelights. Its wood front porch has a shingled gable roof, with a wood face gable trim relief. A hanging balustrade features turned-wood spindles with balls, with similar, radiating spindles forming a star-like pattern centred under the gable.

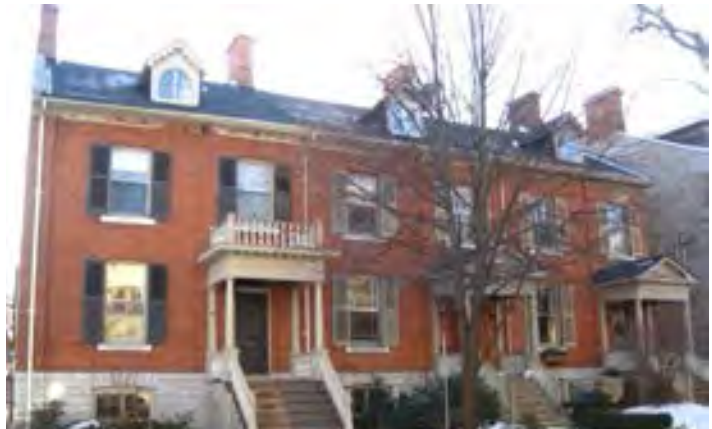
The three units which comprise the 118-122 Earl Street building have design and contextual value. Although it is situated mid-way along Earl Street, between main intersections, the presence of this upscale row-house is enhanced by the entrance to Lily Lane, just southeast of the building. Owing to the setback of the 116 Earl Street building at this intersection, the rubble stone southeast elevation of 118 Earl Street exposed along the lane. Brick window surrounds and a brick chimney found on this elevation compliment the structure's brick façade; brick quoins also extend into the stonework.

The 118-122 Earl Street building has a tall stone foundation supporting each unit's 2½ storeys. It contains moderately-sized basement windows to the southeast of their raised entranceways. Each entranceway bay projects slightly, and contains a front door recessed by two tiers of brick. Although obscured by their porch roofs, each door is slightly arched over a simple corresponding transom. Small gable dormers on each unit contain round-headed windows.

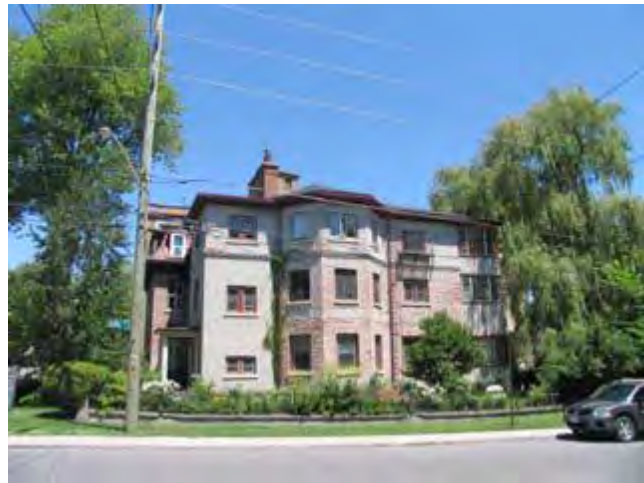
Carruthers Villa with additions; view from southwest

the extension of its Earl Street corners in brick, including the infilling of the original 'inside corner' formed by the tower and the west wing during or after the construction of the apartment complex, it still remains legible within the existing. The additions themselves, though regrettable from a purist perspective, were undertaken with some skill and sympathy for the existing form likely under the auspices of the architect for the Annandale, Colin Drever.

The land assembly by John Carruthers and his son for the family estate allowed for the present expansive complex. In 1873 Carruthers commissioned noted Kingston architect Robert Gage to undertake alterations and additions to the villa. Gage's main contribution to the complex was the stone 2 storey (then) rear wing with mansard roof. This expression of the 2nd Empire style was relatively early for Kingston. It remains largely intact including the mansard roof with patterned slate and bracketed eaves, the rear bay also with bracketed eaves and, in general, the window and door openings though two have been infilled with stone. The porch to the original rear entrance appears to date from the 1920's. It now abuts a further expansion of the later apartment complex.

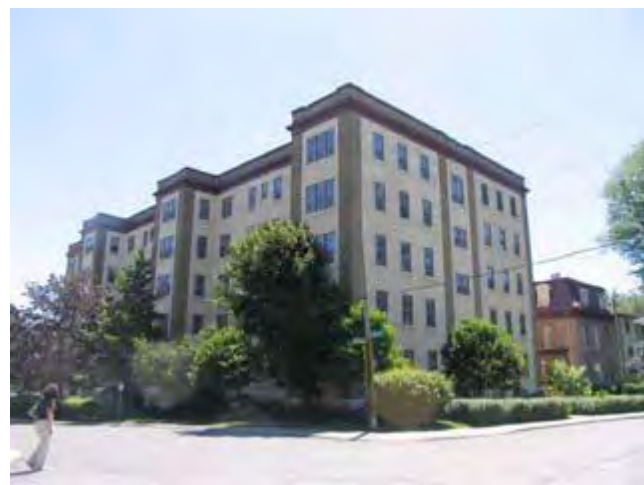
The Annandale Apartments; view from northwest

In creating the three storey Annandale Annex Apartments (on the former site of Chalmers Church) the architect took a further step toward outright modernism with no classical detailing/references but rather a simple box form with the aesthetic effect (very Corbusier like) created by the bands of windows (of the solarium rooms) in the 'field' of stucco. Here however the structure is more traditional (as befits the scale) being brick with the solarium area, stucco on frame. As noted above the brick additions to the original villa, similar in form to the Annex treatment, though interesting in themselves and relatively sympathetic given the situation, are less aesthetically successful when juxtaposed and somewhat denigrating the earlier historic fabric.

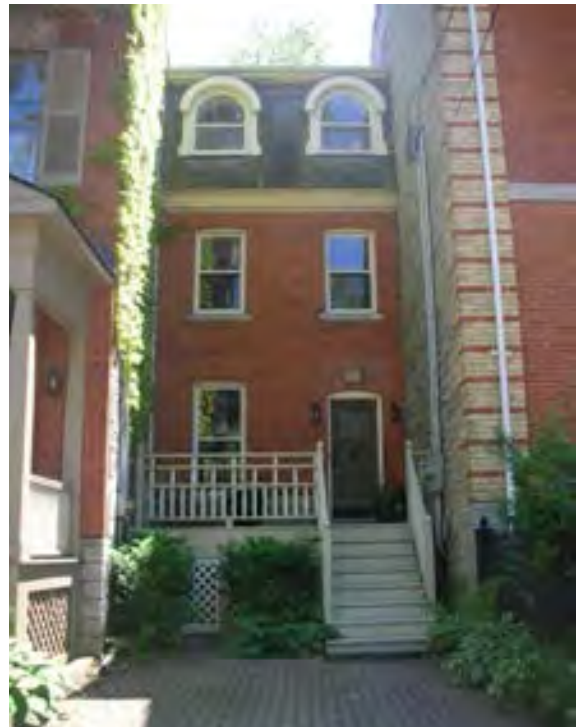
The 126 Earl Street building is a narrow, set-back addition to the neighbouring 128-120 Earl Street building. Flanked by its two larger neighbours, the building supports an uncommon courtyard which also leaves the large buildings' side elevations exposed. The contributing value of this building also derives from its design, which blends appropriately with the 128-130 Earl building, and from its associative value.

The façade of the 126 Earl Street building features a Second Empire style mansard roof face, consistent with the full-width dormer on 128-130, which was also made to mimic that style. A tall wood staircase fronts the building's wood front porch. The porch spans the building's width, as does its wood balustrade. The balustrade consists of plain railings arranged in a chinoise pattern.

The front entrance contains a wood front door with single, square, light. It is comprised of stained-glass with leaded tracery. The light is features a wood hood and sill, and is set above three recessed door panels. The door features what appears to be older metal hardware. Brick voussoirs form a tall arch above the doorway, which contains a centred, square, stone plaque with a floral relief. A 1/1 window with plain wood trim occupies the building's southeast bay. Below this window is a limestone wall, which likely extends from up from the building's foundation, behind the front porch. Matching windows with ashlar sills are found on the second storey.

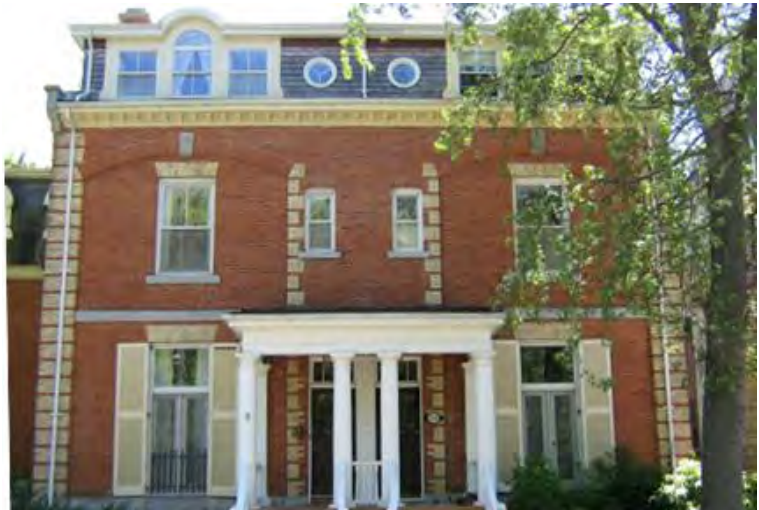
The 128-130 Earl Street building is valued for its design and contextual values, and for its association with the Nickle family.

The design values of this building display a high degree of craftsmanship and artistic merit. The façade of this stone structure is comprised primarily of red brick, divided by an ashlar string course. The outer bays of its first storey contain full-height openings, with French doors below large plain transoms. Wood shutters flank these windows, which are topped by yellow brick voussoirs. Matching voussoirs are found over the second-storey outer-bay windows. They rest on ashlar sills, and are covered by broad red-brick arches that span the width of each outer bay. These are adorned with vermiculated keystones. Spaced yellow brickwork with alternate widths create decorative quoins on the inner sides of each recession, highlighting the buildings centre two bays. These compliment the pilasters at each side of the façade, which feature spaced but uniform yellow brickwork.

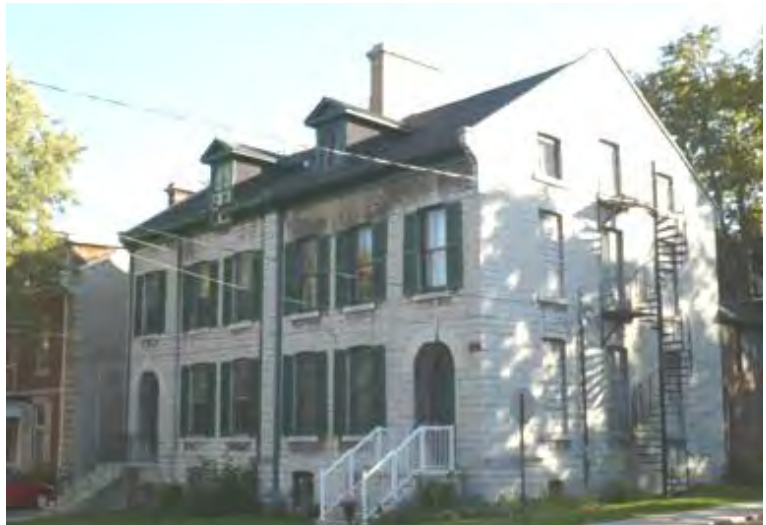
The 132-134 Earl Street building is valued for its design and contextual values, and for its association with the family of Sir John A. Macdonald, Kingston lawyer and Canada's first Prime Minister. The building occupies a prominent spot at the intersection of Earl and Sydenham Street. Its large massing and heavy stone composition are attributes which help to define the character of this intersection.

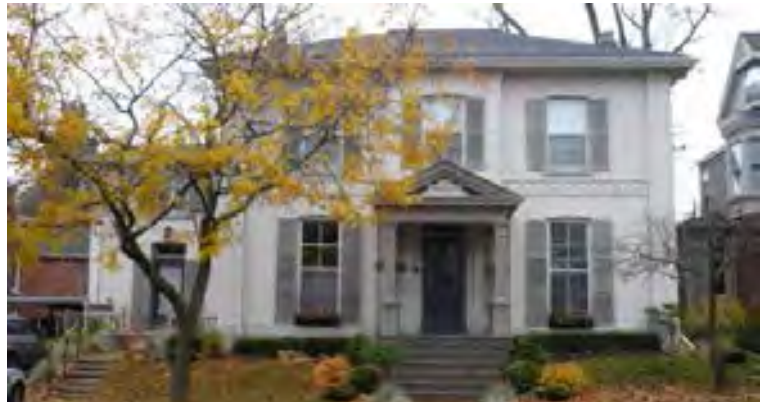
“This brick-faced stone dwelling with its decorative string course was built as a dwelling for Thomas Moore, the merchant tailor who had many rental properties. His family lived here for twenty-one year. Dr. R. R. Macgregor who lived here over forty years converted a window in the east wing into a door to give access to his office.

“This three bay, two-storey stone house with a brick façade has its central door in a two-storey shallow projection and has an end pilaster treatment. The door set in a recessed surround is protected by a Victorian classical porch with pedimented gable, modillions, ornamentation in the tympanum and fluted columns. The large windows in the first storey rest on the hammer-dressed stone foundation and each have two by four sash with large lights. The second storey windows have three by four sash; all façade windows have shutters.

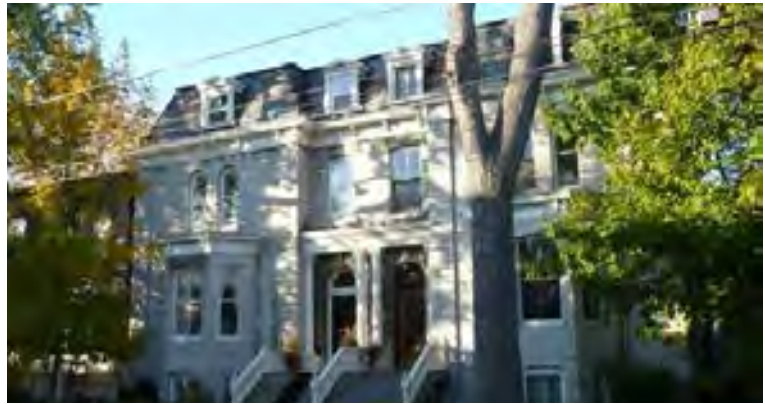
“This double stone house forms an integral part of an important streetscape. Surrounded by houses designed by William Coverdale, which were built twenty years earlier, it illustrates how styles can change and yet blend together.

“Although it is the tallest building in the group, its strong horizontal lines keep it in scale with the others. It was built for Robert and James Gardiner, merchants.

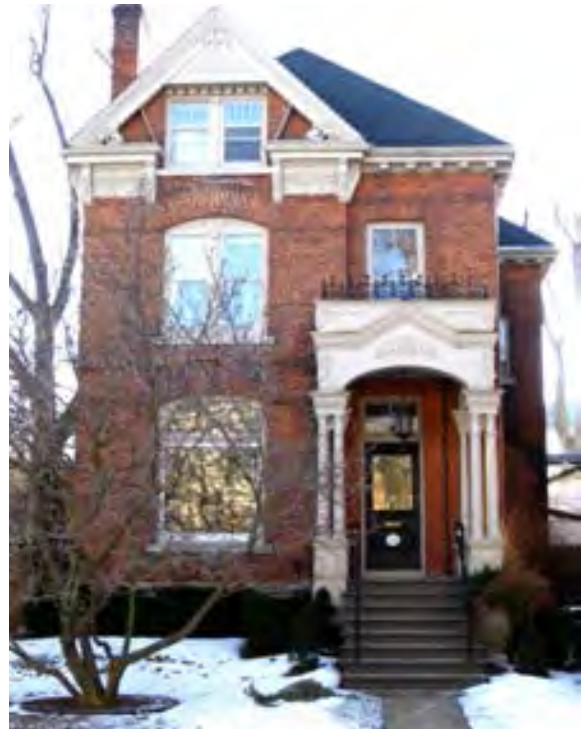
“This dwelling appears as an 1894 addition to an insurance map and its first listing in a Kingston directory is under the name of Edwin Clarence Mitchell. It is an interesting contrast to the ordered symmetry of No. 148 and the unadorned terrace to the west of it. The detailed wood trim is especially noteworthy.

“This two-storey, two bay brick house on a stone foundation has a hipped roof and the soffit has modillions. The first bay projects from the facade and rises to a sharply peaked gable which projects from the hipped roof. The gable has a pediment effect with heavy eaves returns supported by a wide moulded cornice and wooden brackets. The peak of the gable has a decorative wooden in-fill with dentils, and serves as a hood for a pair of small windows in the pediment*

“The first bay has a small window in the foundation, a large window with decorated transom in the first storey and a pair of windows in the second. Both have stone lugsills and sit under elliptical arches with radiating brick voussoirs.

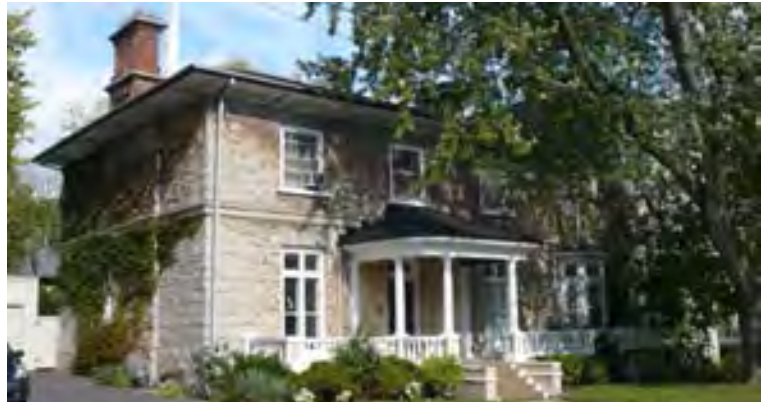
“This residence was built for Samuel Shaw, a merchant and was occupied from 1854 to 1904 by John Kerr. It is one of a group of three buildings of similar design and proportions. It retains its original sash and porch.

“This residence is a two-storey hammer-dressed limestone house with three bays. At one time the stone was painted a brick-red colour. This is now weather worn, and softened. The main entrance, which is rebated, is decorated by a semi-circular moulded arch. On either side are French doors with transoms which open onto a balustraded porch the central portion of which is covered as a protection over the entranceway. A moulded wooden string course divides the upper and lower storeys. The three windows of the upper storey retain their original sashes. The eaves of the hipped roof, which still retains its metal sheeting, are wide and bracketed. A pair of wide brick chimneys with decorative stonework are at the sides of the roof. To the east is a narrow brick addition with an enclosed porch and a tall narrow second storey window.

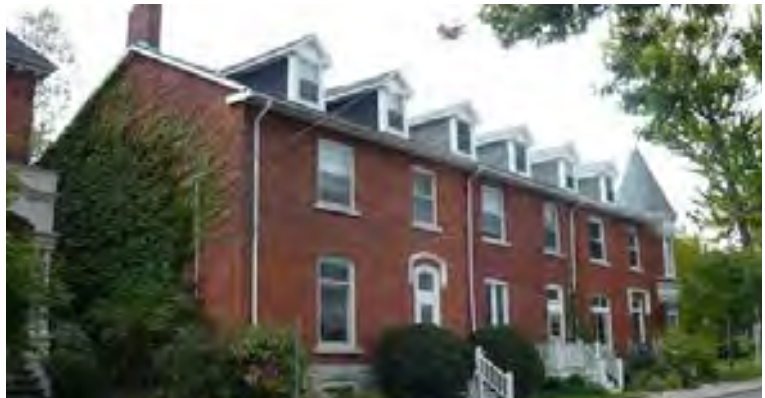
“This brick row of three dwellings, built for William Burrowes in 1867 was called Mozart Terrace and with its corner tower completes a block of notable buildings.

“The three dwellings in this brick terrace each have a window in the first bay and an entrance in the second. A hammer-dressed stone foundation is topped by an ashlar base course and the two-storey terrace has a gable roof hipped at the west end. The first floor windows have segmental arches and transoms; on the second floor they are flat-arched. Each dwelling has two gable-roofed dormers on the front slope of the roof.

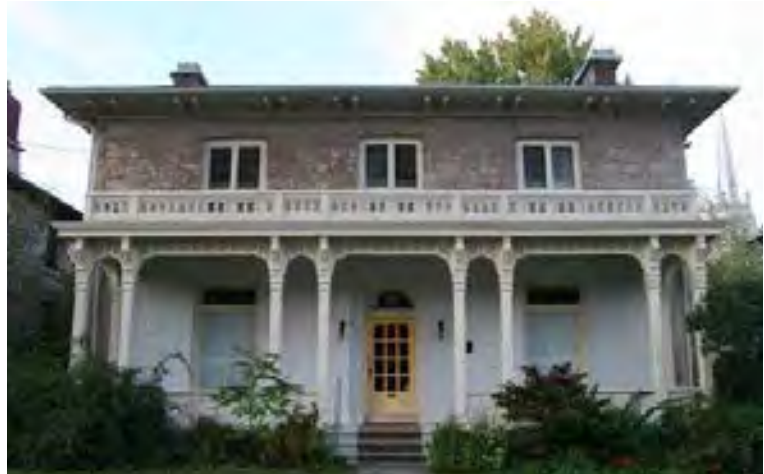
“This residence was built for John Fraser and Catharine Mowat Fraser. It the middle one in the group of three square bracketed houses on Earl Street.

“This is a two-storey, square, hammer-dressed limestone residence of three bays. The entranceway has a semi-circular archway finished with two rows of voussoirs, one slightly recessed, and a fan-light. It was flanked by French doors with a transom. These have been replaced by fixed glazing, the transom being stained glass. A fretwork balcony (c. 1910) runs the length of the front elevation and is topped by a balustrade. This with the string course divides the Upper and lower storeys. At the upper storey, three pairs of French doors with vertical off-centre glazing bars open out onto the balcony. The hipped roof with wide bracketed eaves and a pair of brick chimneys capped with decorative stone, crown the building. There is a later addition to the west which is well set back from the front of the house. The stone has been painted grey.

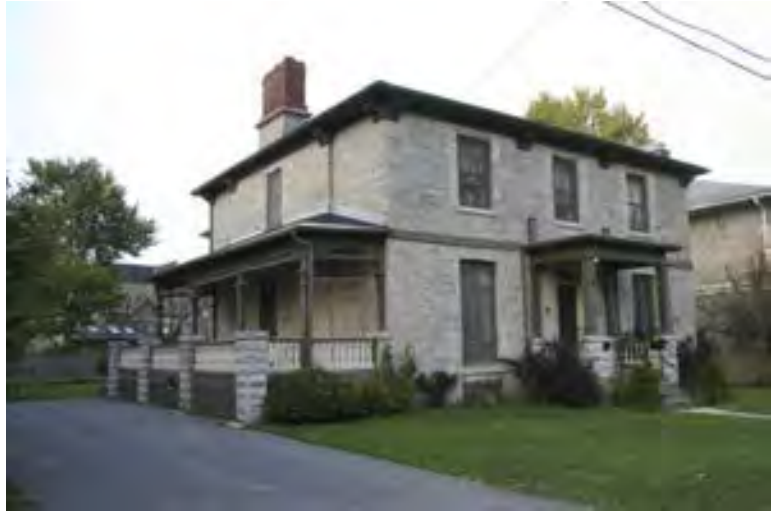
“This home was built for William Grant. John Breden bought it in 1870 for his daughter, Mrs. Henry Cunningham. In 1876 a fire destroyed the upper storey which was subsequently rebuilt. In 1932 the house became the Agnes Maule Machar Home for Women which it still is to-day. It is the westerly house of the group of three houses on Earl Street.

“This residence is a square bracketed three bay house of hammer-dressed limestone. It is of two storeys and on the lower there are French doors with transom and vertical off-centre glazing bars on either side of an arched and fan-lighted entrance-way. The upper and lower storeys are divided by a stone string course across the front elevation. Sash windows, later than the original, are in the upper storey. The hipped roof has wide eaves and is bracketed and the bed mould to the eaves soffit is curved around the brackets where these abut the stone work. A pair of brick chimneys, originally both with stone caps, sits atop the roof. The porch, which is a later addition, covers only the entranceway. To the west is a fretwork porch which runs along the side of the main section of the house. The front section of the house has been painted a pale grey but the natural stone has been retained in the rear sections.

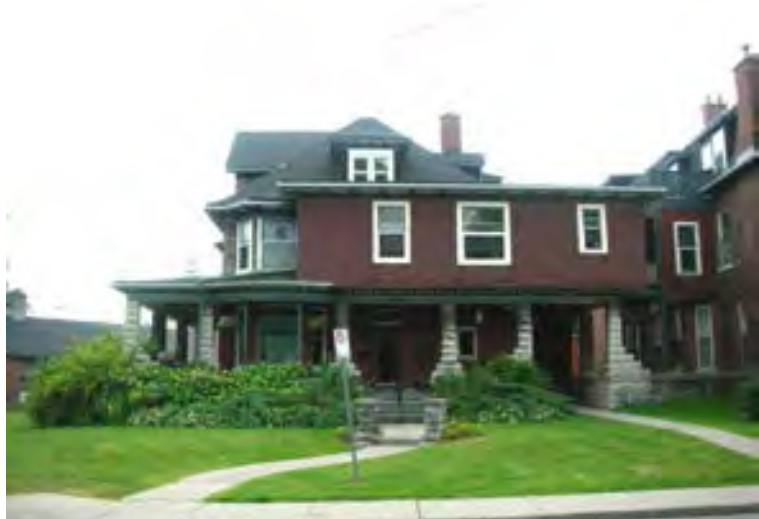
The 170-172 Earl Street building is 2½-storeys and consists of brick on the first storey, and wood shingles on the second. It features a pyramidal hipped roof supporting dormers, and a prominent front porch surrounding the structure's Earl and West Street elevations. The porch is distinguished by large, rough-hewn stone walls and pillars. It contains a distinctive rounded protrusion in-line with the building's full bay window, on the Earl Street side. A second full bay window is found on the structure's West Street elevation. Its second storey is fronted by a balcony, atop the porch roof, with a simple wood balustrade. The main component of 170-172 Earl Street's roof is pyramidal, with dormers containing paired 1/1 double-hung windows. Two of these dormers face Earl and Clergy Streets. Like the main roof they feature large overhangs with simple wood dentils. A larger dormer with a wood shingle face is also found on the West Street elevation. A balcony behind the main roof is located on top of the building's 2-storey rear extension. A revised 1911 version of the 1908 fire insurance map has the 170 Earl Street building drawn by hand, with the inscription "To be 2 ½ wood / Brick 1st / May 1911." The building was likely erected by a grocer named Albert Glover, who had purchased the property at that time. In 1926-27 Glover, who also owned the neighbouring 174 Earl Street building, converted it to a 9-unit apartment building which became known as "Glover Apartments". In 1930-31 part of 170 Earl was converted in to

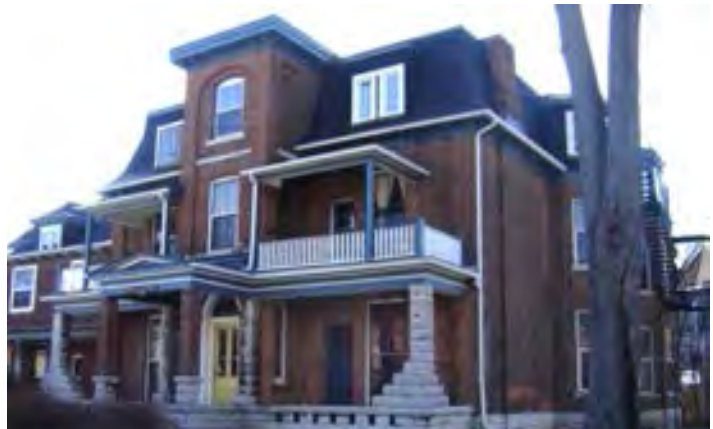
West Street side contains a large window with 24 equal-sized panes. The dormer on the Clergy Street side contains a modern window of no heritage value. The tower itself has a flat top, which terminates at the level of the roof. Wood dentils and small wood brackets are found under on cornice of both the tower and mansard roofs. Brick pilasters define the outer sides of the structure's façade.

The Clergy Street elevation of 174 Earl Street contains two full bay windows with angled returns, each of which is topped by projections from the mansard roof. The first and second storey of each bay contains tall and narrow 6/6 windows on their returns, and 12/12 windows on their fronts. 12/12 windows are also found closer to the rear of the building. Windows in the mansard roof on this elevation of more modern, and are of no heritage value. An extension from the back of the building on the West Street side contains a similar full-bay window with matching fenestration and a small wood second-floor balcony.

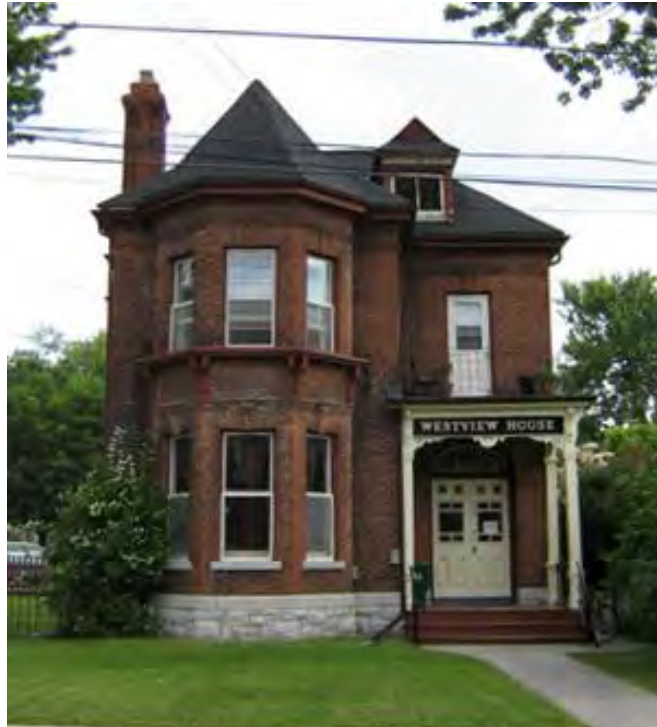
The 179 Earl Street building is valued for its design and contextual attributes. The building is located at a prominent intersection where West, Earl and Clergy Street meet. In style and composition it complements the 170-174 Earl Street buildings across the street. Its façade and western elevation are a main component the Earl and Clergy Street intersection, while its eastern elevation is highly visible from the corner of West and Earl Streets.

sides of each door. A similar arrangement is found to each side of the tower on the second-storey balconies, although the windows on this level are shorter, set-higher, and rest on stone sills. The balconies are covered by shingled roofs supported by plain wood pillars. The second and third storeys of the tower are separated by an ashlar string course. Both storey have 4/4 windows, on stone sills, on the façade side. Brick pilasters on each side of the tower meet at a rounded-arch above the third-storey window. Each side of the tower features a recessed brick panel with circular brick reliefs. The mansard roof has a dormer to each side of the tower. The dormer on the West Street side contains a large window with 24 equal-sized panes. The dormer on the Clergy Street side contains a modern window of no heritage value. The tower itself has a flat top, which terminates at the level of the roof. Wood dentils and small wood brackets are found under on cornice of both the tower and mansard roofs. Brick pilasters define the outer sides of the structure's façade.

The Clergy Street elevation of 179 Earl Street contains two full bay windows with angled returns, each of which is topped by projections from the mansard roof. The first and second storey of each bay contains tall and narrow 6/6 windows on their returns, and 12/12 windows on their fronts. 12/12 windows are also found closer to the rear of the building. Windows in the mansard roof on this elevation of more modern, and are of no heritage value. An extension from the back of the building on the West Street side contains a similar full-bay window with matching fenestration and a small wood second-floor balcony.

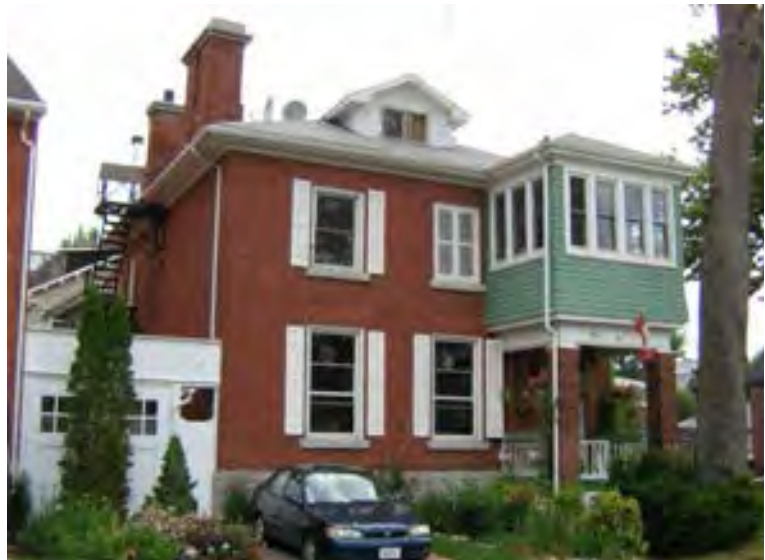
Although seeming to be later in date because of the dominant, 20th-century, two-storey porch, the 2½-storey brick house is likely the three-bay one shown with a hipped roof at the corner of Earl and Clergy Streets in the 1875 Brosius bird's-eye view. It is not on Walling's wall map of 1860 but does appear on the Innes map of 1865. It is possible that 34 Clergy Street was a service wing for this house, as an internal link is shown on the fire insurance plan of 1892.

The style is fundamentally Classical.

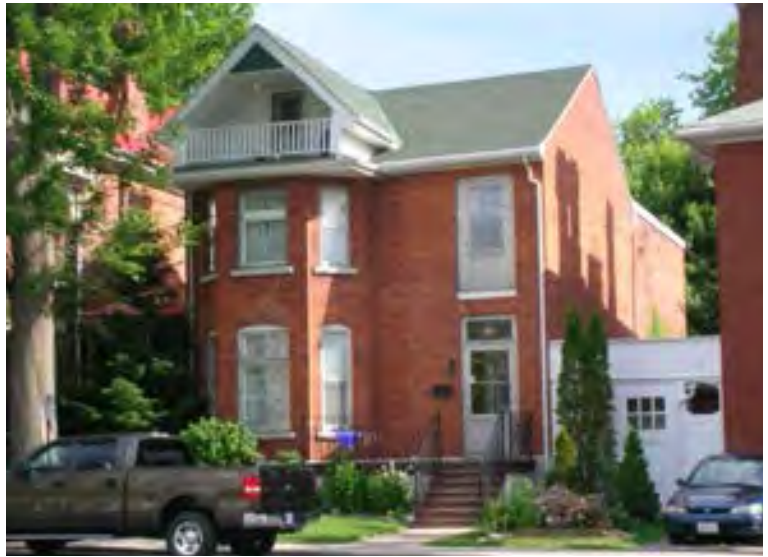
This 2½-storey red brick structure has the hallmarks of a late 19th or early 20th century house with a multi-storey bay window topped by a frame balcony with a gable roof and recessed door. The stone foundation of the bay window has the typical rough-face of this period. The presence of a door on the upper storey of the main house suggests it once opened onto a two-tiered porch. Change is also indicated by the difference in the shades of the brickwork to the west of the upper and lower doors. Adding to the puzzle is the older-looking limestone rear wall visible from the lane, which runs east-west through the Earl, Barrie, William and Clergy block. At right angles and attached to this wall is a two-storey brick wing, shown on the 1892 fire insurance map. On the 1875 Brosius bird's-eye view, a three-bay, two-storey house with a gable roof is shown and may, in fact, be the same building noted on the Innes map of 1865. It is possible that this early house was remodelled at the turn of the 20th century into the house we see today.

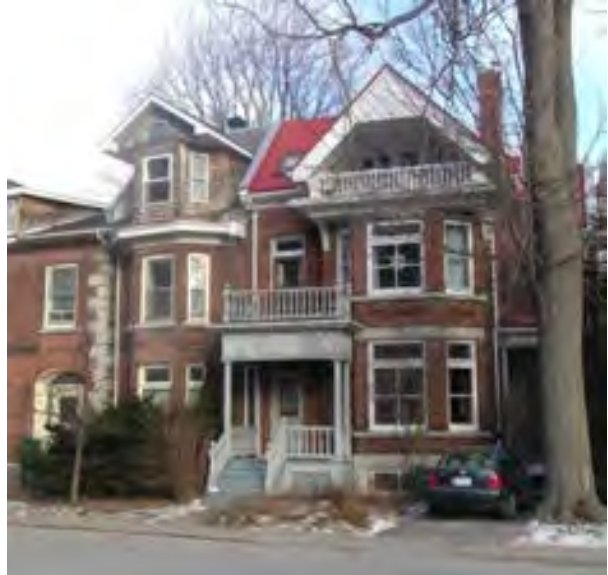
A large complex structure, 193 Earl Street does not appear on either the 1875 Brosius bird's-eye view or in the 1889-1890 city directory but is on the fire insurance plan of 1892 and, in 1895-1896, was occupied by Alexander Robinson. The fire insurance plans from 1892 to 1963 show 193 Earl in an L-shape footprint with a solid internal line between the area accessed by its porch and door and the two-storey bay window plus shingled dormer attached to its west. The latter unit is shown with an internal access to 195 Earl Street, an older double house. This helps explain why the roof of 193 Earl is slightly higher than the portion immediately to its west and is separated from it by a parapet and corbel arrangement.

The basic form of the house is in a common, late 19th century pattern of an off-centre entrance sheltered by a wooden porch, the roof of which acts as a balcony for a second-storey door, as well as a multi-storey bay window with a gable-roofed balcony. One of the unusual features of this late Victorian house is the ornamental relief on the fascia boards on the main balcony and on the triangular part under the roof peak. A turned balustrade runs across the balcony, which is recessed into the main roof. Under the cantilever of the balcony are brackets matching those found on the main cornice. Supporting the balcony floor at each end is a large wooden bracket. Tucked into the L form on the east is a verandah. The finely tooled stone trim, decorative brickwork and terracotta ornaments are particularly attractive.

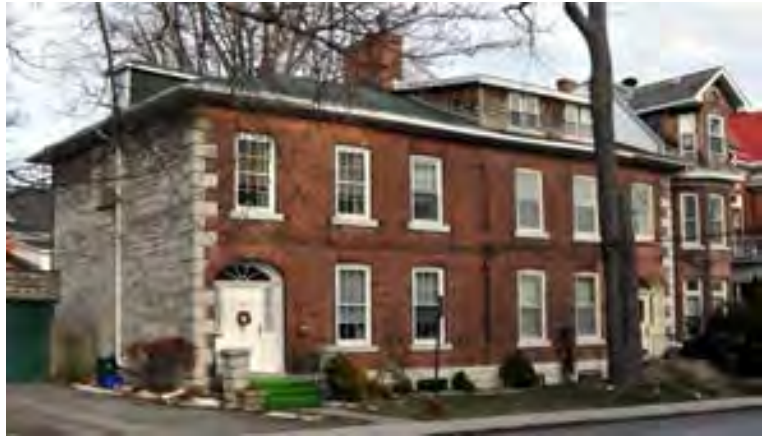
This brick, two-storey, six-bay double house is not on the Gibbs map of 1850 but is shown on the 1860 Walling wall map, as well as the Innes map of 1865. On the Brosius bird's-eye view of 1875, the hipped roof is portrayed. At that time, the two-storey bay window unit attached to the east of 195 Earl is not shown but does appear on the fire insurance plan of 1892. It is attached to 193 Earl Street but the internal link is with 195 Earl Street.

The exposed west end wall is limestone with well formed quoining. Each half of the early house has three double-hung windows in the upper storey; a string course of brick; two windows in the lower storey and a doorway (next to the quoining) with an ellipse fanlight and sidelights; and two basement windows inserted into the stone foundation. In the dividing area between the halves is a brick chimney on the roof and blind recessed narrow panels, one in each storey of the wall. An unusual detail is the curve of one of the stone quoins, cut to accommodate the brick voussoirs over the fanlights.

The original glazing bars are missing in the windows, fanlight and side lights. A turn of the 20th century door is in place. The sill of the widow over the doorway is different than the stone sills elsewhere, perhaps because a later porch has been removed and the affected brickwork replaced. A later shed-roof, shingled, dormer has been positioned in the front slope of the roof. A parapet is placed next to a one-bay addition composed of a multi-storey bay window topped by a shingled large dormer. The addition is late Victorian in style while the main building is Classical in form and detailing.

The original glazing bars are in place in the windows (six over six), fanlight and sidelights. The door is six fielded, solid, panels with a bead running vertically in the centre. A pair of later stone piers is found on the entrance steps.

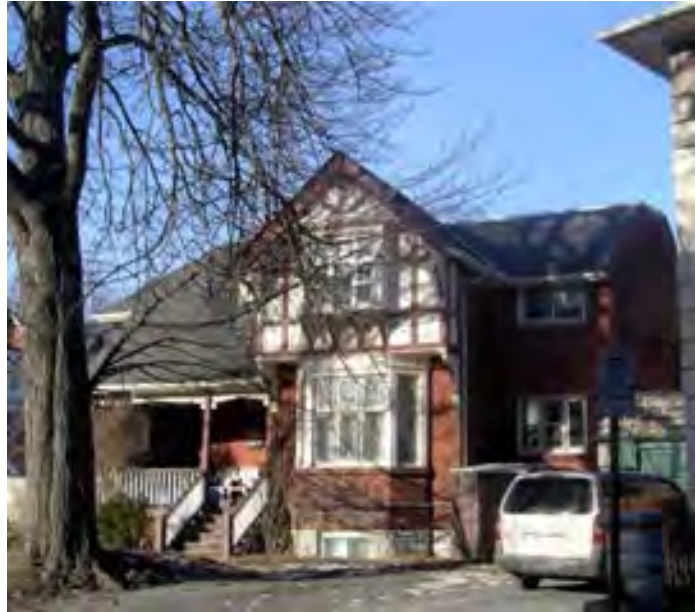
This corner property contains no buildings on the 1875 Brosius bird's-eye view of the city. The city directory of 1889-1890 and the fire insurance plan of 1892 suggest that this red brick, two-storey house was built as a single dwelling (now a double -- the other half being 229 Barrie Street) facing Earl Street. However, by the directory of 1904-1905 and the fire insurance plan of 1908, the street number of 229 is given to the facade facing Barrie Street. Furthermore, a two-storey brick addition (not present on the plan of 1892) is shown on the east and running to the lane, which splits east-west the Earl, Barrie, William and Clergy block. It is likely the single house became a double around 1900.
