**Property Inventory Evaluation**  
**King Street East**

## Property Inventory Evaluation – King Street East

### 31 – 95 King Street East

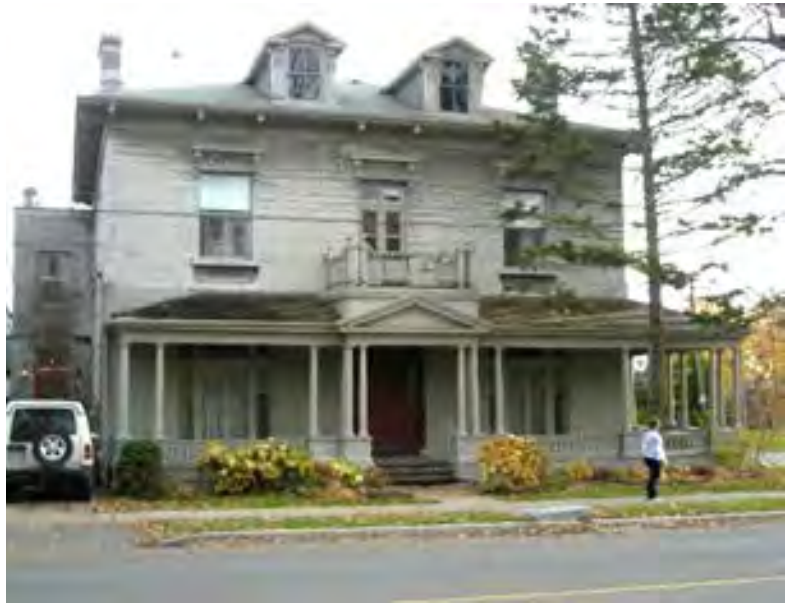
**31 King Street East**

“This two-storey stone dwelling, built in 1853 to a design by John Power, is important to the streetscapes of both Emily and King Street. With its neighbours, it is an interesting study of the ‘cottage orné’ style popular in the 1850s.

“This two-storey, three bay, hammer-dressed stone house has a one-storey, frame, open verandah around the north and west walls. The hipped roof of the verandah is supported by pairs of Tuscan columns rising from paneled piers joined by a turned balustrade. Over the central entrance to the verandah is a pediment rising to a balcony which has triple posts with finials at the front corners of the delicately turned balustrade.

“The pellet mould design is repeated in the frieze and brackets support the cornice. The hipped roof has three large stone chimneys with the circle pattern in stone under the corbelled tops and decorative pots.

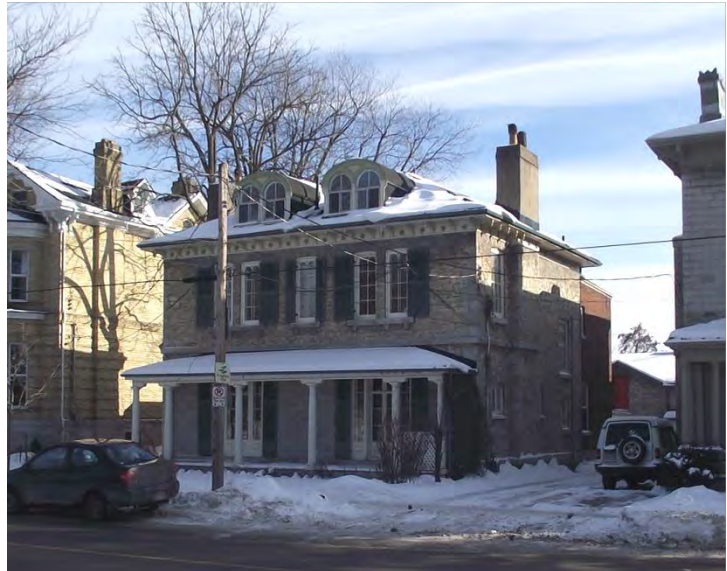
“This two-storey stone house, built in the same ‘cottage orné’ style as 31 King and 5 Emily Street has different decorative details and enhances the interest of this important residential area.

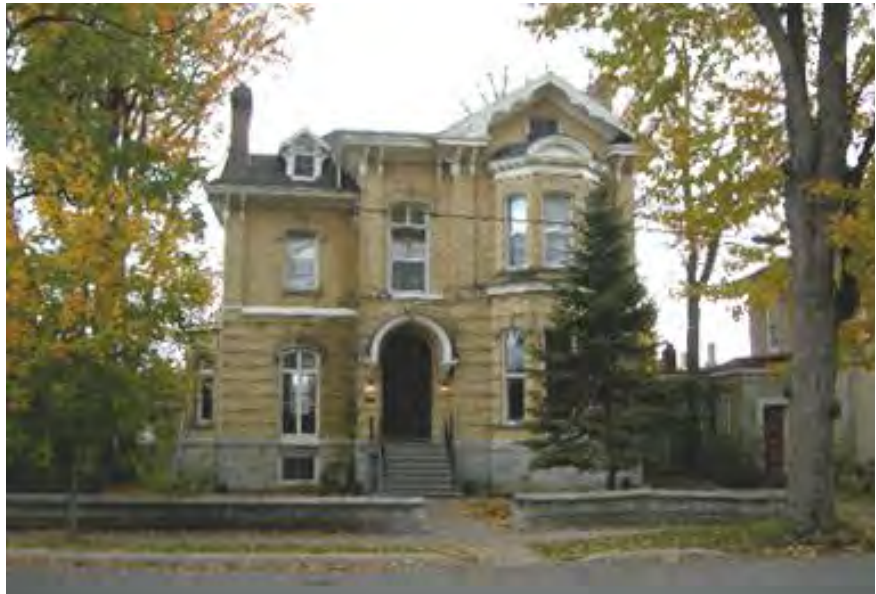
“This yellow brick house, built in 1879 for Edward John Barker Pense, owner of the British Whig, was later known as Bishop’s Court when Bishop E. J. Bidwell owned it. In 1950, it became the property of the Student’s Medical House Corporation. It is an interesting contrast in style and material to the earlier stone houses beside it.

“This two and a half storey brick house is built on an irregular plan with three façade planes and a variety of roof styles and levels. The brickwork on the first storey has recessed courses on the first storey has pilaster treatment on all corners and the storeys are separated by a corbelled brick string course and a plain base course.

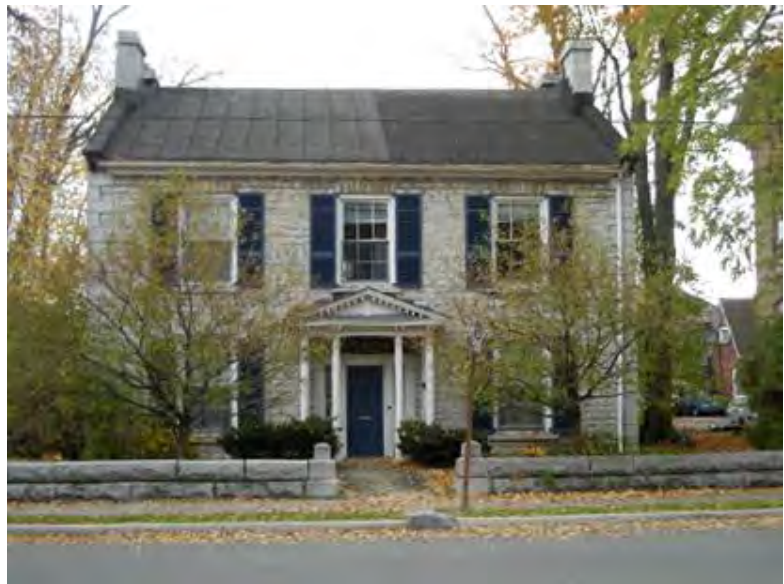
**Facing south from City Park**

“This symmetrical stone dwelling with corner quoins and parapeted end walls rising to twin chimneys is, in the simplicity of its design, a market contrast to the ‘cottage orné’ style at the other end of the block and especially to the asymmetrical house next to it.

“This three bay, two-storey hammer-dressed stone house with ashlar corner quoins and window sills is set behind a low stone wall. The central doorway with fanlight and side lights is protected by a ...

“The roof is covered by ribbed metal; has gable end parapets and pairs of end chimneys. Each gable end has a round-headed window.

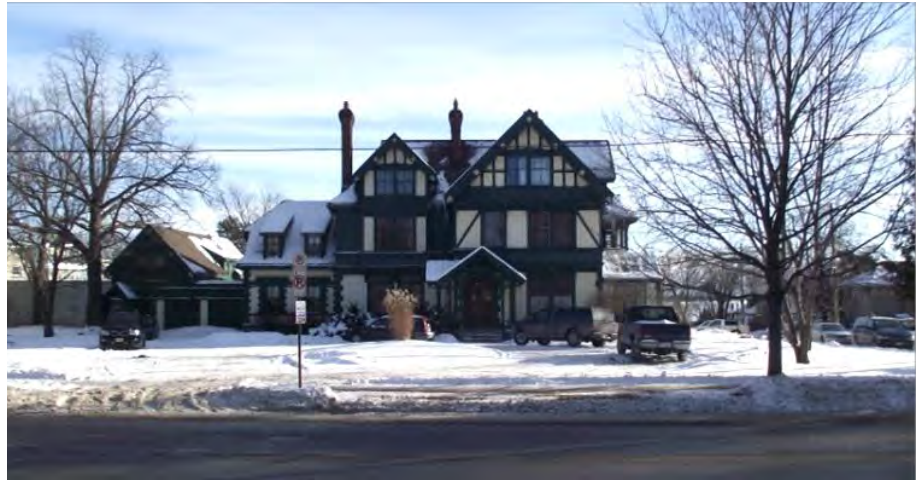
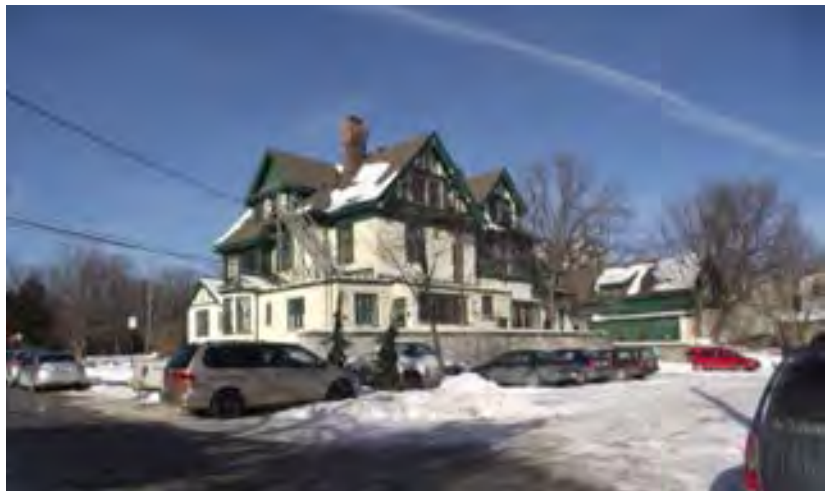
“The design of this remodelled early dwelling as well as its site, well back from the street, serves as an interesting contrast to the other buildings in the streetscape. It was built in 1841 for John Watkins, a wealthy hardware merchant and partner of Samuel Muckleston in a number of building ventures during the capital period. Watkins is best known as the donor of the Watkins Wing of the Kingston General Hospital.

“This two and a half storey stucco and imitation half timbered building was originally a large brick house. The additions, projections and trim have changed the style of the early house. The ridge of the gable roof runs parallel to King Street and there are large gabled projections on both the front and back towards Maitland Street. The roof has three brick chimneys with large corbelled caps.

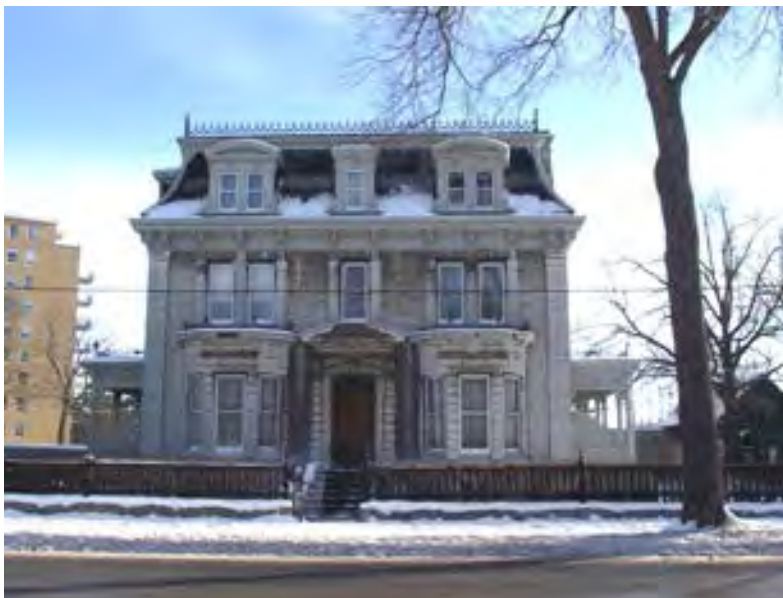
“This handsome Victorian mansion was erected in 1876-77 for Robert Kent, who was, for twenty years proprietor of the British American Hotel, King and Clarence Streets, and a partner in the Canadian Express Company.

“Built of hammer-dressed stone with a pitch-faced foundation and ashlar trim, this three-storey, three bay dwelling has a central door and flanking bow windows. The segmental arched entrance has a moulded, eared surround with keystone, all enclosed in rusticated pilasters supporting an architrave with consoles. A complete entablature, including a segmental arched pediment, rests on the architrave. The flanking bow windows have ashlar chamfered surrounds of rusticated piers and lintels. The windows have large architraves, each with a central moulded string course and iron railings over their cornices.

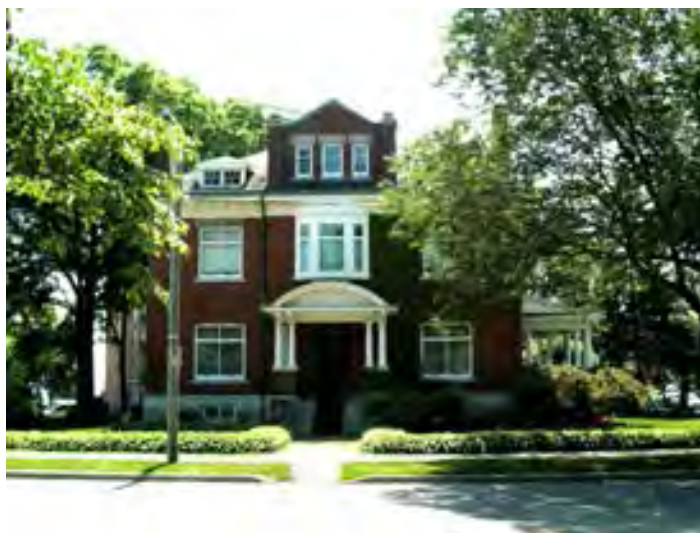
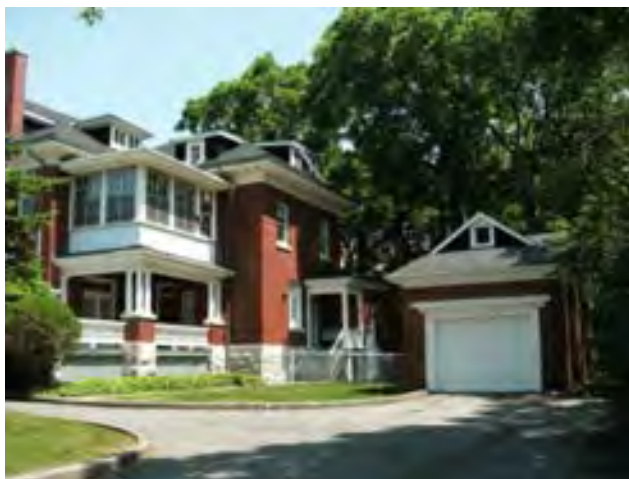
The building at 87 King East is a 3-bay, 2½-storey brick house on a stone foundation. All four of this building's elevations are visible from King and / or Simcoe Street.

The 87 King East building's centralized front entrance has a wood portico with a semi-circular pediment. The pediment's rounded wood tympanum is plain with a projecting dentiled surround. Its eave is supported by two pairs of heavy wood brackets. The portico roof is supported by two sets of three wood columns with square brick bases topped with stone. The wood front entranceway door has a large single pane of glass. Its glazing is decorated with an ornate iron grill that includes vertical bars and a circular centre. This circular pattern is mirrored in the brickwork found in the walkway as one approaches the front porch. A three-tiered wood oriel window is located on the second storey of the façade, above the entrance. Each of its three plain windows is topped with a rectangular transom with leaded tracery. The top of the oriel meets the building's dentiled cornice, merging with its plain entablature. A dormer projecting from the roof

The building's south-western elevation faces Simcoe Street. It features architectural elements similar to the façade. Its large brick-faced dormer contains two 1/1 double-hung windows, but is otherwise identical to the one found on the façade. The dormer's pillars drop through the building's eaves and project from the exterior wall, terminating at the top, and at each inner side, of a slanted porch roof. The roof is supported by a column arrangement like that found on the front porch. This side porch is surrounded by a balustrade with thick, turned-wood elements and a heavy wood handrail.

The north-east elevation of the building contains a second, wood, oriel window; and a full-height, three-tiered, angled bay window. The bay supports a third large and brick-faced dormer with matching angled returns. A smaller dormer is found closer to the rear of the building. This elevation contains four basement windows, with similarly squat windows in the returns of the brick dormer, and on the first and third storeys north-west of the bay window. The building's chimney rises high above the roofline. Below the eave it projects from the exterior wall, and features stone caps over stepped bricks where the chimney converges on one side.

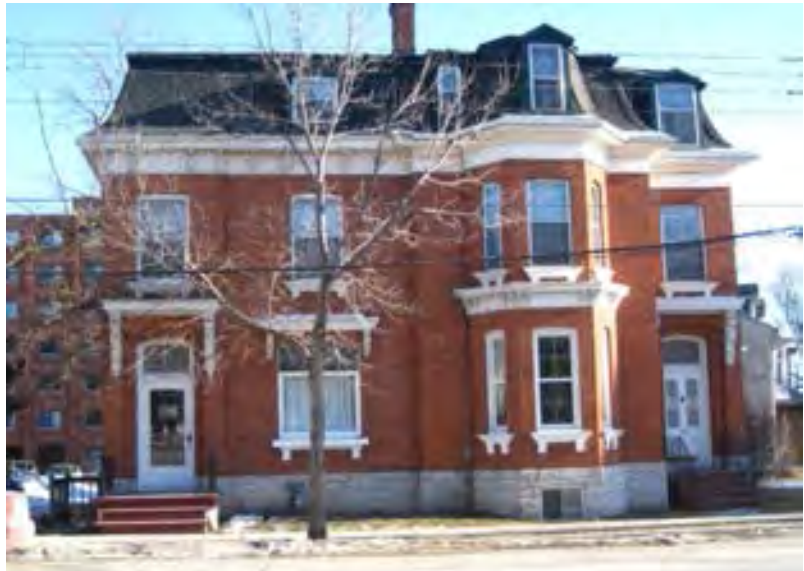
Built in 1875, this dwelling, part of a double brick house, located at 123 King Street East, is of cultural heritage value and interest because of its physical/design value.

Character defining elements that reflect this value include its scale and massing. Other elements reflecting its physical/design value include the dwelling's two and a half storey brick double construction, stone foundation and mansard roof. The entrance bay projects slightly and is characterized by paneled doors under transoms set in segmental arches under bracket supported flat hoods. In 1890 the house had extensive renovations changing the facade of the house. The inner bay was projected slightly to contain a central two and a half storey bay. All the windows are characterized by corbelled sills and brackets. The roof of the bay window section, a truncated tower, has a pediment window on its facade. There is a small narrow gabled dormer to the north and a large dormer with pilasters and pediment over the outer bay. There is a single gabled dormer on the west slope of the roof. A single brick chimney rises from the center of the roof.

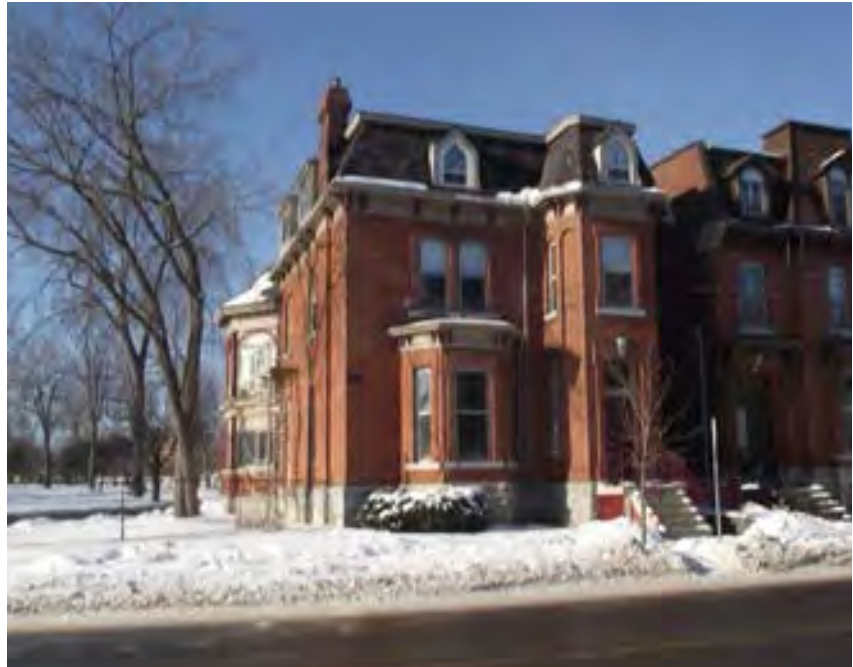
Built in 1874, this brick corner house, located at 130 King Street East, is of cultural heritage value and interest because of its physical/design value and contextual value.

The property has physical/design value. Character defining elements that reflect this value include its scale and massing. Other elements reflecting its physical/design value include the dwelling's two and a half storey brick construction, high stone foundation, ashlar sills and tower and bay projections. The two bay facade is characterized by a tower projection in the northern bay with chamfered corners embellished with round-headed vertical panels. The entranceway, also contained in this bay, have a large stained glass transom under a segmental arch with ashlar keystone. The truncated tower roof has a single gable-roofed dormer in its face. The second bay is characterized by a one-storey bay window over an ashlar sill course and its flat roof is supported by paired brackets. The roof just above this contains a single gable-roofed dormer. The west side of the house is characterized by a chimney breast to the front.

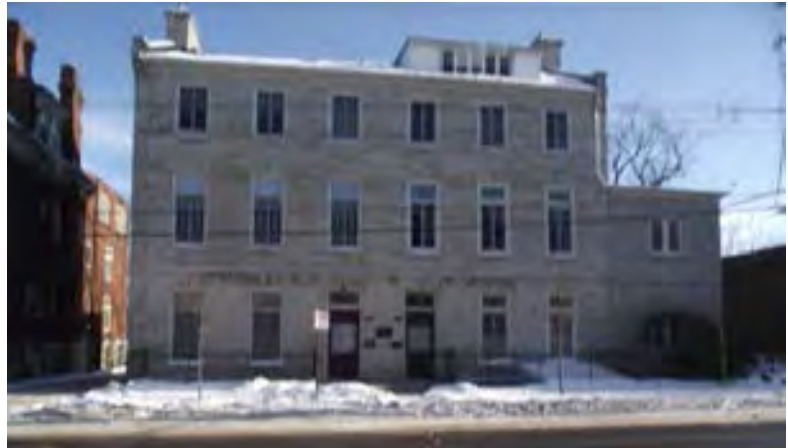
“This large limestone building was erected in 1842-43 as a double house. The extension to the southwest was a later addition. Noble Palmer, a chemist (druggist) and founder of the Kingston Spectator, commissioned William Coverdale to erect the building. Before the plaster was dry, half of the building was occupied by Governor-General Sir Charles Metcalfe, while his predecessor, Sir Charles Bagot lay dying in Alwington House. In 1851, the Kingston Seminary for Young Ladies was in part of the building.

“This large three-storey, hammer dressed stone terrace, six bays wide, has wide ashlar base and string courses and a narrower, third storey sill course. The doorways in the two inner bays have rectangular transoms and are recessed with paneled reveals. All the first and second storey windows have transoms and ashlar sills.

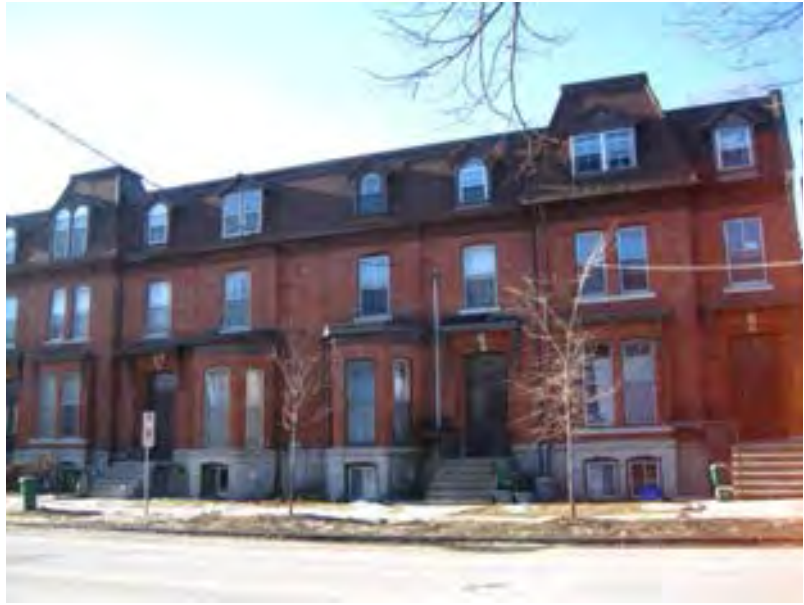
Built c.1875-1876, this brick dwelling, part of a terrace of four houses originally known as “Washington Terrace”, located at 132 King Street East, is of cultural heritage value and interest because of its physical/design value and historical/associative value.

The property has physical/design value. Character defining elements that reflect this value include its scale and massing. The dwelling is part of a three-storey, eight bay brick terrace of four dwellings containing eight apartments. The entranceway is characterized by double doors with transoms set in recessed surrounds. The segmental arches have keystones and the entablature hood-moulds are supported by long consoles. Over the entrance is a single window in the second storey and a round-headed window in the gabled dormers. The two bays next to the end ones have shallow projections rising to truncated towers. The pairs in the first storey are in slight projection and their hood-moulds match those over the entranceway. The two central bays have bay windows with flat a roof in the first storey, single windows in the second storey and a pair of windows in gabled dormers. The mansard roof is characterized by end parapets.

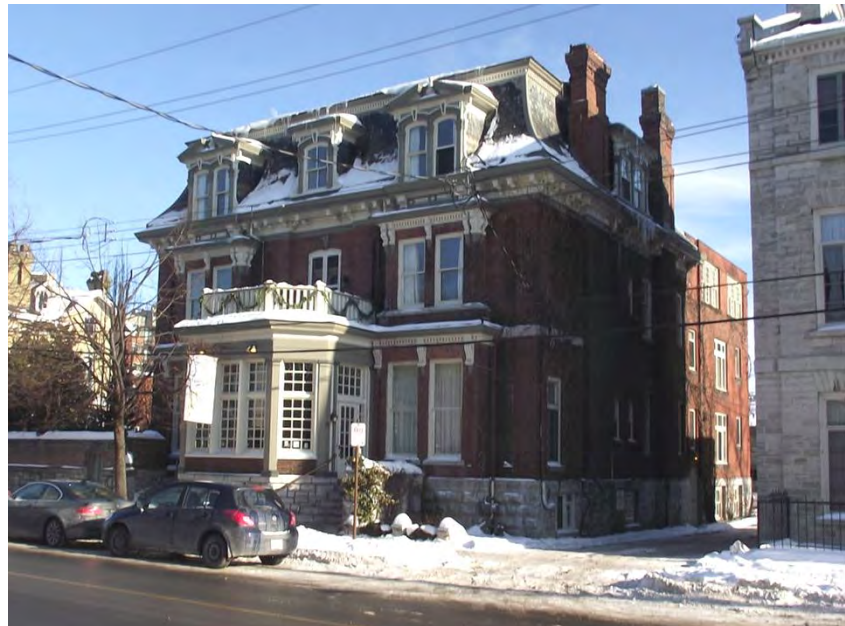
“This Victorian building at 141 King Street East is in marked contrast to the plain 1840’s stone building beside it and represents in its plan, scale and decoration, the development of the stylish mansion forty years later. Built for John Hinds, it was sold by his creditors in June, 1883 to Dr. Kenneth N. Fenwick, a prominent physician.

“This three bay, two and a half storey brick building has a high stone foundation irregularly fenestrated. The central bay has a double door enclosed in a classical frame and glass porch. The porch has a brick base resting on a pitch-faced stone front with flanking ashlar quarter turn stairs whose stone newels are topped by cast iron ornaments. A pitch-faced stone wall with a brick top runs from the north staircase to the north perimeter of the property. The porch pilasters support a wide cornice which is topped by a wooden balustrade. The porch windows have multi-light transoms and similar sash.

“A mansard roof of tessellated slate is bellcast and its cornice has dentils. On the front slope is a flat-roofed dormer flanked by double dormers with broken pediment roofs. All the dormer windows are segmental arched, framed by pilasters and moulded surrounds with keystones.

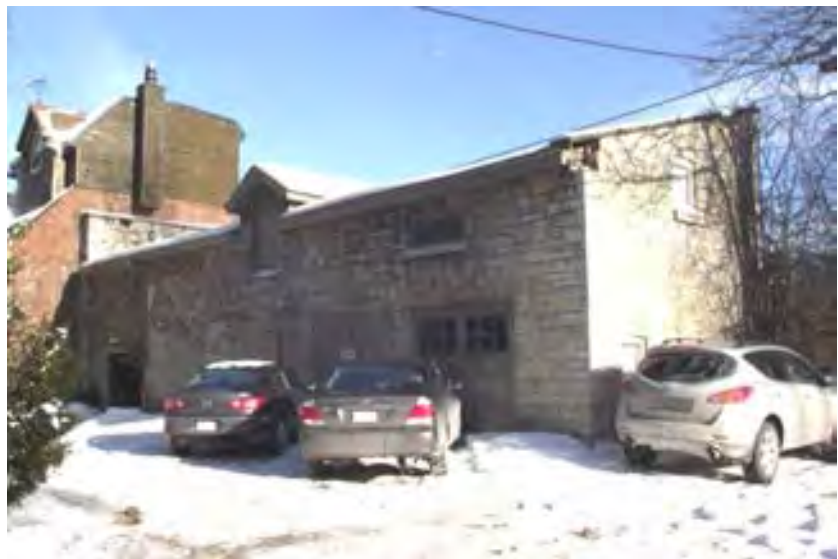
A brick coach house behind the main building at 141 King Street East building was in place by the time that the 1892 fire insurance map was printed. It contains an embedded gable-end dormer, with a peak service door opening, fronting its forward slanting roof with north-side parapet wall. A squat rectangular window in three pieces, with wood trim and an ashlar sill, sits below the cornice of the building's southern end. Its main level contains four sets of large wood vehicle doors, one of which features uppers windows in eight pieces; the others feature tall wood panels. A smaller fifth

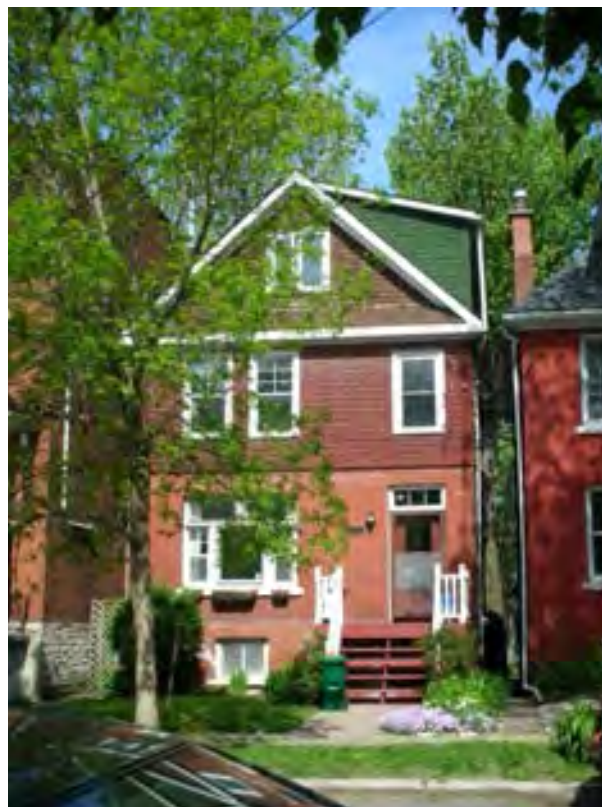
The 142 King Street East building is a simple, 2-bay, 2½-storey brick residence with a front-gable roof. Many of the features of the original structure have been modified. Its original foundation has been bricked-over; the second storey has been clad in newer materials, a large dormer has been added to the northeast side of the roof, and the façade fenestration has been replaced. The main window on the first storey contains two plain rectangular transoms, and 4/1 sidelights. The front entrance features a transom in three pieces, and the second storey contains windows 6/1 windows on its southwest bay. The building's gable features rows of wood shingles with rectangular and diamond-shaped imbrications.

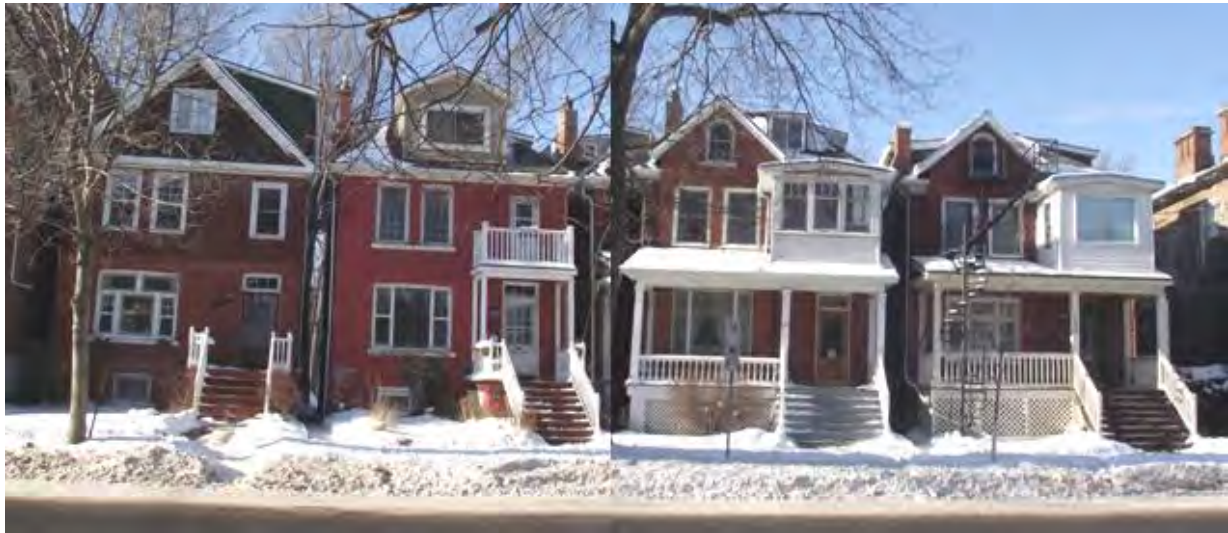
### 150 King Street East

The 150 King Street East building is a simple, 2-bay, 2½-storey brick residence with a hipped-roof and a rusticated stone foundation. The building's façade fenestration has been replaced, and a large dormer has been added to the front of the roof. Although the façade fenestration has been replaced, the windows still feature rough-hewn limestone sills. The front entrance contains a 3-piece transom, and is fronted by a raised wood porch with turned-wood porch and staircase balusters. A balcony above the porch is supported by plain pillars, and features square balusters and newel posts.

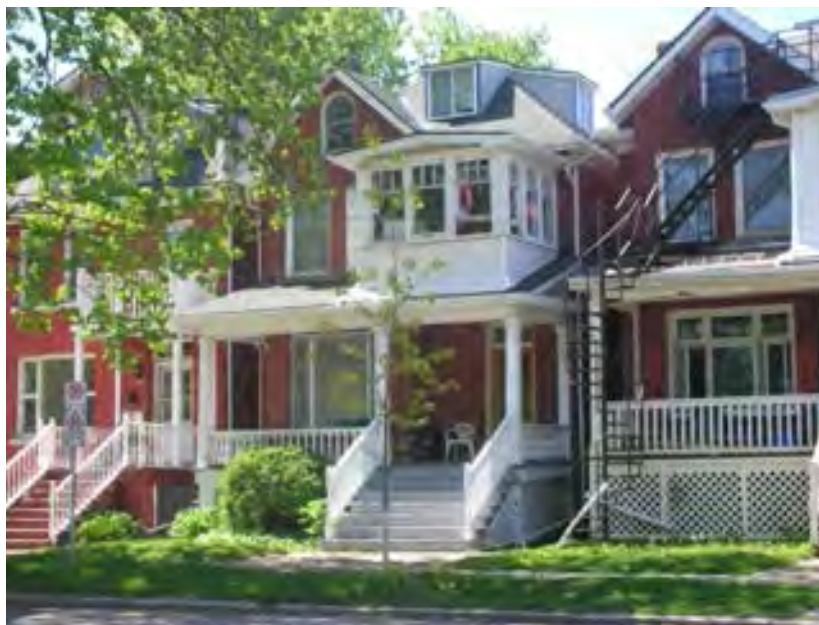
The 152 King Street East building is a 2-bay, 2½-storey structure with a hipped roof and a full-width front porch. The raised porch features a wide set of wood front steps with turned-wood balusters, matching those of the porch itself. The shingled porch roof has a forward slant and is supported by simple wood pillars. The 152 entranceway has a rectangular transom. The window to its southwest contains a rectangular transom over a large, plain window, and tall rectangular sidelights with square transoms. This bay protrudes slightly, forming a tower with a gable-end flush with the building's roofline. The gable contains a plain rectangular window with a half-round transom. The second storey contains two paired 1/1 windows. All of the façade windows are set on ashlar sills and feature simple wood trim. A square sunroom, not of heritage value, has been built on top of the porch roof above the main entrance. It has a very low gable roof and wood planks below the windows. Two modern dormers of no heritage value have been added to the front and northeast elevation of the building's roof.

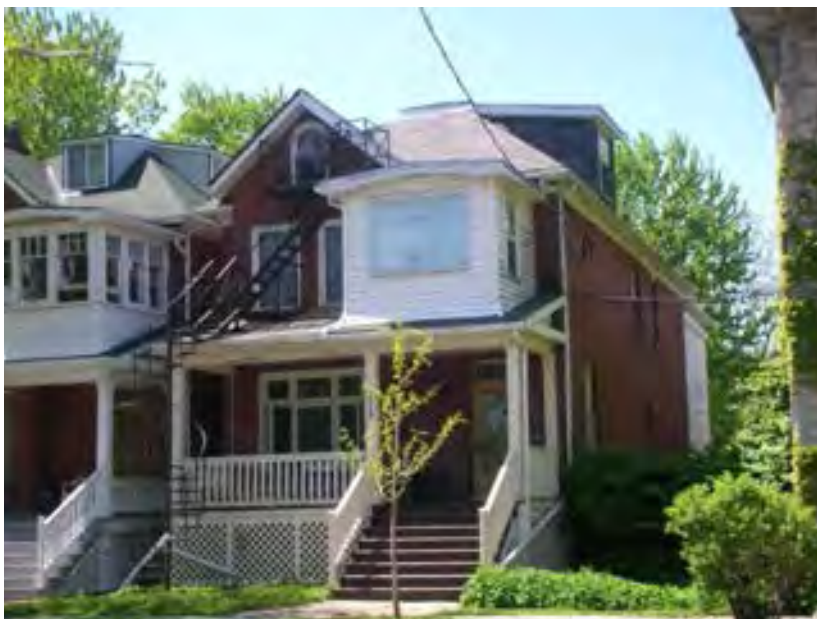
The 154 King Street East building is a 2-bay, 2½-storey structure with a hipped roof and a full-width front porch. The southwest bay protrudes slightly, forming a tower with a gable-end flush with the building's roofline. The gable contains a plain rectangular window with a half-round transom. The second storey contains two paired 1/1 windows. All of the façade windows are set on ashlar sills. A wood sunroom and northeast-facing dormer, not of heritage value, have been added to the building.

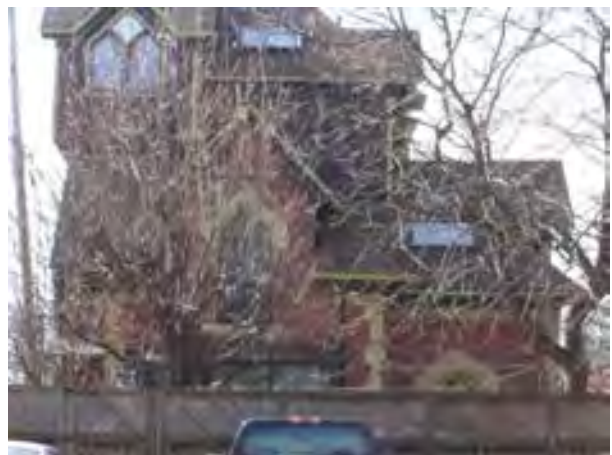
**Southwest elevation, from Ontario Street**

The 155 King Street East building has an unusual contextual profile. It is located in the middle of the city block circumscribed by Ontario, West, King East, and Lower Union Streets. The building is least visible from West Street, and is largely hidden by foliage from King Street East during all but the winter months. Most evident is the building's shingled-faced third storey, which has gables and box-like massing. The building's King and Lower Union Street elevations are appropriate and to their contexts. Its southeast elevation is the most interesting and important, where its brick and wood elements merge with a tall brick wall dividing the property, and which marks the southeast boundary of the Old Sydenham Heritage Area at this point.

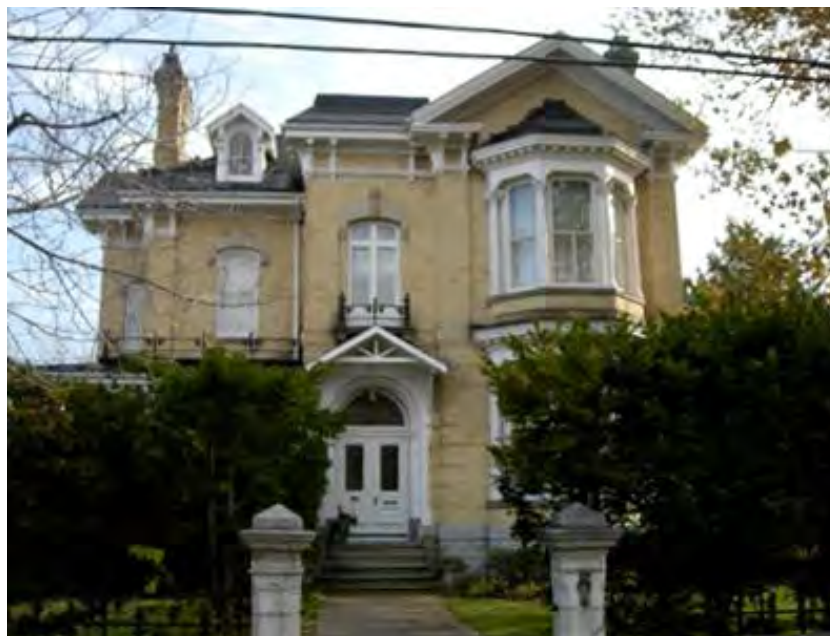
This large, brick Victorian mansion set in spacious grounds was built in 1882 for Dr. Edward Horsey, second son of the architect, Edward Horsey. It is an excellent example of the work of architect Joseph Power, who designed this dwelling. In 1887, when the Doctor moved to Montreal, the dwelling was sold to the Government. This is a slightly larger and more elaborate version of 49 King Street East, built three years earlier.

This two-storey, yellow brick house on a pitch-faced sandstone foundation has a series of facades, each with a different roof. The dominant facade edged by pilasters and topped by a gable roof with eaves returns contains a two-storey bay window. The bay window section rests on an ashlar base and its angular walls have square-headed windows separated by cast iron Corinthian columns supporting ashlar architraves. Each storey has its own cornice with dentils and modillions. The roof of the bay window is a layered umbrella shape.

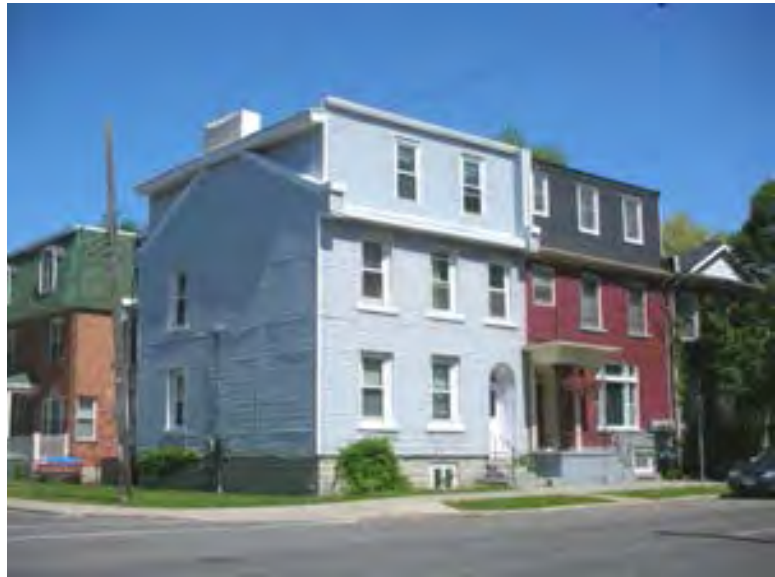
Although altered over time, this 2-storey brick double house has contextual value as a prominent corner building with many of its original, pre-1860 design elements, and as part of the larger row that comprises 160-172 King Street East. The 160-162 King East building does not appear on Gibbs map of 1850. It does appear on Walling's map of 1860, when it stood alone as the earliest buildings that now comprise the larger row. The structure's flat-roofed third storey is new with respect to the age of the building, but the original roofline is evident on the southwest elevation of 160 King, where a firewall and corbels have been capped in newer material. The building's stone foundation is still exposed. Both entranceways are recessed, with half-round transoms, and flanked by wood reveals with panels. Many of the building's original rectangular window opening are still evident; the windows include ashlar sills.

The 160 King Street East building has been clad in material of no heritage value. Its first and second storey fenestration appears to reflect the building's original openings. Its windows rest on stone sills, and its basement façade contains moderately-sized windows. The building's southwest elevation contains a window on each storey near the back of the building, and a foundation window.

The current window is large and rectangular with 1/1 sidelights, and a 3-piece transom with tracery. The second- storey southwest window has been replaced with a smaller one.

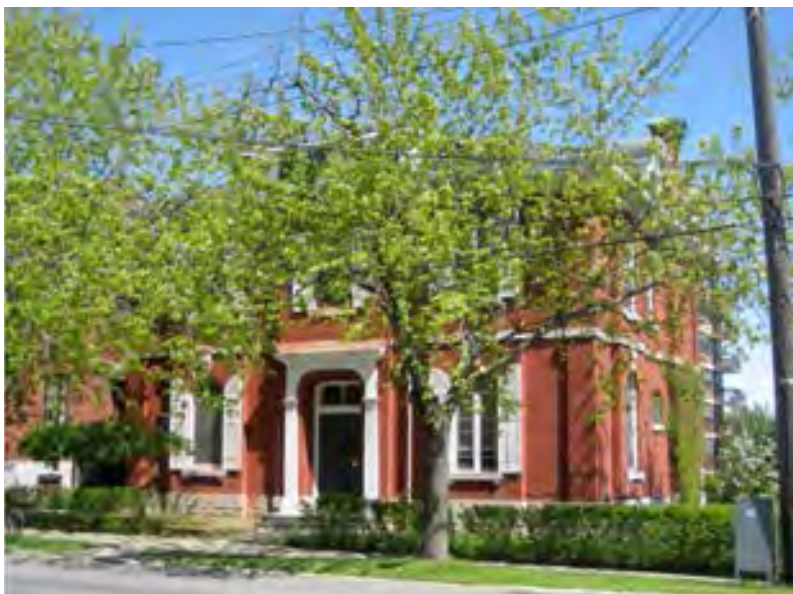
This three bay, two-storey red brick house sits on a stone foundation and has ashlar base and string courses. Each of the bays is projected slightly and there are corner pilaster-type projections. The central bay contains the entranceway with classical surround of frame pilasters and an entablature with dentils. The double door, with round-headed glass panels, is recessed and has a flat-arched transom.

The flanking bays have, in the first storey, round-headed casement windows with ashlar keystones and ashlar sills with brackets. All of the second storey windows have ashlar sills and segmental arches.

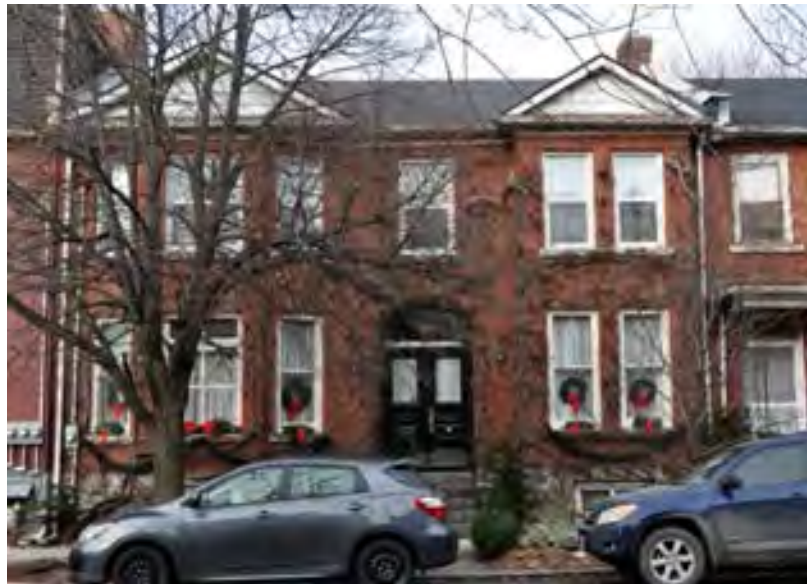
The row of buildings that comprise 160 to 172 King Street East appear on Innes' map of 1865, and on Brosius' map of 1875. The 164 to 172 units do not appear on Walling's 1860 map. The present façade of 164 appears to have been modified, although the date of this modification is not currently known. The recessed entrance, and flanking bays with gable ends, do not appear on Brosius' map and, if they were in place, are not depicted on fire insurance maps from 1892 to 1947. It is possible that this structure replaced an earlier one.

The 164 King Street structure has a hammer-dressed limestone foundation which is distinct from the more finished foundations of its neighbours. The recessed entrance and flanking bays also distinguish this unit from the larger row it is part of. The recessed centre bay contains a set of wood double doors with large plain glazings and panels. They are topped by an elliptical transom containing the unit's street address in gold lettering. Above the entrance is a rectangular window with a 6/6 window arrangement. The same pattern is found on the second storey windows of the outer bays, except the centre second-storey window of the southwest bay is 8/8. Two windows are found under the wood-plank gable of the northeast bay, which projects slightly with flat returns. Its two first-storey windows are tall, paired, rectangular, and 1/1 with a common ashlar sill. The southwest bay is tripartite with angled returns and a matching gable. Matching 1/1 windows are found on this bay's first storey angled returns. Its centre window is 4-piece, topped by a transom with stained glass and tracery.

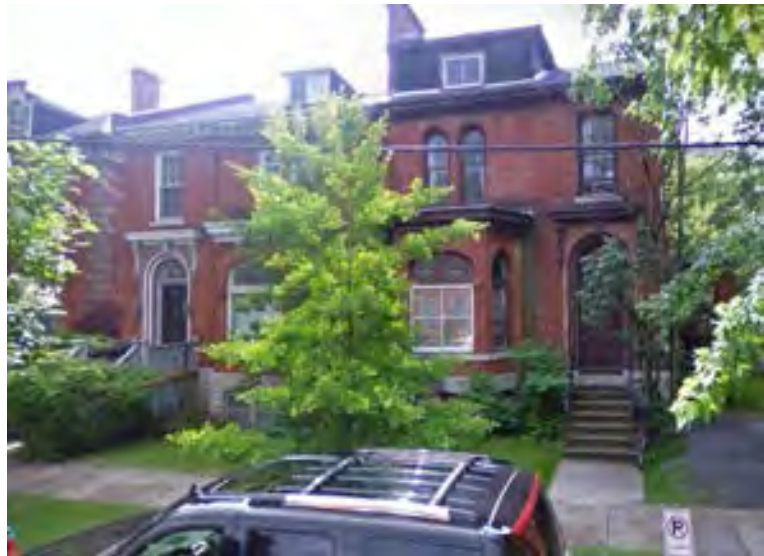
“In 1858 Richard Cartwright (later Sir Richard) commissioned architect William Coverdale to design this double brick dwelling for rental purposes. Conway Cartwright, Sir Richard’s younger brother, lived here for a time. Thomas Parke, a lawyer, and Thomas Briggs, manager of the Frontenac Loan Society, were later owners of the building.

“This house has the distinctive paired windows with round heads in the second storey which were used by Coverdale in many of his buildings. Consequently, with the typical Coverdale fanlights, this is another example of the work of one of Kingston’s most talented architects.

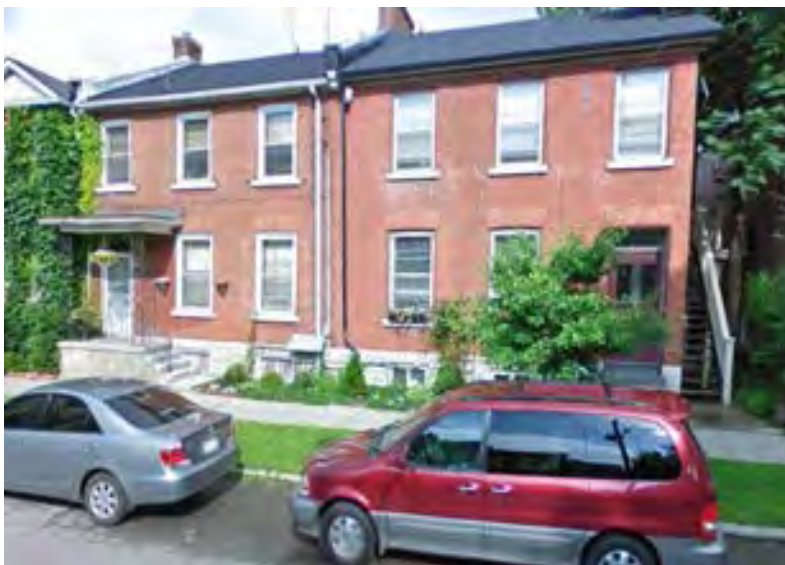
These two structures form the end of a 5-unit row of buildings which all have similar massing, setback and composition. They are more similar in style to the 160-162 King East buildings; the middle unit of this row – 164 – is more stylistic, containing projecting bays and a recessed entrance. As such, the form an appropriate northeast 'wing' of this row overall.

The 168 and 172 King East buildings share a common side gable roof, free from dormers, in-line with the three buildings to their southeast. Each has a low parapet firewall dividing the roofline along its southeast side, which rising to a low but very wide brick chimney with a tiered brick pot. Their fenestration is tall and rectangular, symmetrical, and reverse-identical. Their outer bays contain the front entrances, which rise above a stone foundation containing rectangular basement windows.

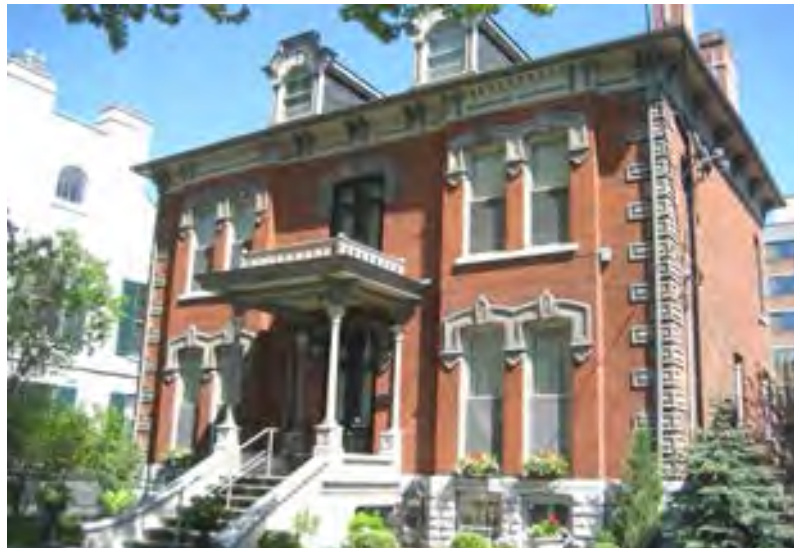
“This residence was designed by William Newlands, architect, for Donald Fraser, a banker. This 1885 brick dwelling with the 1858 double brick and the 1873 brick corner house present an interesting study in the design and ornamentation of brick houses over a quarter of a century and the work of three Kingston architects.

“This three bay, two-storey brick house is built on a high stone foundation. Across the entire façade is a one-storey, later verandah with paired columns on brick piers and a plain balustrade. The corners of the façade have quoins with raised panels and the channelled hood-moulds over all windows have decorative keystones and pendant label stops.

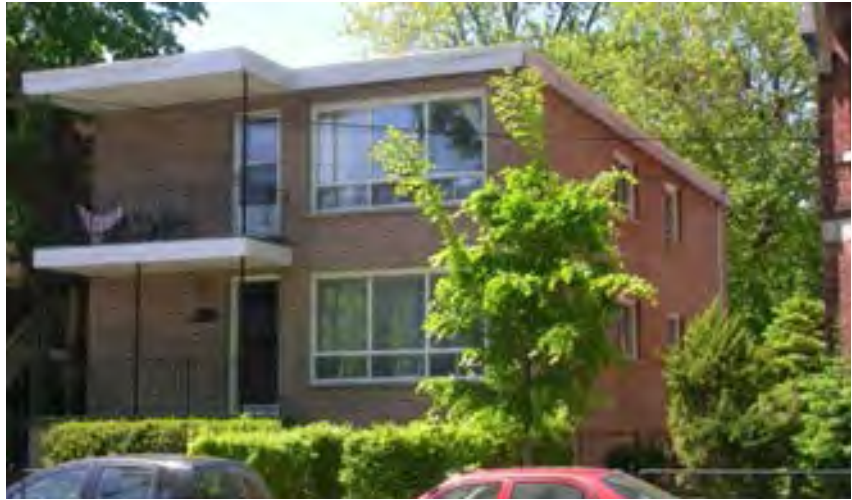
The 1965 fire insurance map does not illustrate the dwellings that occupied this block at the time. However, the present building dates to that era. While newer structures often compliment and contribute to the historic areas they occupy, the present building is contextually out of place in the Old Sydenham Heritage area. (Its flat roof, projecting hoods, and large front windows give this structure a distinctly different character.)

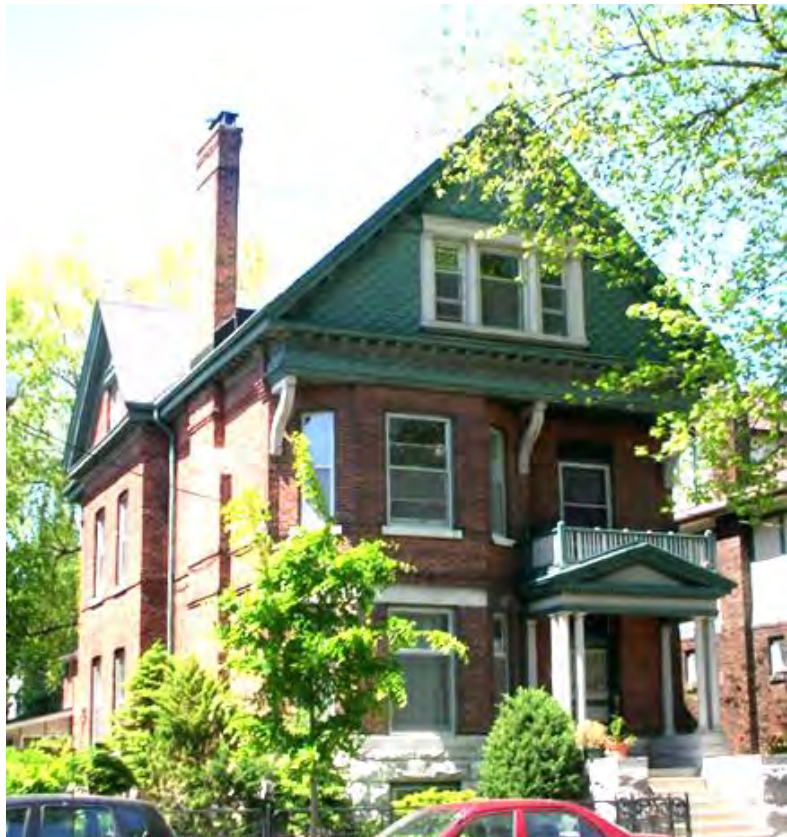
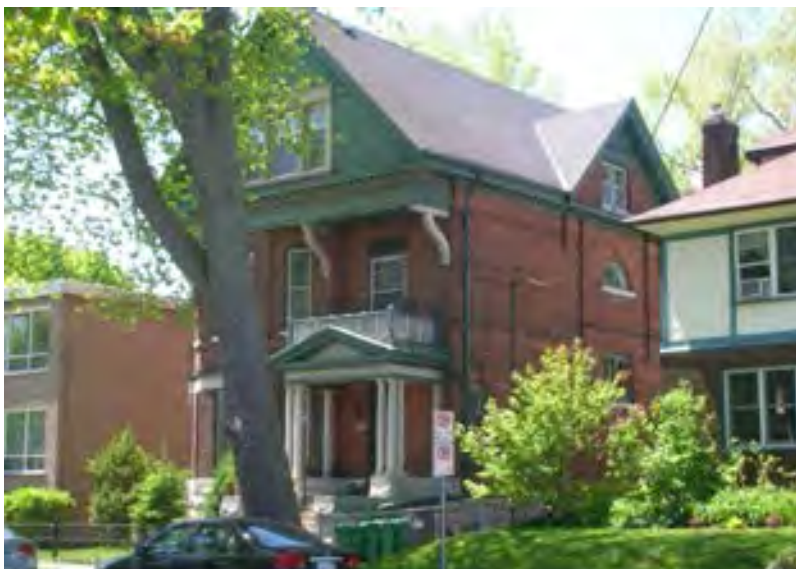
The building's front entrance, on the northeast of its two bays, is approached by a set of concrete steps flanked by stone walls that merge with the building's tall stone foundation. The front balcony is distinguished by two sets of three plain wood columns, with matching rear pilasters, supporting a second-storey balcony above. The wood balcony contains a pediment front with dentil-lined bargeboard and a plain, tympanum. A simple wood balustrade surrounds the balcony. Both the front entrance and balcony

door feature transoms with stained glass and leaded tracery; the former has the building's street address number etched in the glass.

The southwest half of the building contains a full-height, three-tiered, bay with angled returns. The bay contains 1/1 windows with brick flat-arches and ashlar sills. A common ashlar lintel and brick string course separate the bay's first and second storeys.

A matching, common ashlar sill forms a base course below the windows and above the building's hammer-dressed stone foundation.

Each side-elevation of 176 King East has distinctive elements which are clearly visible from King Street. On the southwest wall a partially embedded chimney rises well above the building's roofline. A rectangular bay protrudes slightly from this elevation, set near the back of the building. It contains two windows on each storey: these are supported by ashlar sills and topped by brick flat-arches. The bay is topped by a large gable with a single window and brick facing, dentil-lined bargeboard, and decorative woodwork at the top.

A matching dormer is found on the building's northeast elevation. This wall contains a number of distinct windows. An elliptical window, serving as a sidelight to the first-storey front entrance, is outlined by a brick surround, and four slightly protruding keystones spaced quarterly. A fanlight window with an ashlar sill is found under the dormer on the second storey. Below the fanlight, on the first storey, is a pair of casement windows with simple wood trim and an ashlar sill. Two sets of brick pilasters, unequal in height and with tiered lower ends, extend from the building's eaves, flanking the latter two opening.

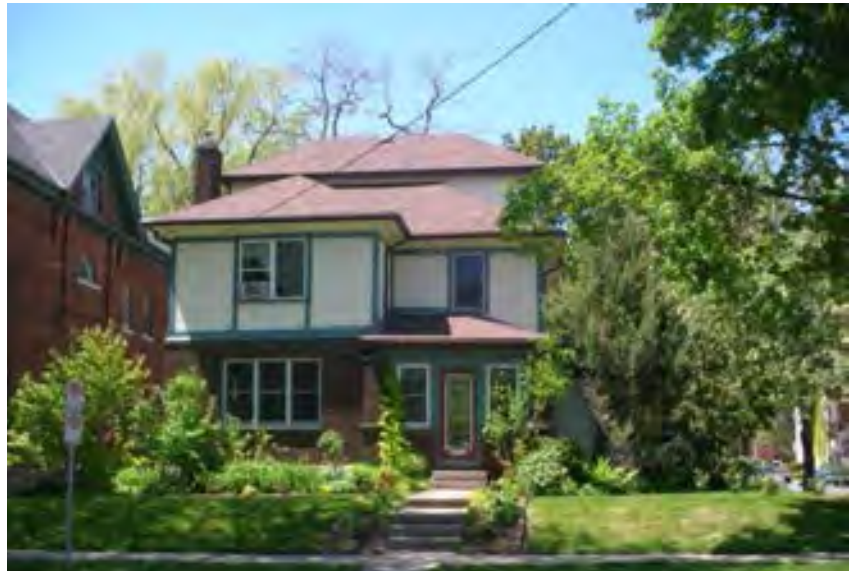
The 1924 fire insurance map shows that a 1½-storey wood structure, with a series of extensions, existed at this location at that time. By 1947 it has been replaced by this structure, which exhibits a different setback and footprint. The 1947 map shows a 2-storey brick structure with a square footprint and a second-storey roughcast exterior.

A 1-storey northeast extension to the building, added after 1947, features the same elements as the main structure's second storey. These include roughcast panels with stickwork, 1/1 windows, and a hipped roof. Dormers that rise above the second storey of this building also have a hipped roof. They create a second roofline, adding to this building's tiered appearance and its offset massing. These are distinctive features which contribute to its design value.

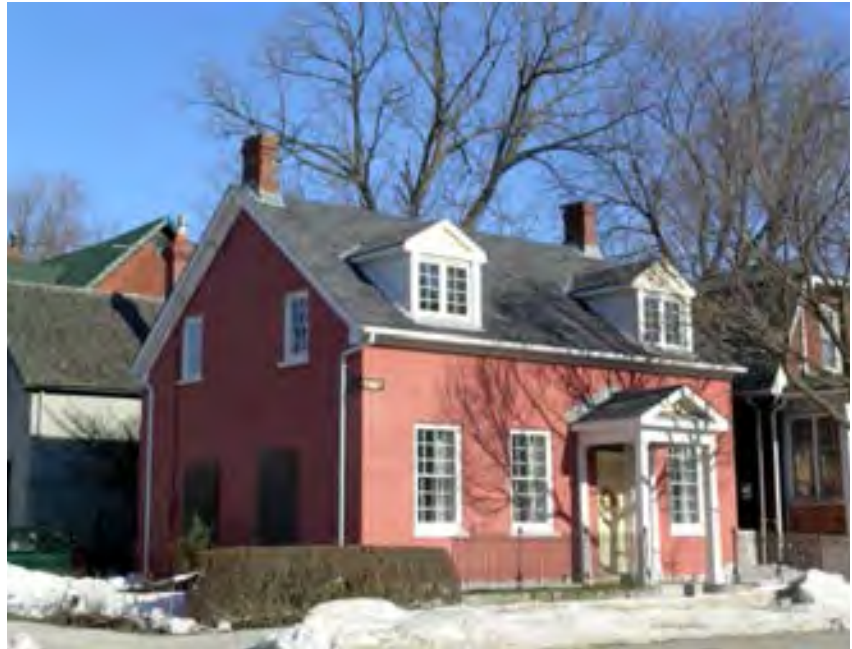
**194 King Street East**

“This is likely one of the earliest dwellings on this street and represents, in its size and style, a typical unpretentious cottage.

“This brick cottage, four bays wide, was originally roughcast. The doorway in the third bay has a rectangular transom divided into four lights. The entrance is protected by a wooden portico with pediment supported by Doric columns and pilasters. The foundation is rough stone.\*
