**Property Inventory Evaluation**  
**King Street East**

## Property Inventory Evaluation – King Street East

### 31 – 95 King Street East

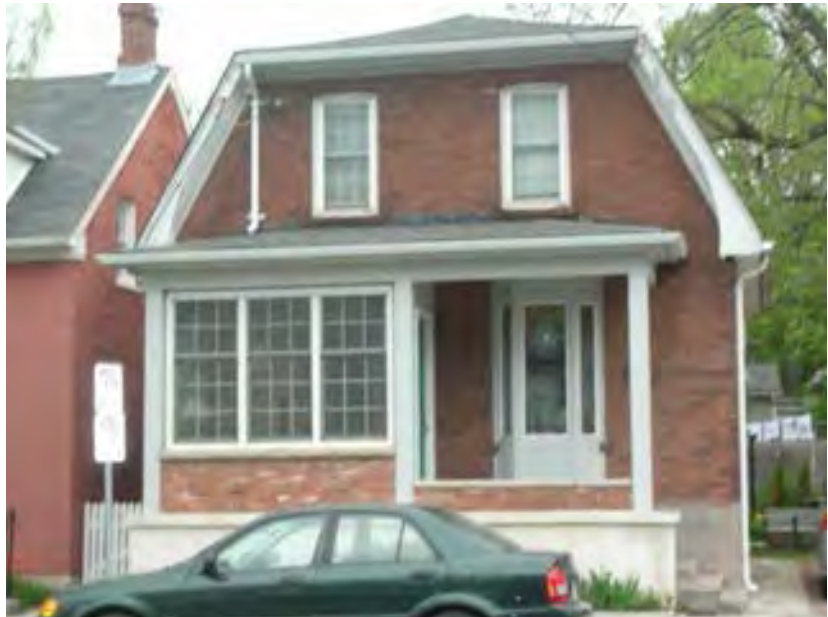
This structure appears on the 1947 fire insurance map, but is absent from the 1924 map.

Its design attributes do not harmonize with one another, or with the character of the Sydenham Heritage Area. The building's relatively modern front porch and full-width window, as well as its narrow bay window, concrete foundation, and unusual roofline, are all features which define this building's character. But these – particularly in combination – do not contribute any historical or architectural significance. The building's rare hipped / side-mansard roof, with heavily-projecting eaves, would be appropriate at a higher elevation and / or with a more sympathetic mixture of elements.

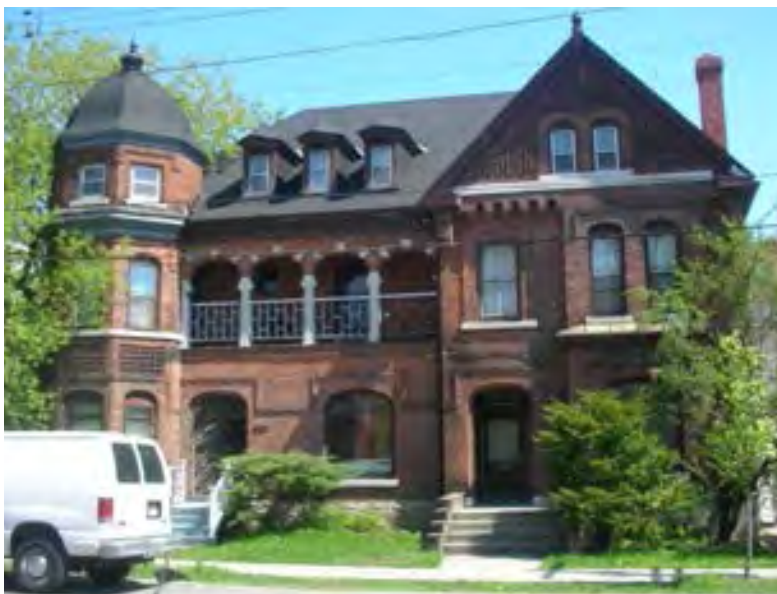
The presence of this building on the 1892 fire insurance map, and its absence from the 1889 directory, suggest a construction date between 1889 and 1891. This date-range, as well as the building's style and features, are consistent with its attribution to architect Joseph Power, here being made. In 1886 Joseph Power had the 52 Earl Street building erected for Dr. William Anglin (see entry for 52 Earl Street). Two years later he designed Victoria Terrace, near the corner of Montreal and Queen Streets. These buildings exhibit the same use of brickwork panels, Moorish motifs, ornate gable ends, and mixture of stone and brick.

The building displays a high degree of craftsmanship and artistic merit, and is central to defining the architecture of King Street East. The building's most prominent design elements include its octagonal northeast tower, with conical roof and Moorish pinnacle. Squat rectangular windows with medieval hood moulds are found on the tower's outer faces. The same hood moulds top the pair, arched, and full-height windows on the second storey of the building's most southern bay. The rectilinear pattern of these moulding is echoed in a string course across the first storey of the two central bays, framing the upper reaches of its two large, arched windows. It continues across the top of the two southwest projecting bays' recessed front entrance and matching arched window. Intricate brickwork is found on panels over the tower's first-storey windows, the southwest gable's face, and scalloping arches suspended from the northeast half of that gable's entablature.

Contrasting stone elements include ashlar lintels and a string course on the tower. A rough-hewn limestone foundation is evident on the centre bays, while the tower foundation is smooth ashlar. Ashlar is also used on one of the building's most important and distinct features: the Moorish archways and columns fronting its second-storey terrace, connecting the building's projecting outer bays and tower. The brick arches contain three ashlar voussoir stone each, and are supported by plain ashlar columns.

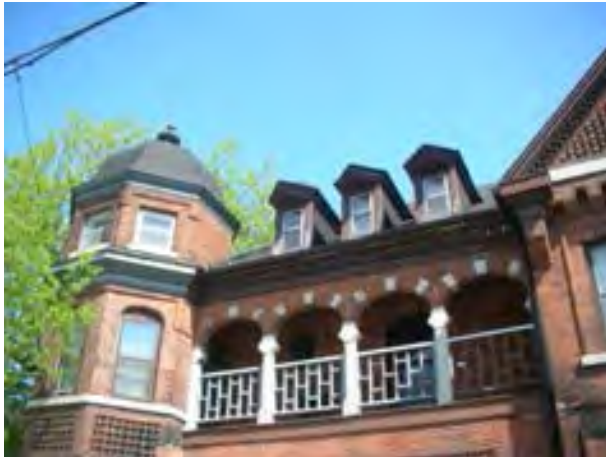
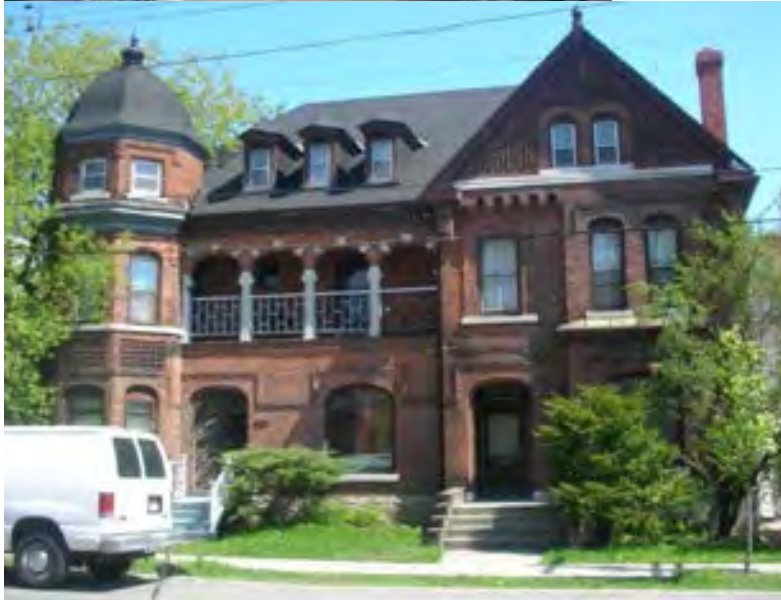
with inversely-flared capitals. Connected the columns is a chinoise balustrade of wood. The building's wood double doors, leading to the 197 King unit, feature recessed panels and rows of square glazing framing their large main openings. Each is topped by a half-round window.

Three dormers across the building's centre bays are unusual in that their roofs form pointed, heavily-projecting hoods.

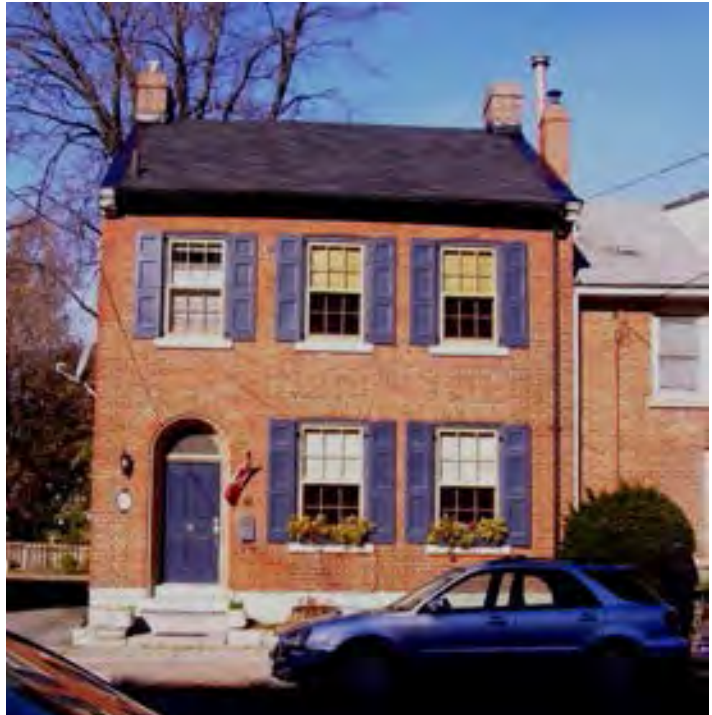
**198 KING STREET EAST**

“This two-storey, three bay brick house sits on a limestone foundation and has a gable roof with end parapets supported by ashlar corbels. There are chimneys at each end of the ridge of the roof. The square-headed windows have radiating brick voussoirs and ashlar lugsills.

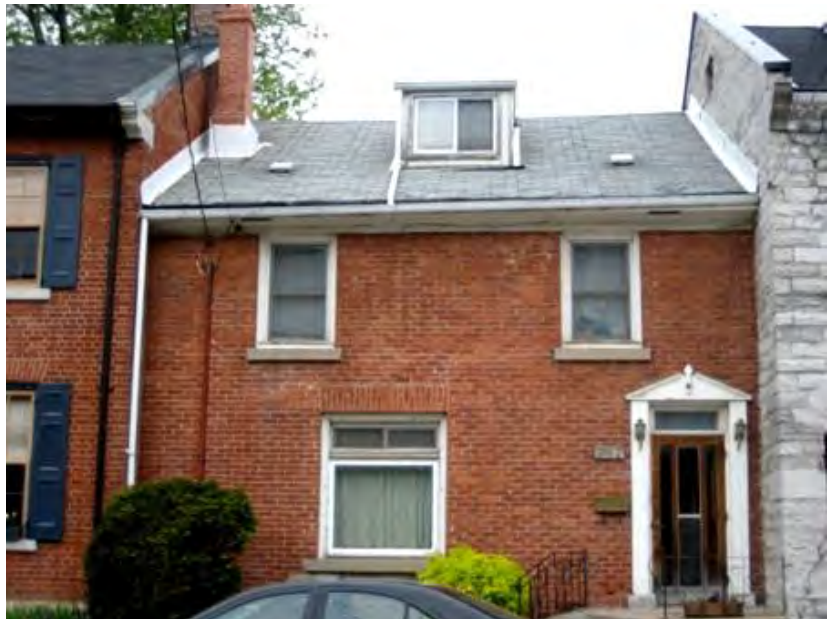
“This two-storey, two bay brick dwelling has a gable roof with boxed cornice and a shed dormer on the front slope of the roof.

“The entrance, now altered, has a classical frame surround with pediment and finial. The large modern window has a rectangular and ashlar lugsill.

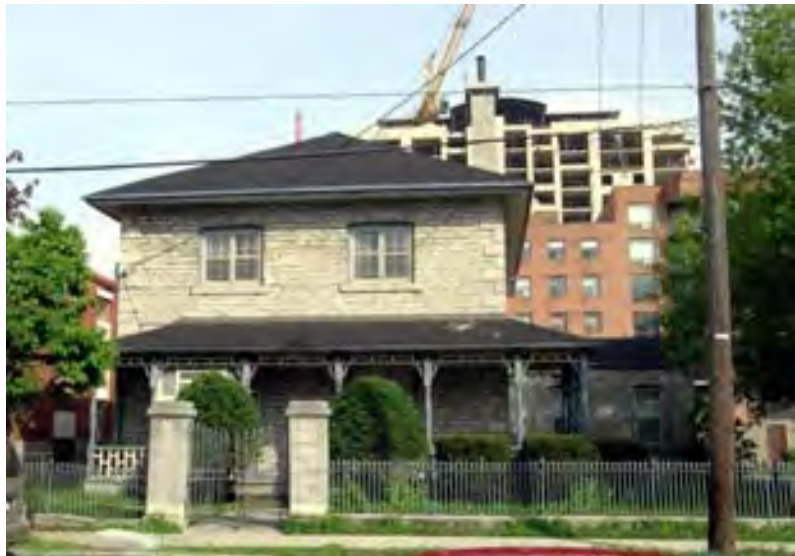
“This two bay, two-storey hammer-dressed stone house has, on its facade corners, chamfered ashlar quoins. The entrance in the first bay and its flanking window are enclosed in a hip-roofed verandah which extends along the south wall also. The verandah has ornately turned slender posts and trelliswork. The entrance is further protected by a frame and glass enclosure, constructed of vertical and diagonal boards and small lancet windows. There is an ornamental panel above the front window of this enclosure.

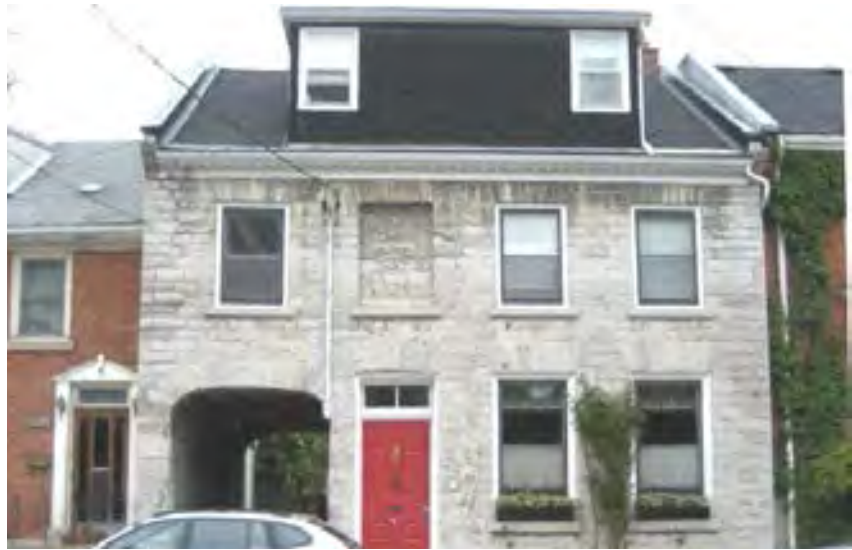
“Duncan Sinclair, shipwright, had this stone house with arched carriage-way built in 1851 next to his house, No. 202 (now altered). In 1854 he sold this property to John Craig, one of the carpenters who worked on City Hall.

“This four bay, two-storey, hammer-dressed stone building has a large modern flat-roofed dormer across the front slope of the gable roof.

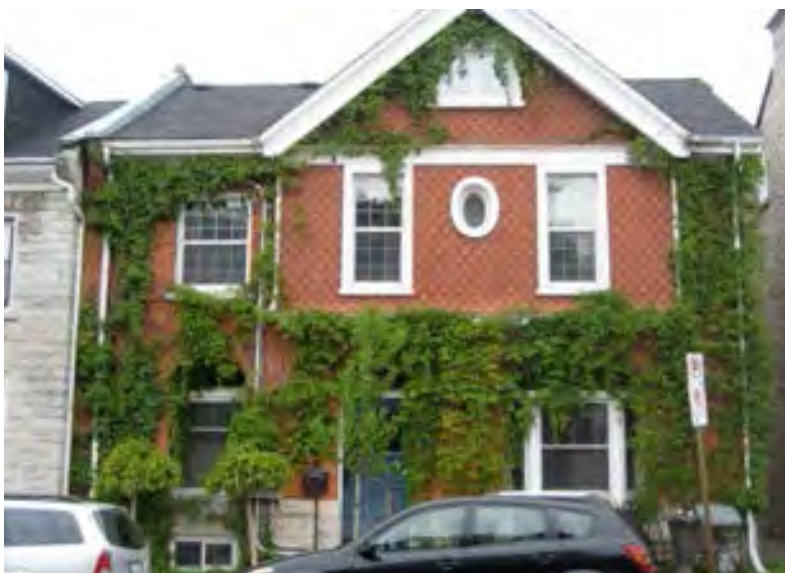
“This brick dwelling has the stone foundation rising to an ashlar string course at the window sill level in the front and has stone to the level of the second floor at the side. The first bay contains a window with semicircular transom; in the second bay the door is recessed under a semicircular arch and has a wood surround. The third bay has a wide window flanked by side lights with slender pilasters and an entablature, and a fanlight under a semi-elliptical arch with label moulding.

“In the second storey, the first bay has a single window with ashlar sill. The second and third bay are contained in a projection faced with small shingles containing a small circular window flanked by sash windows and surmounted by a projecting gable roof with wide plain bargeboards. In the pediment of the gable is a single window.\*

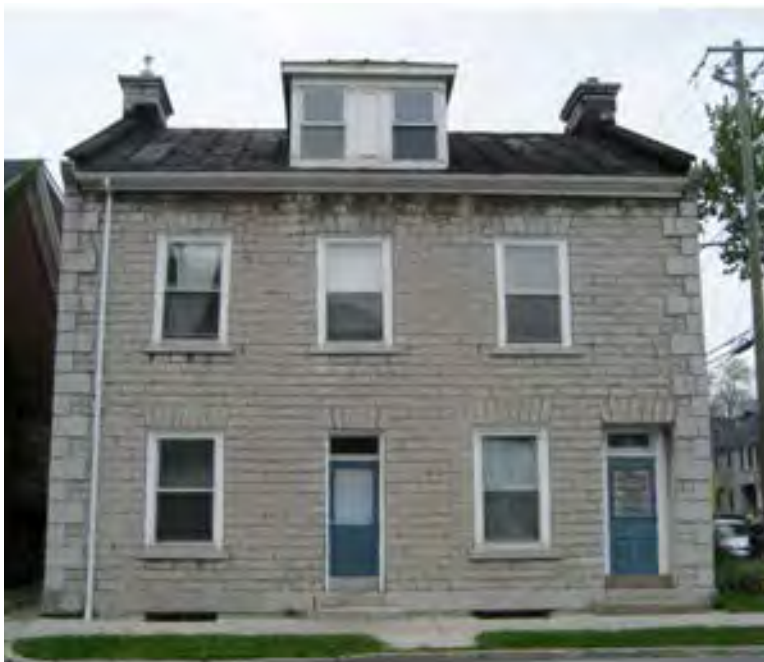
“This double house of coursed limestone has corner quoins, is four bays wide and two storeys high, with a low stone foundation. The steeply pitched gable roof has corbels supporting parapets which rise to stone chimneys with ashlar caps. The central dormer has a hipped roof and three windows separated by strip pilasters.

“The rear wing, the earlier limestone building, has a low pitched gable roof and is two storeys but, with no foundation course, it is lower than the later section.

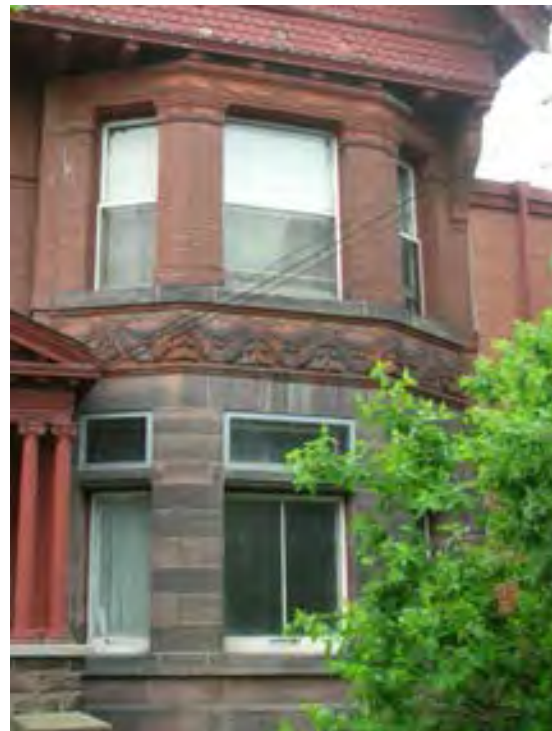
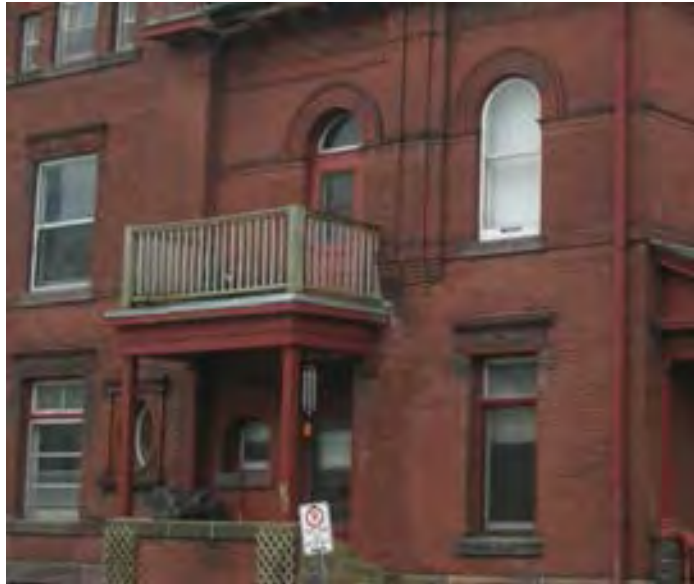
This building has a hipped roof with a flat top, defined by gables and dormers. A large projecting gable facing King Street contains a wood face with fish scale imbrications. Its three adjacent windows are set below a

scrolling wood relief. The gable is supported by rounded brick corbels and rafter-style wood brackets.

Under the gable's southwest side is a muted three-piece, full-height bay window with angled returns. The bay has recessed rectangular windows. Its first storey has a stone face, in contrast to this building's dominant use of red brick. The stone used here differs the 'standard' Kingston limestone used for the stone elements of nearly all other heritage buildings in the Old Sydenham Heritage Area. More research is required to determine its

source. This imported stone features remarkable striations of pink, orange, gray and brown. It is also found on bases that support tripartite sets of wood pillars that support the building's front balcony, and the foundation facing King and Earl.

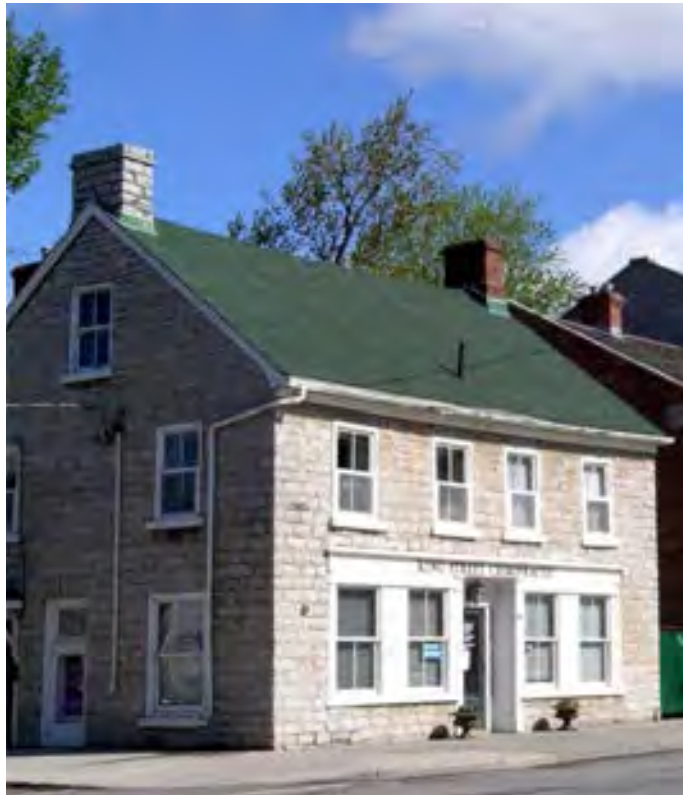
This building's heavy wood window surrounds on the first storey of its façade, reflect its previous use as a commercial structure. At one point, large plate glass windows, on each side of the central entranceway, had been installed for display purposes. The original openings were likely symmetrical, and compatible in size with those on the second storey. In the seventies, the larger windows were replaced with openings more proportional to those above them. Those 2/2 windows, which matched the second storey openings, were more sympathetic to the building's heritage character than the present windows 1/1 configuration. Two gable dormers, installed in 2011, feature appropriate 2/2 window configurations, and are symmetrically aligned across the front face of the gable roof. Their dominant size mitigates the building's heritage character to some extent, however, and they are not considered character-defining elements of the building.

The building's second storey windows rest on vertically furrowed ashlar lugsills. They are surmounted by flat arches of rectangular blocks, with a wedge-shaped keystone causing them to spread slightly. A pair of matching windows is found symmetrically placed on the second storey of the building's Earl Street elevation, and immediately below the chimney. Alterations to this elevation's first storey, however, have resulted in oversized 1/1 windows, and are symmetrically placed and supported by stone sills. Evidence is still present of a centralized side entranceway which has been filled in since the building was used for commercial purposes.

A one-storey wooden garage that has long occupied the rear of the property, was extended to its present size, or replaced altogether, between 1915 and 1924. Now joined to the main building by a short corridor, its roof serves as a balcony for the residential unit's residence. The rectilinear style of its wood balustrade is appropriate. The garage proper features a large common opening covering two bays, with two pair of barn-style wooden doors, each with six-piece upper lights, decorative wood cross bars and suitable metal hardware.

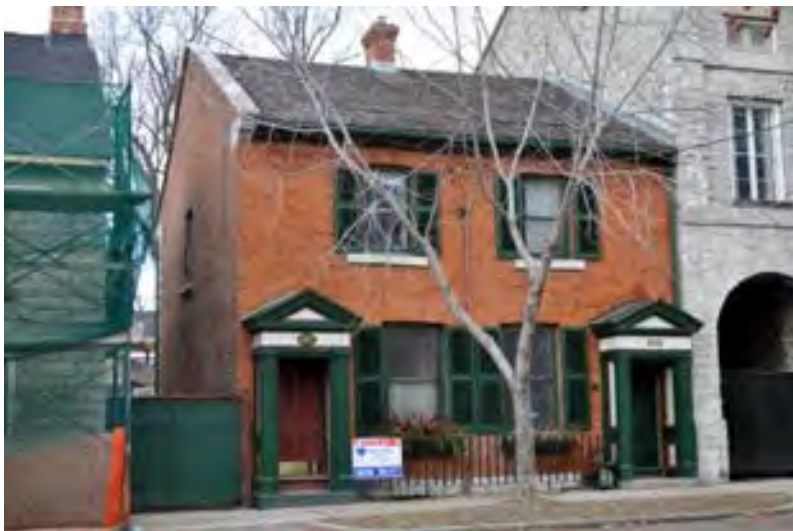
“There are only three exposed sides to this building. Red brick in a common bond faces the King Street and south sides while limestone in a rubble course faces the back. The building rests on a limestone basement. Construction in brick had, earlier in the century, been a rare occurrence in Kingston because of its scarcity. By the 1860's, good local brick was more plentiful. The only chimney for this building, also in brick, is centrally placed on the ridge of the roof.

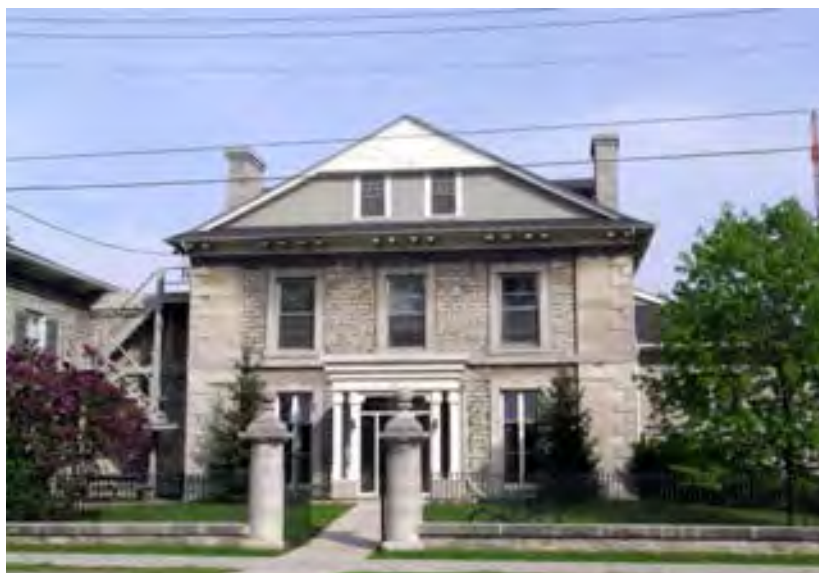
“This impressive house was built as the town house of John Solomon Cartwright and was well suited to the prominence of the Kingstonian who was a lawyer, judge, banker and Member of the Legislative Assembly of Upper Canada. In order to have his law office and law students nearby, Cartwright constructed the attached two-storey building at 223 King Street East. The house at 221 is maintained today as business and professional offices.

“The main entrance is now covered by an aluminum porch and inside the porch only a portion of the original surround is visible. The door has also been replaced. On the remaining three sides of the house, most of the architectural features have been almost obliterated by extensive modern additions and alterations. Still untouched are the upper storey windows, facing the lake.

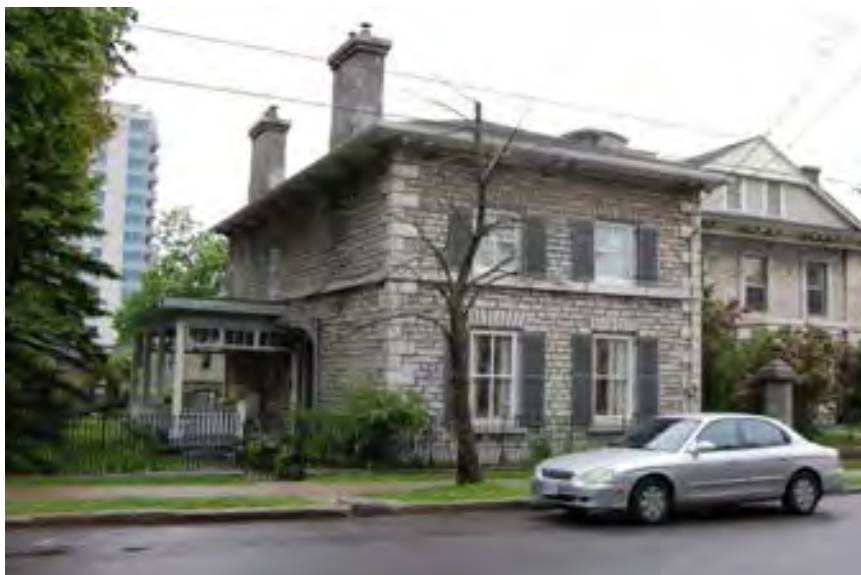
“The design of this building is simple, in keeping with its function. However, in order to provide a visual link between the two buildings many of the same structural and decorative features are used in both. Although not as tall as the house, the office section has the same broad hipped roof with wide bracketed eaves. It also is constructed predominantly of hammer-dressed limestone with ashlar used for the decorative features, the basement, string course, quoins and pair of chimneys. These features are emphasized by the chamfering and furrowing on the main facades while they are simplified elsewhere.

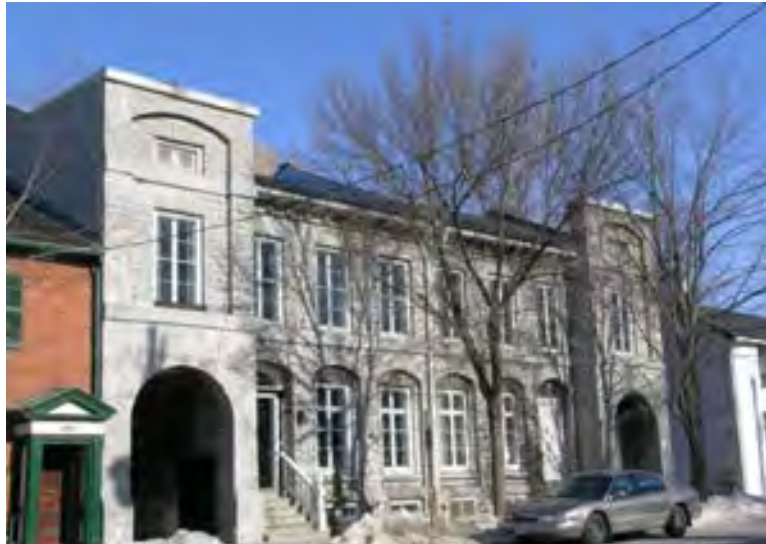
“This double residence of substantial scale is symmetrical throughout except for recent minor alterations. Its central two-storey portion of six bays houses the main entrances while the projecting pavilions are two and one-half storeys high and contain carriage-ways. The high basement level of the central section has four rectangular windows with voussoirs while the bays abutting the pavilions contain the stairways leading up to the main entrances on the first floor. In the main floor all openings are recessed in a series of interlocking segmental arches while the carriageways have semicircular arches.

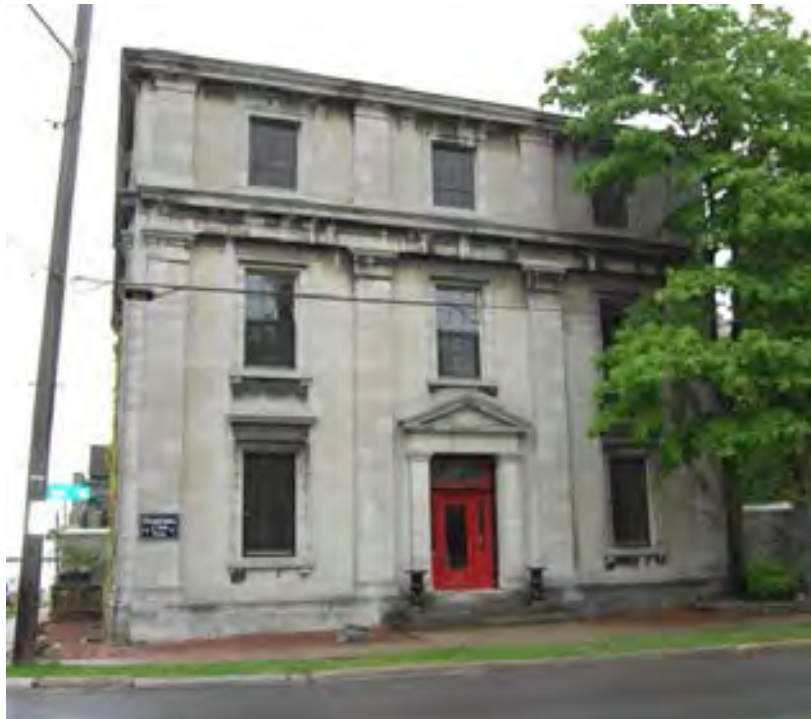
“... The doorway, the central point of the facade, has an attached pediment resting on two pilasters. Here, as on the other pilasters, edges are horizontally furrowed. The doorway is square-headed and recessed but the door has been replaced by a modern one.

“In the classical manner, the fenestration of the main facade is symmetrical, with a window on either side of the entrance and in each bay of the two upper storeys. The ground storey windows are the most elaborate. Resting on solid ashlar lugsills with two plain square brackets beneath, the windows have a moulded surround and are surmounted by a blank ashlar frieze and a cornice-like projection. A rectangular block above the cornice projects from the wall surface and is the width of the window surround. The three second storey windows have no entablature but are otherwise identical to those below them. In the attic storey, the windows with the same moulding and sill, are shorter than the others.

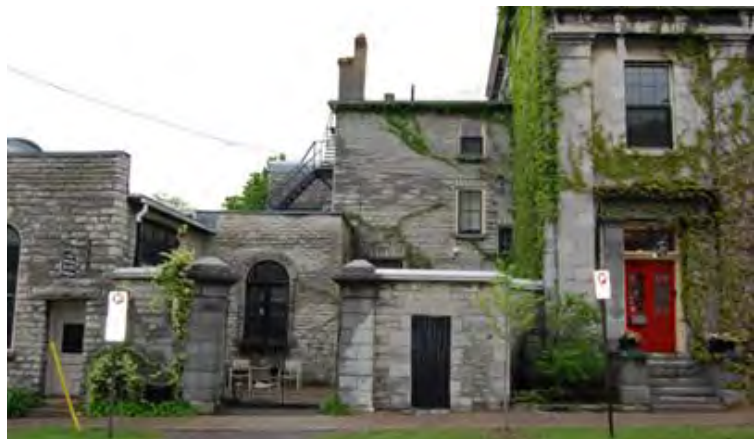
“On the William Street facade, also constructed of smooth ashlar, the overall design is the same as the main facade except in the treatment of windows and the entrance. The windows are less ornate and rest on plain ashlar lugsills which do not project so far as those on the main facade. Two plain rectangular windows are recessed into the basement level and protected by iron bars. All the windows of these two facades retain their original glazing.

“The side entrance, located in the east bay of this facade, is approached by a set of boxed ashlar steps which rest on a beveled base. This formerly gave access, through a spacious interior hallway and up an elegant staircase, to the private apartment of the bank manager. Each of the double-leaf doors has a cornice-like projection with a row of small dentils below it on the top rail. The rectangular upper panel is glazed in an asymmetrical pattern and this is repeated at right angles in the transom. Four smaller rectangular fielded panels form the lower half of the door.

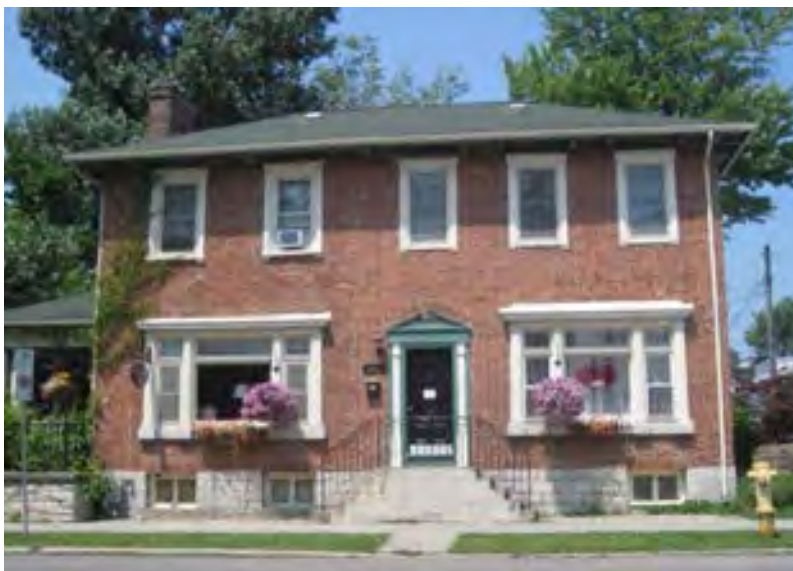
“This large red brick house, though greatly altered, is an important component of the streetscape. It is said to have been built by Archdeacon George O. Stuart for a relative, Dr. Murray. In the 1830's it housed a seminary and from 1837, it served as the home and office for such men as the Rev. William Herchmer and William Ferguson, then for a series of doctors – Horatio Gates, C.A. Irwin and A.R.B. William. For a time it was the Children's Aid Office and a Day Care Centre.

“The main section of this large two-storey red brick building has a broad hipped roof with a wide overhang. The King Street facade has a central doorway with a wooden surround of fluted pilasters supporting a broken pediment. Flanking wide window emplacements have fluted supports for an entablature and each contains a central window with narrow side lights, all with fixed transom lights. The five windows in the second storey have shaped wooden lintels trimmed with moulding and have decorated lugsills. They are double-hung and no original glazing remains.

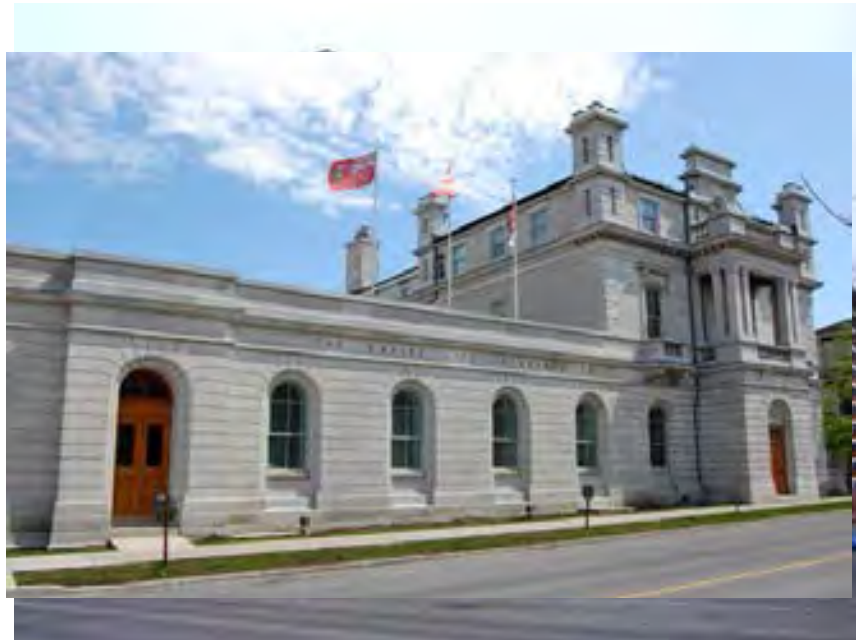
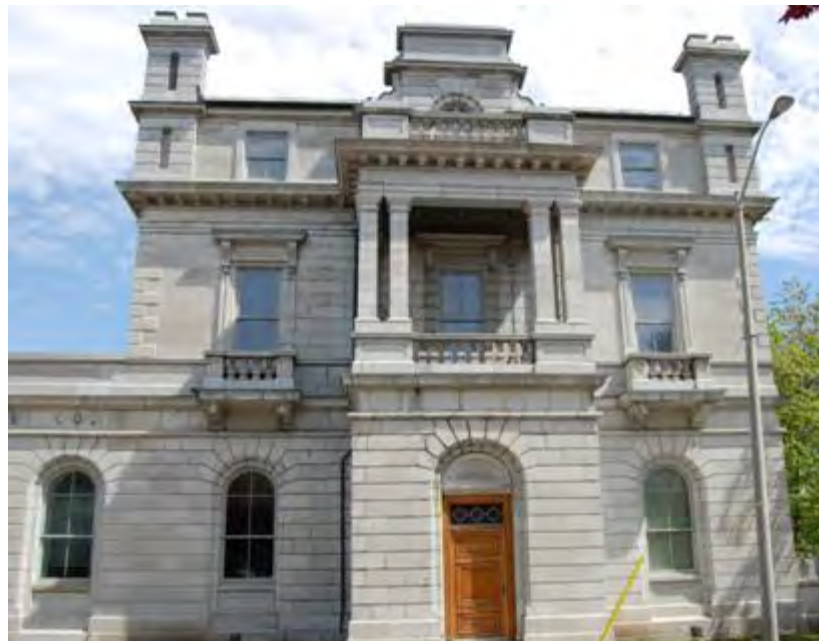
The Empire Life Insurance building, built in 1853-1854, is located at 243 King Street East; it occupies a corner lot formed by King Street East and William Street. The building is constructed of ashlar blocks and built in the Baroque Revival style. The property was designated under part IV of the Ontario Heritage Act by the City of Kingston on August 16, 1976 under by-law 8892.

Designed in 1853-54 by architect William Hay of Toronto, the building was modeled after the style of late sixteenth-century Italian palaces. Hay enriched the shape of the building by adding elaborate two-storey porches and balustraded balconies. Stonework throughout the building has been given a variety of treatments in order to emphasize certain architectural features. On the first storey, round arched windows rise from the base of the building and the rustication is fanned to form a head for each window. The main entrance on King Street projects from the wall and rises three levels. The door is paneled with a rectangular glazed transom light and above this a round arch contains a shell motif carved in stone.

In contrast to the rustication of the ground floor the second storey is of plain ashlar with raised and bevelled quoins at each corner. The windows are square-headed and each opens onto a balcony. Narrow pilasters frame the windows on the sides and each top is decorated with a lintel above a rectangular panel and supported by a pair of scroll corbels with an acanthus leaf motif. Above the entrance is an open balcony similar in design to the small balconies in front of the windows. Atop the balcony rests an entablature, its cornice decorated by dentils. On the third storey is another balcony, which surrounds a small round arched window whose head breaks into a decoration on the roof, thus adding further emphasis to the main entranceway. Each corner along the roofline is marked by an ornamented chimney-stack.

- balustraded balconies
- round-arched windows with fanned rusticated stone
- three level main entrance
- shell motif carved in stone above doorway
- square-headed windows which open onto balconies
- window frames decorated with lintels and scroll corbels with acanthus leaves
- bevelled quoins at each corner of the building on the second storey
- entablature between the second and third storey decorated with dentils
- third storey round-arched window topped with roof ornament
- ornamented chimney-stacks at each corner of the roofline

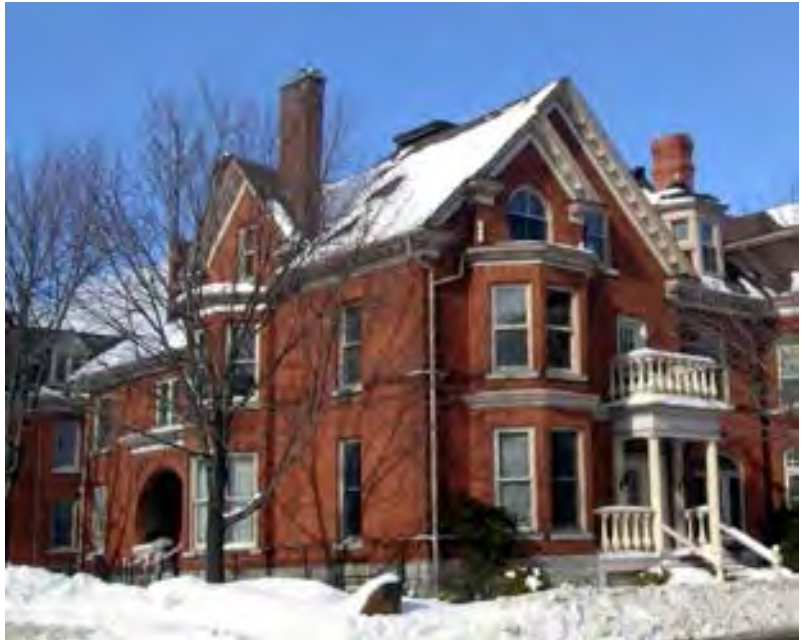
“This house at 244 King Street East, is one of five brick dwellings side by side in this block, was built on the site of ‘The Corner House’, home of Dr. James Sampson, physician, penitentiary surgeon and a founder and first dean of Queen's Medical School. The Corner House was destroyed by fire.

“This three bay, two and a half storey house sits on a high stone foundation topped by an ashlar course and has a brick string course at the sill level of the second storey windows.

“The third bay, two storeys under a pitched roof, has a parapeted end wall rising to a stepped brick chimney. In the first storey is a triple window with elliptical, stained glass transom under radiating brick voussoirs. The windows are separated by slender fluted columns with boxed capitals incised with circles. In the second storey is a single window and on the roof a bay dormer has a full front window and small side ones. The roof of the dormer is an octagonal dome crowned by a finial.

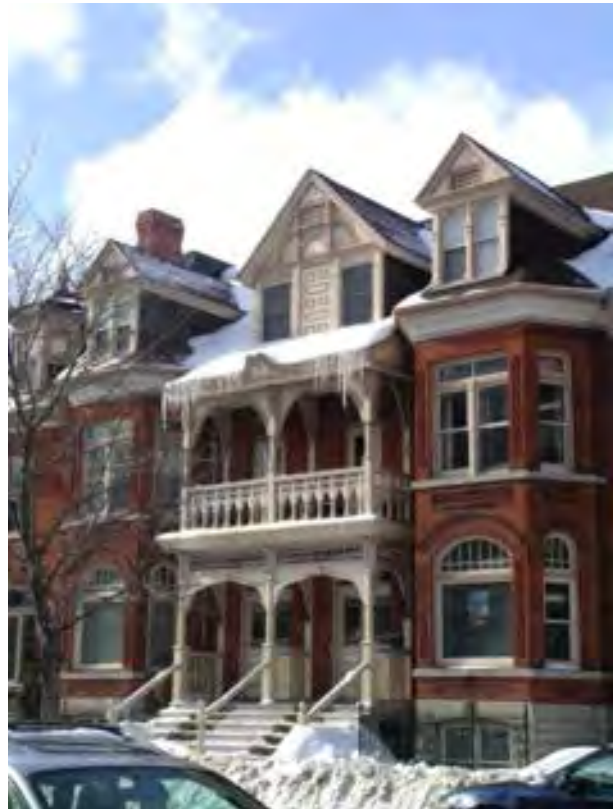
“This double dwelling, part of a row of brick houses of similar scale and design, was built to plans of William Newlands for Dr. Leonard Clements. The building, completed in 1892 has the typical Newlands shell motif in the gable and decorative panels. Dr. Clements left the building to his daughter, Josephine Macnee, who maintained it as rental property.

This two-storey, four bay brick double house on a high stone foundation, has doors in the inner bays and bay windows in the outer ones. The first storey bay windows have large segmental arched windows with label moulds and smaller round-headed windows on the angled walls. The ashlar sill course has decorative panels below it. Roll mouldings with vertical grooves flank the large first storey window and the second storey double window. The first storey windows have small paned arched transoms; all second storey windows have rectangular transoms.

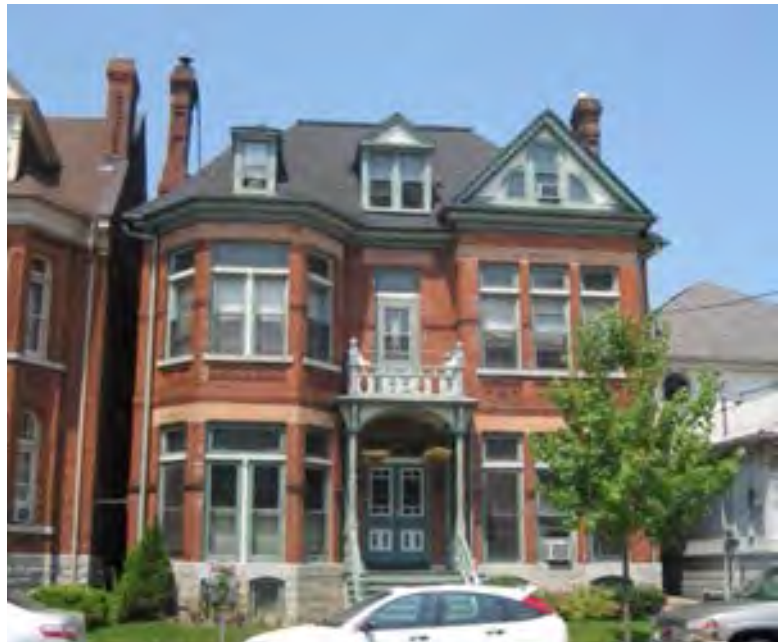
“This house is the last in the row of brick dwellings in this block and it was the first one finished. This building, while using the same material and repeating the bay window sections of the other houses, is different in the number and size of window openings and more generous use of ashlar and of decorative panels.

“This two and a half storey, three bay brick house is built on a high hammer-dressed stone foundation with ashlar base course which forms the lintels for the basement windows.

“The first bay is an angular two-storey bay window which rises to a hipped roof. In the first storey, the base course forms the continuous sill for the three window openings which are joined at the top by a wide ashlar lintel. The angled sides of the bay have single windows in each storey; the front of the bay has a pair under a common transom in each storey. All windows on the facade have stained glass transoms. Below the sills of the second storey bay windows are decorative terra cotta panels. The second storey windows also have a common ashlar lintel.

“The central bay contains the entranceway, double doors under a wide stained glass transom, all protected by a frame porch. Slender turned pillars rise to decorative brackets and arches supporting a flat roof edged by an iron railing. A single door opens onto the balcony; a wide ashlar lintel tops the stained glass transom.

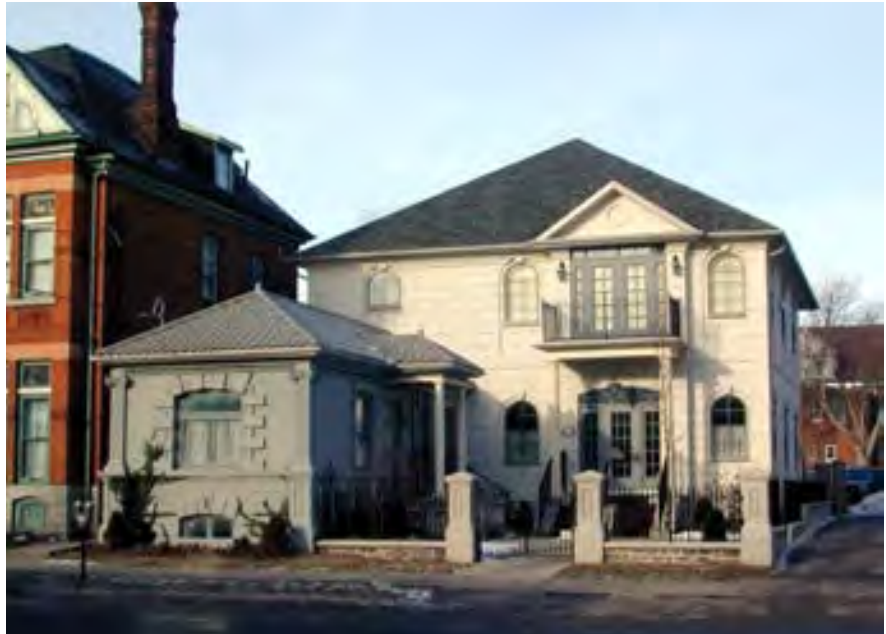
Built in 1909,<sup>\*</sup> this small office, located at 258 King Street East and known as “The Architect’s Office,” is of cultural heritage value and interest because of its physical/design value and association with an architect. It was designed and used by architect Henry P. Smith, 1864-1913, who lived in a separate house, at the rear of the lot. His house was demolished in 2000, and a replacement building, designed by architect Al Cromarty, attached to the far end of the office. At this time, a porch with two columns was added to the office on the long entrance wall. Smith selected Beaux Arts classicism as the style. It is an early example in Kingston of moulded concrete (instead of traditional stone), as well as having a tile roof evoking Mediterranean architecture (instead of the customary roof covering of metal or wood). These aspects suggest Smith wanted to ally himself with new ideas in architecture at the beginning of the 20<sup>th</sup> century. It was also unusual, at the time, to have a building devoted only to an architect’s business and in such a prominent location.

The building is one-storey over a high basement and under a hipped roof, which originally had two stubby vertical projects at the intersections of the hip but now has the roof’s far end extended to the new building on the rear. The King Street façade, one bay

wide, has corner pilasters with Ionic capitals and fluted shafts with bases resting on paneled pedestals, which frame the high basement. Above the capitals of the pilasters is an egg-and-dart band topped by colored tiles in a narrow band extending around the building under the eaves. The front, large central window has a dozen large “keystones” superimposed on the surrounding moulding. There is a gently arched transom over a rectangular window divided into two sections by a vertical glazing bar. The southwest wall has a single opening in the form of a vertical oval window positioned near the street. There are four prominent “keystones” in the window’s moulding. Now plainly glazed, there was originally an intricate leaded-glazing pattern. The northeast entrance wall, consisting of four bays, has a recent porch and steps. The wall surface is treated with a pattern of rusticated “stone blocks.” There are three windows with one-over-one, double-hung sash, and resting on a continuous string course.

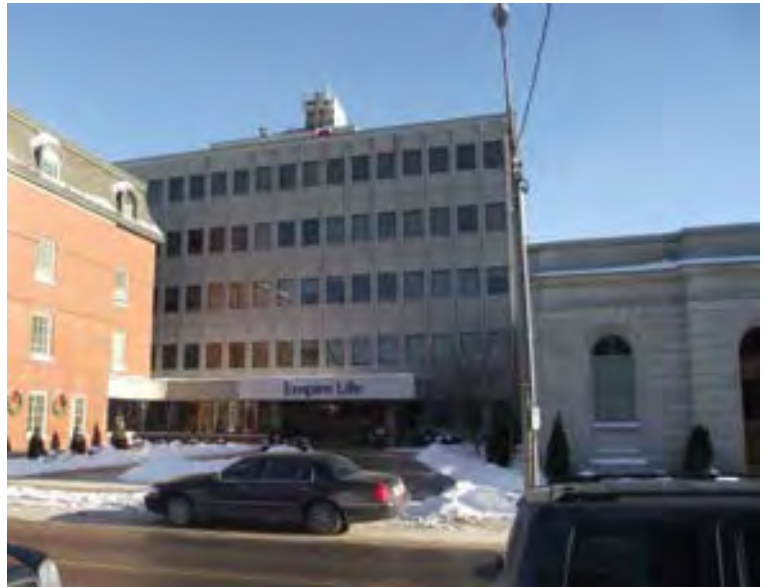
### 259 King Street East

This modern addition to the Empire Life Insurance Company's complex of buildings has a strong setback from King Street East, which supports a large courtyard between two of its older buildings. These features are a deliberate and conscientious manner in which the architect(s) have helped to preserve the historic King East streetscape. But, while they are supportive, they are also mitigating features: the design elements of the 259 King East building do not contribute to the Old Sydenham Heritage Area, and the building is therefore not a valued attribute of this property or the district. However, the 259 King East property retains historical value due to its association with a prominent Kingston institution.

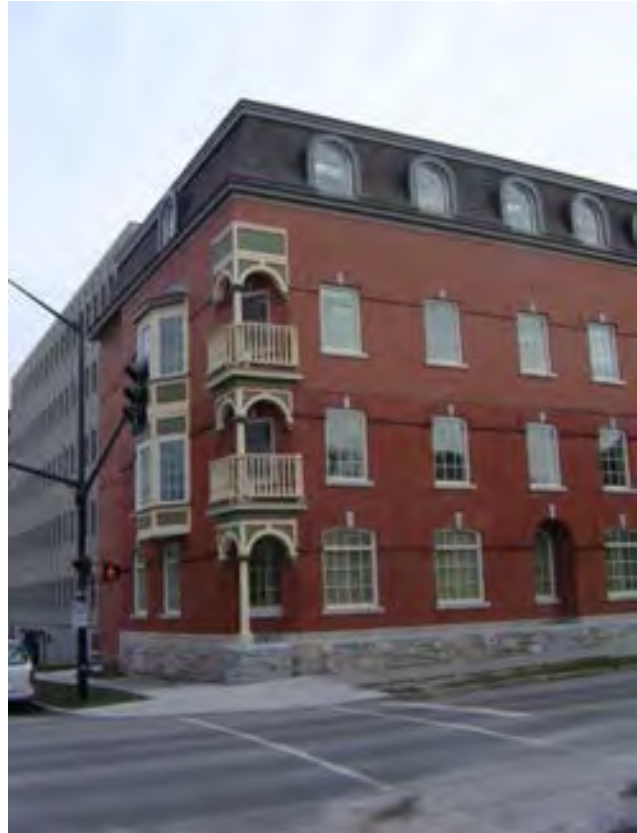
A fire in 2005 placed the future of this 1904 building's future in jeopardy. The structure was salvaged by its owner, the Empire Life Insurance Company, but modified and expanded in the process. Additional storeys were added to the building, one of which is partially housed by a replicated mansard roof. The expanded storeys' bricks were specially manufactured to match the original ones.

The original brick building on this property was 2½-storeys tall with a mansard roof. Its corner cut facing the intersection of King and Johnson Streets is original. The present balconets and the Johnson Street 2-storey oriel window have been replicated from their original counterparts, although expanded to cover the added third storey. The building retains a multi-paned window configuration, and recessions in the third and fifth bay of its King Street elevation.

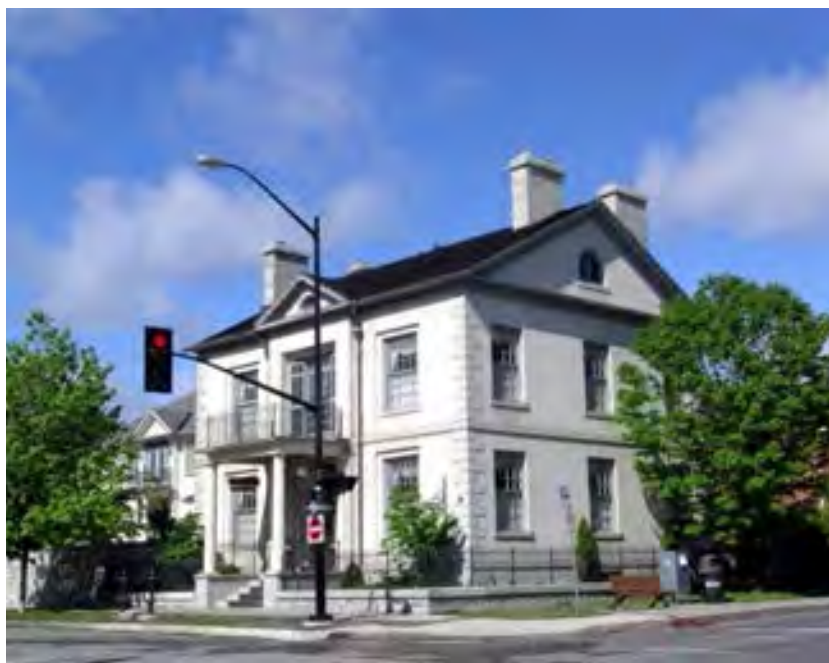
“This house is a fine example of a town residence built in the Loyalist style by a shipwright and shipping line owner for his family.

“The Gildersleeves owned the house until 1909 and the next owner, W.R. Glover was there for fifty-three years. With few exceptions, the house is little altered and it has generally been maintained with an appreciation of its architectural and historical merit.

“The rectangular house is built of hammer-dressed limestone with projecting chamfered quoins of vertically furrowed ashlar. The angle drafts of the chamfered quoins are boasted to give subtle emphasis to the corners of the building. The architectural details such as the base of the King Street facade which contains the basement windows, the string course between the first and second storeys, the two pairs of chimneys and the window sills are all in smooth ashlar with vertically furrowed face.

“The two street facades have been stuccoed, but on the remaining two sides of the house, the smooth ashlar quoins around the windows are still visible. All windows but the two on the ground floor of the King Street facade retain the original sashes, and all of these except three on the Johnson Street facade and one at the rear, retain the original glazing bars. The columns of the portico have been repaired by the addition of square fluted bases.

“The garden wall on King and Johnson Streets is of hammer-dressed ashlar with smooth stone coping. A pair of square smooth ashlar pillars topped by ball finials, mark the entrance from Johnson Street to the yard behind the house. Evidence of iron gates remain. The stone coping has been replaced by concrete on a length of the Johnson Street side, and by thin stone coping on the King Street side when this length of wall had to be rebuilt in 1970.\*
