Property Inventory Evaluation

William Street

**20-22-30 WILLIAM ST.
FRONTENAC CLUB INN**

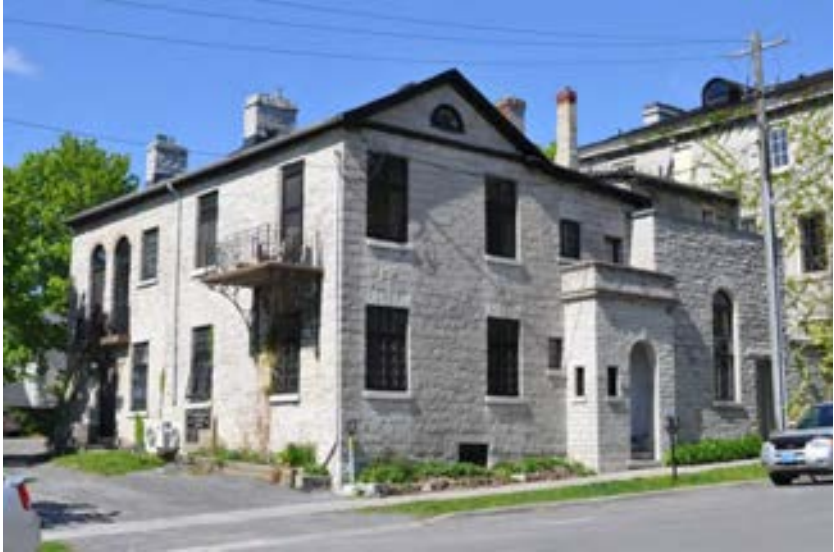
In addition to its historical association with the Cartwright family, this building has a high contextual value. It blends with the other limestone structures in the immediately surrounding area, including 221, 223, 225 and 243 King East; as well as the brick row comprising 128-136 Ontario, to its southeast. It occupies an important location close to the waterfront, and is highly-visible from that perspective. Built on the slope rises from the shoreline, the building has a southeast elevation that overlooks the Cataraqui River. The 20-22 William building merges with a later, c. 1908 structure, built for Frontenac Club, who purchased 225 King Street that year. Its design attributes include its stone composition, 2-storey massing, low and wide stone chimneys, and a William Street gable with fanlight. Most of the building's windows are tall and rectangular, on ashlar sills, with 8-piece transoms and window patterns. Two balconies project from its southeast elevation. The south-western balcony contains paired doorways with round-headed openings with ashlar hoods and matching transoms. The first storey below these contains a rectangular entranceway doors.

The William Street entrance projects from both the main massing, and the c. 1908 building. It is bordered by three small rectangular windows: two above it and one to its Ontario Street side. The former have tall stone voussoirs. The entranceway door is recessed behind a half-round arch. The projection has a stone entablature framed by moulded ashlar sills. Small rectangular sidelights are set in the face and southeast side of the projection.

Quoins on the southeast elevation divide the 20 William Street building from 22, which is set further back. These suggest that 22 William, which appears as a 1½-storey extension on fire insurance maps,

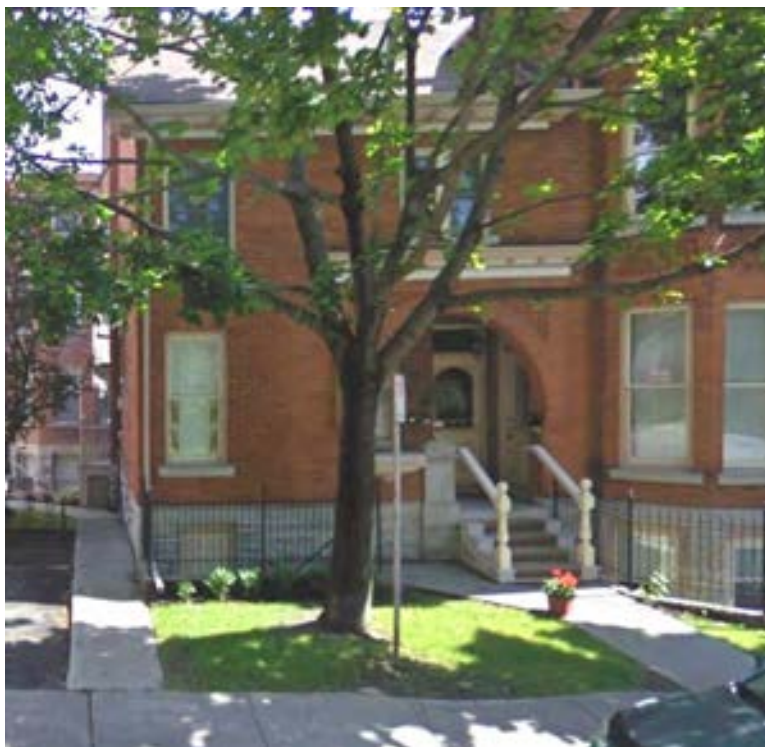
41 WILLIAM STREET

Architecturally this extension harmonizes with the larger building. Its character defining elements

include a deeply recessed entranceway and porch under a Romanesque arch. Decorative brickwork spandrels top the arch under a projecting flat hood, with bracketing cornice, matching that of the extension's side-gable roof.

A stone pillar borders one side of the entranceway. Paired rectangular windows on a common ashlar sill are located above it. Two rectangular windows on ashlar sills, on the bay northwest of the entrance, are 1/1; the lower one contains a round-headed mullion with arms. A second entranceway, a tall rectangular window, and a series of smaller, irregularly-placed windows are found on the rear elevation. Two tall brick chimneys rise from this wall. One is partially embedded; the other fully.

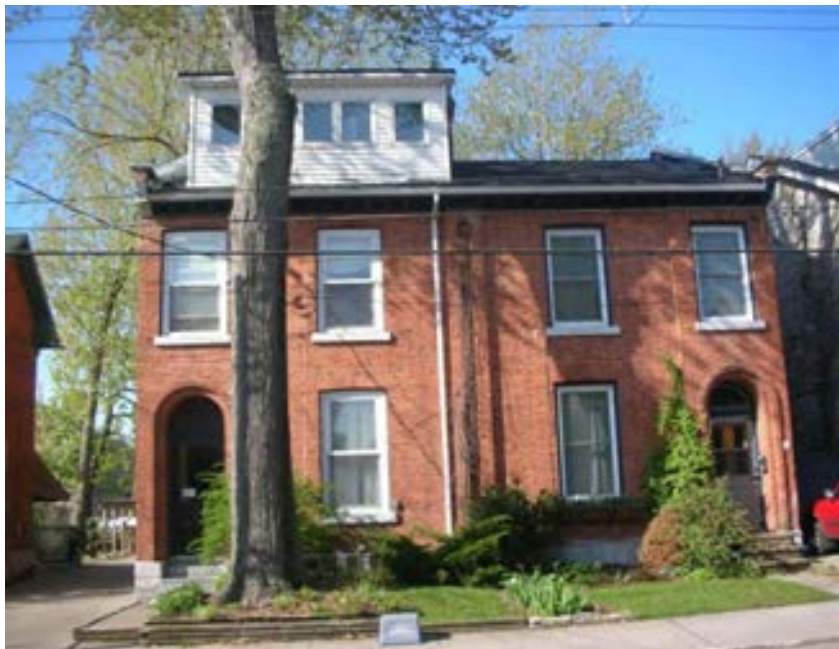
44-46 WILLIAM STREET

The 44-46 William Street building's design values include its outer bay entranceways, which are recessed behind round-headed arches with simple, projecting, brick surrounds. Each wood-framed entrance contains a round-headed transom. The structure rests on a stone foundation with sunken basement windows. It has a side-gable roof flanked by brick firewalls capped with stone. Symmetrically-placed and simple 1/1 rectangular windows, with plain wood surrounds and ashlar sills, fill the remainder of the façade. The outer bays project slightly, and the units are divided by a brick pilaster.

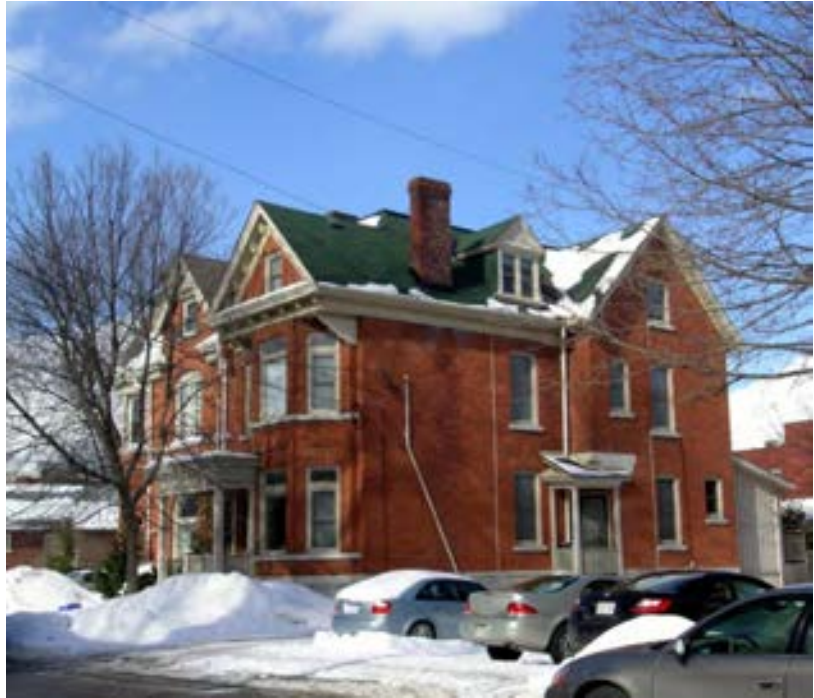
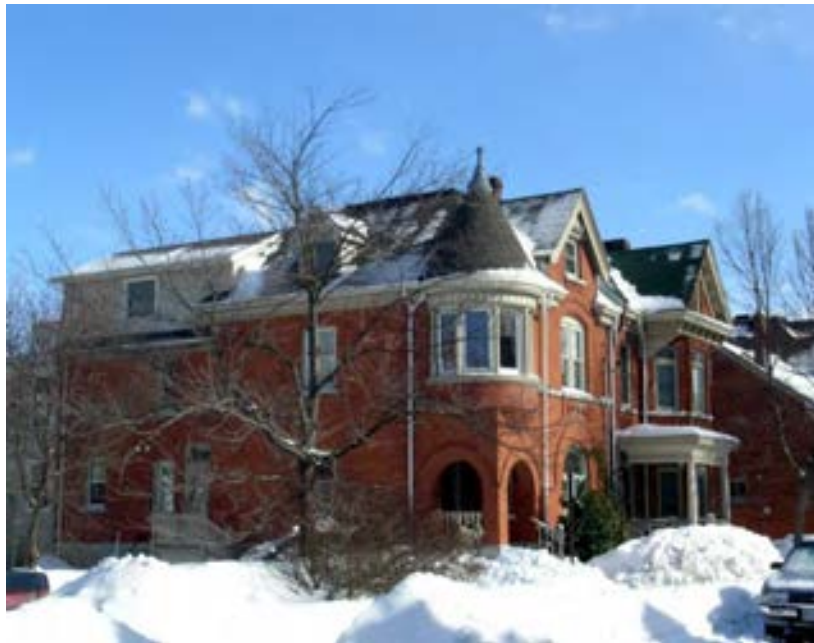
The grander features are concentrated at 47 (where the original owner/developer lived) including a colonnaded turret with conical roof corbelled impressively to its round form from the brickwork of the umbrage at its main entrance. The umbrage itself is formed, in Richardsonian fashion, by two broad arches at right angles sharing a brick cornered column on a rock faced ashlar limestone pier with beveled cut stone cap. The arch is repeated in magnified form as the main window opening of the first storey. The corbelled stone margent which defines the upper edge of the arch voussoirs is carried between

them and takes a horseshoe form at the window. The front eave line of 47 is 'broken' by the extension upwards of the brick wall plane as the face of the cross gable with its paneled and mould verge. The main cornice also is paneled with dentillation above. The roof is otherwise comprised of a main hipped section with low slope section above which originally would have had iron cresting at the perimeter.

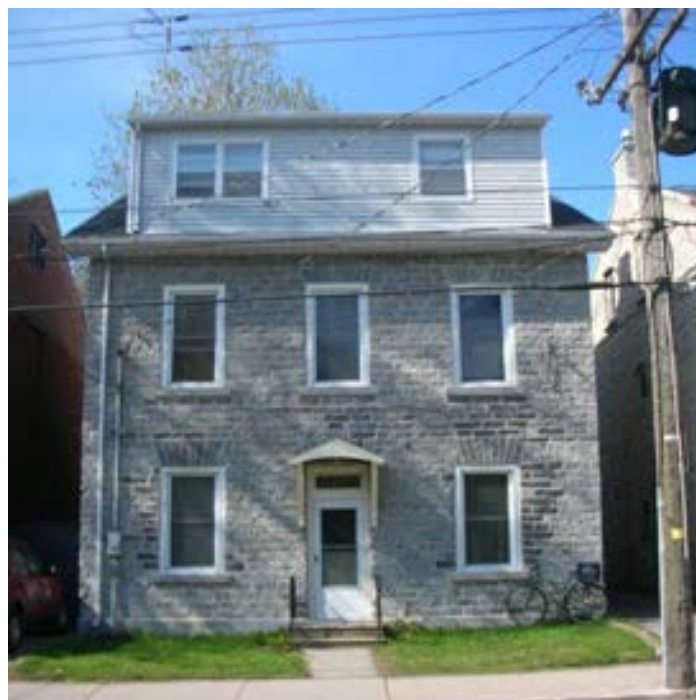
The structure is well-suited to the southwest side William Street, between King East and Wellington, which is comprised of several stone and brick houses with compatible massing, flat façades, side-gable roofs, and similar setbacks. Its design attributes include its stone composition, symmetrical fenestration with a centralized entrance and small rectangular transom; tall stone voussoirs and ashlar window sills, side-gable roof, and an ashlar base course.

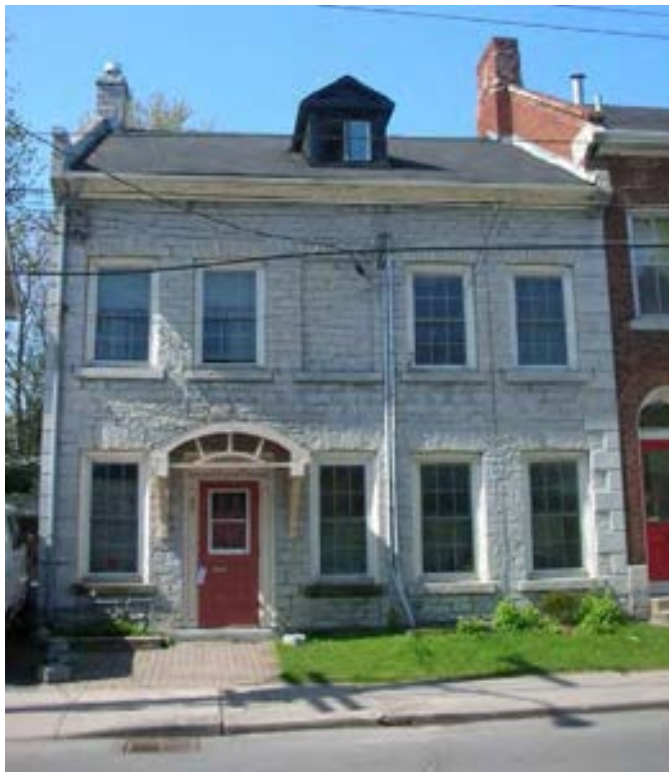
This building is well-suited to the southwest side William Street, between King East and Wellington, which is comprised of several stone and brick houses with compatible massing, flat façades, side-gable roofs, and similar setbacks. Its design attributes include its stone composition, symmetrical fenestration with an offset front entrance and panelled wood surround; its 6/6 window pattern, ashlar window sills, northwest-side quoins; and a southeast firewall with a large stone corbel rising to a stone chimney.

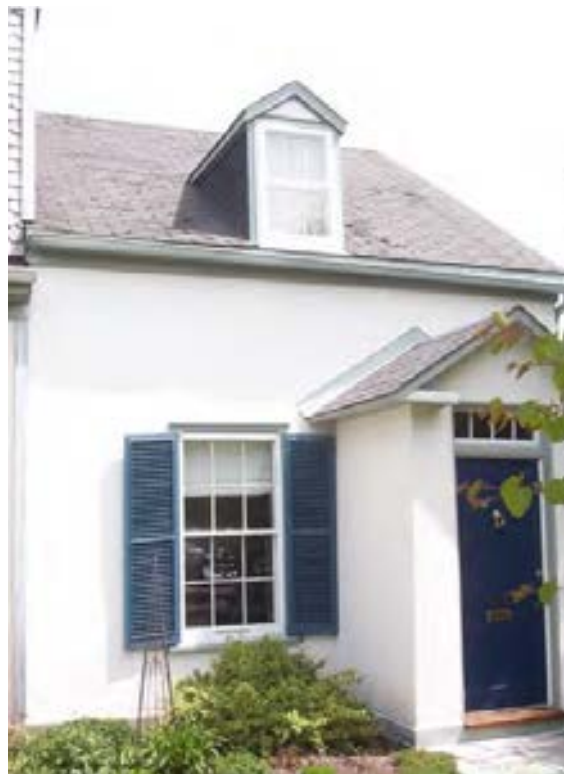
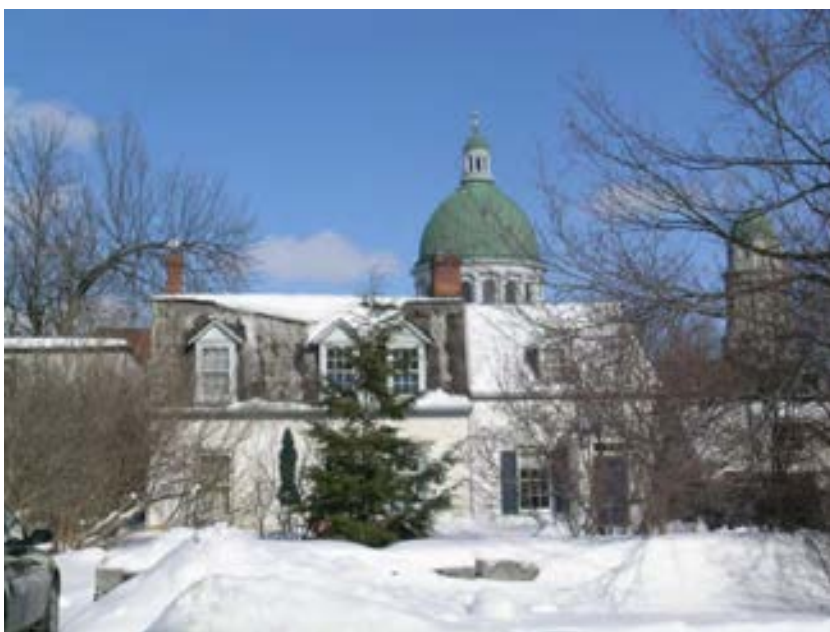
53-55 William Street
J.McK.

The property has physical/design value. Character defining elements that reflect this value include its scale and massing. Other elements reflecting its physical/design value include the dwellings two and a half storey stucco construction, two bays wide with a door in the east bay protected by a stucco gable roofed vestibule. A simple dormer adorns the centre of the gabled roof. Importantly this small cottage is unique to the streetscape of Kingston, where almost all houses of this period are near the street line. This dwelling by contrast is set back from the street located at the back of the property line.

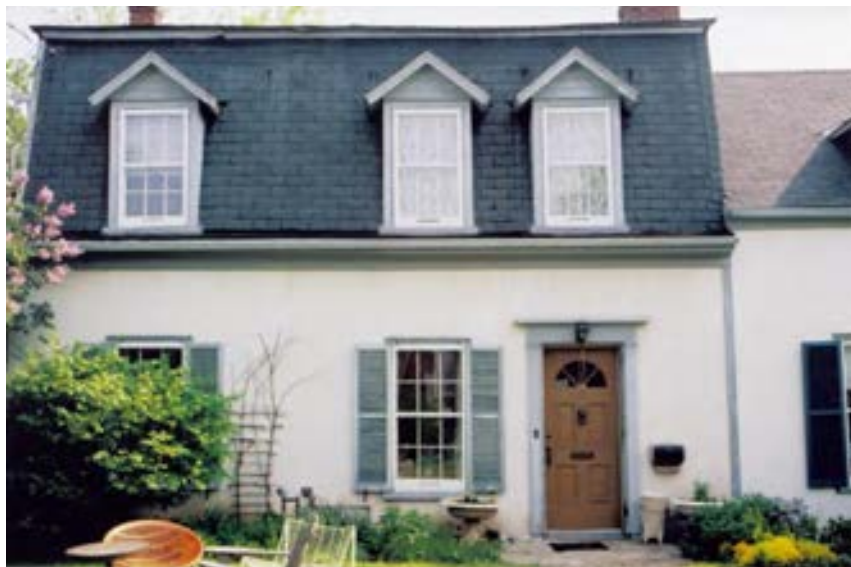
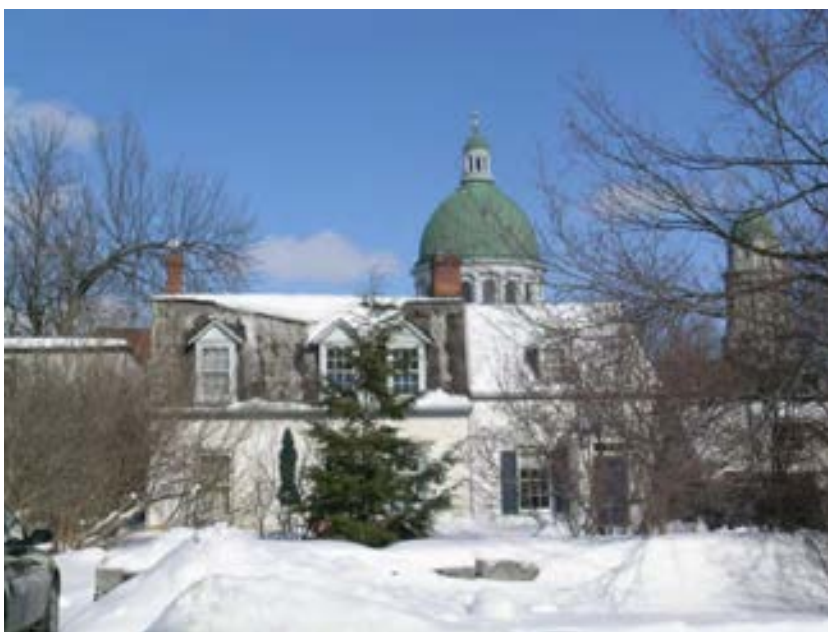
53-55 William Street
J.McK.

The property has physical/design value. Character defining elements that reflect this value include its scale and massing. Other elements reflecting its physical/design value include the dwellings two and a half storey stucco construction, two bays wide with a door in the east bay protected by a stucco gable roofed vestibule. A simple dormer adorns the centre of the gabled roof. Importantly this small cottage is unique to the streetscape of Kingston, where almost all houses of this period are near the street line. This dwelling by contrast is set back from the street located at the back of the property line.

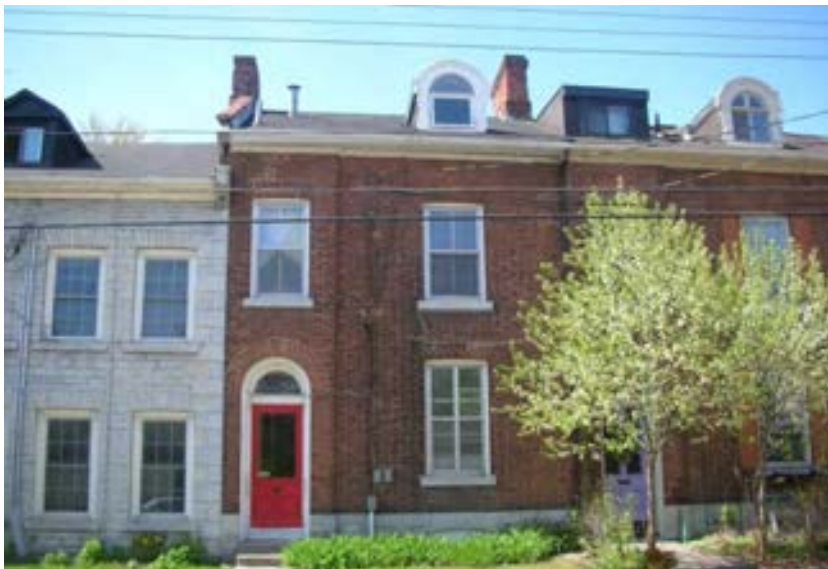
56-58-60 WILLIAM ST.

Built in 1854, this terrace, located at 56-60 William Street, is of cultural heritage value and interest because of its design and contextual values. The structure is well-suited to the southwest side William Street, between King East and Wellington, which is comprised of several stone and brick houses with compatible massing, flat façades, side-gable roofs, and similar setbacks.

The property has physical/design value. Character defining elements that reflect this value include its scale and massing. Other elements reflecting its physical/design value include the dwellings two bay, two and a half storey red brick terrace construction, stone foundation, and square arched windows and stone lugsills. The arched entranceways and windows directly above them are set in very shallow projections and there is a shallow pilaster-like projection marking the division 58 and 60. The doorways of these dwellings are characterized by steps rising through the foundation to the recessed door. Paneled reveals complement the semi-circular transoms and paneled doors. The front slop of the roof is characterized by round-headed dormers with wood surrounds. A firewall with stone corbel is located on the southeast side of 56. It rises to a wide brick chimney. A second brick chimneys is found on the southeast side of 58. The chimney on 60 William is stone.

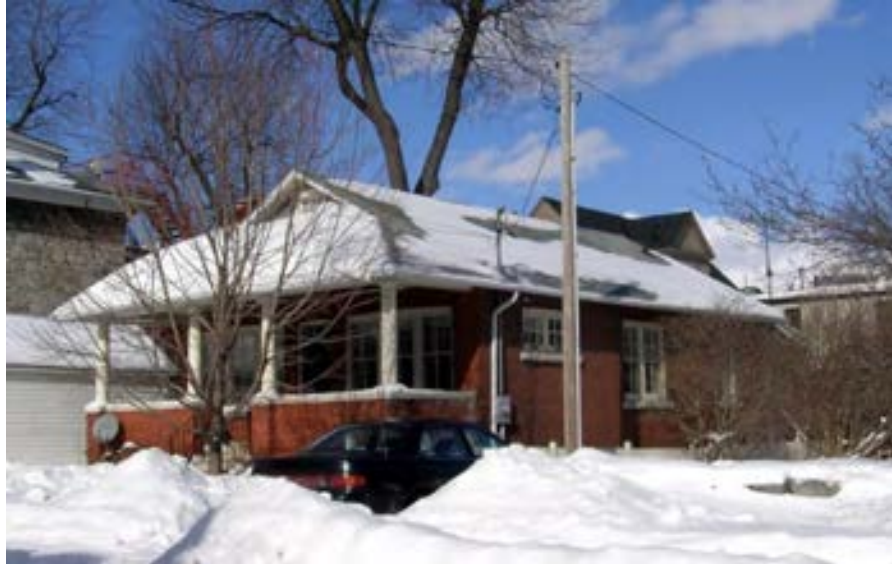
59 William is a good, if modest, example of a 'Craftsman' style bungalow, a residential form which became popular in the early 20th century in North America but has earlier

antecedents in the British Arts and Crafts Movement of the later 19th century. While the stylistic basis is always rooted in a sense of almost rustic simplicity here it takes a particularly austere, though still picturesque form. Indeed in general form - three bay, hipped roof with deep overhang which includes the verandah at the front - it is very close to the picturesque cottage type of the 1830- 50 period, both ultimately derived from the South Asian bungalow. A gable with 3-light window arises from the hip at the façade adding visual interest. The large tripartite window openings (6/1 light sash) flanking the main door compensate in terms of natural light for the deep verandah roof. The door and window openings are arched with a 'triple row of headers' and the brick itself is the dense red brick associated with the style. The simple, turned verandah columns extend from a brick wall which, typically Craftsman forms both the foundation and 'balustrade' of the element. The frame garage is also original.

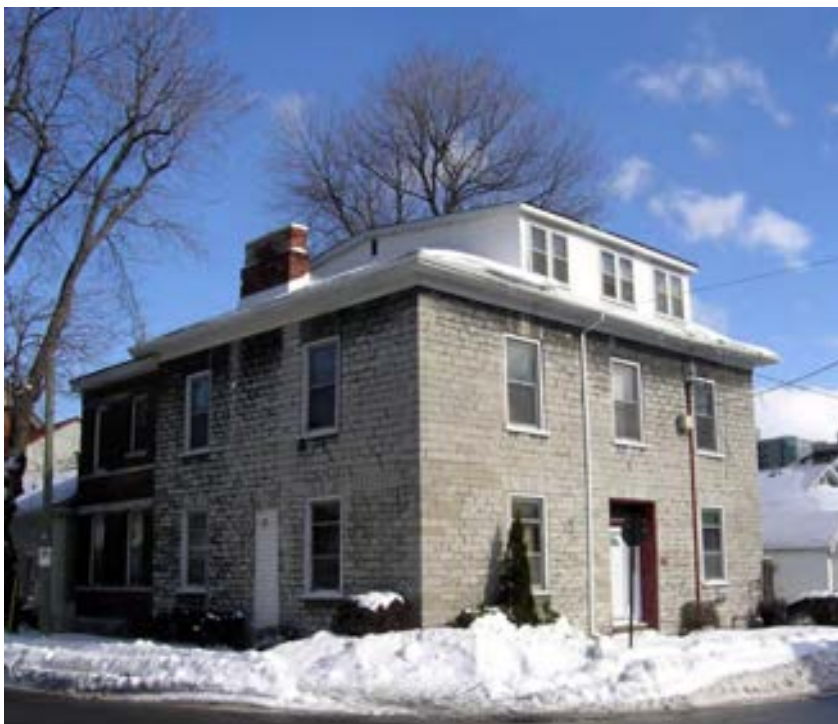
Built in 1841, this stone dwelling, located at 63 William Street, is of cultural heritage value and interest because of its physical/design value.

The property has physical/design value. Character defining elements that reflect this value include its scale and massing. Other elements reflecting its physical/design value include the dwelling's large roughly coursed limestone construction, consisting of two stories, a low hipped roof and wide brick chimneys inset at each side of the roof. The main facade, three bays wide, has symmetrical, widely spaced openings. The central entranceway is deeply recessed with only the original rectangular transom remaining. The western facade is three bays wide and is characterized by a central door flanked by windows. Voussoirs indicate an earlier opening which is now blocked. The rear of the dwelling is characterized by a simple brick addition.

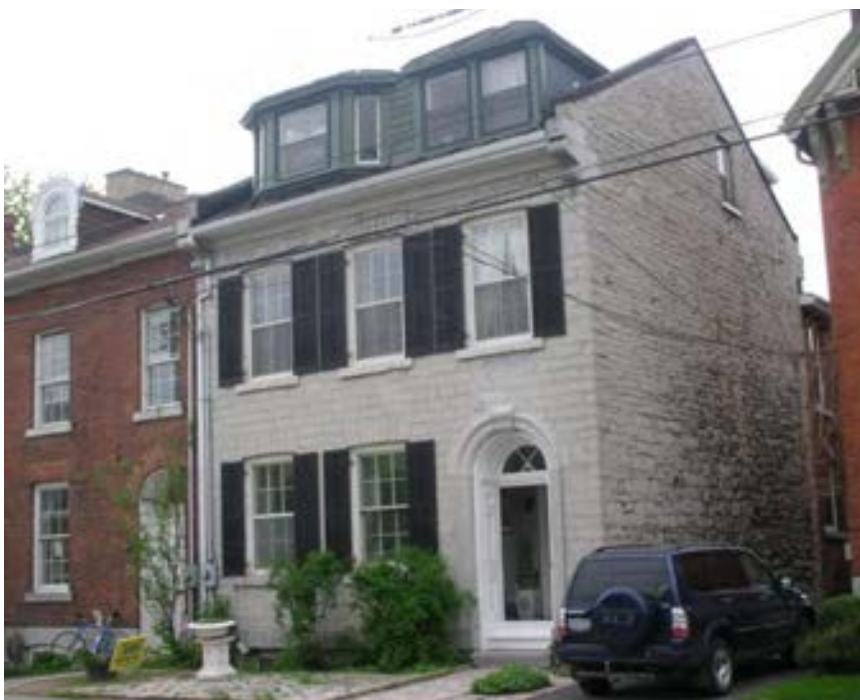
The structure is well-suited to the southwest side William Street, between King East and Wellington, which is comprised of several stone and brick houses with compatible massing, flat façades, side-gable roofs, and similar setbacks. Its design attributes include its regular fenestration with 6/6 window patterns; a side gable roof with curved stone corbels supporting fire walls; and its smooth stone finish, which contrasts with its rubble stone northwest elevation. The building's entrance is in the northwest of its three bays. It is recessed under an ashlar hood with a keystone. Wood reveals with recessed panels flank the doorway, which is topped by a half-round transom with curvilinear glazing bars.

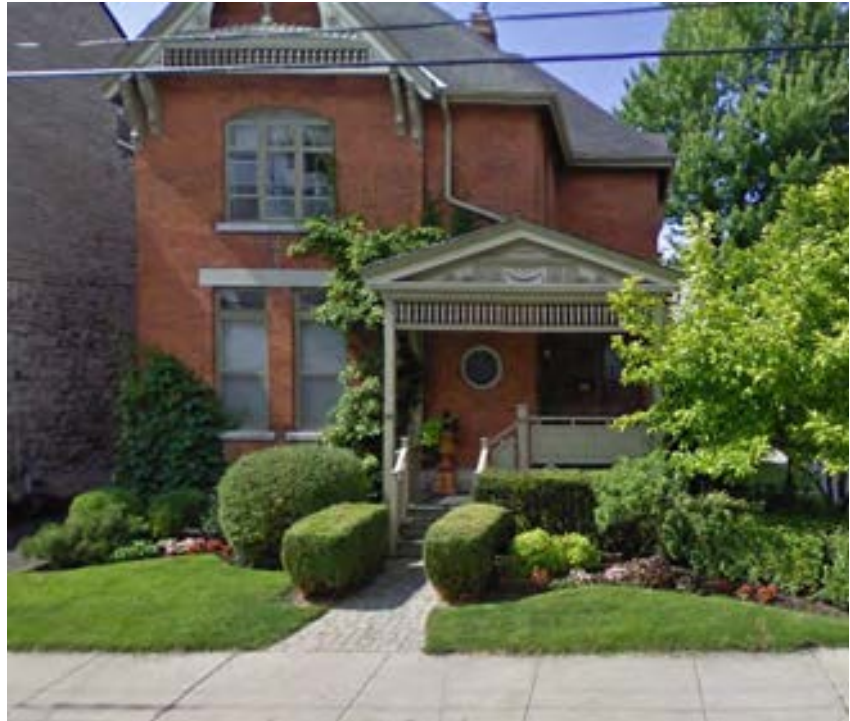
This building departs from the pattern of flat-façaded houses, with shallow setbacks, that comprise most of this streetscape. It serves, however, as an effective end to that pattern, and is appropriately designed for its prominent corner location. This building has design attributes that display a high degree of craftsmanship and artistic merit. Among these is its eclectic massing, tall brick chimney, staggered-hip roof, William Street tower with crowning gable, and its front porch with gable roof. The woodwork on the tower and porch gables is of exceptional quality. Each features a row of turned spindles that form a hanging balustrade amid other elaborate designs. The tower gable contains half-round trim divided by a turned wood column. It has button reliefs under the bargeboards, and is supported by pairs of heavy curved-wood brackets. The denitled porch gable's tympanum contains an elaborate wood relief centred on pilasters supporting a hood and rounded reliefs.

The tower's second storey contains a large opening with three windows, each with a square transom in 6-pieces. The windows share a common ashlar sill. The two windows below them, on the first storey, share a common, heavy ashlar lintel; they have separate sills and are divided by brick. These windows have rectangular transoms with leaded tracery. A round window with stained glass and tracery faces William Street from the porch entrance, which wraps around part of the building's main massing and features a wood-panel balustrade.

The Wellington Street elevation has a high stone foundation; an entranceway topped by blind wood fanlight with a shallow hood, and asymmetrical window openings. Those on the second storey are contain multi-paned transoms; the south-western two of these have slight arches over small wood

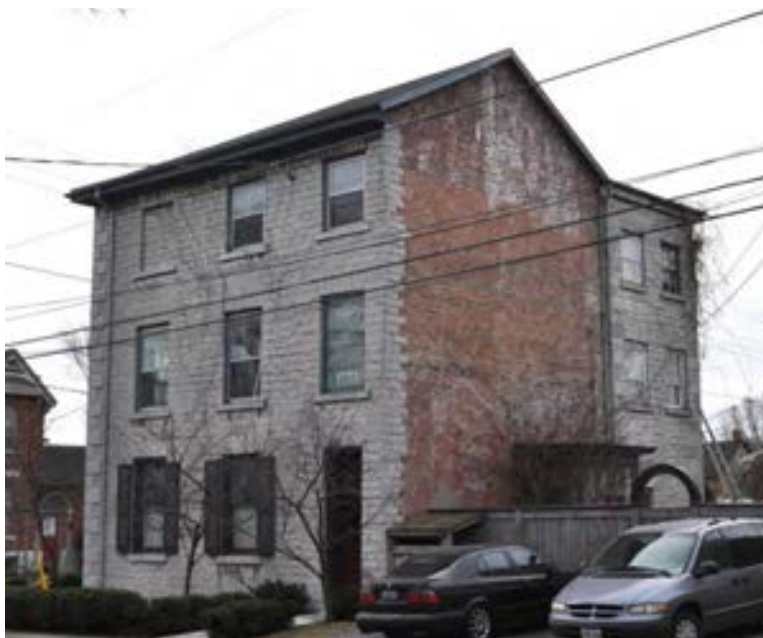
The property has physical/design value. Character defining elements that reflect this value include its

scale and massing. Other elements reflecting its physical/design value include the dwellings three-storey corner construction, made of hammer-dressed limestone with ashlar base course, window sills and quoins at the street corner. The side and rear gable walls are brick and one portion of the rear wall not under the gable is stone. Many of the windows retain the early six over six glazing, with the exception of one filled window opening on the third storey.

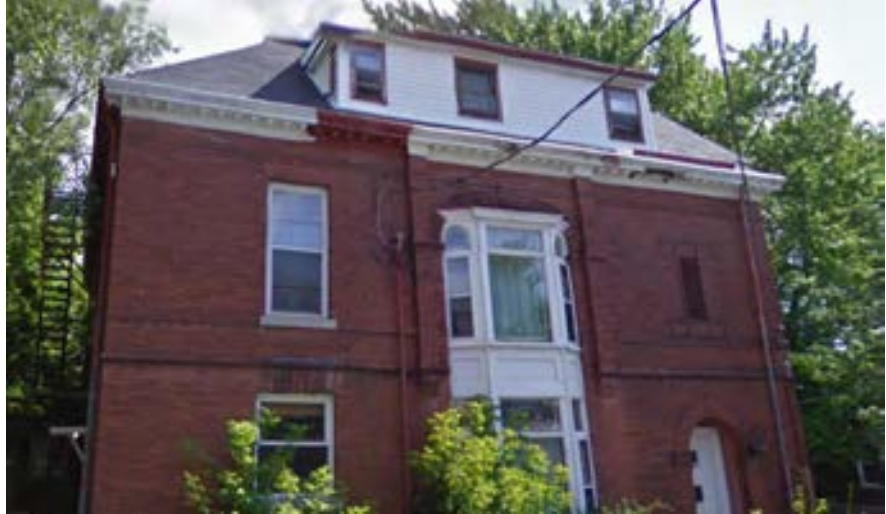
75 William Street is the southwest elevation of 100 Wellington Street, a large 3-bay, 2½-storey brick house constructed for physician Dr. Isaac Wood in 1901. See 100 Wellington Street entry for more details.

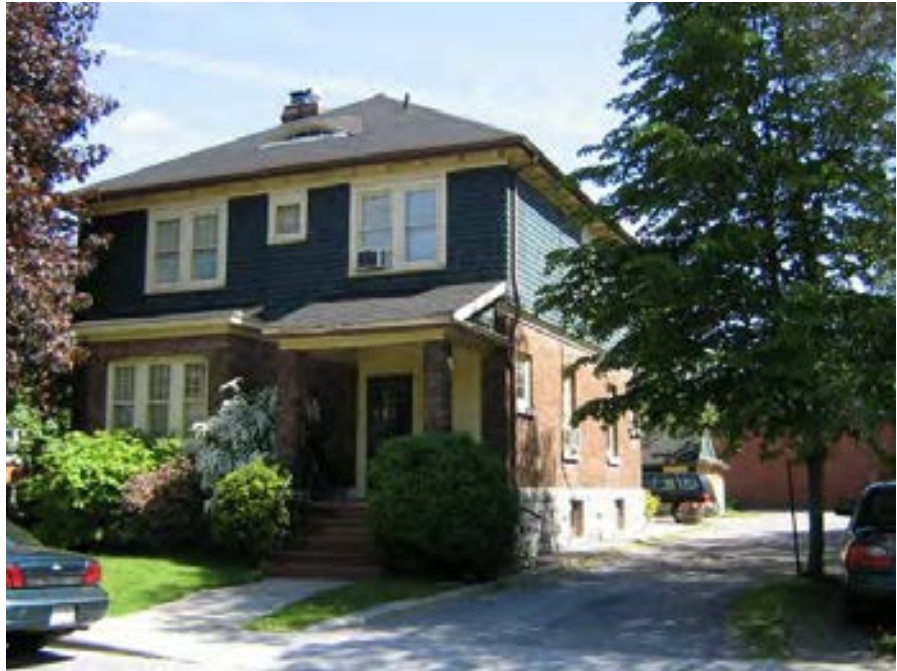
79 WILLIAM STREET

The main 79 William Street building is valued for its design attributes. The structure is a 2-storey, 2-bay brick building on a limestone foundation. Its first-storey exterior is brick, while the second is clad with wood shingles. The building's main massing is square, with a pyramidal roof. At the rear of the building, on the Wellington Street side, there is a 1-storey brick wing, to which a smaller, 1-storey wood extension is attached. A wood front porch is sheltered by a roof supported by two square brick pilasters. The alternate bay features a shallow, rectangular, bay widow with three 9/1 windows surrounded by plain, medium-sized wood trim and separated by thick, plain wood mullions. The main windows on the second-storey façade are also 9/1. Centred between these is a 9-pane casement window with broad, plain wood surrounds which, like each adjacent window, abuts the building's plain wood entablature and bracketed cornice. Much of the building's remaining fenestration matches that of the front façade, containing windows with 6, 9 and 12 panes of glazing. A rare root cellar entrance with a wood-plank door and cover is located between the building's main massing and the rear wing, on the southeast side of the building. An uncommon, muted, and semi-circular dormer protrudes slightly from the faced roof, containing a matching window in three pieces.

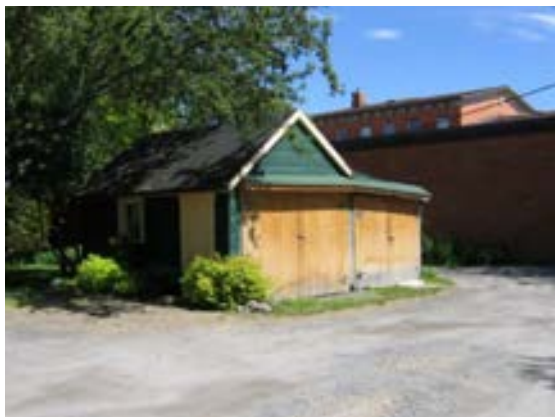
Automobile garage

At the rear of the property is a two-vehicle automobile garage made of wood and framed with a sheet metal veneer. The veneer is imprinted to simulate the look of rusticated stone blocks. Its main section has a gable roof, a simple wood door; and a fixed, square window of four lights. The rear of the building has a similar window with 8 lights. A second section of the building has a mildly sloped roof. Each section of the building contains a set of large wood double doors spanning its southeast elevation.

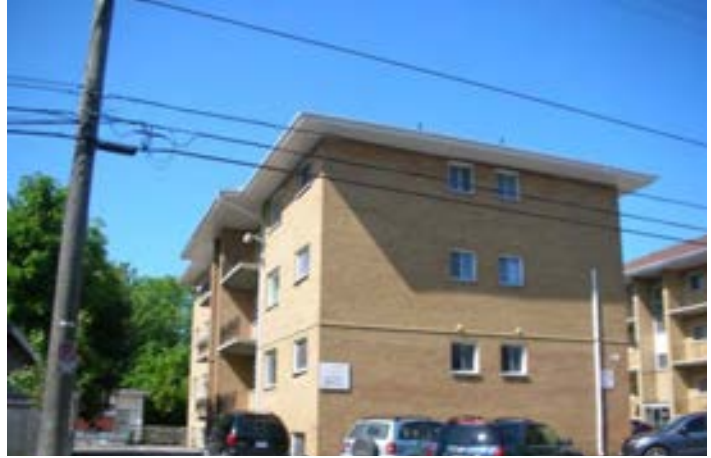
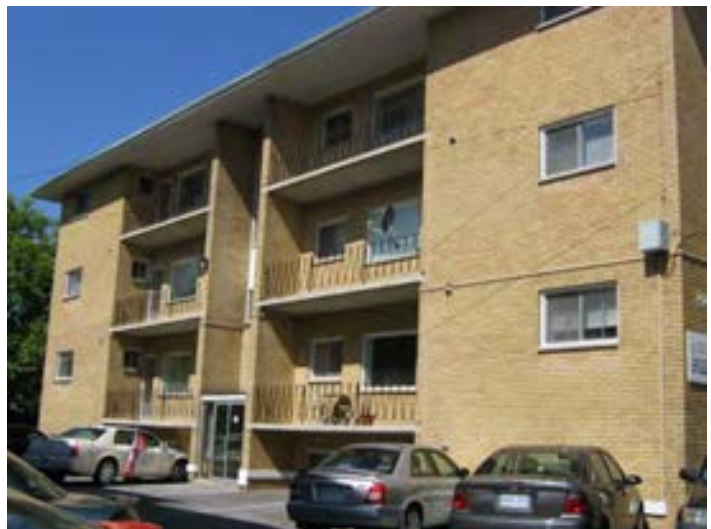
These apartment buildings were erected as part of a Sydenham Ward renewal project in the mid-1960s. Each is 3 storeys tall with a flat roof, square and rectangular fenestration, and recessed balconies with concrete floors and iron balustrades.

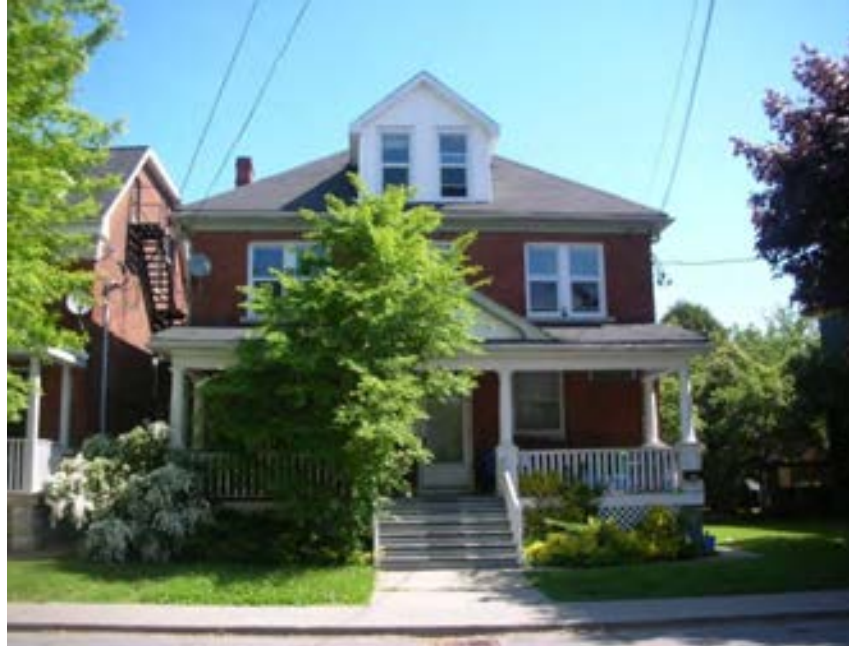
85 WILLIAM STREET

In addition to its historical associations, the 85 William Street building has design values which contribute to the William Streetscape. The structure is a 2 ½-storey, 3-bay brick house with a rusticated limestone foundation, and a full-width wood verandah. Its main massing is rectangular with a pyramidal roof, with a 2-storey gabled wing at the rear. The verandah is approached by wood stairs that span the width of the centre bay. Its roof is supported by six wood columns, two of which are embedded at the building's façade. Each column sits on a square base with recessed panels. The porch roof has a pediment-dormer centred over the front stairs, with a plain wood bargeboard. Its tympanum has been clad in modern siding which is not of heritage value; a large gabled dormer on the roof facing William Street has been similarly covered. Window units throughout the building are relatively new, compared to the age of the building. But the second-storey façade openings, on each other bay, maintain an appropriate paired window pattern, with wide mullions and shared stone sills. They flank a smaller, centralized rectangular window. Alteration of the first-storey façade fenestration has been less sympathetic. It is possible that a presently-false door on the building's southeast side is related to its previous function as a doctor's office.

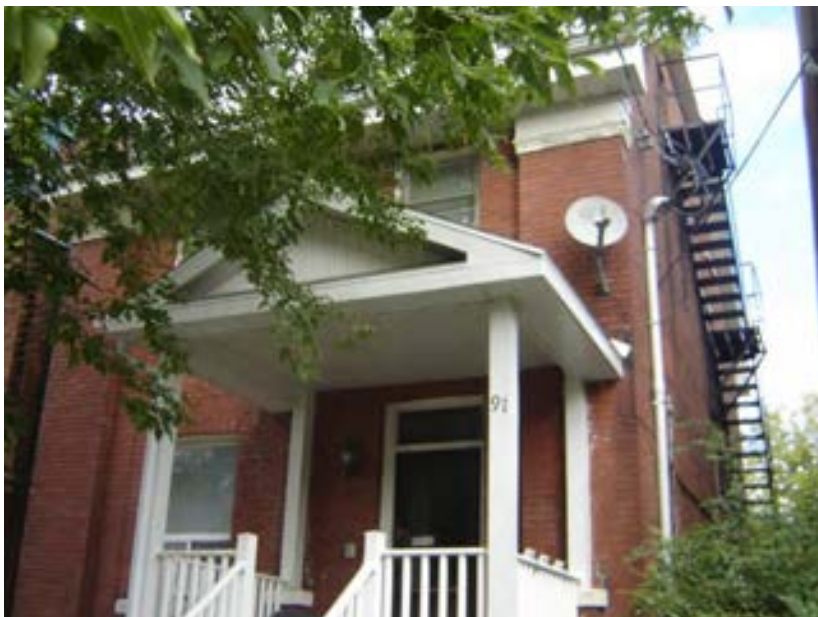
The 91 William Street building was constructed for Canadian Pacific Railway Conductor, John Craig, in 1916. While this building is simple in overall design, it has a number of distinct architectural elements which contribute to its design and context values. Amongst these elements is its flat-topped side-gambrel roof; the broad brick pilasters flanking the structures 2-bays; and the ashlar base course topping its rusticated stone foundation. The front entrance porch is supported by matching foundation stones, and topped by pediment-roof. The entranceway door is topped by rectangular transom, and the building's main windows are rectangular on stone sills. Like the porch roof, a large front dormer has been clad in modern materials. It features a Palladian window arrangement with a blind central fanlight.

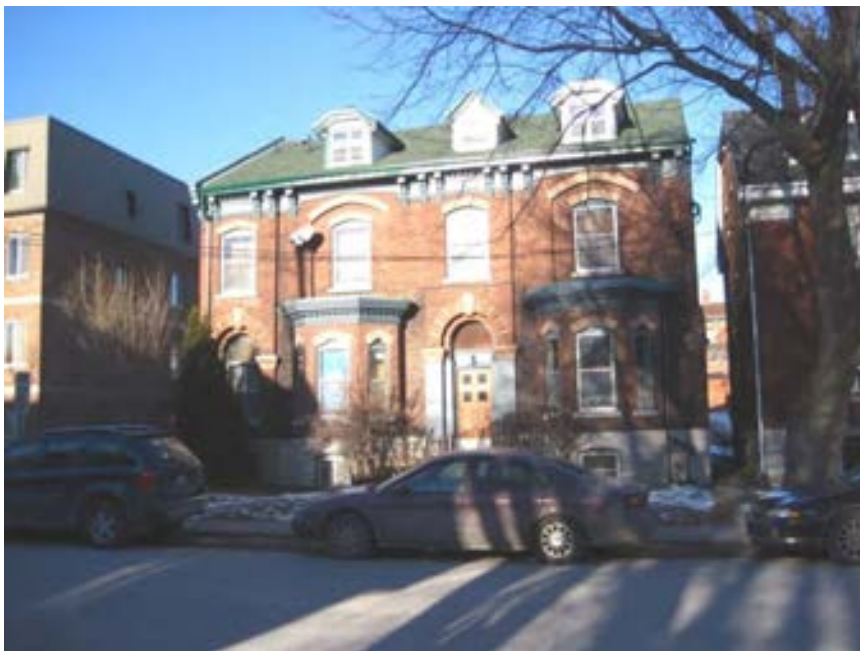
93 WILLIAM STREET

Built in 1880, this brick dwelling, located at 93 William Street, is of cultural heritage value and interest because of its physical/design value.

The property has physical/design value. Character defining elements that reflect this value include its scale and massing. Other elements reflecting its physical/design value include the dwelling's brick construction, possibly at one point a double house, four bays wide with openings in the first and third bays. The pilasters and capitals with keystone semicircular arches are identical. The first bay once possibly a entrance is now a door and the third bay contains the main entrance to the dwelling. Both the second and fourth bays are characterized by projecting bay windows. The gable roof is characterized at the west end by a parapet rising from a corbel. At the east end a chimney rises through the roof near the ridge. A second chimney rises from the centre of the roof ridge. The front slope of the roof is characterized by three dormers, two with hipped gables and the central one with a plain gable.

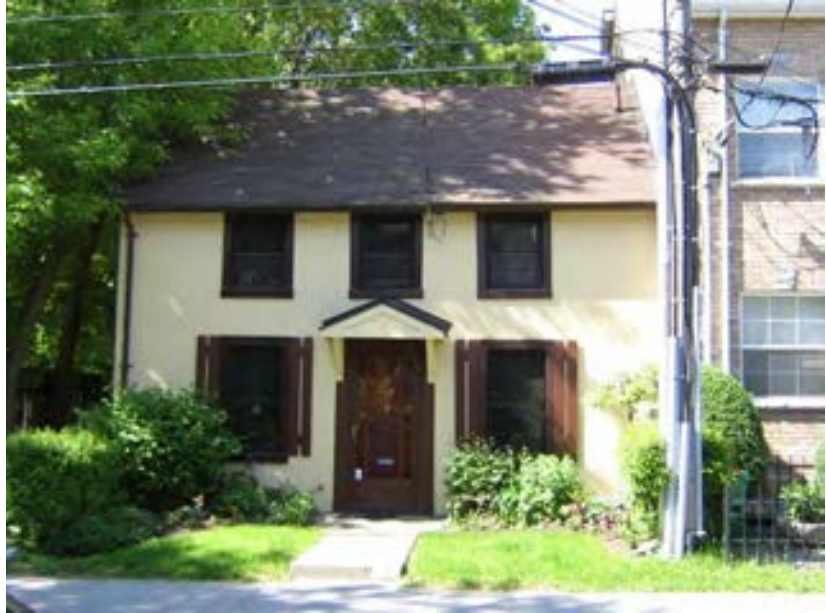
This building is a significant contribution to the William Streetscape. Its design attributes include a side-gable roof, symmetrical fenestration, central entranceway, roughcast exterior and frontal greenspace. The shallow entranceway hood and 6/6 window patterns are appropriate to this building.

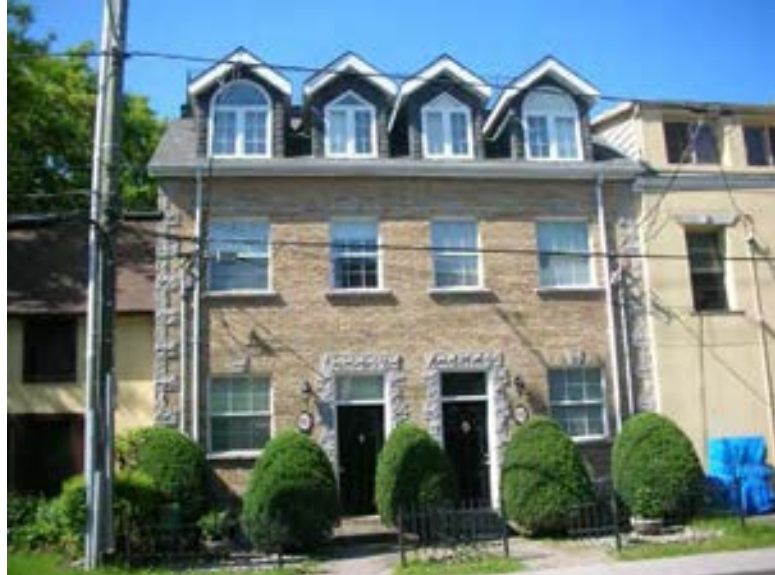
The 96-98 William Street building is a tall, 2½-storey brick double-house with prominent, closely-spaced dormers. Fire insurance maps show that a 2-storey wood double-house existed on this site for many years, but the present structure is unrelated to the previous one. This newer building exhibits some design elements which are appropriate to its context. These elements include its massing, which extends the bold face of 104-106 William Street, and its contrasting use of brick and stone: particularly the manner in which stone sills, keystones, entranceway surrounds, and quoins are used to contrast with the building's brick façade. The entranceway transoms and 6/6 window patterns are appropriate to this structure's design.

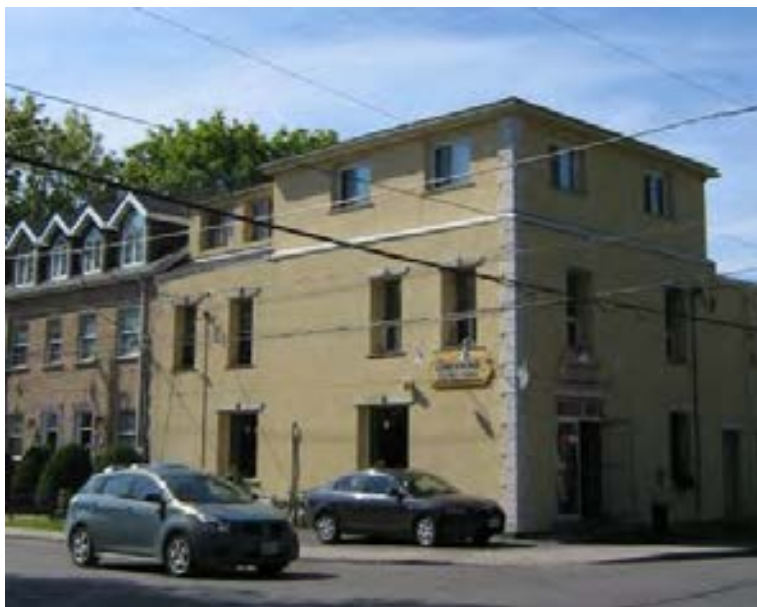
The present exterior of 104-106 William Street covers a stone structure which appears to have been erected by 1850, according to maps by Gibbs and Vavasour. It is clearly depicted on the 1892 fire insurance map as a double building divided by a firewall. A grocery store occupied the 2-storey 104 William Street unit at that time. The 106 William Street corner unit was depicted with 2 ½ storeys. The same arrangement is preserved today, although a dormered extension was later added to the roof of 104. The 1908 fire insurance map shows that 104 William was 2½-storeys by that time. A “Chinese Laundry” occupied 106 in 1908; it was labelled “Cleaners & Dyers” in 1924. This building’s historical association with commercial enterprises contributes to its heritage value. Prominent corner locations such as this one were popular locations for shops with services being offered to local residents. Its present function as a restaurant continues that tradition. The building’s height, bold flat façade, and minimal setback make it highly visible. Stone quoins and window hoods with embedded keystones are an inappropriate contrast to its roughcast exterior. There is no longer an entrance on the William Street side of the building.

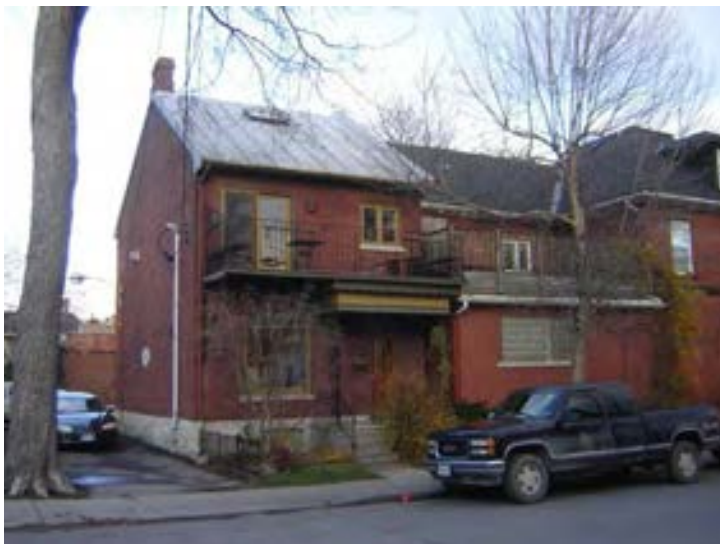
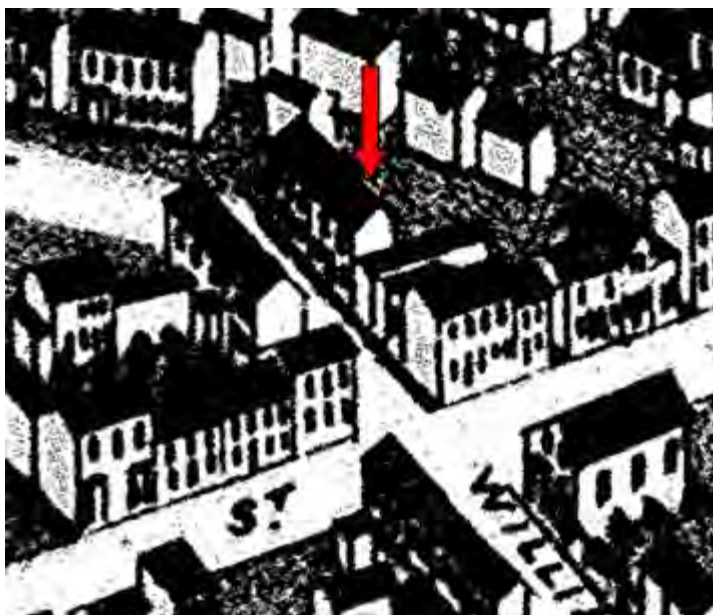
111 WILLIAM STREET

The building's present fenestration has been modified, and a second-storey balcony has been added.

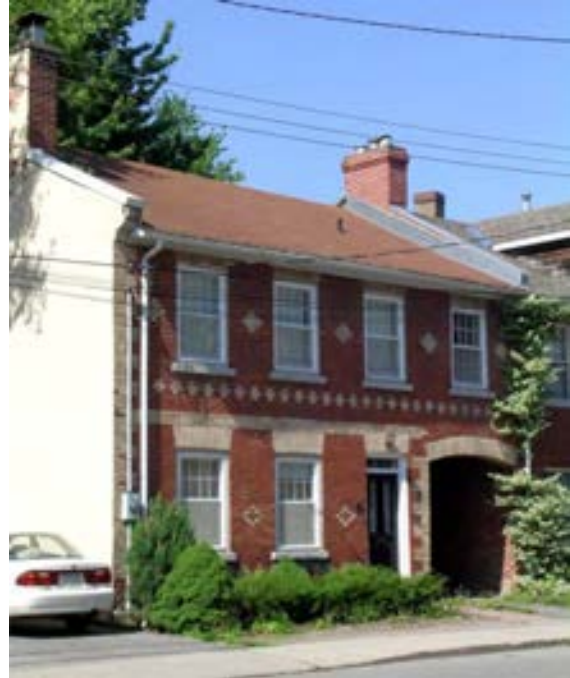
The four bay brick dwelling was a notable addition to the pre-existing brick double house 114-116 William to extend the terrace. Its exuberant use of buff brick to accent the window and door arches, quoins, stringcourse and as a decorative cross and/or diamond motif between openings and at each floor level is particularly noteworthy and indicates the broader range of materials by then available and greater license of decorative expression. Though there are other excellent examples of dichromatic brickwork within Kingston it remains relatively rare. Of interest is the manner in which the buff

stringcourse is terminated as it meets the cambered arch of the carriageway rather than being integrated with it. The carriageway and its broad arch is the other distinguishing feature of the façade the arch being neatly inserted into the existing wall of 114. Unlike its neighbours the façade is laid up in stretcher bond. The window openings are slightly cambered with 8/8 light sash and limestone sills. The limestone foundation can be barely seen above current grade. The side gable terminates in a parapet at the southeast and is supported with a stone corbel. The roof ridge is noticeably lower than that of the older double house to which it is attached.

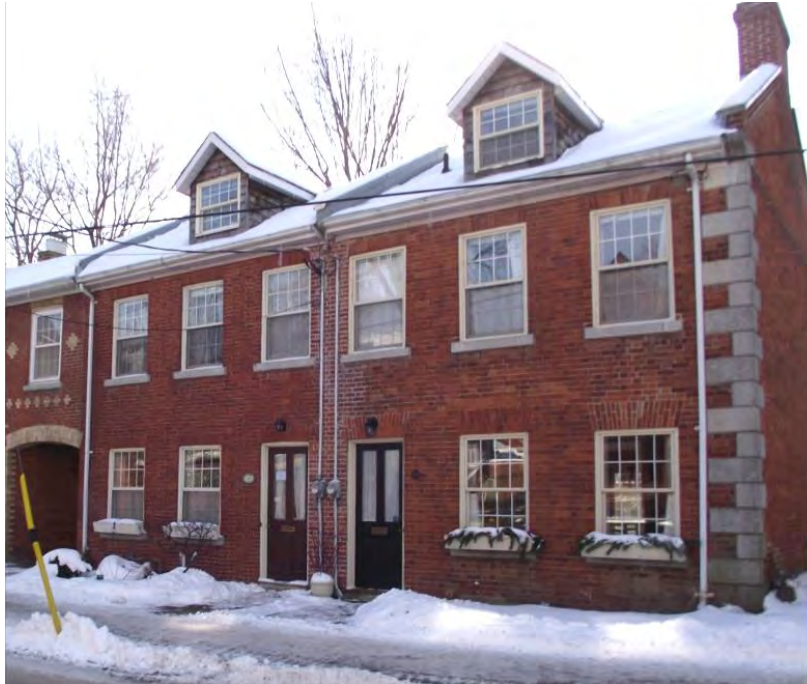
114-116 William Street forms two thirds of an interesting brick row on this varied streetscape. Both sections are constructed in Flemish bond, considered very 'fine work' until mid 19th century but then increasingly rare with the growing popularity of the 'stretcher' bond finish both in 'solid brick' and later, veneer construction. The workmanship is high with the incorporation of Queen's closers' by the window and door openings.

The 2½-storey height with side gable, respective three bay facades separated by fire parapets, are typical of brick terrace construction. The parapets are supported at the eaves with moulded stone corbels. Window openings are rectangular with flat, voussoired arches and 'shouldered' limestone sills. One surprising difference between the sections is that the arches of the first storey openings of 116 William are 'complex' while those of 114 are simply individual voussoirs. This suggests that the two sections were not completed simultaneously as one building program. The other unusual feature is the presence of prominent chamfered limestone quoins at the gable end of 116 William. This suggests the possibility that prior to the construction of 112 William Street 114 William also had stone quoins, removed with the integration of 112 William and its associated arch.
