Property Inventory Evaluation

William Street

**20-22-30 WILLIAM ST.
FRONTENAC CLUB INN**

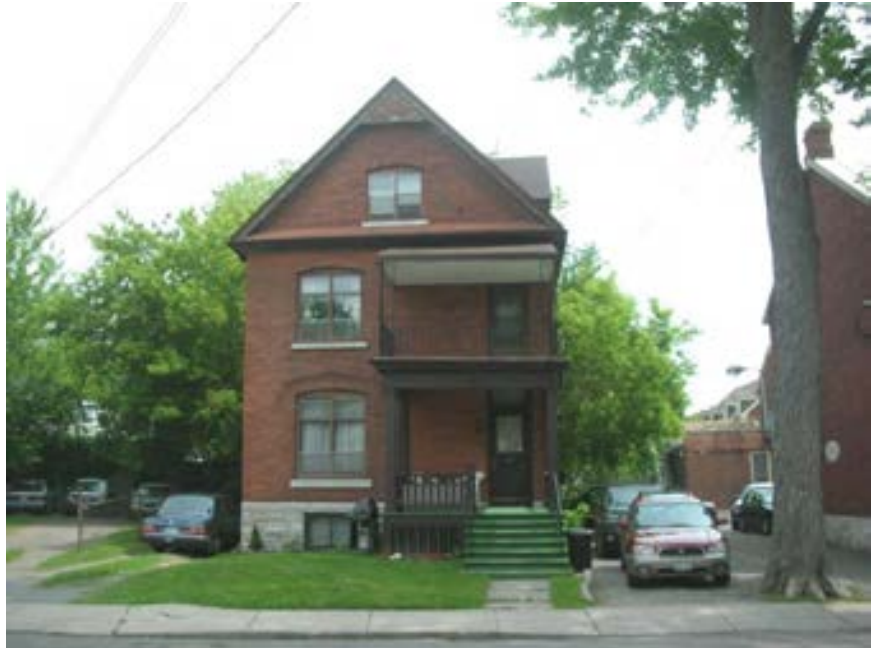
The 115 William Street building is a 2-bay, 2 ½-storey brick house on a stone foundation. The building is generally simple and bold in design, with a number of decorative elements. A slightly arched voussoir above the first storey main window is accentuated by a decorative hood with squared ends. In contrast, the main second storey and gable end windows have simple brick arches. A sunburst design is found at the peak of the building's gable end, which is separated from the second storey by a projecting, sloped eave. The south-eastern bay of the building is dominated by a large front porch and hooded balcony of no heritage value.

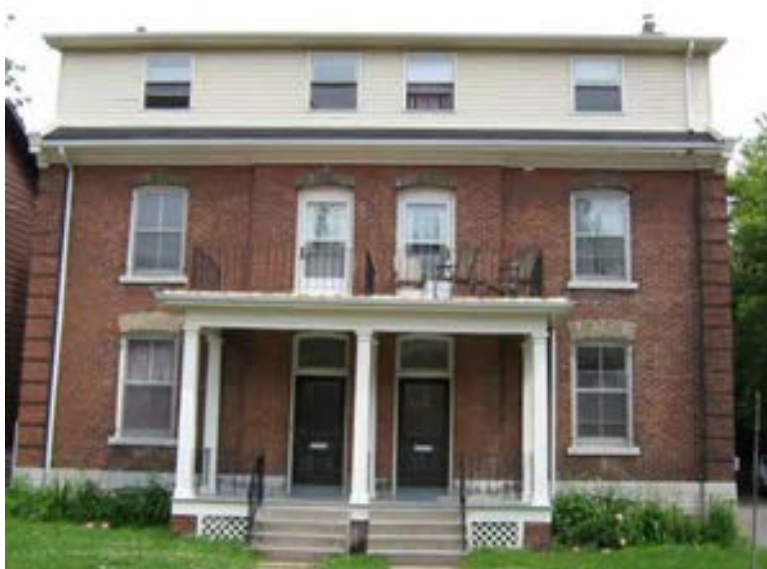
A dominant feature of this 2-storey red brick double-house is its large wood porch and balcony spanning the centre two of its four bays. The balcony has a simple iron balustrade and a dentiled cornice. It is supported by three plain, square pillars at the front and embedded pilasters at the building's façade. The central bay protrudes slightly, and contains the main entranceway doors for each unit. The doors are wood with large plain panes of glazing above brass mail slots and recessed wood panels. Each door is topped by a slightly arched transom with plain glazing, and with each unit's street address etched in the glass. The remaining fenestration features yellow voussoir bricks: those on the second storey contain keystones of the same material. Brick pilasters with quoins frame the building. A full-width dormer on the building's frontward-sloping roof is not sympathetic to its design, and is not a valued design attribute.

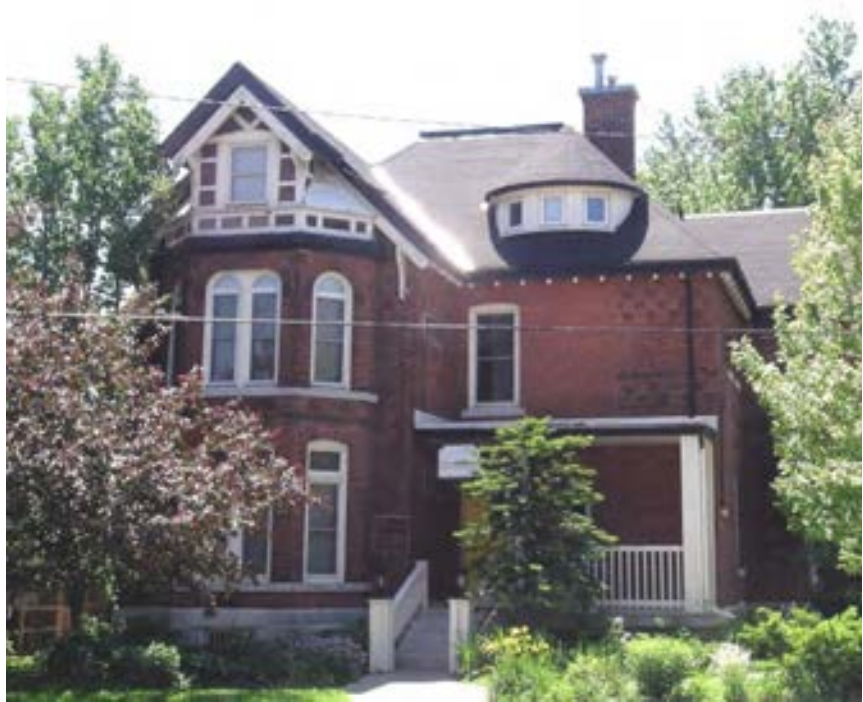
118 William Street is an eclectic late Victorian detached residence which incorporates a wide range of forms, materials and techniques into an integrated composition. The general original form, 'L' Plan with a further full height projection to the west (acknowledging the public nature of that elevation) is Queen Ann in sensibility as indicated by its

main hipped roof with cross gables. The hipped roof was once surmounted with cresting and features a conical dormer/turret with three windows. The area around the windows is finished in decorative wood shingle. The peak of the front cross gable is layered with decoration and features a complicated geometry in which the angled bay form is resolved into a gable dormer within the main cross gable. Both the gable dormer verge and the main cross gable verge are paneled with intricate ornamentation, are supported on wood fretwork brackets and have rounded ends. The decorative exposed rafter tails at the eaves of the building are also round and pierced with a circular hole. The face and cheeks of the gable dormer is finished with galleted panels. The 2nd storey of the cross gable features a dipartite arched window at the face of the bay with single arched windows at each of the other angled sides. The paired units share an opening supported by an unusual arch form with flat top and curved 'corners'. At the first storey the bay windows have stained glass at the transoms with bird and floral motifs. The floral motif is carried into the terra cotta panels set between the storeys.

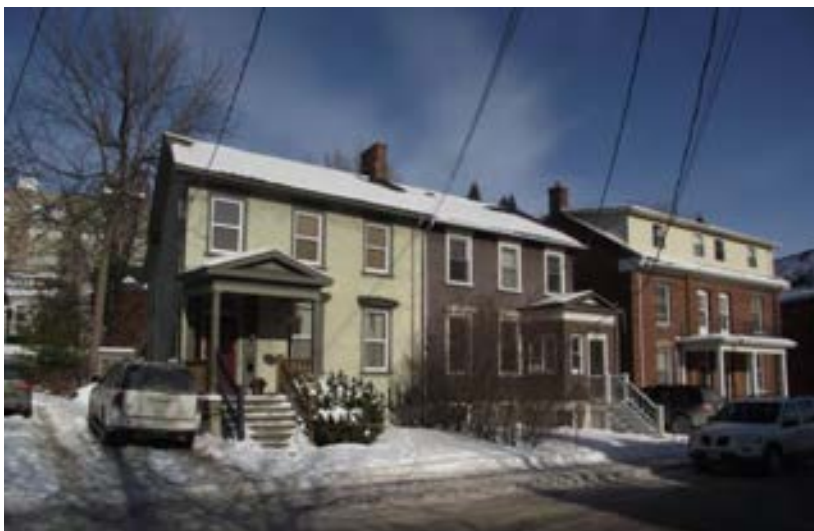
This 6-bay wood and roughcast double house appears on Brosius' map of 1875, with only one front portico. It is not on Innes' map of 1865. The property was purchased by a builder named John Bowes in 1857, who may have had the present structure erected. Part of this building's contextual value stems from its neat alignment with the neighbouring 117-119 William Street structure. Although different in composition and style, their compatible massing, flat facades and side gable roofs create a uniform row placed just northwest of the bend in William Street.

The design features of 121-125 William include the mirror symmetry of its units, and original wood and roughcast composition. Rectangular windows with simple wood trim occupy each floor of each bay apart from the entranceways. Those on the first storey have modest hoods. A common brick chimney is centred along the apex of the building's roof.

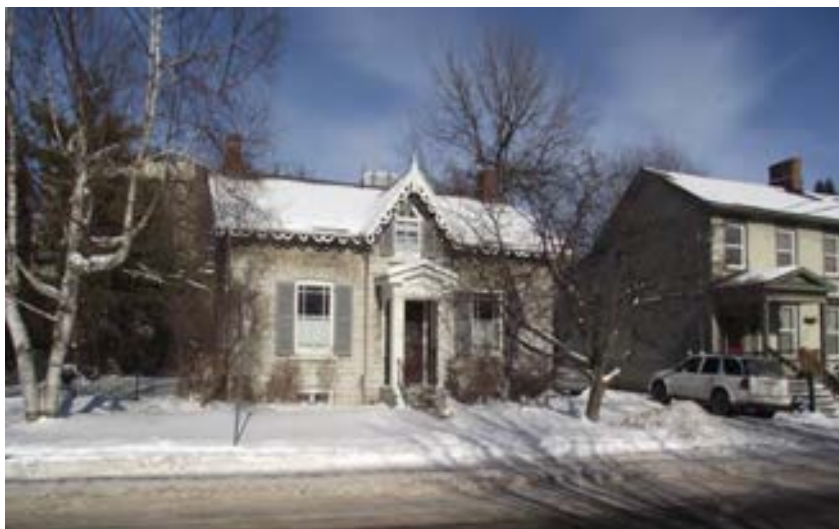
“This typical Ontario cottage, built of limestone and decorated with Gothic bargeboards, was built almost twenty years later than its style indicates. An 1865 map [by Innes] shows no building on this lot but the building was there before 1871, according to assessment roles.

“This three-bay, one and half storey, Ontario cottage is built of smoothly coursed limestone and topped by a gable roof with stone chimneys inset at each end of the ridge. The central gable rises from a slight projection and the façade eaves and gable are decorated in Gothic style, looped bargeboard with a heavy moulded finial at the peak of the gable.

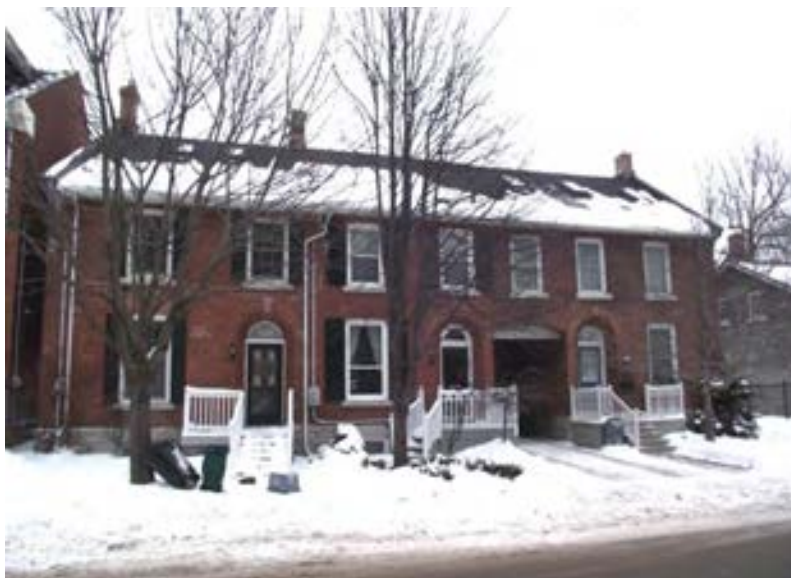
This 2-storey brick terrace is in keeping with the double houses that line this block of William Street: 117-119, 121-125, and 139-141 William. Each of these buildings is placed close to William Street and has a generally flat façade and a side-gable roof. One of this structure's distinct, character defining elements is the carriageway between the 133 and 137 William Street units, which also gives 133 William a third bay on its second storey. Each unit features a front entrance recessed behind two tiers of brick, and a brick voussoir with projecting keystone. A similar arrangement is found topping the first storey facade windows. The building sits on a rough limestone foundation. Two brick chimneys extend from parapet walls at each end of the roof; a third is centred between the 135 and 137 units.

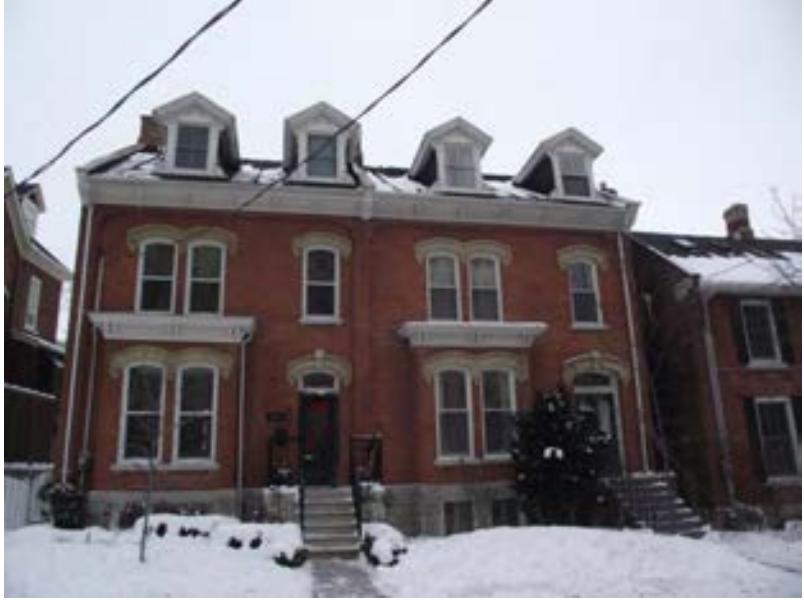
The 139-141 William Street building was erected for a customs agent named Joseph Quigley, by renowned Kingston architect William Newlands. Quigley had purchased the property in 1882. The Quigley family resided in 141 William Street until it was sold and occupied by Joseph Dunn and his family in 1929. This 4-bay, 2½-storey double-house is more elaborate than the other multi-unit dwellings found along this block of William Street, but is compatible in terms of its setback, its massing, side-gable roof, and its nearly-flat façade.

This building is slightly taller than the neighbouring 133-137 William terrace, and is situated higher on the slope of the street. The red brick façade features a projecting surround, curved at its upper corners, and forming pilasters that both frame the building and divide the units. A 1-storey rectangular bay window projects from the northwest side of each unit. They are topped by flat projecting roofs, with dentil-lined cornices supported by paired scrolling brackets. Each has paired 1/1 windows with slight arches, common ashlar sills and brackets, and common drip moulds. The mouldings are comprised of contrasting yellow brick. They are heavy and ornate, with hanging pendants and projecting borders.

The same window and moulding arrangement is found above each bay window. The southeast bays have single, matching moulds over their second-storey windows and entranceway doors. Each entrance has a curved ashlar keystone.

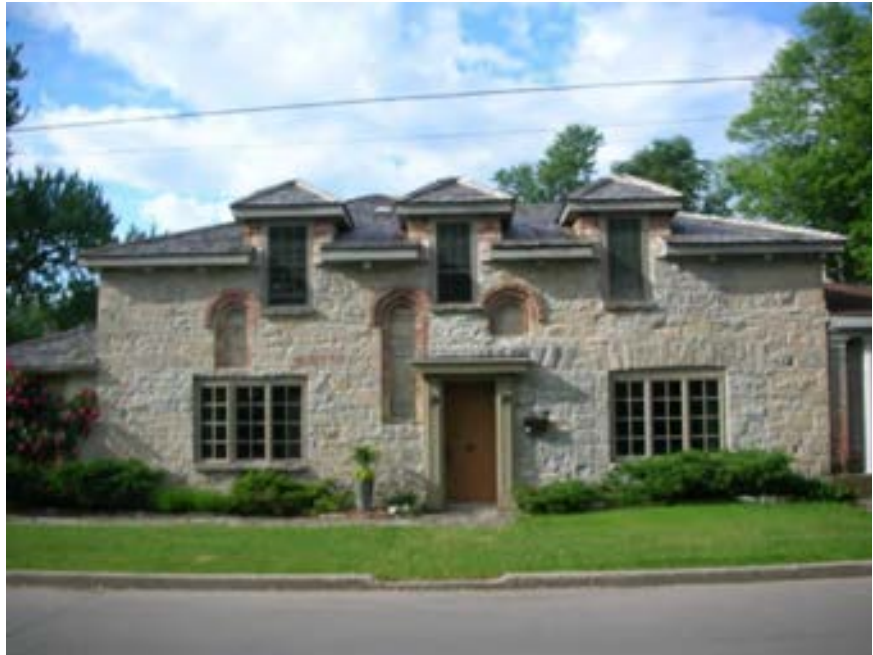
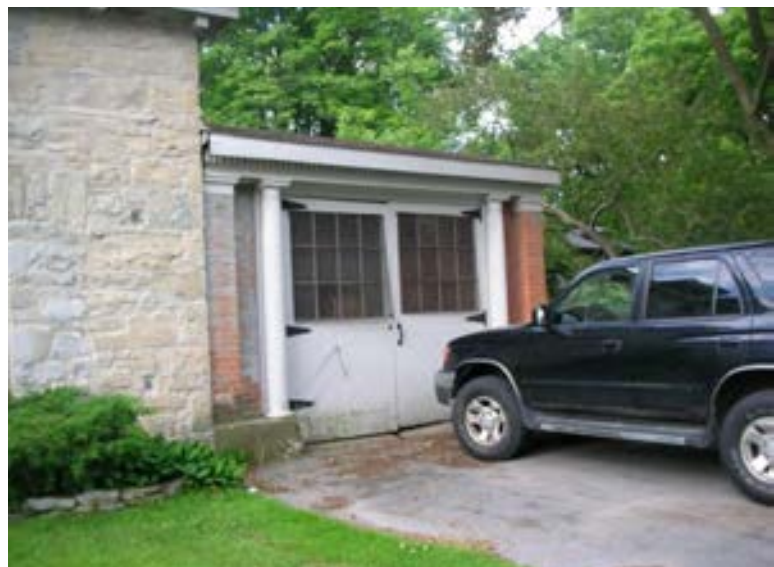
The 150 William Street building is a 1½-storey stone structure with a 1-storey brick automobile garage added to its northwest elevation by 1924, and a 1-storey wood extension on its southeast elevation, added after 1963. The main building features a hipped roof with wood shingles. Wood brackets support the cornice. Three embedded dormers, flush with the façade, extend above the main roofline. Each contains a 6/6 window, and is topped by cut-gable roof with wood shingles. The first storey contains two sets of three, 8-piece rectangular windows. These flank the centralized front entrance, which features with wood pilasters supporting a flat hood.

Brick arches and stone voussoirs indicate where some of the building's original openings were located. Three narrow and recessed brick window surrounds, with half-round arches, are located on the southeast and middle bays of the structure. The outer two are respectively truncated by a first-storey window, and stone voussoirs from a previous opening above the entranceway. The centre one extends to mid-level of first storey.

The building's eastern extension is comprised of wood, with a hipped and wood-shingled roof. It contains a doorway and two pairs of tall casement windows. The hipped-roof of the structure's north-western extension, which serves as an automobile garage, is also shingled. It has a plain entablature with a dentiled cornice. Wide brick pilasters with wood capitals support the roof on from each side of this brick extension's façade. They rest on the extension's tall concrete foundation, which protrudes at these points. Fluted wood columns with square capitals also rest on the foundation, flanking the extension's two wood garage doors.

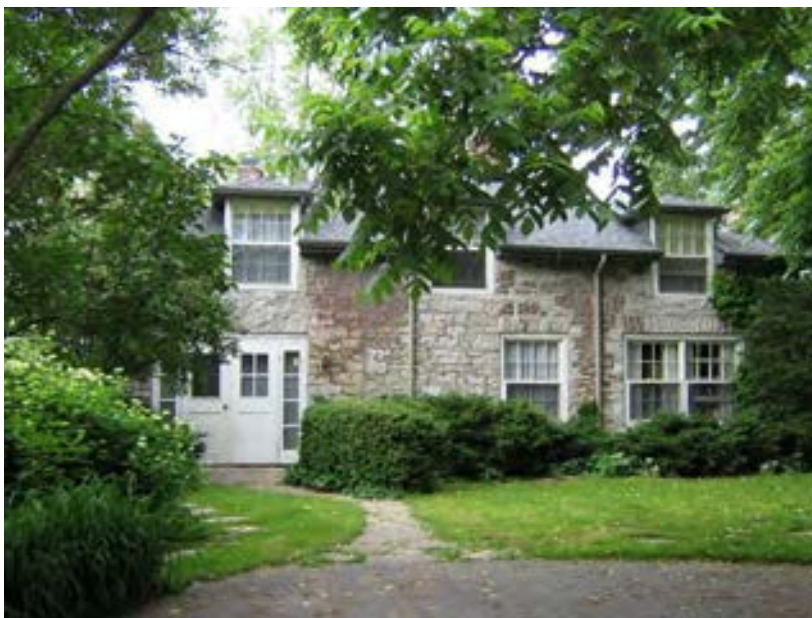
This property was sold to John Kerr in 1854, along with the property behind it, facing Earl Street. The Kerr family occupied the 55 Earl Street building until 1905, and had this building erected by 1892. It appears as a 1½-storey stone shed on the 1892 fire insurance map, but not on the map by Brosius, published in 1875. It first appears as a residence in the Kingston directory of 1980.

This is one of three repurposed former coach houses on this stretch of William Street. Together they define the character of the streetscape: they are three of just four buildings facing William Street from this block, and the only three of heritage value. The greenspace in front of this building, and that of the 149-151 Earl Street property adjacent to it, provides a particularly valuable context for this building.

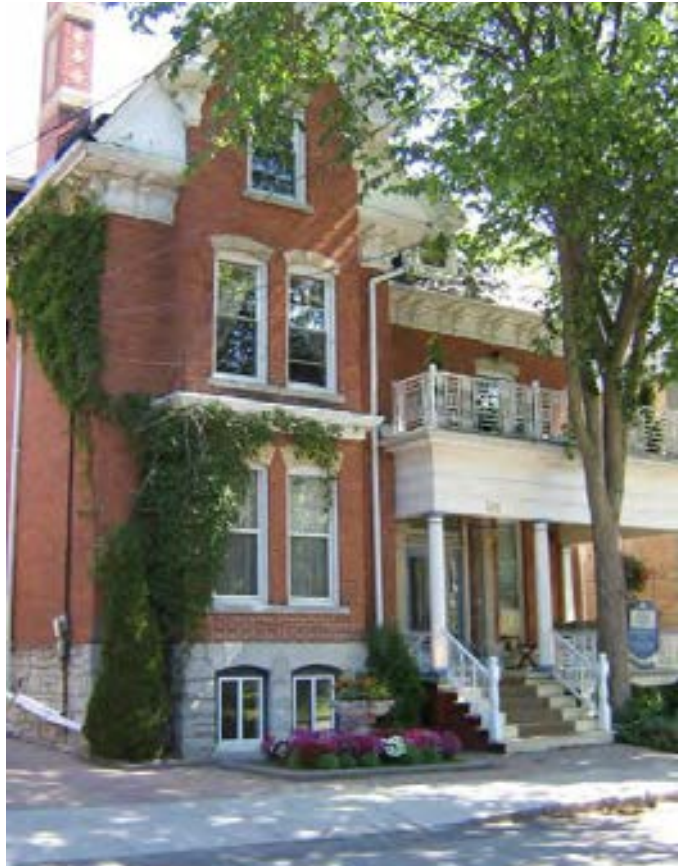
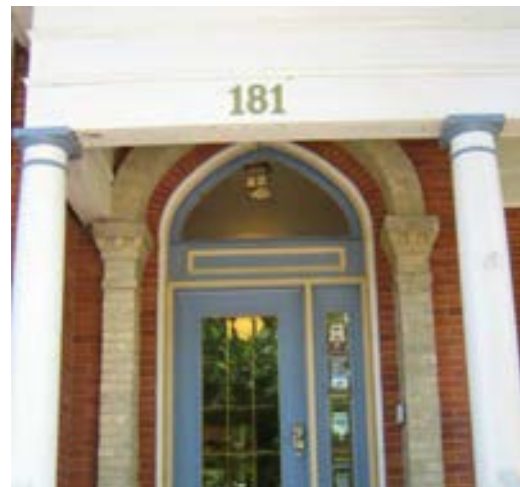
This structure was designed in the Queen-Anne style of architecture. It features eclectic massing, a hipped roof with dormers, a tower with a gable roof, and an adjacent front porch and balcony. The tower protrudes slightly from the western bays. Two arched windows in the tower's foundation are topped by solid ashlar voussoir stones. Its first and second storeys contain paired 1/1 windows with wood trim on a common ashlar sill. Each window is arched, with yellow-brick voussoirs that contrast with the architect's principle use of red brick. These two sets of windows are separated by a wood ledge featuring a series of carved-wood floral designs. A window matching those on its first and second storey is found on the tower, inside this bay's exceptionally tall gable-end. The gable has a wood face flanking each side of the tower. Its eaves returns form projecting ledges supported by scrolling wood brackets. These merge with the surrounding building cornice.

The eastern bay is recessed, with a wood porch and balcony. Below the porch roof cornice is a large, three-tiered frieze of plain wood planks. Wood columns with square capitals and bases support the roof and entablature. The porch and balcony are surrounded by an ornate balustrades comprised of turned-wood spindles arranged in a chinoise pattern. Arched windows on the porch and balcony are topped by yellow-brick voussoirs. The front entrance is located in the facade wall of a projecting brick vestibule, tucked under the balcony. Yellow-brick pilasters with flared capitals flank the entranceway door. These support a yellow-brick arch of Moorish design. The arch surrounds a large, matching transom with etched glass containing diamond and Greek key designs.

Two red-brick chimneys are found on the building. One of these is located just behind the apex of the slanted rear roof, on the building's eastern side. The second, much taller chimney is located on the west side of the front gable roof, set back slightly from the front of the building. Each chimney contains crosses, bands, and panels of yellow-brick.

The eastern elevation of 181 William Street contains a rectangular bay window on its first storey. It is topped by a low-pitch hipped-roof, and an elaborate entablature that contains dentils and heavy wood scrolling brackets. The bay window foundation contains two basement windows with solid ashlar voussoirs. The first-storey bay, and the second storey of this elevation, contains paired windows with yellow voussoirs. But those on the bay have fully half-round arches and voussoirs that merge at a centre pilaster. The windows on the second storey, and a third window found in a side-gable on this elevation, match those found on the tower façade.

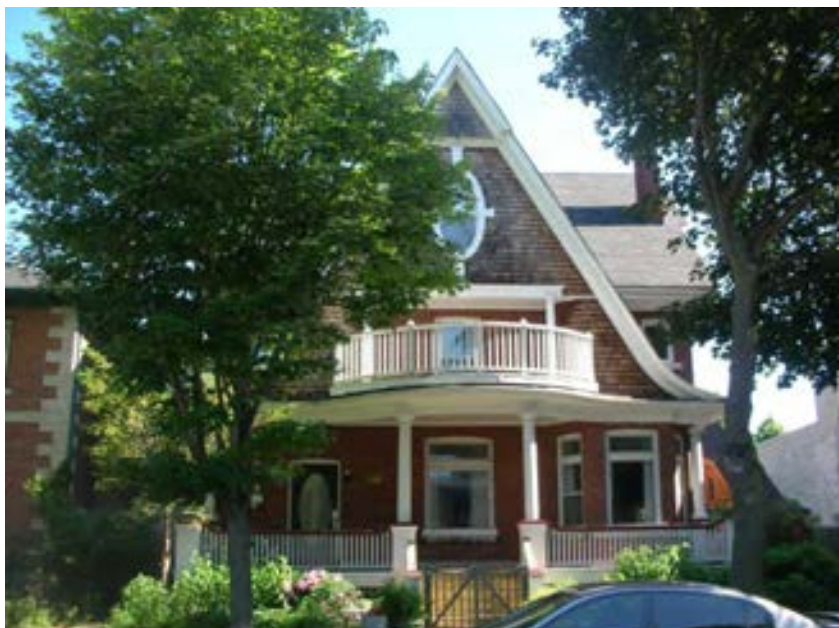
The architectural features of this building are rare in the Sydenham Heritage Area. It is good example of America Shingle style. The structure is based on a straightforward rectangular massing, but its 2-storey from gable mimics the appearance of an A-frame structure. The gable has a significant overhang, a wood-shingle face, and contains a large oval window in its upper storey. The window is framed with a thick wood surround with quartering darts. The tip of the gable projects slightly. Its lower storey features a number of curvilinear elements. The outer sides flare out where they meet each side of the porch roof below. The porch supports a balcony, across the middle of the gable, with a rounded wood balustrade. The balcony door is recessed behind flanking curved walls and set under a wooden hood supported by plain wood columns. The A-frame’s slope inward, from the balcony up, leaves two triangular corners of the building’s main massing exposed on the second floor: each contains a short rectangular window on an ashlar sill.

Tall gable ends on this building’s side elevations contain sets projecting pediment tops, supported by rafters, with oval windows matching that found on the façade. Below these are Palladian window arrangements without the centre fanlight, on heavy wood sills with brackets. The gables have wood shingle faces.

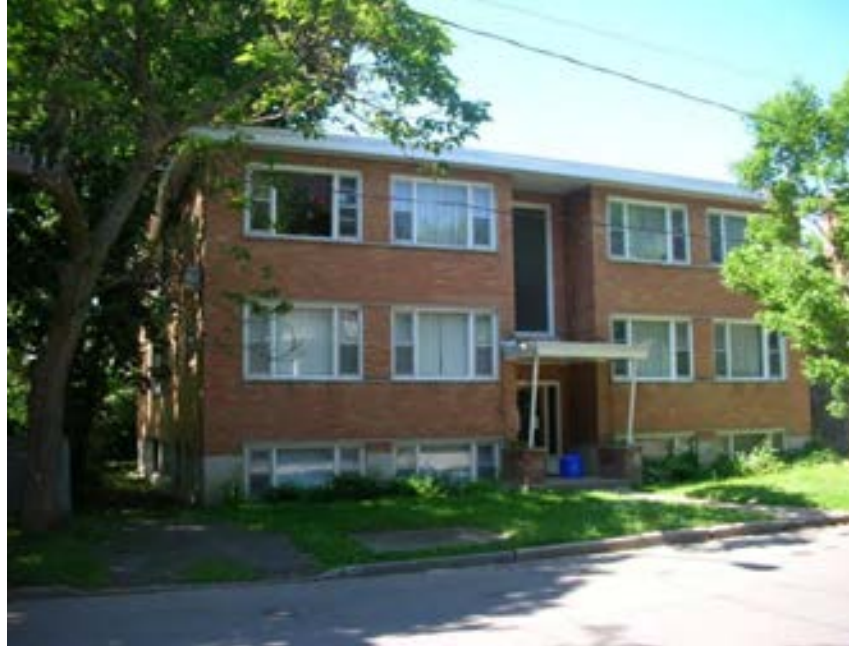
This apartment complex is larger in scale than the two coach houses that otherwise comprise this streetscape. Its mostly-flat façade and box-like massing is appropriate with respect to those building's, but its overall features – including its flat roof, flat entranceway hood, and dominant windows – are not sympathetic to the character of this area. Directory information indicates that the structure was erected in 1956-57.

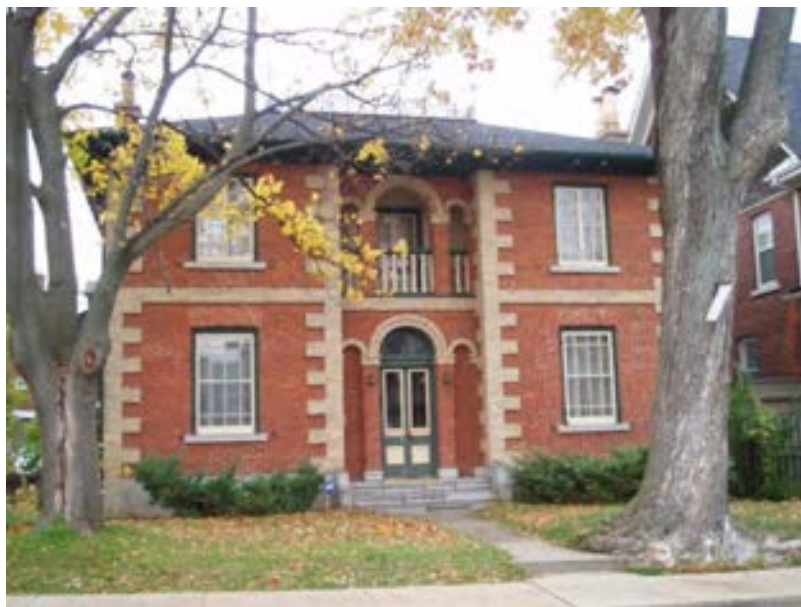
This brick dwelling has a two-storey umbrage or recessed central bay. The detail of the trim, iron cresting and decorative chimney pots add to the significance of this dwelling designed by architect and contractor, James Stewart. Stewart came to Kingston in 1843 from Peterhead, Scotland; went to Ottawa about 1860, followed by the United States where he and his sons did extensive work.

The structure's umbrage is faced on each storey with a slightly recessed brick triple arch. In the first storey, the central semi-circular arch holds the entranceway; the flanking blind arches hold side lights. On the second storey, all three arches are open and an ornate frame balustrade joins the supporting columns. All of the arches have tessellated buff brick.

The foundation is stone with an ashlar finish. Windows in both stories flanking the central bay have flat arches, lugsills, and appear to have the original small-light sashes.

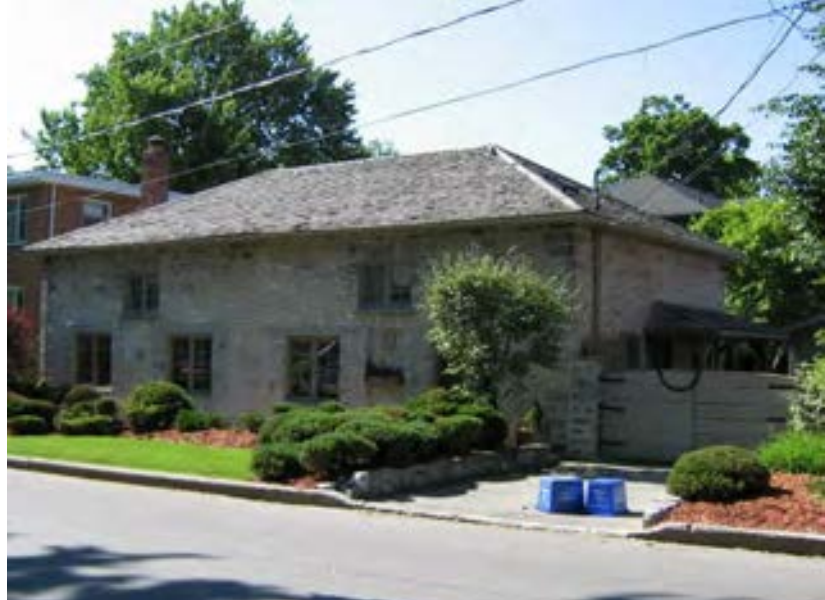
The 186 William Street building is a 4-bay, 2-storey stone building with a hipped roof. While its windows are relatively new, they feature appropriate 6/6 and 8/8 window patterns and suitable wood surrounds. Embedded wood lintels above the first-storey windows – one in each bay – suggest spots that stable doors might have occupied. The opening for an entranceway, between the first and second bay from the west, has been filled-in with matching stone. Voussoirs over the second-storey windows suggest original openings. A tall brick chimney rises from the building's east elevation, and is incorporated along that wall.

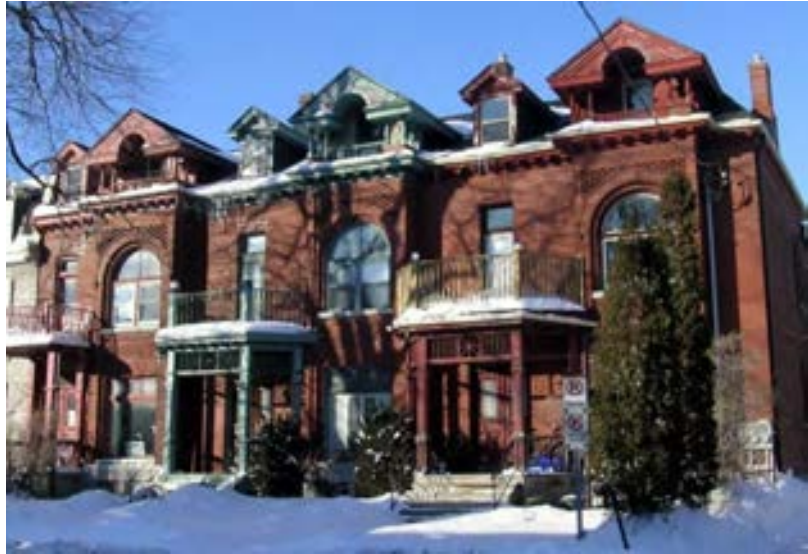
While the architect still remains unknown 197-201 William Street brings together a number of late 19th century architectural styles in a satisfying composition based on the rhythm of the three 'stepped forward' full height bays and the stature provided by the umbraged gables with balconettes which surmount them. Stylistically, the Queen Ann form and roof line has been combined with a broad Richardsonian Romanesque window arch as the dominant element, and juxtaposed with the fine Eastlake detailing of the verandah frieze. An excellent balance has been struck between robust and attenuated features.

The coursed ashlar limestone foundation rises to a water table course which is integrated with the lintels of the basement windows. The brickwork has been well executed with the main windows set within a two storey arched niche. A panel has been created above the large picture window and the brick corbelled up to the limestone sill of the window above. The main articulation occurs in the forming of the 2nd storey window arch and the treatment of the arch spandrels. The arch has a margin in relief which extends from the projecting 'keystone' (also formed of brick) to brick corbels at the 'spring' points. The spandrel panels above the arch shoulders are formed of alternating 'dogtooth' and block units further accenting the arch. This detail is found at John Power's 1890 Pump House (within a circular panel).

The arch motif is extended as the broken pediment of the 3rd storey cross gables as well as serving to provide space for the window/door opening on to the balconette. The moulded eaves of the cross gables are deep and return at the front to the arched opening. They are 'supported' on paired turned columns themselves set on brick piers with a railing of heavy turned balusters between. The face of the gables are clad in fish scale shaped wood shingles. The main soffit is deep and the frieze features 'mutules' and a large wood roll at the wall junction (a combination found on many Kingston buildings of this period). The transom of the picture window has stained glass (now missing at 197.)

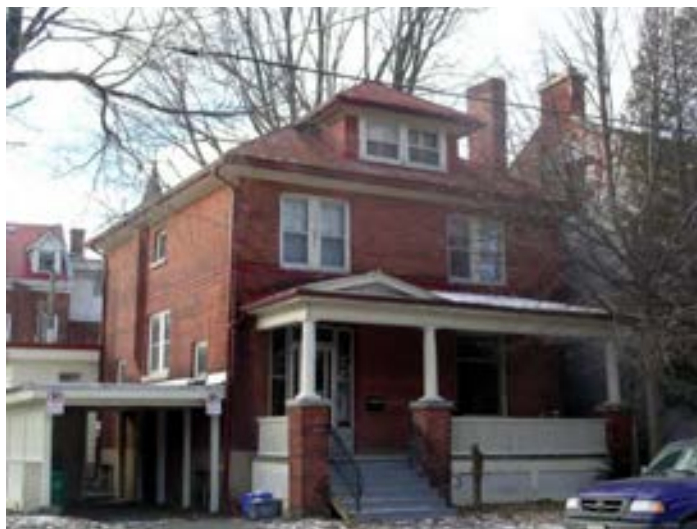
As is frequently found in houses of the early 20th century, it is “four square”. The roof is hipped and features a hipped-roof front dormer. There are two windows in the upper storey, each with a heavy divider creating a pair of double-hung windows, each with four panes above a single pane. The lower storey has a large window and a doorway with a rectangular transom and sidelights. Across the width of the street facade is a one-storey wooden verandah (shown on the plan of 1908) with three short columns supported on brick square piers. Steps lead towards the entrance area, which is marked on the verandah by a shallow pediment and closer spacing of the posts. A horizontal band runs across the front facade just above the verandah in place of window sills and continues on the east side wall, where it is interrupted by a corbelled brick flue. There are four irregularly placed windows with stone sills in the east side wall. The frame open shelter for cars does not appear on the plans until 1963.

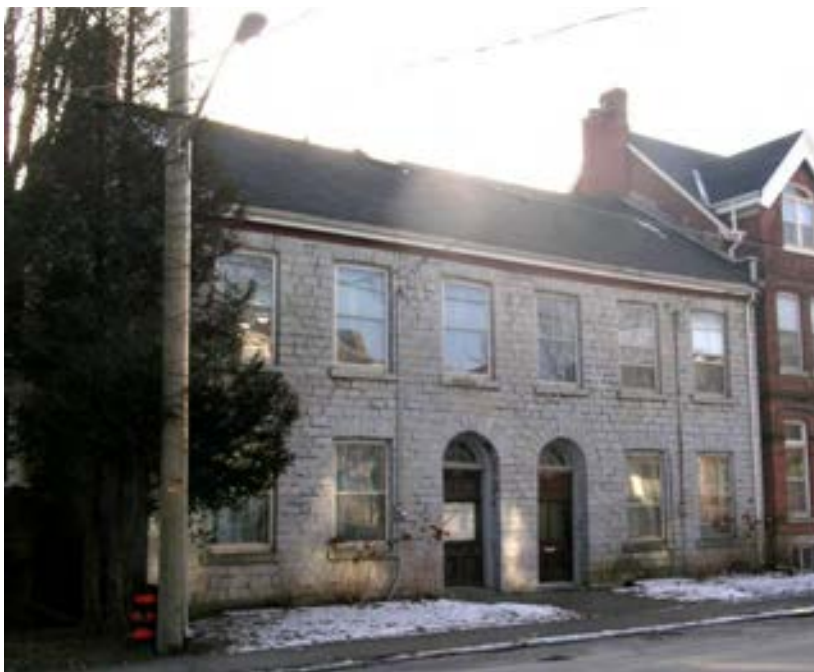
The double, two-storey, six-bay, stone house retains its early appearance, as alterations have been of a minor nature such as the removal of the original glazing bars in the double-hung windows and the middle fielded panels in what were originally six-panel doors. The round-arch transoms have retained the original glazing pattern. In each half, there are three windows in the upper storey and two in the lower storey plus the door, which is located near the centre of the facade. The end walls rise in parapets, enhanced by carved corbels. Only the street facade is in stone -- the remaining walls are in brick.

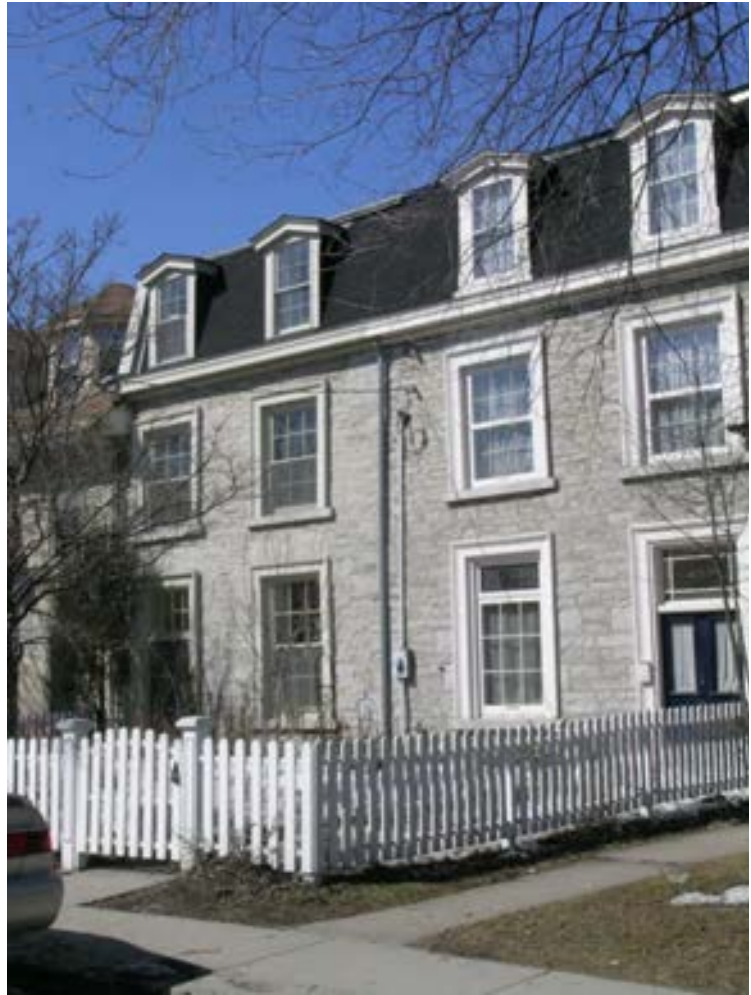
House", 50' long by 24' wide ... walls 12' high, gables 10' high" which well could be the current first storey of 205 William. It is the only section of the double house with voussoired arches over the openings. Other anomalies such as the narrower door opening of 205 and its proximity to the west wall as well as the 'broken' nature of the stone coursing between 203-205 further suggest this evolution. It seems that at some point prior to its depiction in the 1875 Brosius 'bird's eye view' map it was incorporated as part of two storey double house with a Mansard roof. If the Brosius image is accurate then at that time it was a pavilion type mansard (almost a gambrel form). With no structure to its east a parapeted fire gable was not then necessary.

As evidenced also by the Brosius view the roof form was quite unusual in the area at the time. However, shortly after, Robert Gage designed a brick mansard roofed double house at the northwest corner of the block. The parapeted fire gables are brick but rest on stone corbels which also terminate the moulded eave/cornice. The extremely heavy/deep window surrounds suggest that the stone may have at one time been finished with stucco which would have also served to unify the composition but this has not yet been confirmed. It appears (BAHS p.294) that until relatively recently both first floor window openings had stained glass transoms but this now only survives at the eastern window. The gable dormers with 'eared' and 'shouldered' casings around the windows are typical of the 2nd Empire style and closely associated Mansard roof form.

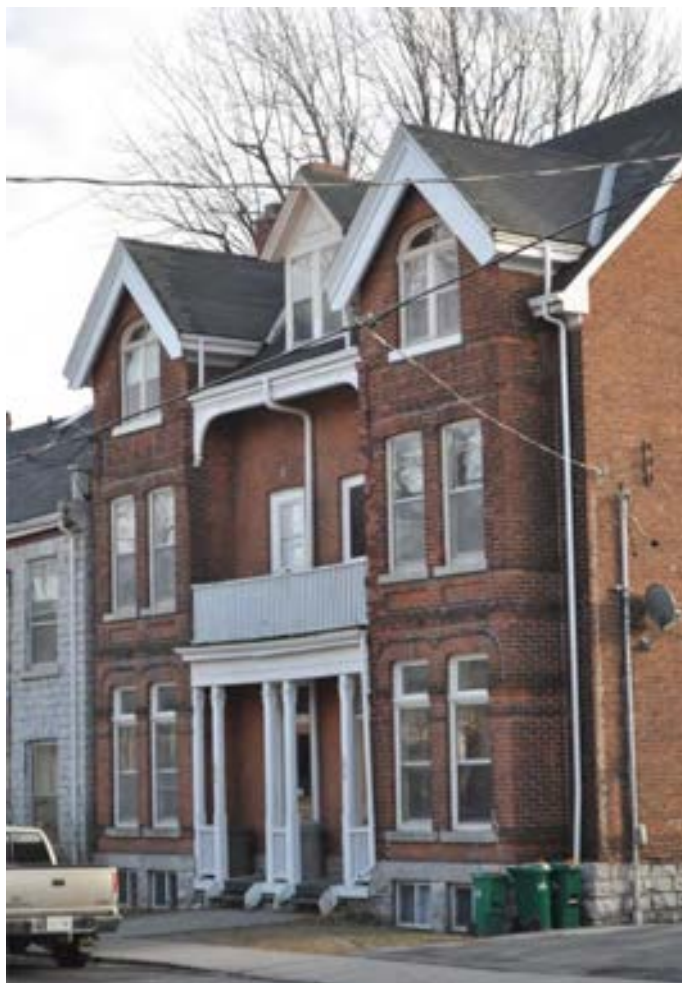
The centre two bays are recessed between projecting pavilions topped by gable roofs at right angles to the main roof. Each pavilion has a pair of windows in the basement (in a stone foundation), main floor and upper floor but one arched window opening in the top floor. The main-floor windows have rectangular transoms, above which the corners of the brickwork gently curve, as is echoed in a brick moulding over the voussoirs. A gable-roof dormer sits in the centre of the front plane of the main roof.

The upper floor in the centre recessed area has two doorways leading to a balcony formed by the roof of the wooden porch sheltering the main-floor pair of doorways. The latter have rectangular transoms. A nicely curved and panelled fascia board reaches between the pavilions just below the cornice level. The brickwork is particularly fine and detailed creating mouldings and patterns of checkerboards and angles.

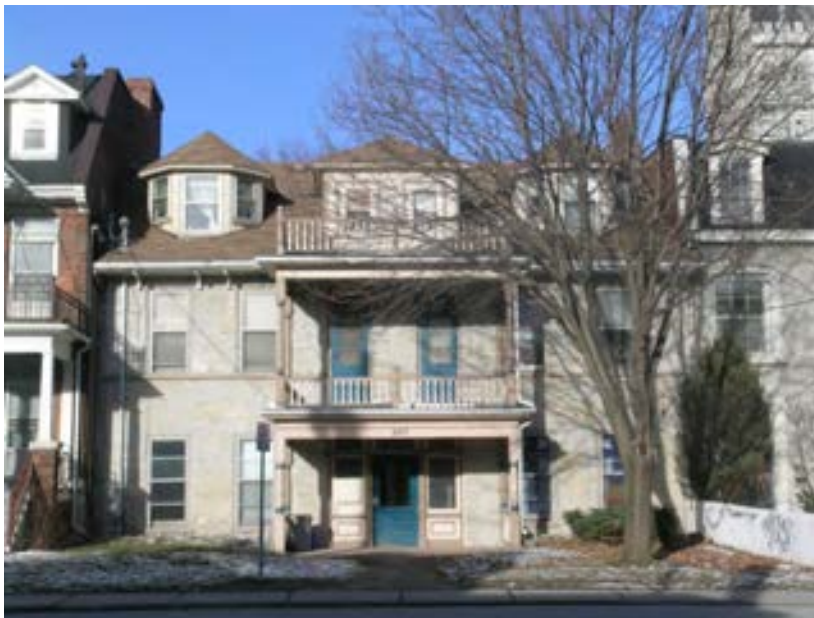
George Browne, the most celebrated of Kingston architects, designed his own residence in a restrained, classical style featuring symmetry and the rhythm of the door and window openings. The roughly coursed

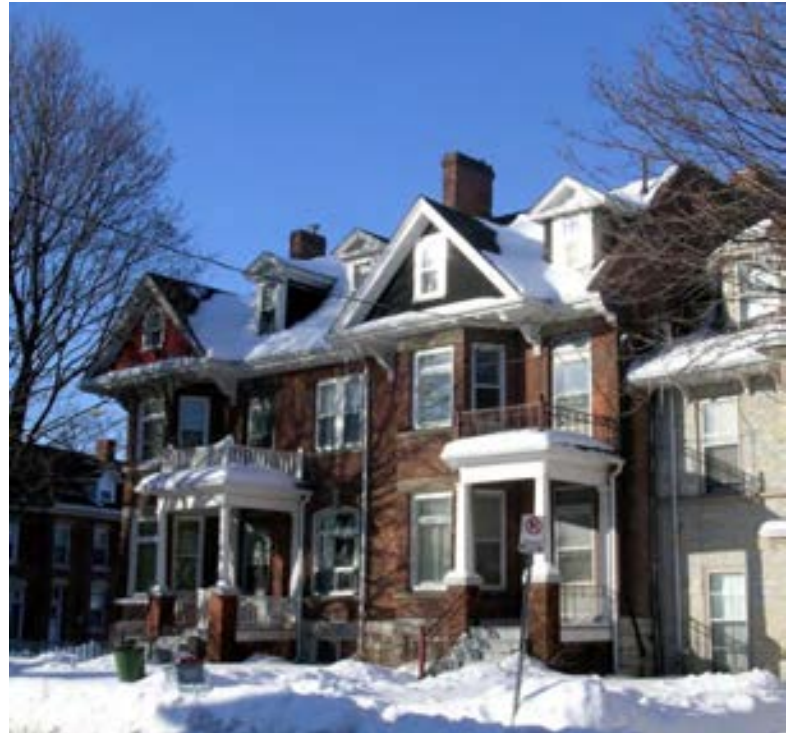
View from William Street

The wall plane is broken by full height bays surmounted by pedimented cross gables at William Street and, it seems, originally a pyramidal roof at Barrie (the existing dormer, though early, is not original). The varied wall planes beneath a complex roof configuration composed of a combination of gables and hips are characteristic of the Queen Anne style. It appears that the main hip roof resolved into a low slope section at the ridge which probably originally had iron cresting.

The rock faced ashlar limestone foundation rises to a deep water table course with the contrastingly (relatively) smooth face of the stretcher bond brickwork above. At the William Street elevation each corner of the projecting bays is defined through its full height, i.e., squared and then angled from section to section rather than just angled adding a further sense of relief and shadow lines. The windows at the sides of the bays are double hung while the central window is one large pane with a transom above.

The beaded board soffit is deep with mitred corners. The frieze features 'mutules' and a large wood roll at the wall junction (a combination found on a number of Kingston buildings of this period). Large consoles, with paneled fronts and floral scrollwork incised into the sides, 'support' the corners of the cross gable pediments. The face of the pediment at 215 retains its painted, decorative wood shingle

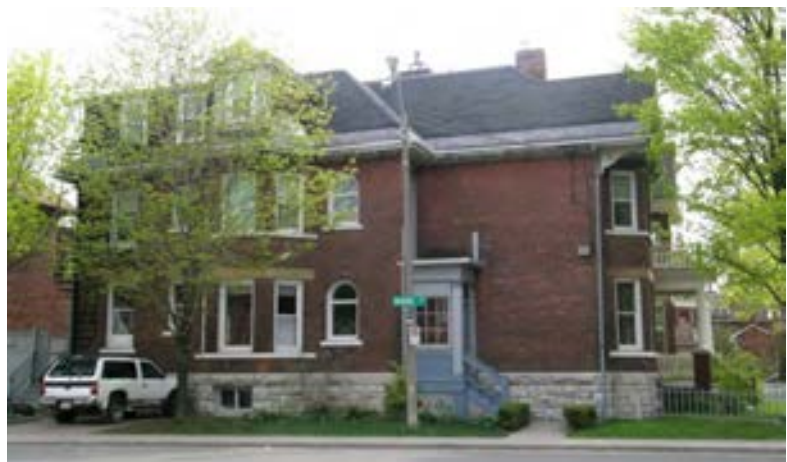
Barrie Street elevation

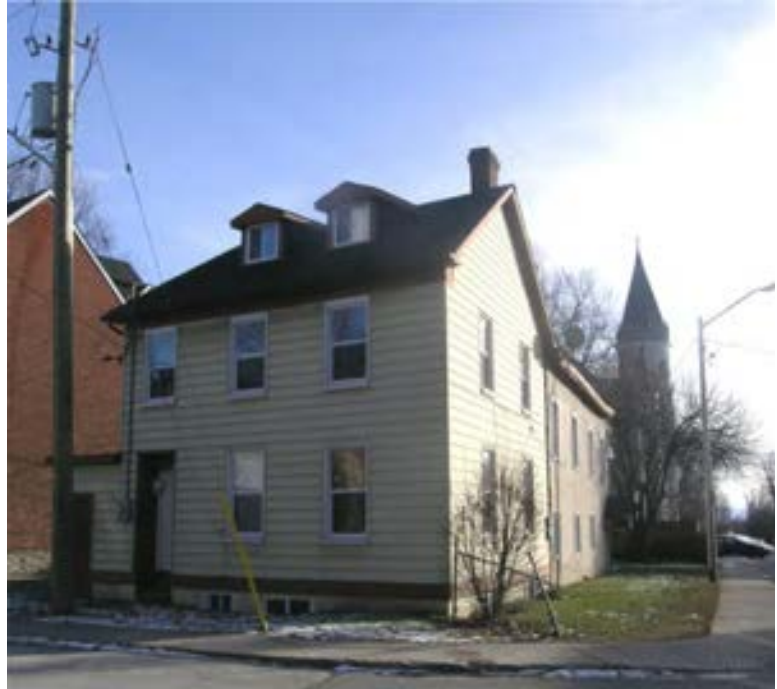
Facing south along Barrie

The only frame house on the Earl, Barrie, Clergy, William block, 214 William at Barrie Street is not on the Innes map of 1865 but does appear with a short wing along Barrie on the Brosius bird's-eye view of 1875. It is a two-storey, three-bay structure with a gable roof, which sports a pair of dormers on the William Street slope. Presently covered on horizontal siding, it is noted as stuccoed on the 1892 fire insurance plan. By this time, the Barrie Street wing (see 231 Barrie Street) has been lengthened to meet the lane, which runs east-west through this block. The brick wing on the east side wall is not on the plan of 1892 but does appear on the plan of 1908. The low frame addition fronting William Street was built after 1963.

The upper storey of the main house has three double-hung windows with the original glazing bars removed. The main storey has two modernized windows and a doorway. There are two windows in each of the storeys on the west wall. One of the interesting aspects of the structure is how the west side wall conforms to the angle of Barrie Street. Although a plain structure, the proportions are pleasant, and the rhythm of the fenestration traditional.

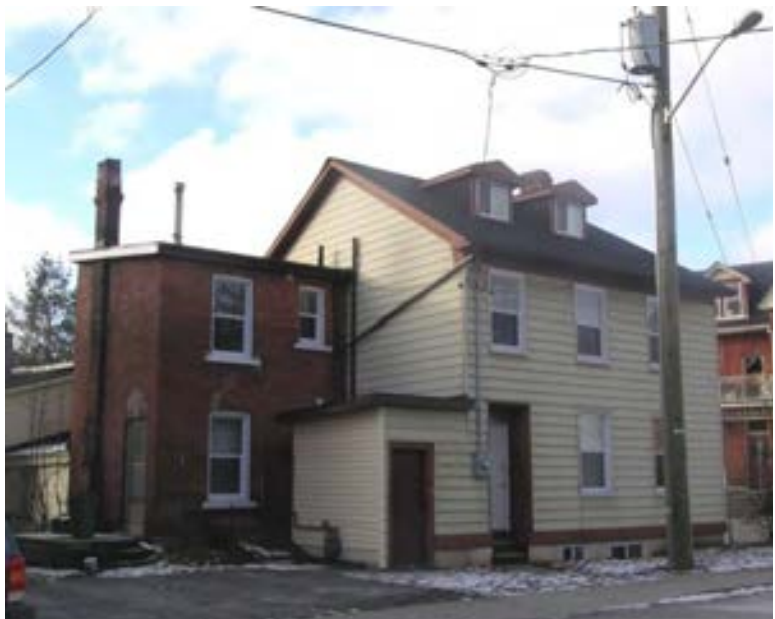
Facing southwest from William
