Property Inventory Evaluation

Courthouse Complex

The Frontenac County Courthouse Complex

National Historic Site

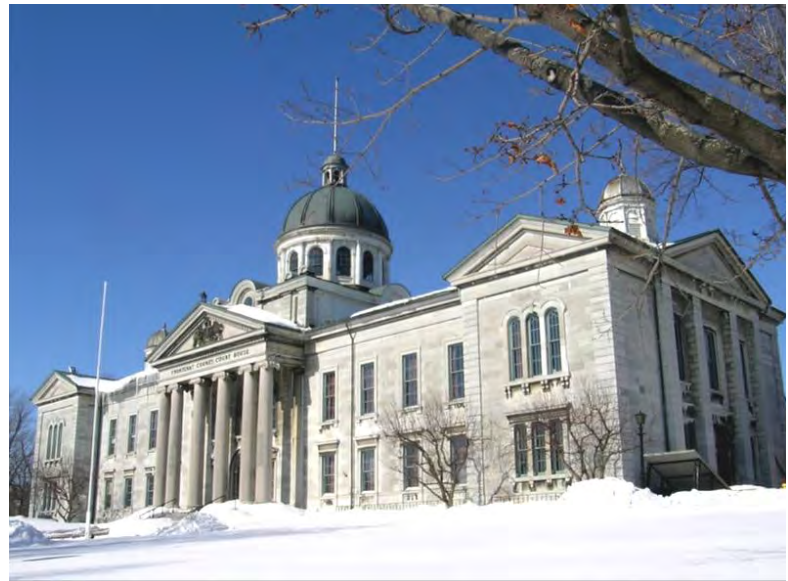
County Courthouse

A new site was selected in 1853 for a new building, designed in 1855 by Horsey & Son, as a replacement for the old downtown Midland District Court House.* The new location was on an elevated piece of land overlooking open ground, in the early stages of being landscaped for a city park (and once under consideration as the site of a proposed parliament building when Kingston was the capital of the United Canadas in 1841-44) and, in the far distance, Lake Ontario.

On 24 March 1875, fire broke out destroying the interior detailing and Horsey's original semi-hemispherical, tin over wood, dome. The architectural firm of Power & Son (John Power and his son Joseph) were awarded the commission to design a replacement dome and a new, separate registry office. The new dome (restored in recent years) is elevated on a drum of arched windows placed between Corinthian engaged columns supporting a pronounced cornice, semi-hemispherical dome, which is topped by a round cupola with windows. This is an outer dome sheltering a much shallower inner dome, its underside visible from the interior of the second-floor. Horsey's stone walls and grand Ionic portico survived the fire. Unfortunately, almost all the post-fire interior detailing was destroyed, first in the east wing after a fire of 10 March 1931, and then throughout during a modernization effort in 1964 by Drever & Smith. At that time the east and west exterior entrances were modernized and a stone addition placed against the north wall.

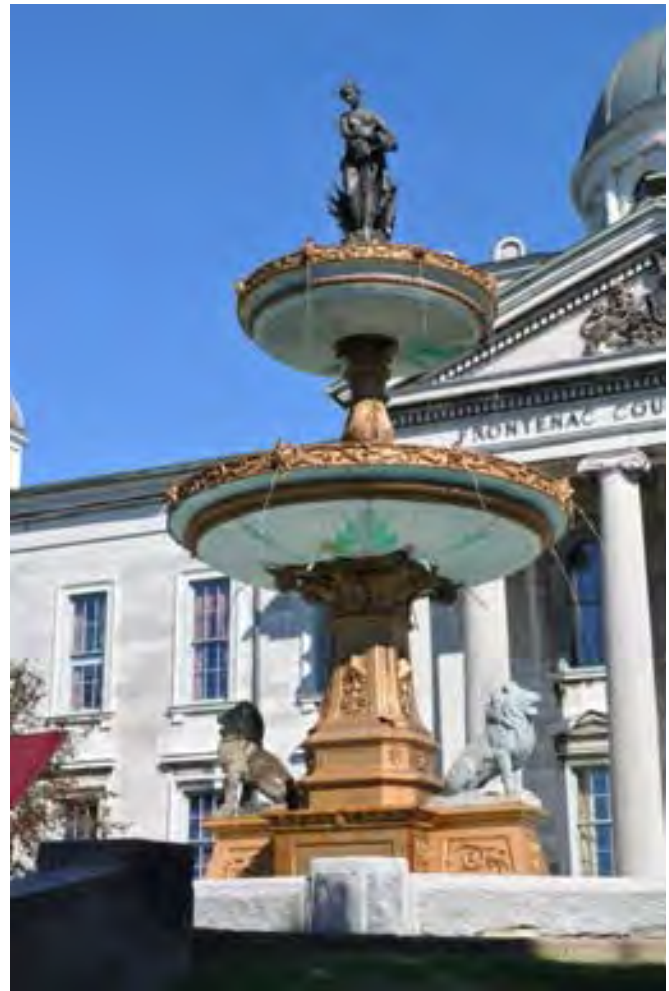
The Kirkpatrick Fountain

There are two tiers of round basins over a base guarded by a pair of seated lions surrounded by an octagonal basin and, at the fountain's top, the statue of a classical female holding an urn and sporting a shell necklace with bulrushes at her feet. She likely represents a Greek nymph associated with water, springs or fountains (Egeria was associated with the latter).*

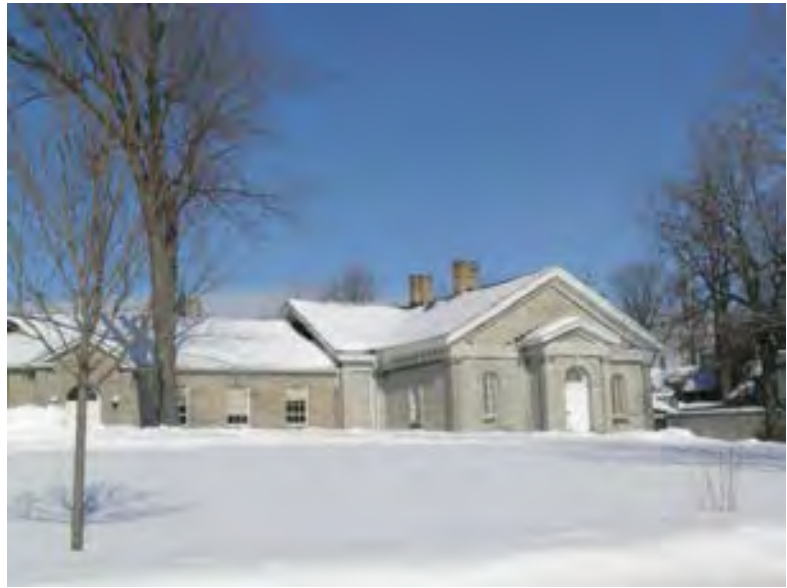
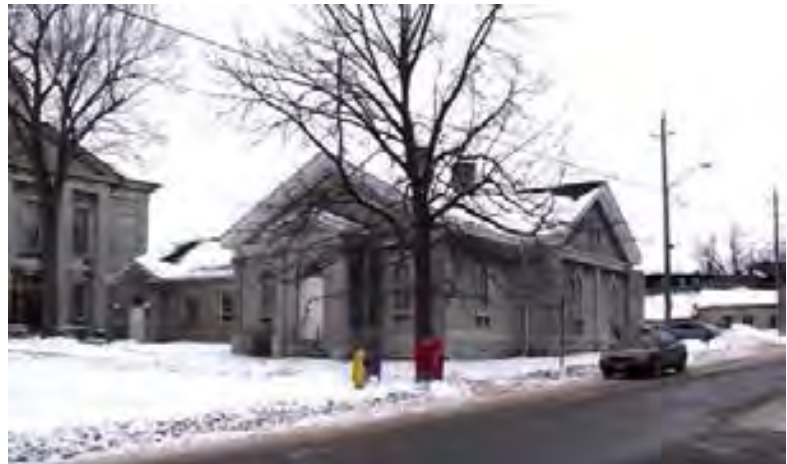
Registry Office

The registry office is of particularly fine stonework including Ionic pilasters, keystones, pediments and arched windows. The original front, facing the open land of City Park, is divided into three bays echoing the interior vaulting system. The windows and transom are protected by vertical iron bars. The east side wall, as it faces West Street, was formally designed with articulating pilasters and, within the pediment, a pair of blind, recessed, arched panels. There are three arched and barred windows along West Street including one in a parapet front, behind which is a low lean-to section.

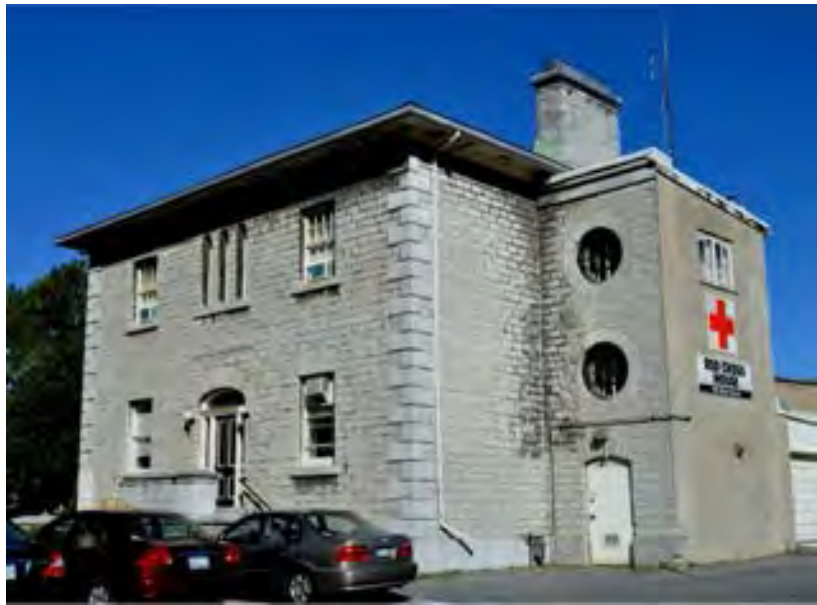
Jailor's House

The building is Classical in style (and, as such, is compatible with the court house) with emphatic symmetry and central focus on the south and north faces, which have a number of similar features. The width of the entrance doorways is balanced by the tripartite arched windows in the south facade's second storey; this window motif echoes ones found on the court house. The theme of a triad is repeated in the grouped brackets on the cornice and in the three bays in each of the south, west and north walls.

Classical balance is spoiled by the loss of one set of stone chimney stacks on the west side of the hipped roof.

Placed outside of, but adjacent to, the stone jail walls (demolished 1973), the jailor's house's formal design was meant to be seen, as one approached the court house complex from the west. Now on the east, it sits exposed with its amputated jail passageway, because a parking lot has usurped the jail, its exercise yards and protective outer walls.
